2006 CACHE CREEK STATUS REPORT AND TREND ANALYSIS

1996-2006

YOLO COUNTY

July 25, 2006

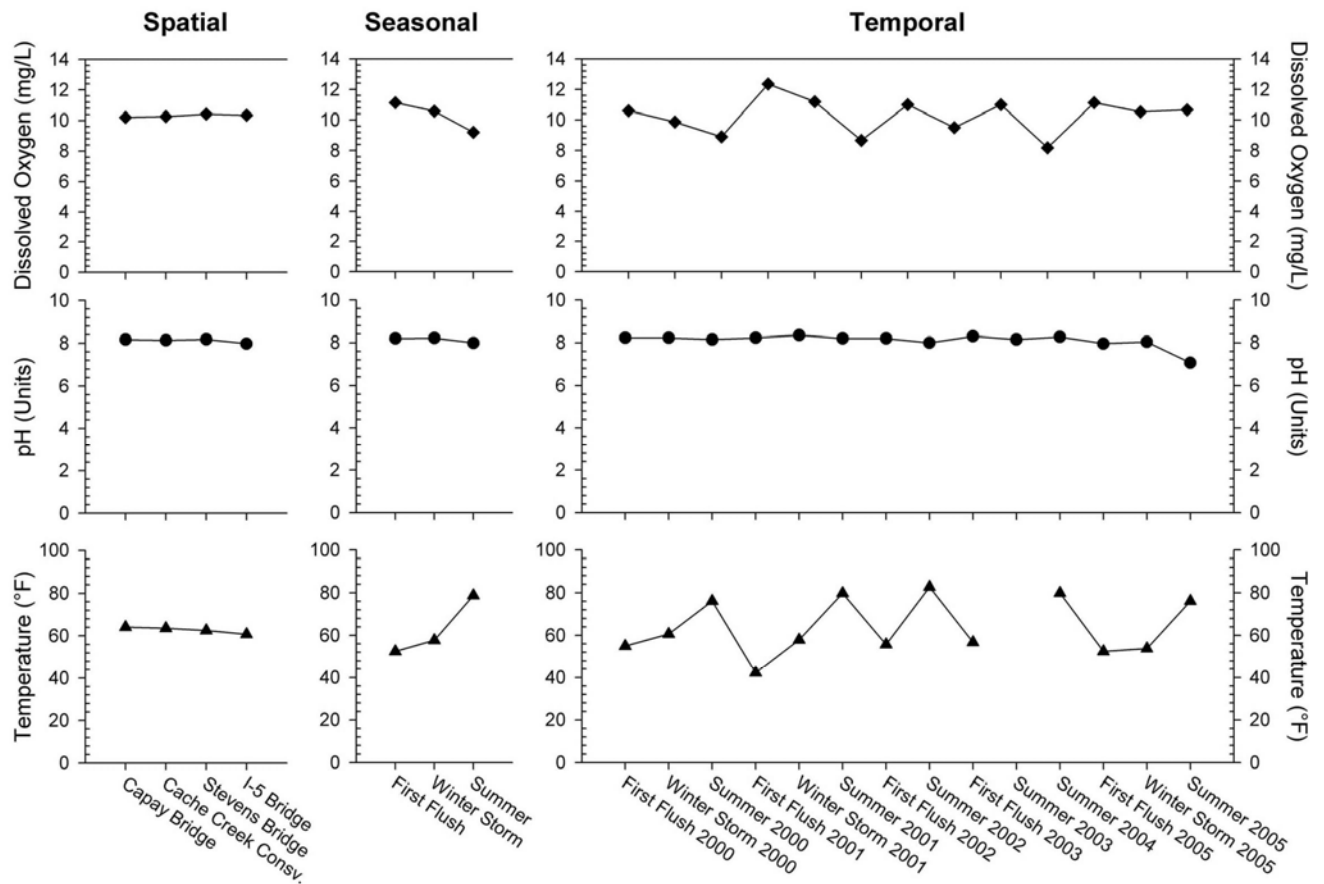
FIGURE 3-5: Dissolved oxygen, pH, and temperature data for the years 2000-2005.

pH: Little difference was observed between sample sites located directly on the creek. Gordon Slough appeared to have a significantly lower concentration. However, due to a limited data set at this site it is difficult to confirm a true difference. A slight decrease in pH during the summer was observed, which was likely due to the low results at the I-5 Bridge in Summer 2005. A possible small decrease in pH values may be developing over the last two years. The only result that did not meet the water quality criteria, in addition to the Gordon Slough samples, was the sample taken at the I-5 Bridge during Summer 2005 which had a value of 5.3.

Temperature: No trends were observed with this analysis. A slight decrease in temperature was observed upstream to downstream between sample sites located directly on the creek. Gordon Slough appeared to have a significantly higher temperature. However, due to a limited data set at this site it was difficult to confirm a true difference. An expected increase in temperature from First Flush to Summer was observed. All Summer samples exceeded the water quality criteria.

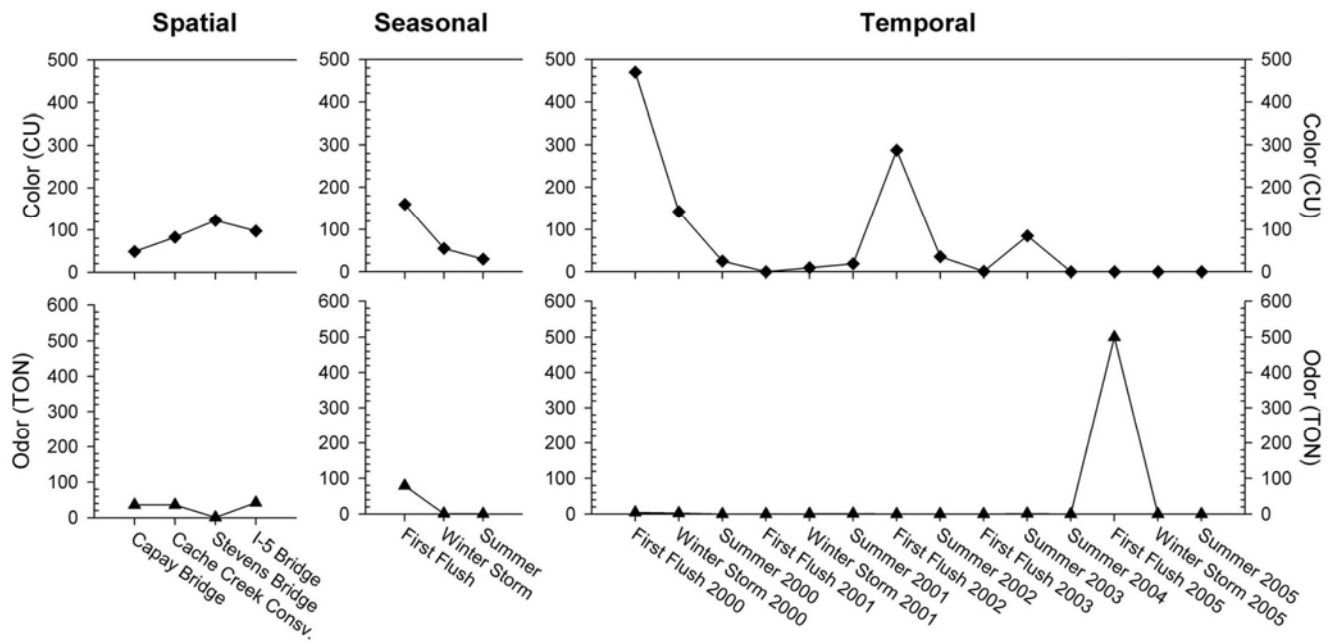
FIGURE 3-6: Color and odor data for the years 2000-2005.

Color: An increase in color from Capay Bridge to upstream of Gordon Slough to Stevens Bridge was observed, with a decrease at I-5 Bridge. Gorgon Slough had significantly lower color. However, due to a limited data set at this site it was difficult to confirm a true difference. A seasonal decrease in color was observed from First Flush to Summer. This was expected because color closely tracks suspended sediment, which is primarily controlled by available material and stream velocity. Consistent sampling with respect to the storm hydrograph would be necessary to identify trends due to its dependence to stream velocity.

Odor: No trends were observed with this analysis. A large spike in Odor was observed during the First Flush 2005 sampling, likely due to the timing of sample collection with respect to the storm hydrograph. This spike significantly skewed the results.

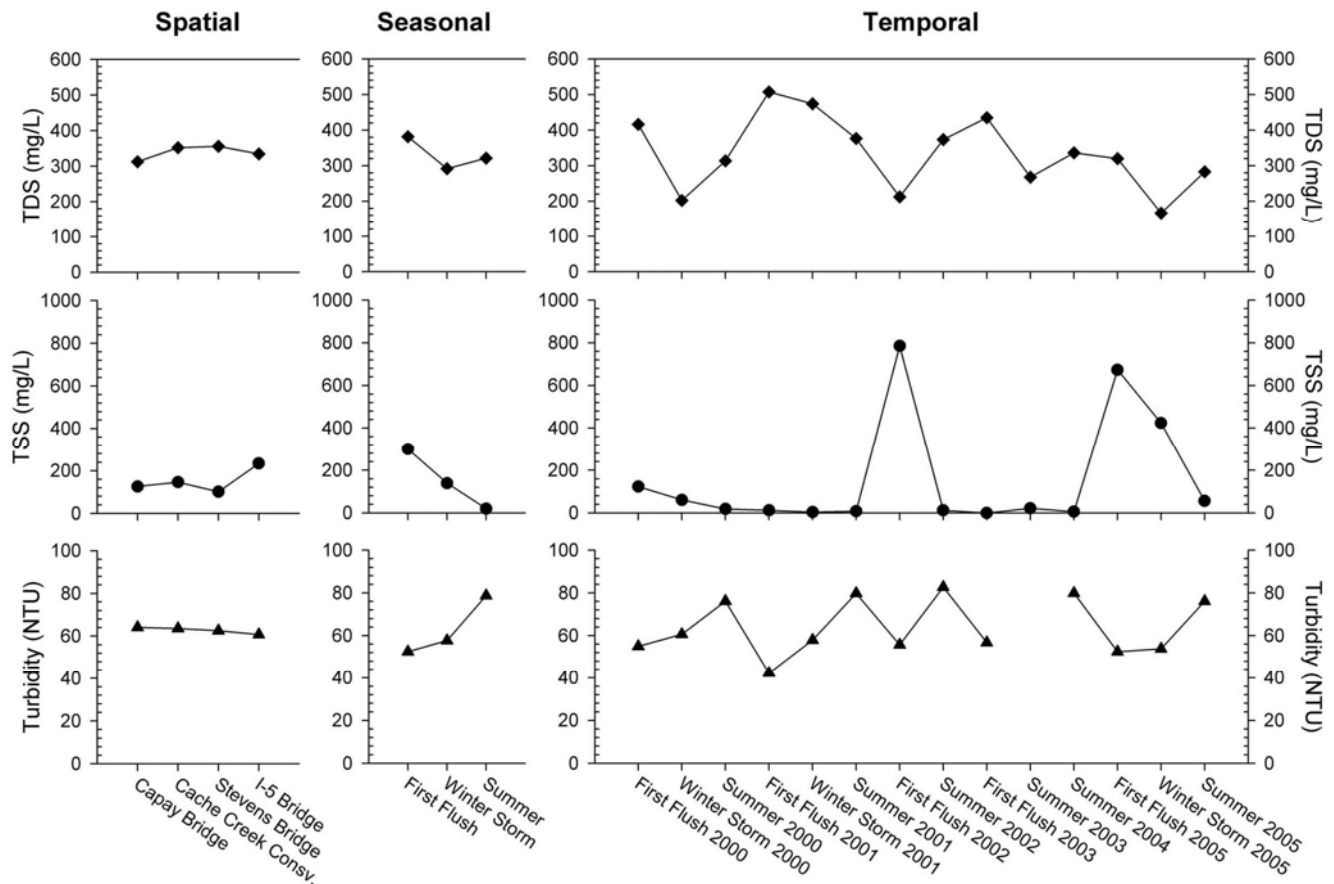
FIGURE 3-7: Total dissolved solids, total suspended solids, and turbidity data for the years 2000-2005.

Total Dissolved Solids (TDS): No trends were observed with this analysis. Concentrations remained relatively constant between sampling sites. High concentrations during First Flush were observed, likely due to flushing of the system. Low concentrations were observed during Winter Storms, probably because of dilution during higher flows. Summer concentrations were between the other two sample times, representing low-flow and already leached conditions.

Total Suspended Solids (TSS): A possible increasing trend between sites on the creek may be occurring. Stevens Bridge is significantly lower than the trend would suggest, and may be caused by not including elevated data observed during the last four sampling events. Gorgon Slough had higher concentrations. However, due to a limited data set at this site it was difficult to confirm a true difference. Concentrations decreased from First Flush to Summer samplings, as expected, due to the seasonal fluctuations of flow, which determine the availability of fine material and required velocities. The County conducted a more in-depth study of TSS in Cache Creek during 2004 and 2005. Results of this study are summarized in Section 2.9.

Turbidity: A possible increasing trend between sites on the creek may be occurring. Stevens Bridge is significantly lower than the trend would suggest, and may be caused by, not including elevated data observed during the last four sampling events. Gorgon Slough had higher concentrations. However, due to a limited data set at this site it was difficult to confirm a true difference. Turbidities decrease from First Flush to Summer samplings due to the to the seasonal fluctuations of flow, which determine the availability of fine material and required velocities. The County conducted a more in-depth study of turbidity in Cache Creek during 2004 and 2005. Results of this study are summarized in Section 2.9.

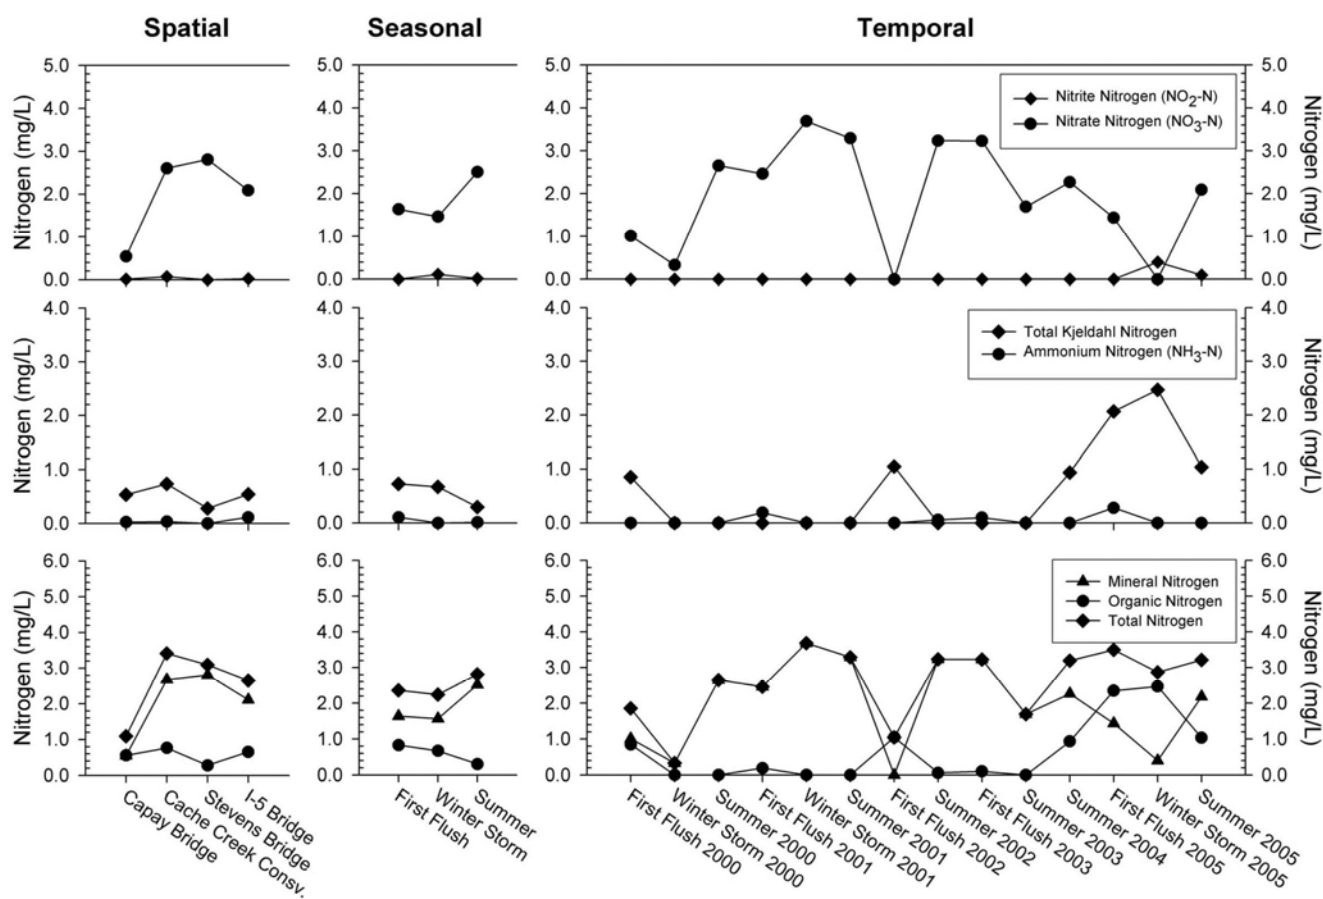
FIGURE 3-8: Nitrogen data for the years 2000-2005.

Ammonia Nitrogen: A statistical trend of increasing Ammonia Nitrogen from upstream to downstream may be occurring. It was difficult to confirm this trend due to a reduced data set for Stevens Bridge and Gordon Slough (due to a change in sampling sites) and the sporadic occurrence of ammonia above detectable limits. The First Flush samples have higher concentrations than Winter Storm or Summer samples, both of which typically do not exceed the reporting limit.

Organic Nitrogen (TKN minus Ammonia Nitrogen): Due to the relatively high concentrations of TKN to Ammonia Nitrogen, Organic Nitrogen trends are the same as discussed for TKN above.

Total Nitrogen (Sum of Mineral Nitrogen plus Organic Nitrogen): A possible increasing trend in Nitrogen was observed. Capay Bridge had the lowest observed concentration of all the sites. Upstream of Gordon Slough, Stevens Bridge and I-5 Bridge all had about the same average concentrations, while Gordon Slough was almost 50% higher. This elevated concentration at Gordon Slough was likely due to the reduced data set size and the recent acquisition of the site for sampling. First Flush and Summer have the same approximate concentrations, with Winter Storm being the lowest likely due to dilution.

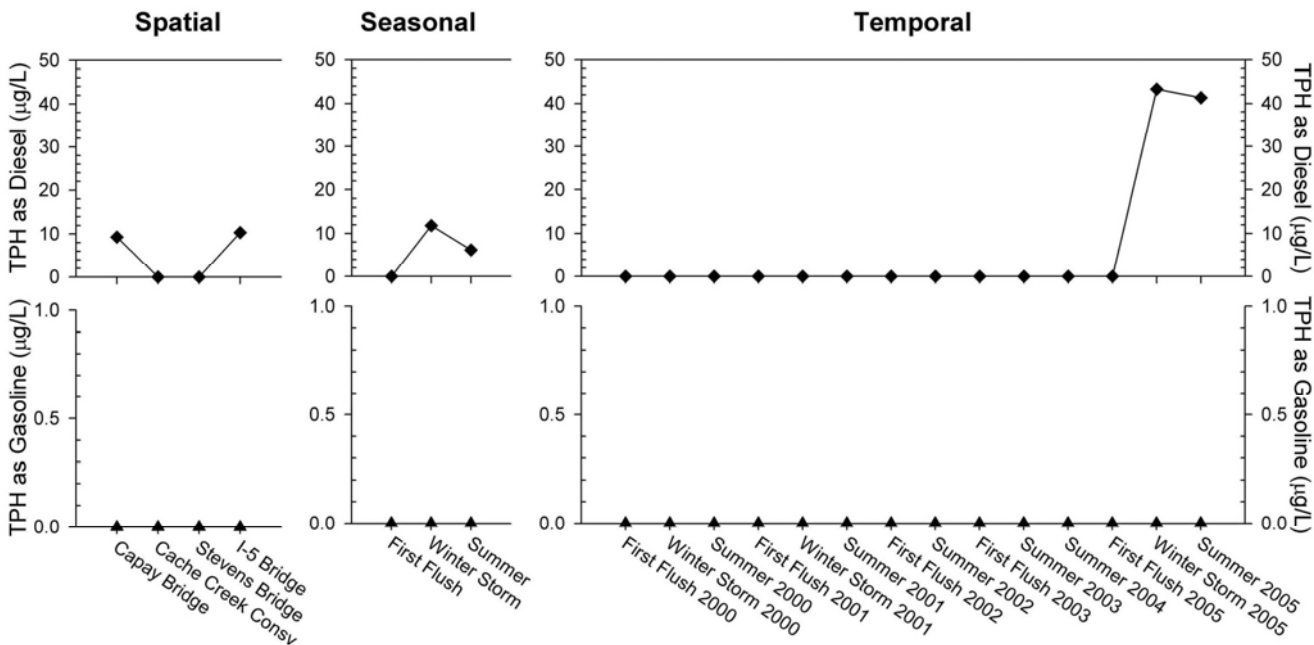
FIGURE 3-9: Petroleum data for the years 2000-2005.

Orthophosphate Phosphorus: Not detectable in any sample.

TPH as Diesel: The small available data set does not show any trends at this time. Diesel was only detected in the last three sampling events. However, the small available data set does show a flushing trend with the highest concentrations during First Flush, decreasing during Winter Storm, and the lowest in Summer. Results may be indicative of an increasing trend.

TPH as Gasoline: Not detectable in any sample.

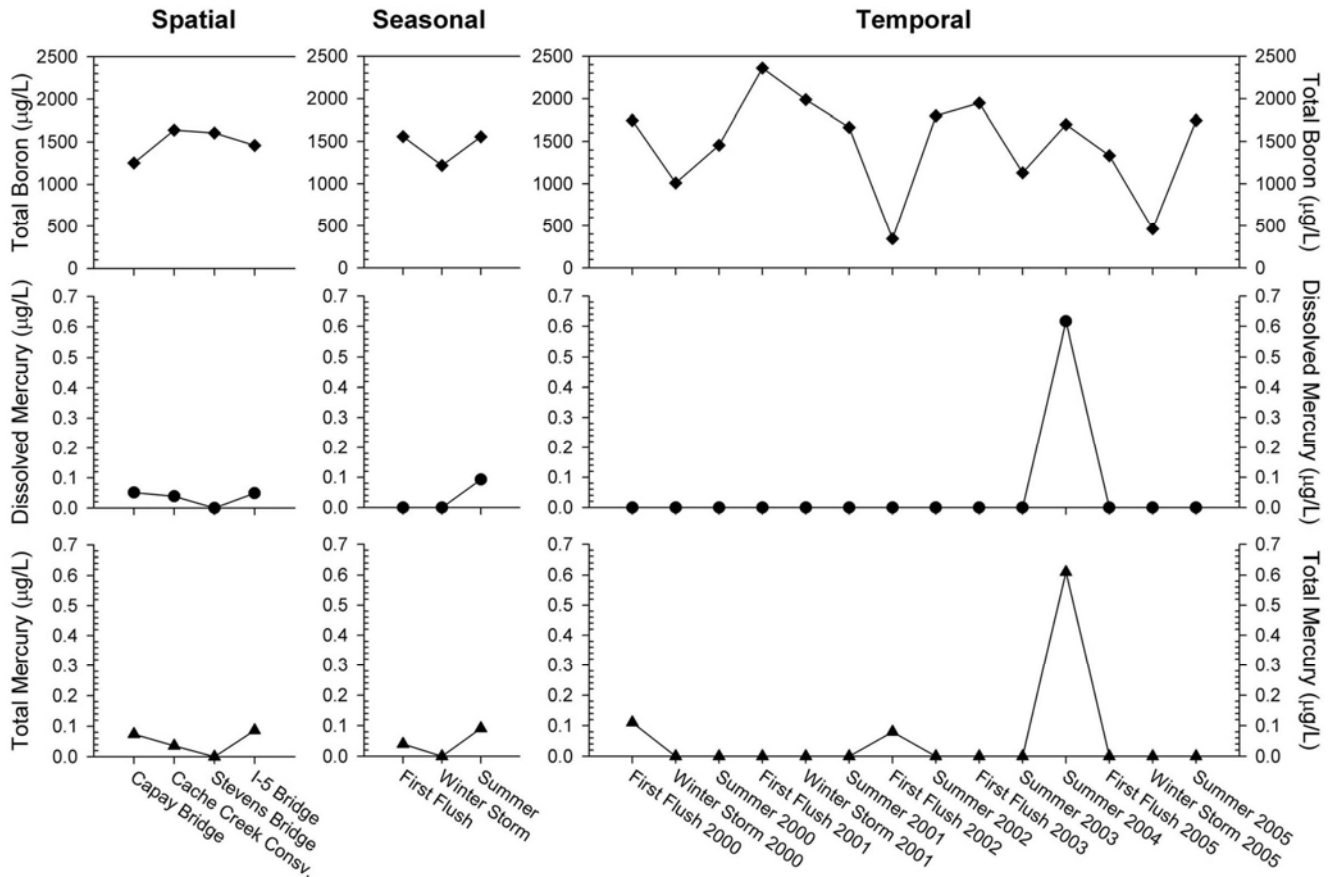
FIGURE 3-10: Boron, dissolved mercury, and total mercury data for the years 2000-2005.

Total Boron: No discernable trend was evident. All sampling events were above the 600 ug/L water quality objective except for First Flush 2002 and Winter Storm 2005. Capay Bridge and Gordon Slough average concentrations are similar and less than upstream of Gordon Slough, Stevens Bridge and I-5 Bridge which also have similar average concentrations. First Flush and Summer have the same approximate concentrations, with Winter Storm being the lowest likely due to dilution.

Total Mercury: No trends were observed with this reduced data set. However, detectable concentrations of Mercury in half of the First Flush samples do indicate a seasonal flushing trend.

Total Mercury was only detected during the First Flush 2000, 2002, 2006 and Summer 2004 sampling events. The extremely elevated concentrations observed during the Summer 2004 compared to all other samplings appear to be an anomaly at this point in time, although further investigation may be warranted. The three First Flush events had average concentrations that were similar to each other, but the Summer 2004 concentration is almost six times greater.

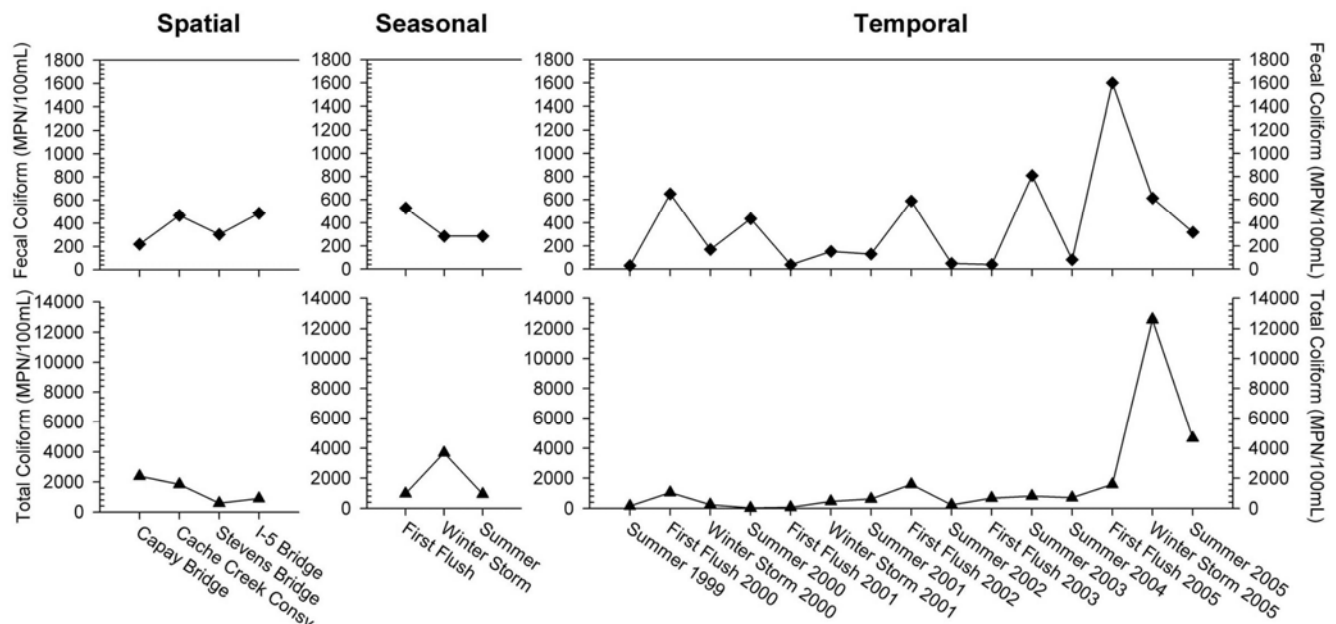
FIGURE 3-11: Bacteria data for the years 2000-2005.

Fecal Coliform: Fecal coliform levels upstream of Gordon Slough was considerably greater than average concentrations at any of the other sites. The increase may be a result of local land use practices.

Total Coliform: The increasing trend observed was primarily due to a change in analysis dilution methods, which allows for accurate detection at higher concentrations. Stevens Bridge was a factor of 10 less than the other sites, likely due to it being sampled only when the analysis had an upper reporting limit. Relatively constant average concentrations at the other four sites indicate uniformity throughout the creek system. A flushing trend may be present with the highest concentrations during First Flush, decreasing during Winter Storm, and the lowest in Summer.

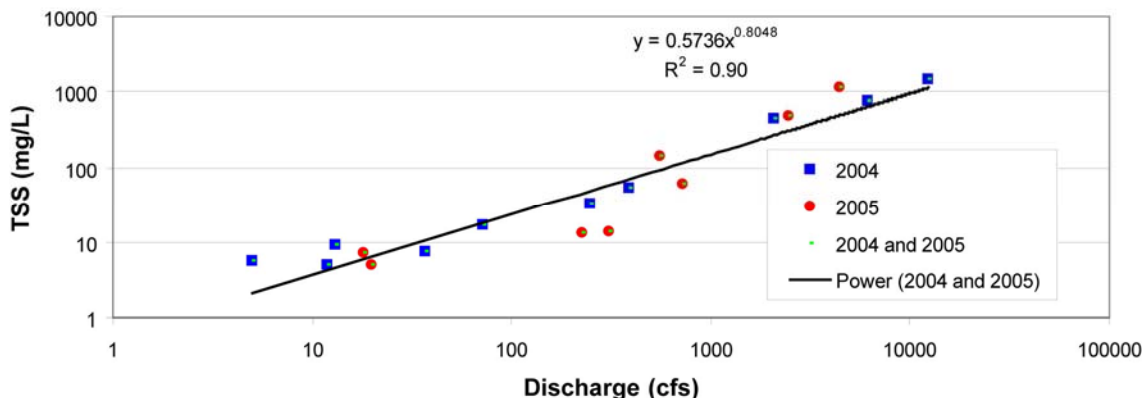
Figure 3-13: Total Suspended Solids (TSS) vs. Discharge for samples taken at County Road 99W during 2004 and 2005 monitoring periods.

Although Cache Creek is a much smaller hydraulic system than the Sacramento River, the annual average TSS concentration in Cache Creek is of similar magnitude to that of the Sacramento River measured at Freeport. Summer TSS concentrations in Cache Creek are lower than the Sacramento River, while peak winter flow values are an order of magnitude higher. Total mass of sediment passing Yolo in 2005 was 104,101 tons. This was considerably less than the quantity for 2004, which was 265,664 tons. This can be explained, in part, by the higher flow events in 2004.

Over 99% of the sediment mass flux passing Yolo for each year was associated with the two or three large flow events that occurred on Cache Creek during each wet season. There is considerable inter-annual variability in the year-to-year flux of TSS passing through Cache Creek although the County’s turbidity and TSS study shows that despite the variability, Cache Creek consistently remains so turbid that the potential increase in turbidity due to projects such as bank stabilization are so small in comparison that they are almost impossible to measure. Gordon Slough also represents a significant source of high turbidity water to Cache Creek during the summer irrigation season.
