# 2006 CACHE CREEK STATUS REPORT AND TREND ANALYSIS

**1996-2006**

## **YOLO COUNTY**

**July 25, 2006**

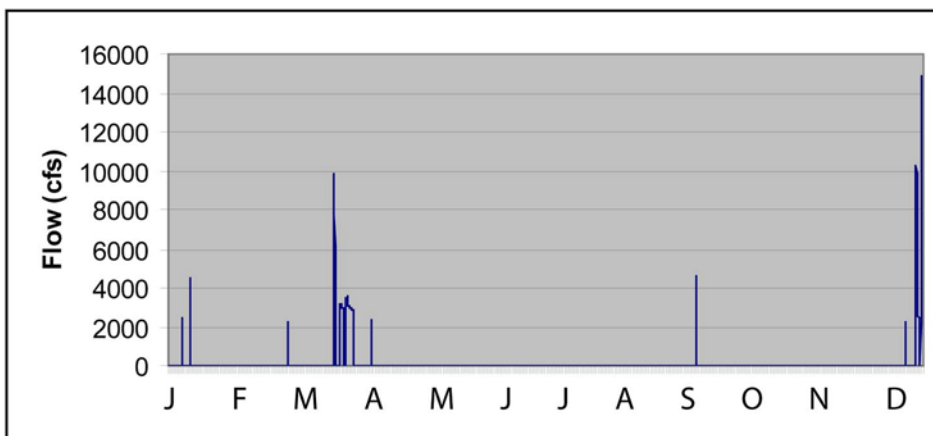
FIGURE 3-2: Cache Creek 2005 Hydrograph at the Rumsey Gage Station (DWR)

\*NOTE: Flows at the Rumsey gage were below the rating table for most of 2005.

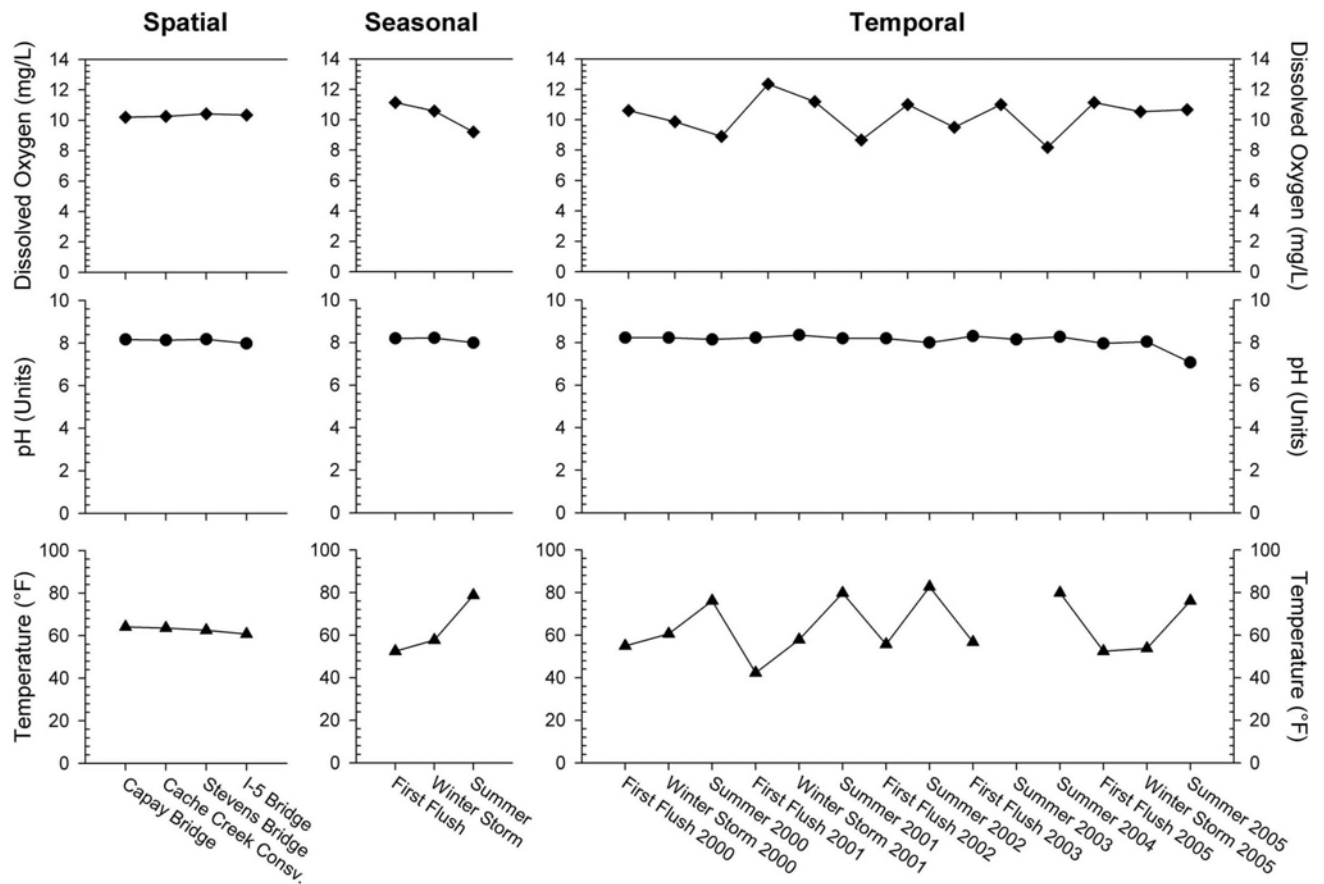
**pH:** Little difference was observed between sample sites located directly on the creek. Gordon Slough appeared to have a significantly lower concentration. However, due to a limited data set at this site it is difficult to confirm a true difference. A slight decrease in pH during the summer was observed, which was likely due to the low results at the I-5 Bridge in Summer 2005. A possible small decrease in pH values may be developing over the last two years. The only result that did not meet the water quality criteria, in addition to the Gordon Slough samples, was the sample taken at the I-5 Bridge during Summer 2005 which had a value of 5.3.

**Temperature:** No trends were observed with this analysis. A slight decrease in temperature was observed upstream to downstream between sample sites located directly on the creek. Gordon Slough appeared to have a significantly higher temperature. However, due to a limited data set at this site it was difficult to confirm a true difference. An expected increase in temperature from First Flush to Summer was observed. All Summer samples exceeded the water quality criteria.

**FIGURE 3-5:** Dissolved oxygen, pH, and temperature data for the years 2000-2005.

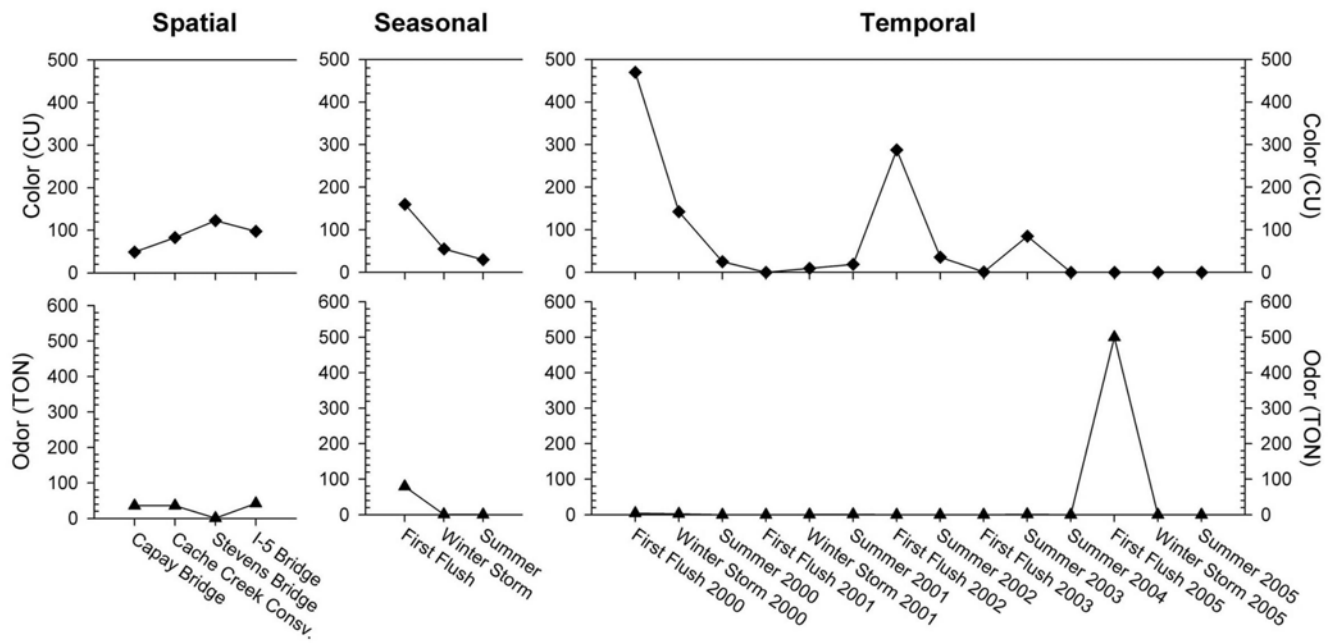
**Color:** An increase in color from Capay Bridge to upstream of Gordon Slough to Stevens Bridge was observed, with a decrease at I-5 Bridge. Gorgon Slough had significantly lower color. However, due to a limited data set at this site it was difficult to confirm a true difference. A seasonal decrease in color was observed from First Flush to Summer. This was expected because color closely tracks suspended sediment, which is primarily controlled by available material and stream velocity. Consistent sampling with respect to the storm hydrograph would be necessary to identify trends due to its dependence to stream velocity.

**Odor:** No trends were observed with this analysis. A large spike in Odor was observed during the First Flush 2005 sampling, likely due to the timing of sample collection with respect to the storm hydrograph. This spike significantly skewed the results.

FIGURE 3-6: Color and odor data for the years 2000-2005.

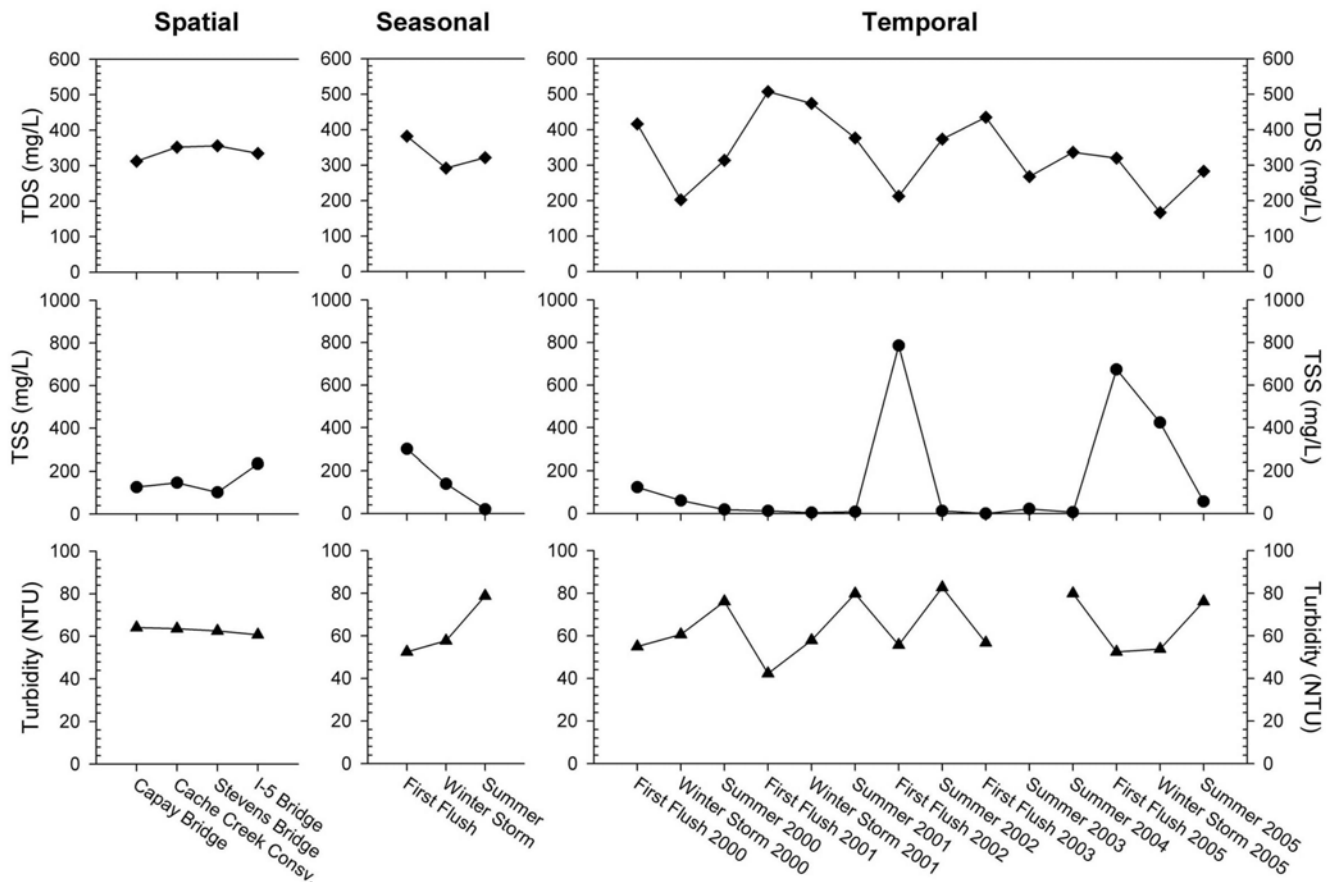
**Total Dissolved Solids (TDS):** No trends were observed with this analysis. Concentrations remained relatively constant between sampling sites. High concentrations during First Flush were observed, likely due to flushing of the system. Low concentrations were observed during Winter Storms, probably because of dilution during higher flows. Summer concentrations were between the other two sample times, representing low-flow and already leached conditions.

**Total Suspended Solids (TSS):** A possible increasing trend between sites on the creek may be occurring. Stevens Bridge is significantly lower than the trend would suggest, and may be caused by not including elevated data observed during the last four sampling events. Gorgon Slough had higher concentrations. However, due to a limited data set at this site it was difficult to confirm a true difference. Concentrations decreased from First Flush to Summer samplings, as expected, due to the seasonal fluctuations of flow, which determine the availability of fine material and required velocities. The County conducted a more in-depth study of TSS in Cache Creek during 2004 and 2005. Results of this study are summarized in Section 2.9.

**Turbidity:** A possible increasing trend between sites on the creek may be occurring. Stevens Bridge is significantly lower than the trend would suggest, and may be caused by, not including elevated data observed during the last four sampling events. Gorgon Slough had higher concentrations. However, due to a limited data set at this site it was difficult to confirm a true difference. Turbidities decrease from First Flush to Summer samplings due to the to the seasonal fluctuations of flow, which determine the availability of fine material and required velocities. The County conducted a more in-depth study of turbidity in Cache Creek during 2004 and 2005. Results of this study are summarized in Section 2.9.

**FIGURE 3-7:** Total dissolved solids, total suspended solids, and turbidity data for the years 2000-2005.

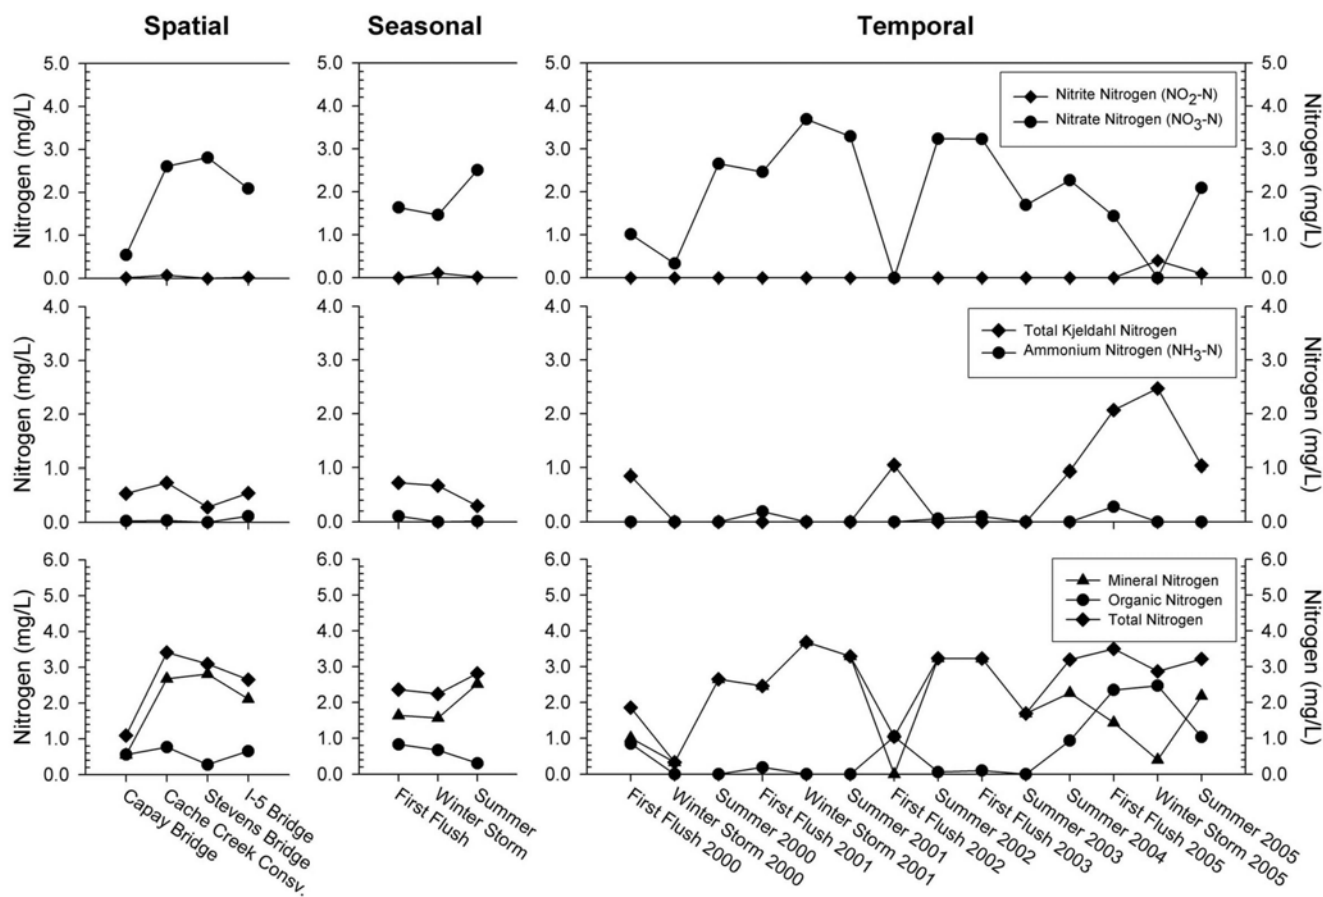
**Organic Nitrogen (TKN minus Ammonia Nitrogen):** Due to the relatively high concentrations of TKN to Ammonia Nitrogen, Organic Nitrogen trends are the same as discussed for TKN above.

**Total Nitrogen (Sum of Mineral Nitrogen plus Organic Nitrogen):** A possible increasing trend in Nitrogen was observed. Capay Bridge had the lowest observed concentration of all the sites. Upstream of Gordon Slough, Stevens Bridge and I-5 Bridge all had about the same average concentrations, while Gordon Slough was almost 50% higher. This elevated concentration at Gordon Slough was likely due to the reduced data set size and the recent acquisition of the site for sampling. First Flush and Summer have the same approximate concentrations, with Winter Storm being the lowest likely due to dilution.

FIGURE 3-8: Nitrogen data for the years 2000-2005.

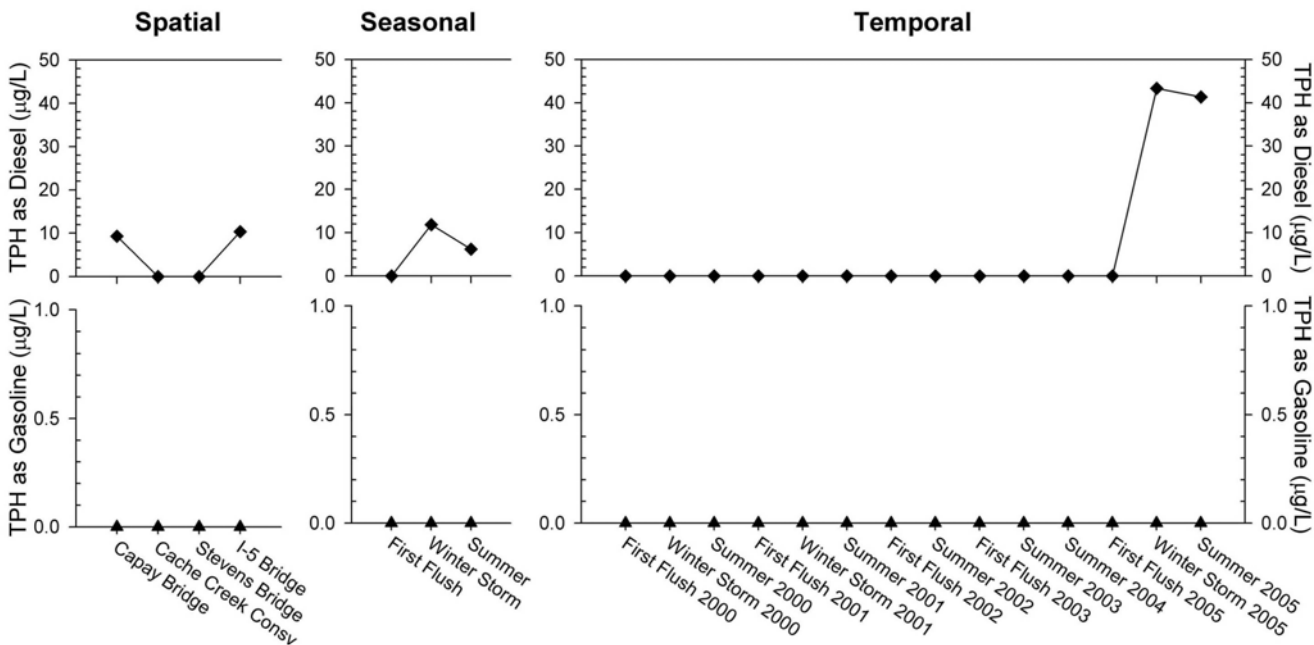
**TPH as Diesel:** The small available data set does not show any trends at this time. Diesel was only detected in the last three sampling events. However, the small available data set does show a flushing trend with the highest concentrations during First Flush, decreasing during Winter Storm, and the lowest in Summer. Results may be indicative of an increasing trend.

**FIGURE 3-9:** Petroleum data for the years 2000-2005.

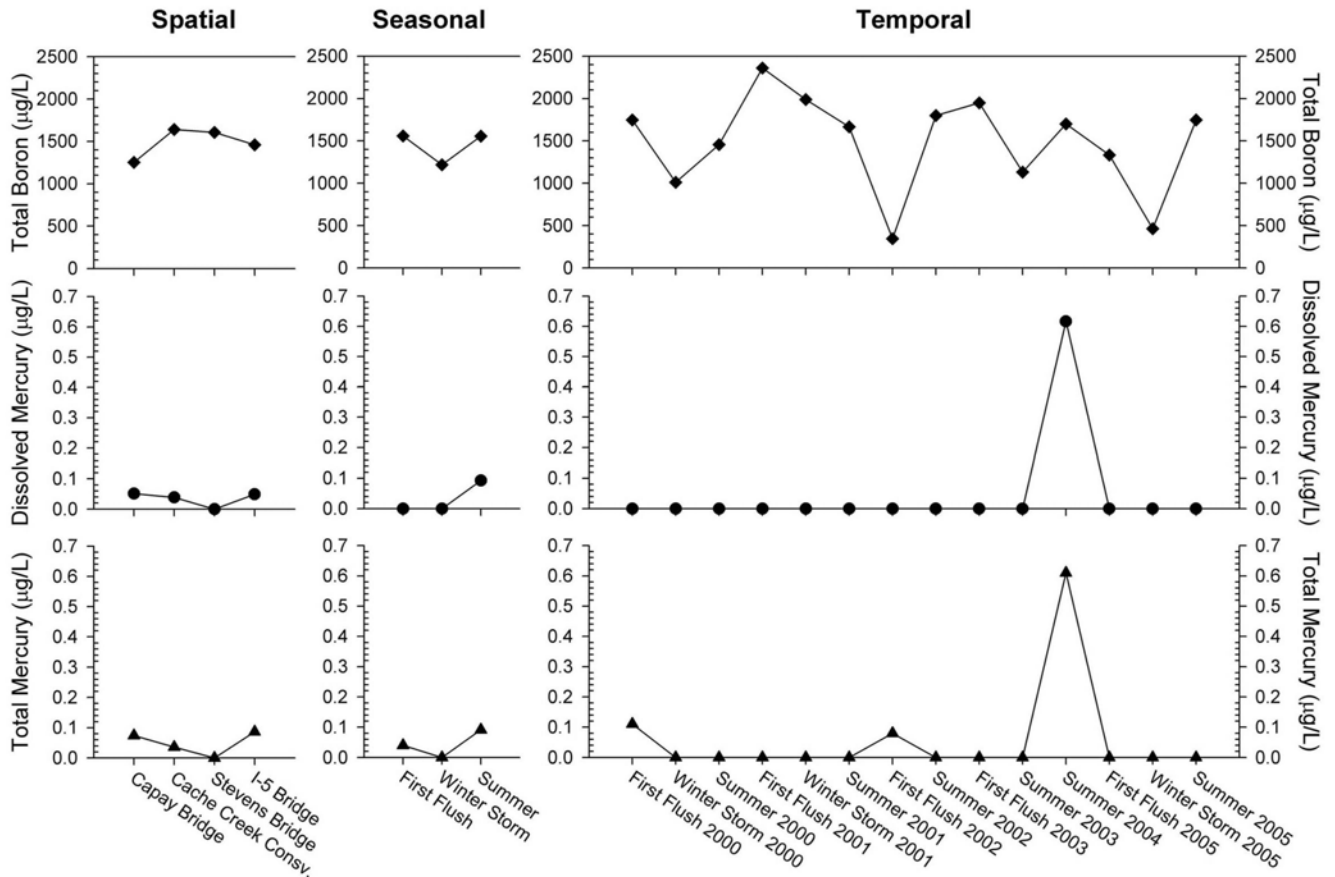
**Total Boron:** No discernable trend was evident. All sampling events were above the 600 ug/L water quality objective except for First Flush 2002 and Winter Storm 2005. Capay Bridge and Gordon Slough average concentrations are similar and less than upstream of Gordon Slough, Stevens Bridge and I-5 Bridge which also have similar average concentrations. First Flush and Summer have the same approximate concentrations, with Winter Storm being the lowest likely due to dilution.

**Total Mercury:** No trends were observed with this reduced data set. However, detectable concentrations of Mercury in half of the First Flush samples do indicate a seasonal flushing trend.

Total Mercury was only detected during the First Flush 2000, 2002, 2006 and Summer 2004 sampling events. The extremely elevated concentrations observed during the Summer 2004 compared to all other samplings appear to be an anomaly at this point in time, although further investigation may be warranted. The three First Flush events had average concentrations that were similar to each other, but the Summer 2004 concentration is almost six times greater.

**FIGURE 3-10:** Boron, dissolved mercury, and total mercury data for the years 2000-2005.

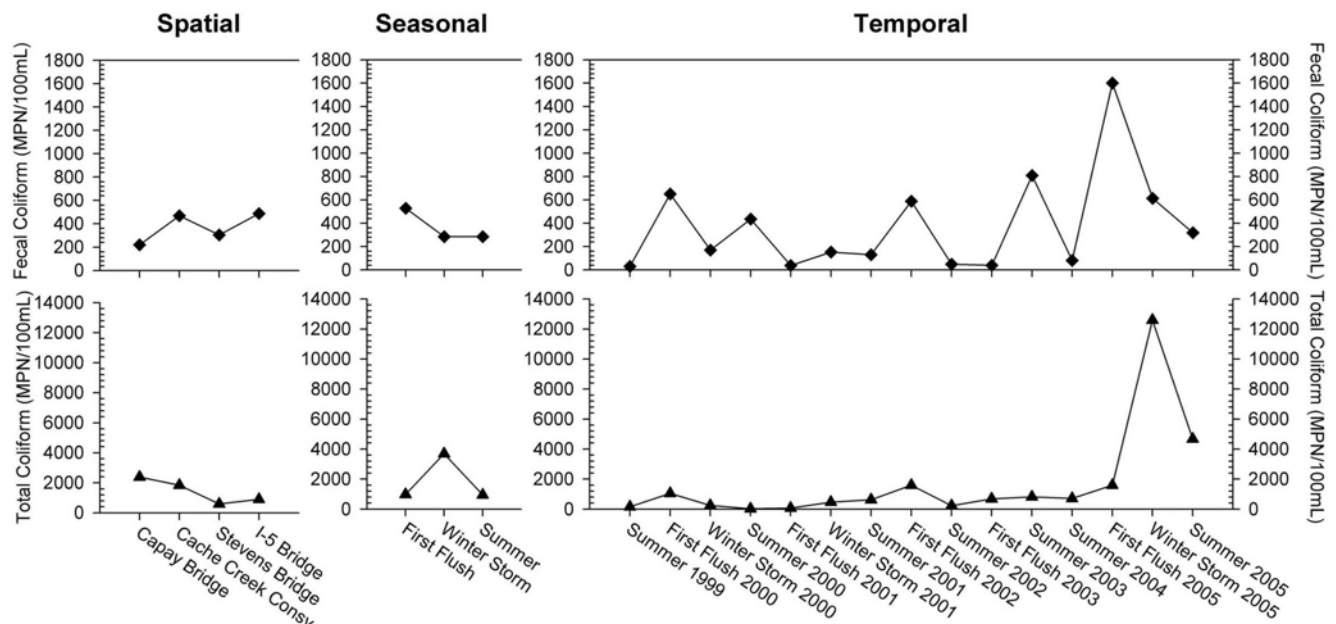
**Fecal Coliform:** Fecal coliform levels upstream of Gordon Slough was considerably greater than average concentrations at any of the other sites. The increase may be a result of local land use practices.

**Total Coliform:** The increasing trend observed was primarily due to a change in analysis dilution methods, which allows for accurate detection at higher concentrations. Stevens Bridge was a factor of 10 less than the other sites, likely due to it being sampled only when the analysis had an upper reporting limit. Relatively constant average concentrations at the other four sites indicate uniformity throughout the creek system. A flushing trend may be present with the highest concentrations during First Flush, decreasing during Winter Storm, and the lowest in Summer.

**FIGURE 3-11:** Bacteria data for the years 2000-2005.

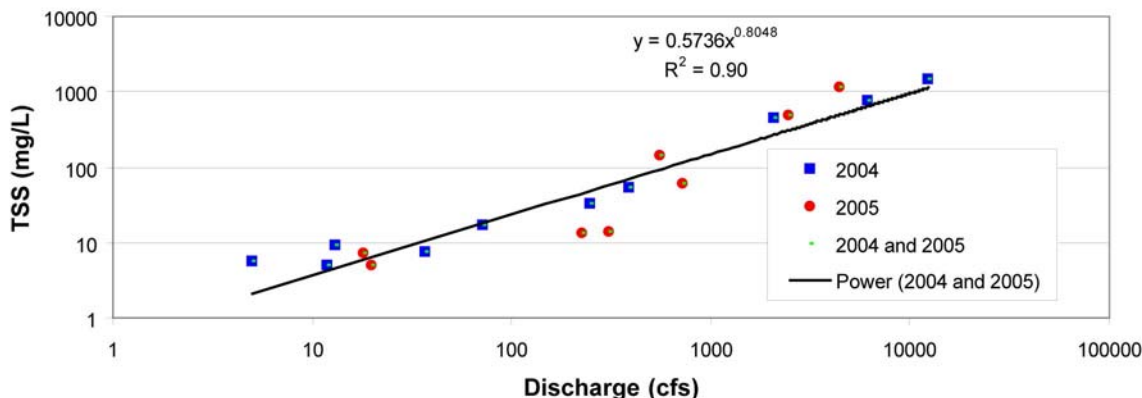
Although Cache Creek is a much smaller hydraulic system than the Sacramento River, the annual average TSS concentration in Cache Creek is of similar magnitude to that of the Sacramento River measured at Freeport. Summer TSS concentrations in Cache Creek are lower than the Sacramento River, while peak winter flow values are an order of magnitude higher. Total mass of sediment passing Yolo in 2005 was 104,101 tons. This was considerably less than the quantity for 2004, which was 265,664 tons. This can be explained, in part, by the higher flow events in 2004.

Over 99% of the sediment mass flux passing Yolo for each year was associated with the two or three large flow events that occurred on Cache Creek during each wet season. There is considerable inter-annual variability in the year-to-year flux of TSS passing through Cache Creek although the County’s turbidity and TSS study shows that despite the variability, Cache Creek consistently remains so turbid that the potential increase in turbidity due to projects such as bank stabilization are so small in comparison that they are almost impossible to measure. Gordon Slough also represents a significant source of high turbidity water to Cache Creek during the summer irrigation season.

**Figure 3-13:** Total Suspended Solids (TSS) vs. Discharge for samples taken at County Road 99W during 2004 and 2005 monitoring periods.
