**Re: Canvasback Well Pump Modification
Yolo County, California**

California American Water
Canvasback Well Pump Modifications

As-Built
Well Construction Details

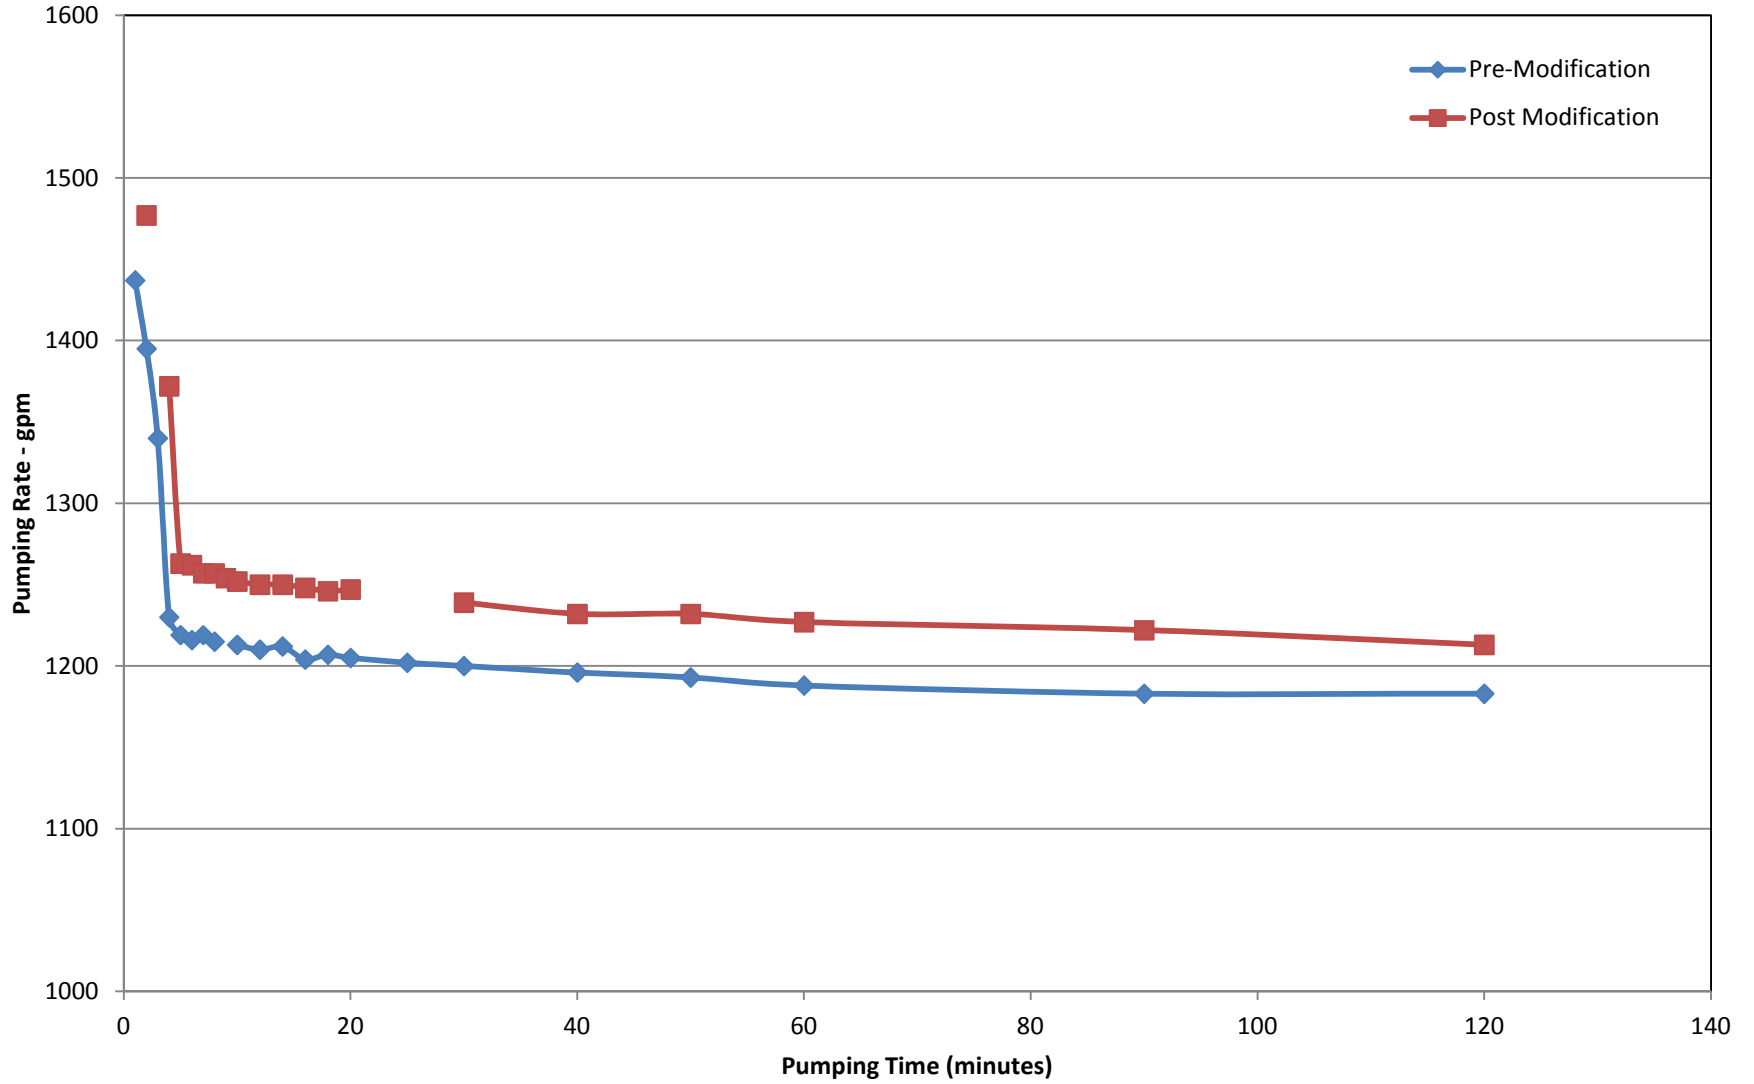
FIGURE 1
PUMPING RATE VS. TIME
PRE- AND POST- PUMP MODIFICATION

The well was pumped at an average rate of about 1,260 gpm for two hours. The slightly higher pumping rate is likely due to the static water level being at a shallower depth (less head to pump against). The pumping rate after the intake was installed was similar to the pumping rate prior to the extension of the intake, which indicates the pump contractor returned the well to a similar operating condition. Figure 1 shows the pumping rates.

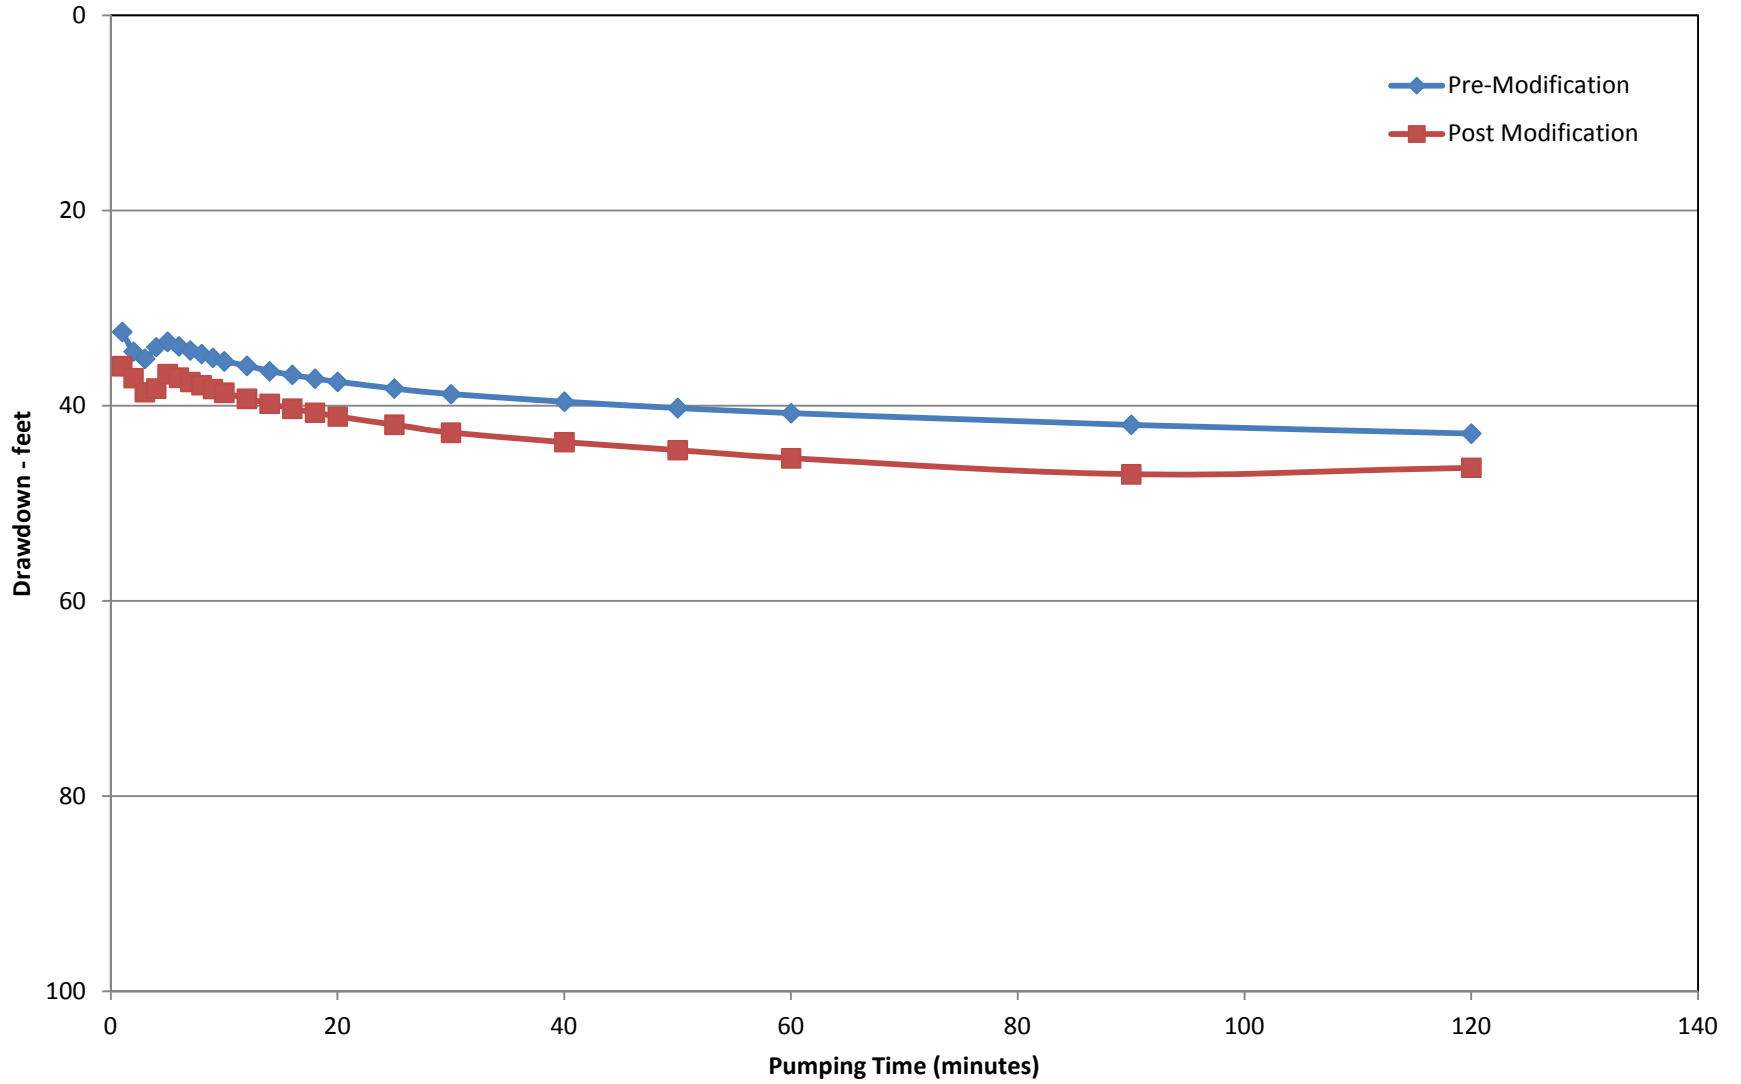
FIGURE 2
DRAWDOWN VS. TIME
PRE- AND POST- PUMP MODIFICATION

The pumping rate for the pre-pump intake modifications was lower than the post-pump intake modifications test. Because of the higher pumping rate during the post-pump intake modifications test, the drawdown was about four feet lower. Lowering the pump intake did not affect the pumping capacity. Figure 2 shows the differences between the pre- and post-pump intake modification drawdowns.

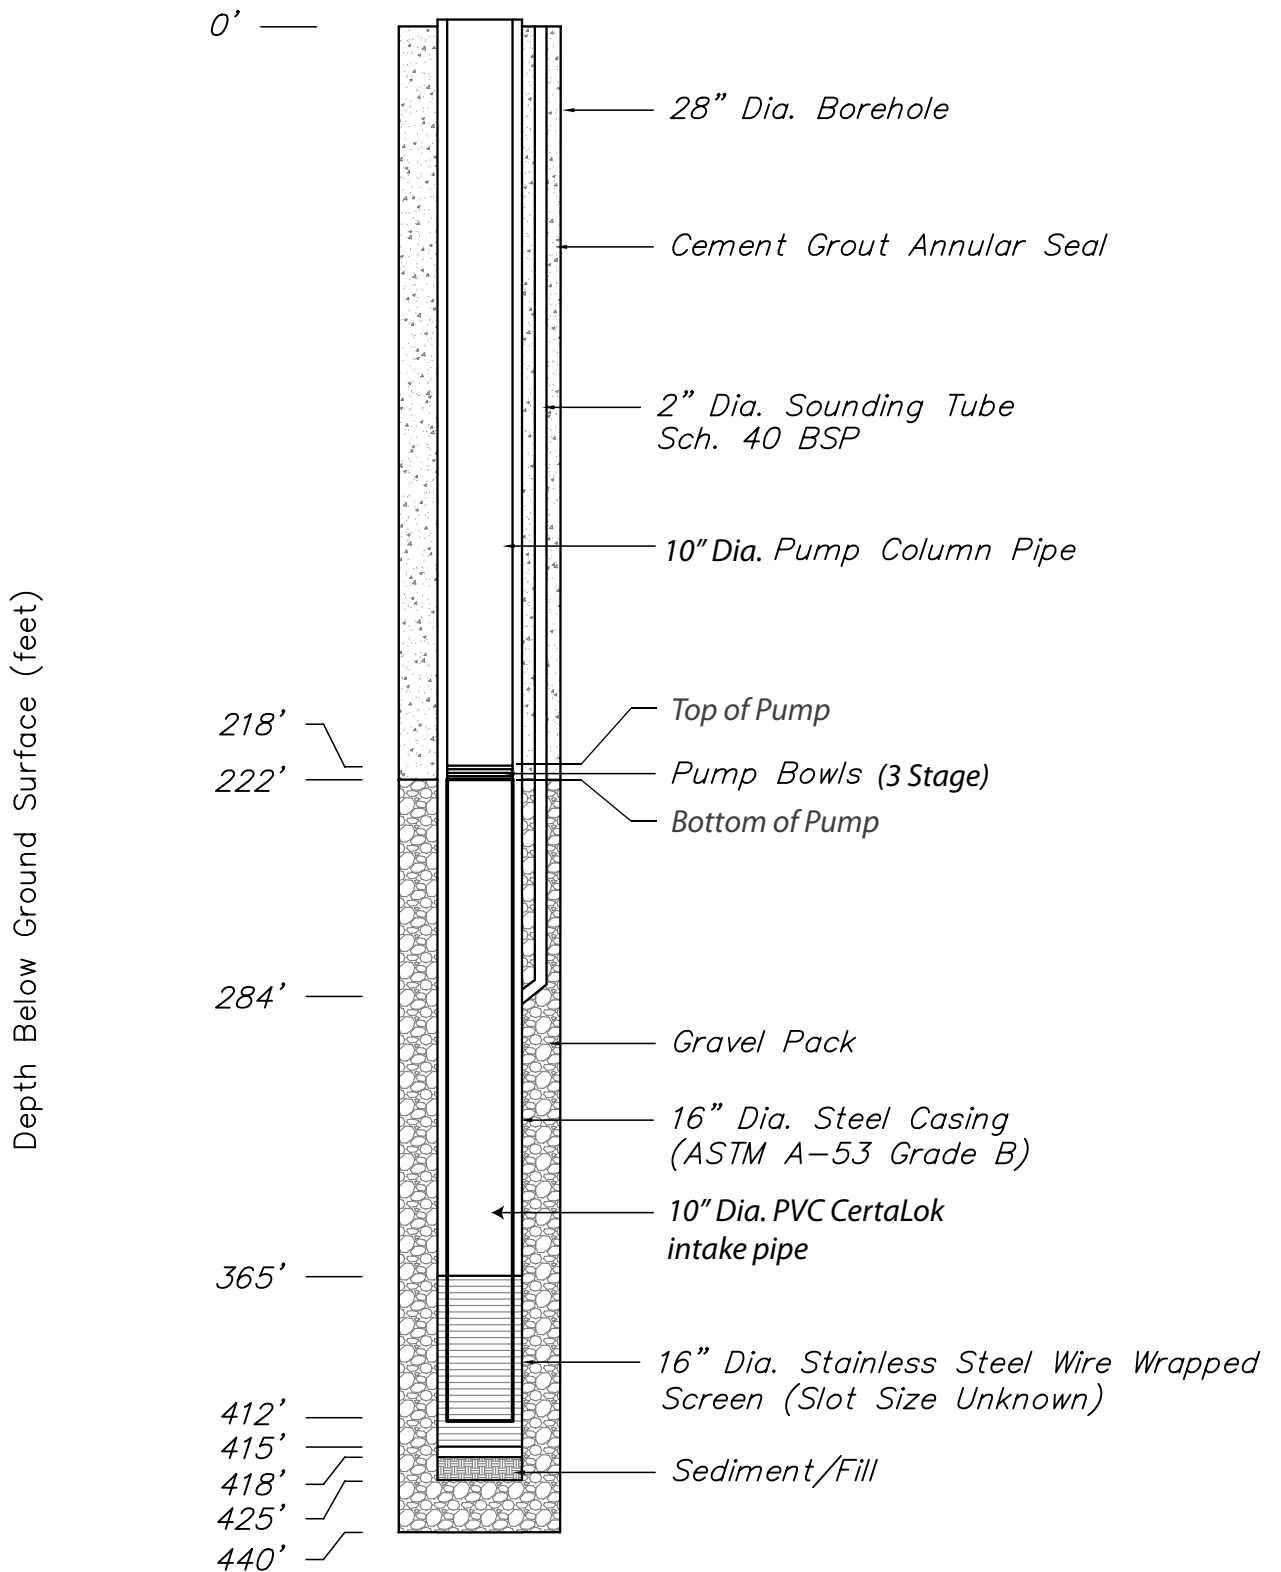
Kirby Pump & Mechanical of Rancho Cordova, California removed the pump from the well and added 190-feet of 10-inch diameter CertaLok PVC pipe to the pump intake and re-installed the pump. The intake for the pump is now at 412 feet bgs and the well's total depth is 425 feet. Figure 3 shows the modified pump details.

During the work, grommets, which center the line-shaft that drives the pump and prevents wobble, were found to have excessive wear. The new rubber grommets come from the manufacturer with a tolerance of about 0.015-inch tolerance. The grommets were measured to have a 0.050-inch tolerance, about three times the tolerance of new grommets. The pump contractor recommended replacement of the grommets as he was concerned that they could fail in the near future, which would require having to remobilize and pull the pump. The grommets were replaced during pump installation.
