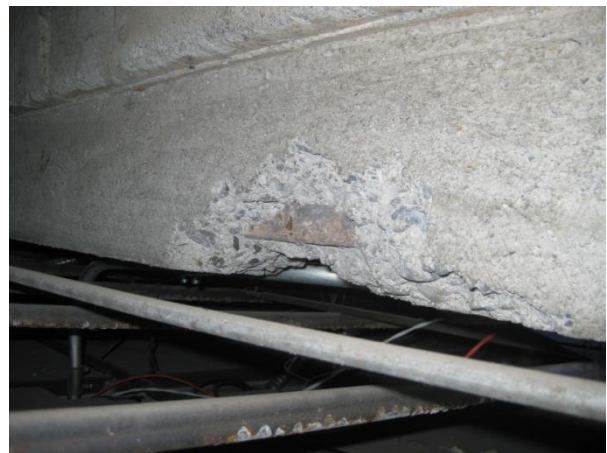
Image 72 – Exposed Rebar

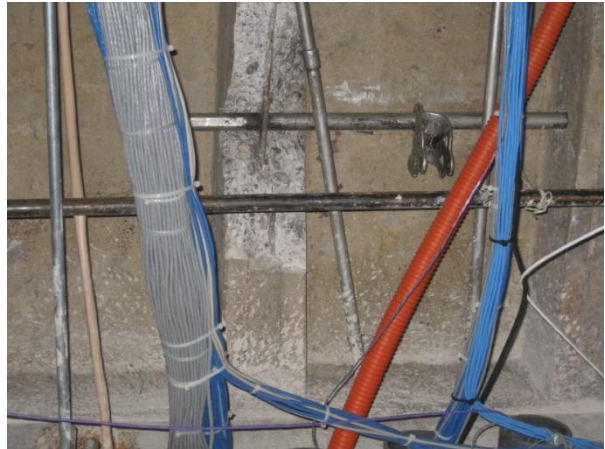
Image 74 – Exposed Rebar

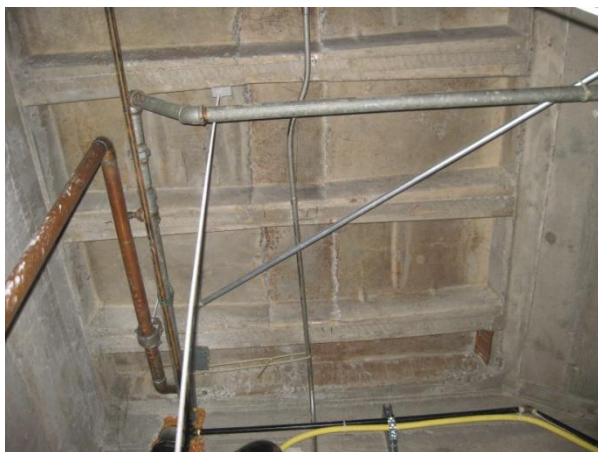
Image 75 – Un-braced Utilities

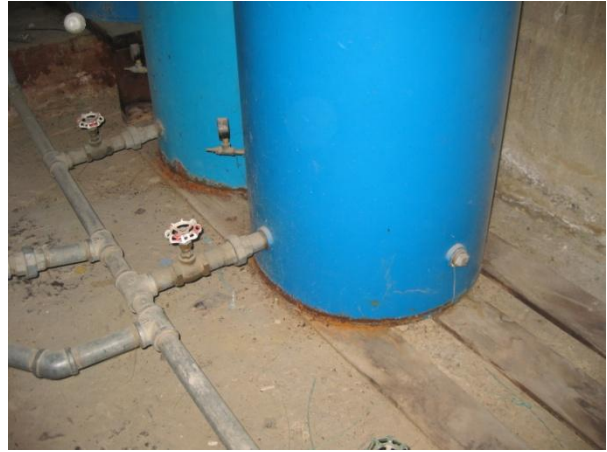
Image 78 – Tank without Base Anchorage

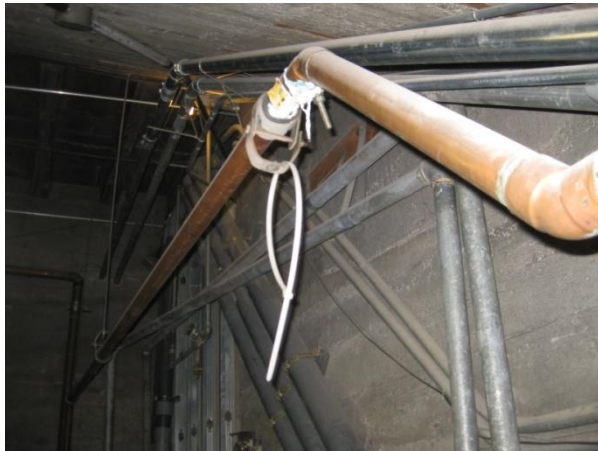
Image 79 – Un-braced Utilities

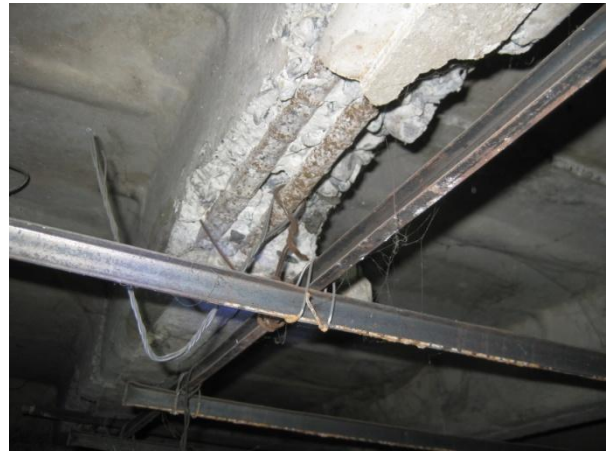
Image 80 – Exposed Rebar Supporting Ceiling Channels

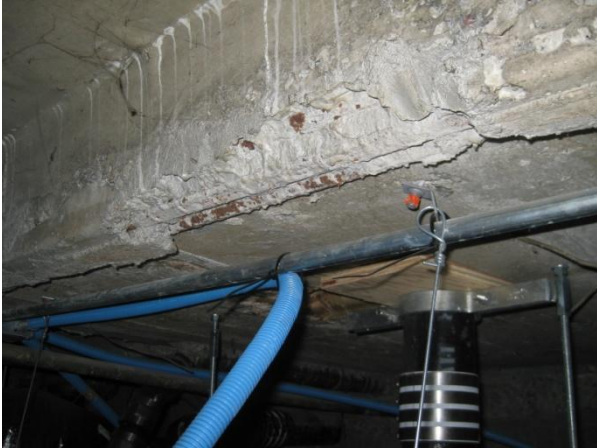
A photograph showing a ceiling area with significant water damage. The concrete is heavily cracked and peeling away, revealing the underlying rebar. Blue flexible hoses and a metal pipe are visible in the foreground, suggesting a mechanical or utility area.
<p>Image 81 – Exposed Rebar Supporting Ceiling</p>	<p>Image 82 – Exposed Rebar at Water Damage</p>

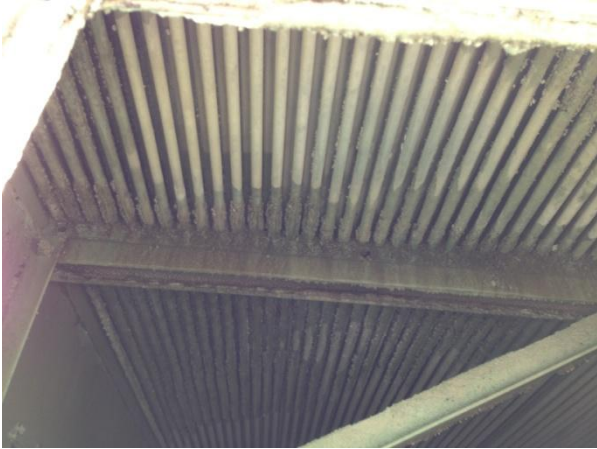
<p>Image 83 – Hollow Clay Tile</p>	<p>Image 84 – Fluid Cooler Mineral Deposit Build-up</p>
