LIONAKIS

# TABLE OF CONTENTS

Yolo County Administration Office  
625 Court Street, Room 202  
Woodland, CA 95695

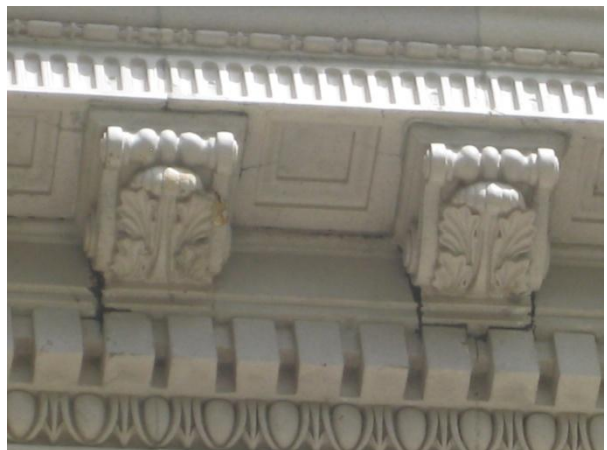
- 2) Standing water was observed over cornice overhang around the perimeter of the building. Repetitive Terra Cotta decorative elements below cornice appear shifted in some locations. Water damage at interior face of 2nd floor walls below roof was also observed. We recommend further investigation of water damage to cornice and cladding anchors. Improvements to water drainage system should be incorporated to overall building improvements.

Image 20 – Water Damage at Underside of Cornice

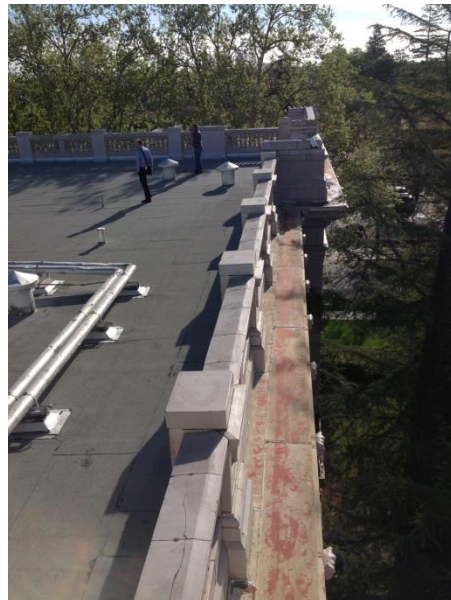
Standing water and paint deterioration was observed at the cornice overhang around the perimeter of building.

Image 28 – Worn Paint at Cornice

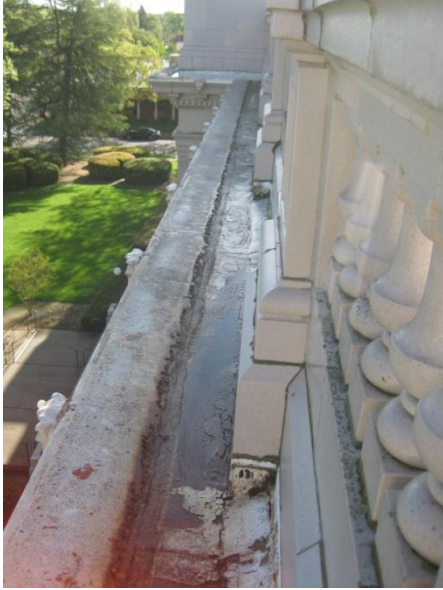
Image 29 – Standing Water at Cornice

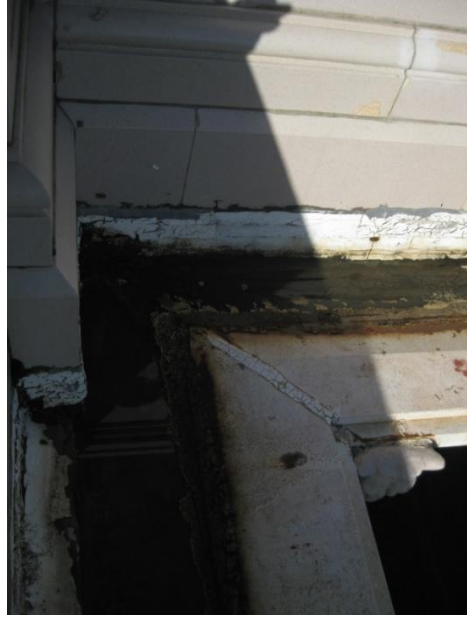
Image 30 – Standing Water at Cornice

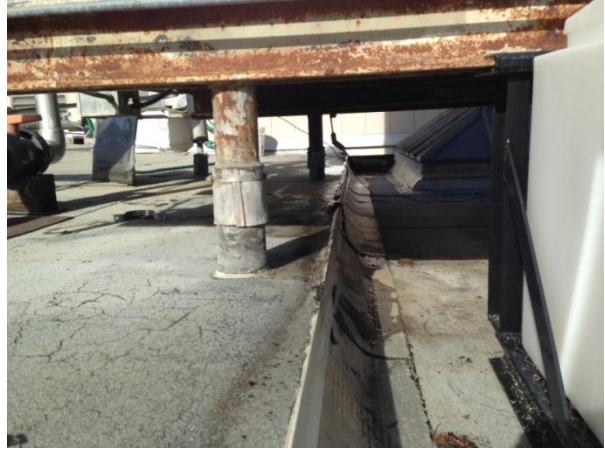
Image 42 – Fluid Cooler Leakage

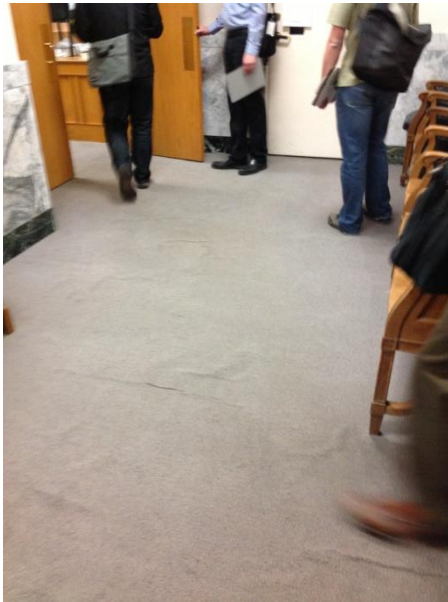
Image 51 – Worn Carpet

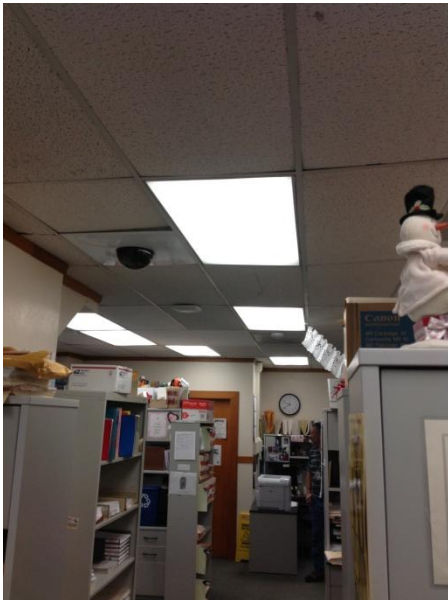
Image 67 – Damaged Ceiling Tile

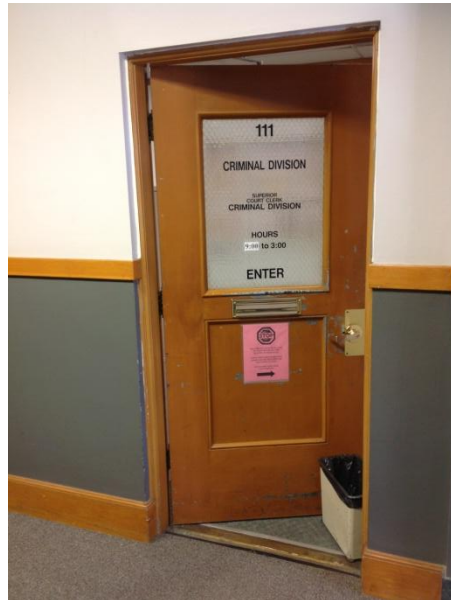
Image 68 – Finishes Worn at Door

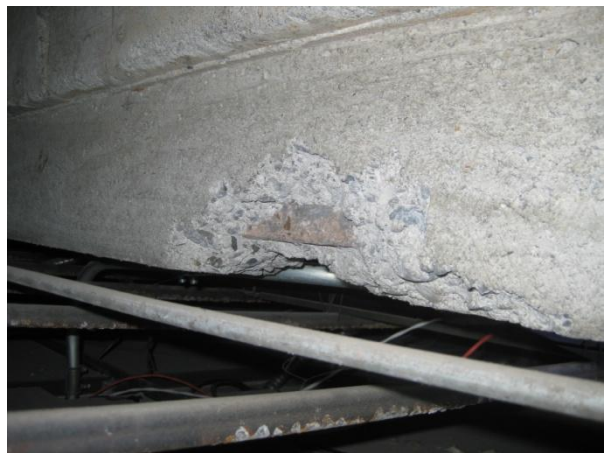
- 3) Spalled concrete with exposed rebar was observed at underside of concrete floor joist elements. The exposed rebar in some locations appears to be due to lack of consolidation in original construction. Other locations adjacent to original floor drains display evidence of past water damage. In some locations, ceilings and utilities were observed to be supported from exposed rebar. We recommend further exploration of concrete joists to determine extent of concrete damage and repairs required.

Image 72 – Exposed Rebar

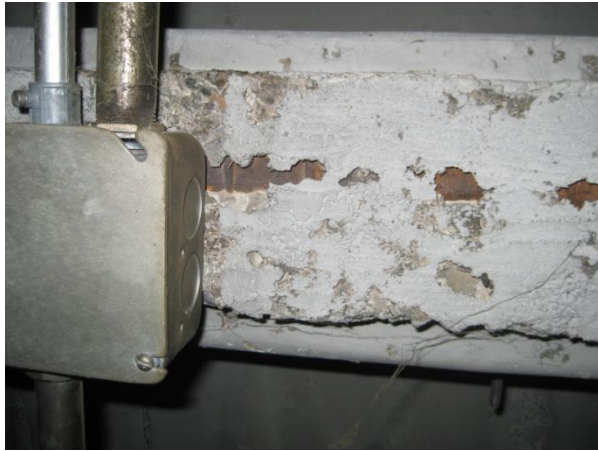
Image 73 – Exposed Rebar – Underside of Concrete Floor Joists

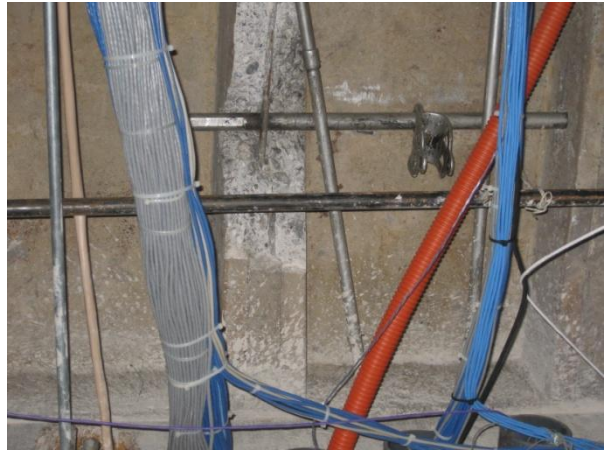
Image 74 – Exposed Rebar

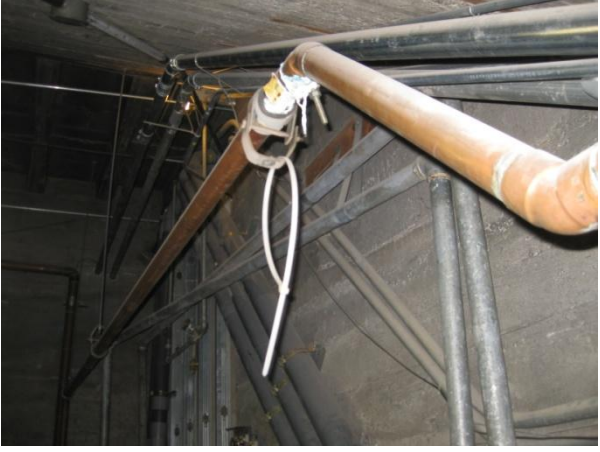
<p>Image 79 – Un-braced Utilities</p>	<p>Image 80 – Exposed Rebar Supporting Ceiling Channels</p>

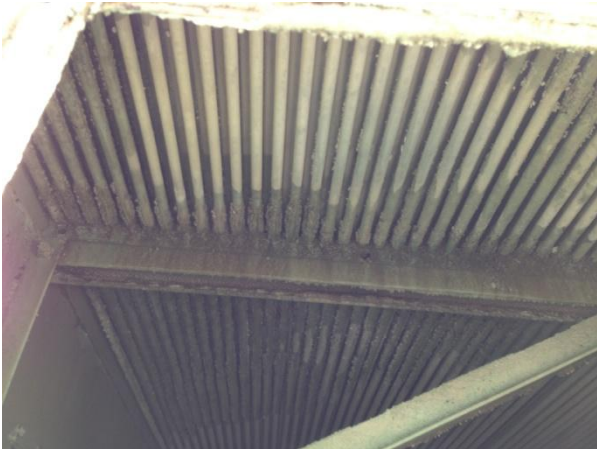
<p>Image 83 – Hollow Clay Tile</p>	<p>Image 84 – Fluid Cooler Mineral Deposit Build-up</p>
