June 16, 2016

Job No. 8596.001

**Subject: Willowbank County Service Area – Willowbank Farms, LLC Oakside Well Supplemental Well Evaluation**

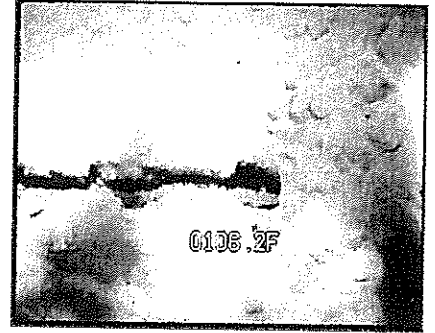
Depth: 106.2 Feet

Based on the available records and anecdotal information, the Oakside Well is constructed to a depth of at least 131 feet, with well screen starting at 106 feet below the top of casing and continuing to 131 feet, with a horizontal slot (possibly louver) pattern. The well casing is reported to have breaks (possible separation) at depths of 113 and 114 feet. The blank well casing and well screen have heavy encrustation, which is typical of older wells. The well was reported to produce upwards of 1,000 gpm over four irrigation seasons; however, no testing data (flow rate and pumping water level data) was available for review to assess this account.

WELLBORE SNAPSHOTS	DEPTHS (SideScan-Feet)	WELLBORE / CASING INFORMATION
	36.3	Static Water Level with Oil Layer
	106.2-131.0	Perforations
	113.2	Break
	114.3	Break
	131.0	Well Bottom with Fill

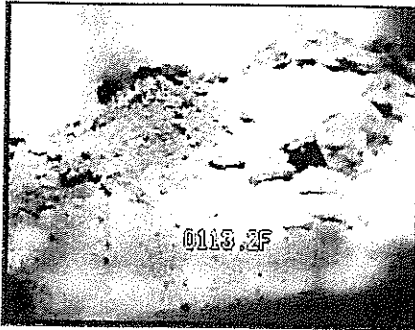
Depth: 113.2 Feet

- Static water level was observed to be 36.3 feet
- Well pump setting depth was 90 feet
- The well casing is 12-inch inside diameter
- The well casing was reported to be broken at depths of 113 and 114 feet
- Well is screened from 106 feet to 131 feet
- Total measured depth is 131 feet (top of sediment fill)
- The well casing was reported to have heavy buildup

Notes: Breaks at 113.2 and 114.3

- A site visit should be conducted to confirm the motor horsepower and to visually assess the condition of the pumping station (i.e. motor condition, electrical, discharge piping).
- Assuming adequate access for water level measurements and an existing flow meter, conduct a pumping test with the existing pump to document groundwater levels (static and pumping), flow rate, specific capacity (gallons pumped per foot of water level drawdown), and sand production.
- Obtain water samples and analyze for suitability for landscape irrigation.
- Re-assess and prepare report to the feasibility of providing landscape irrigation from this well.
