2017 CACHE CREEK ANNUAL STATUS REPORT

**** Public Review Draft – Not Yet Approved by Board of Supervisors ****

October 1, 2016 to September 30, 2017

CACHE CREEK TECHNICAL ADVISORY COMMITTEE

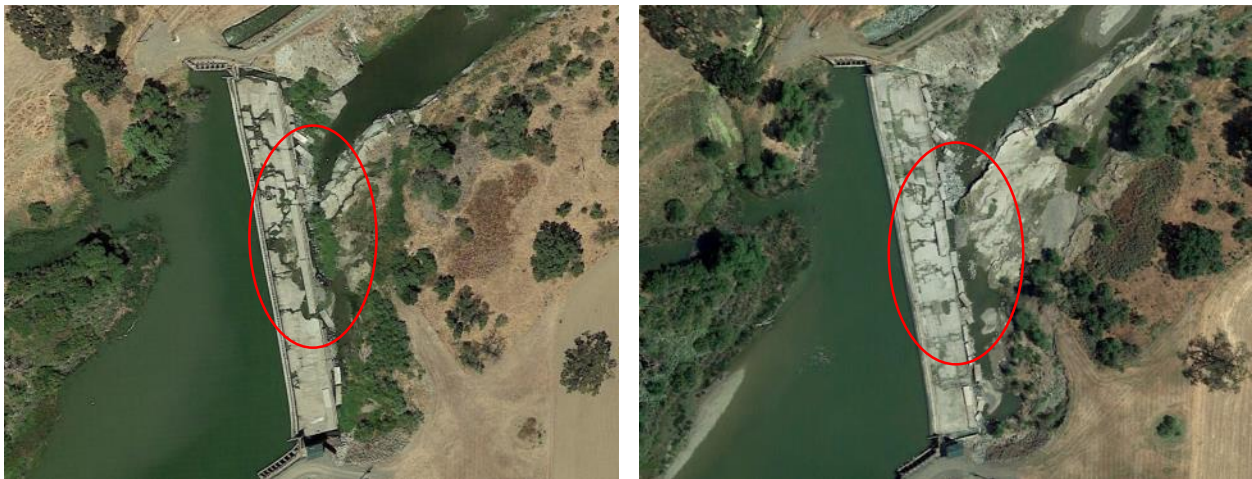
Capay Dam continues to exhibit flow-related damage to the concrete “pads” that were installed on the apron. At present there are only three to four pads left and a comparison of 2016 and 2017 imagery shows that at least nine or ten new pads were moved off the apron during winter 2016-2017 (Figure 9 and Figure 10). These will break/decay over time and will eventually be a source of debris in Cache Creek downstream.

Figure 9: Photos showing Capay Dam in 2016 (left) and 2017 (right). 2017 photo shows several additional concrete pads were forced off the dam apron. Imagery courtesy of and copyright Google 2017.

- Capay Dam – Remedies to prevent future damage of the dam and movement of the dam’s concrete pads into the channel should be undertaken.
- PG&E Palisades – The erosion control blanket and all associated infrastructure be removed and the palisades either be removed entirely or cut at or below ground level and revegetation/natural stabilization project be implemented.

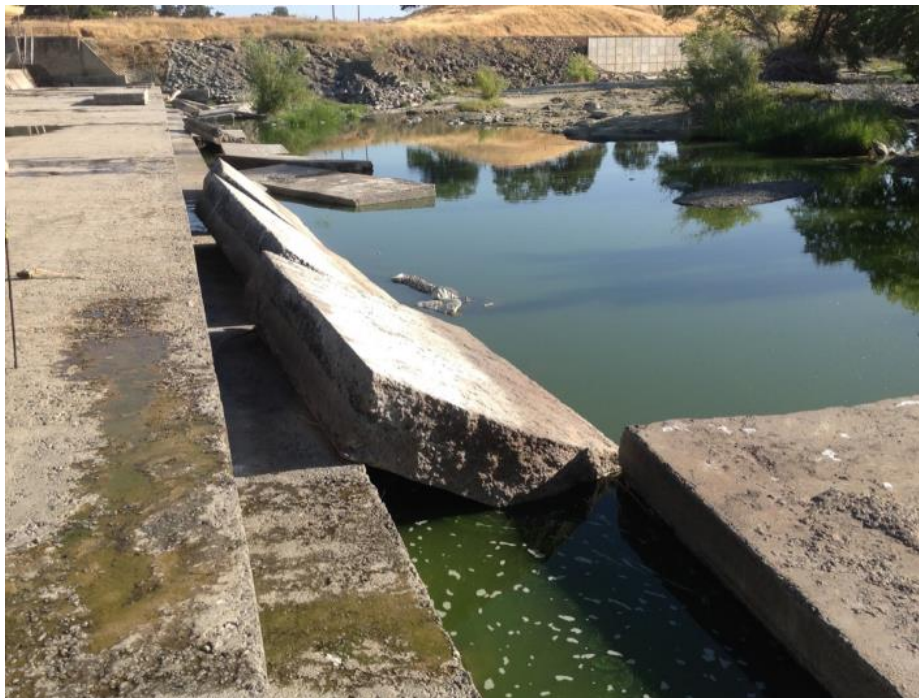
Figure 10: Photo showing concrete pads that have slid off the Capay Dam apron.

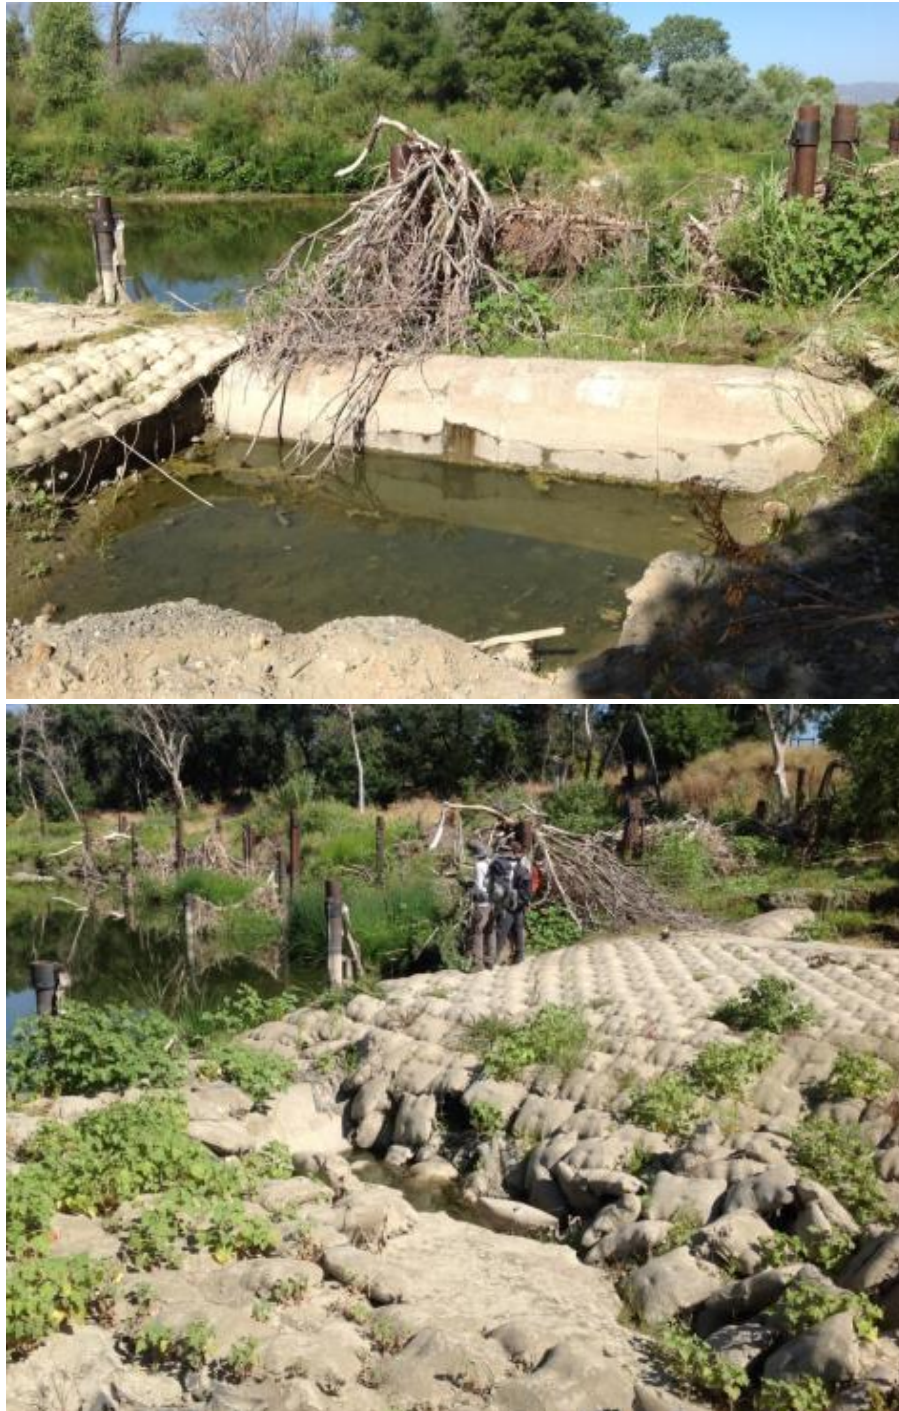
The PG&E Palisades and erosion control blanket exhibited signs of new damage from flows during winter 2016-2017. Two major scour holes were observed near a concrete pipe at the left (looking downstream) bank and in the blanket itself (Figure 11).

Figure 11: Photos showing scour holes in erosion control blanket at PG&E Palisades site.

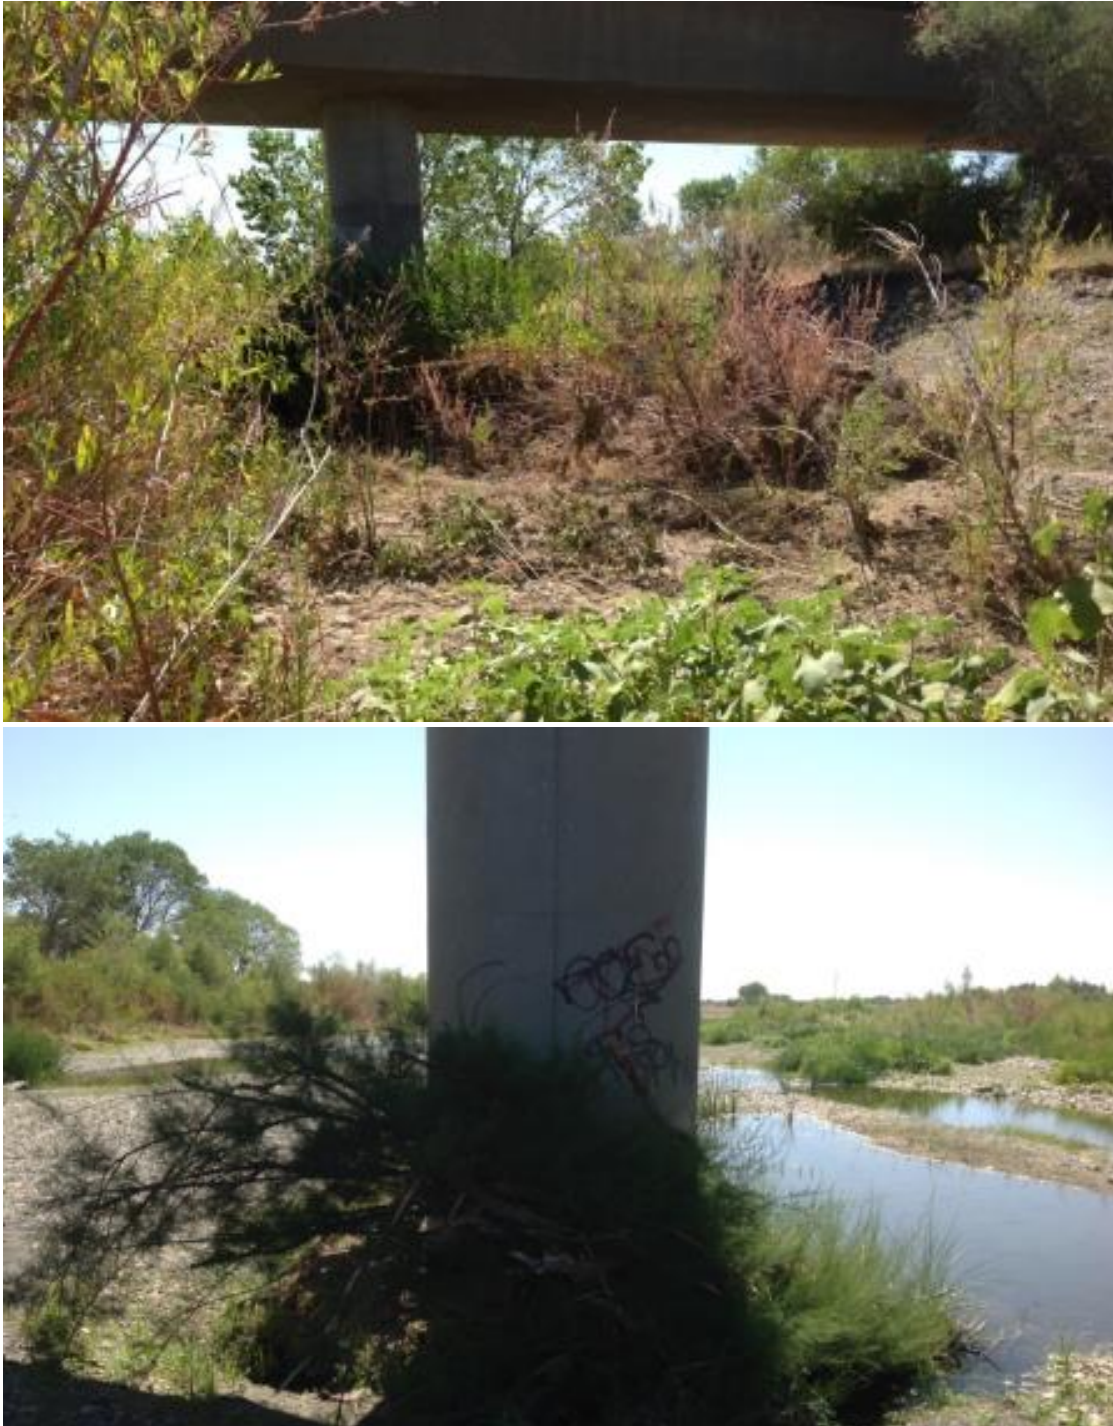
The Capay Bridge did not exhibit significant change such as the appearance of scour holes or other signs of significant sediment transport that removed vegetation during winter 2016-2017 (2).

Figure 1: Photos showing Capay Bridge. The channel bed was not significantly scoured and vegetation in the bed is clearly visible.

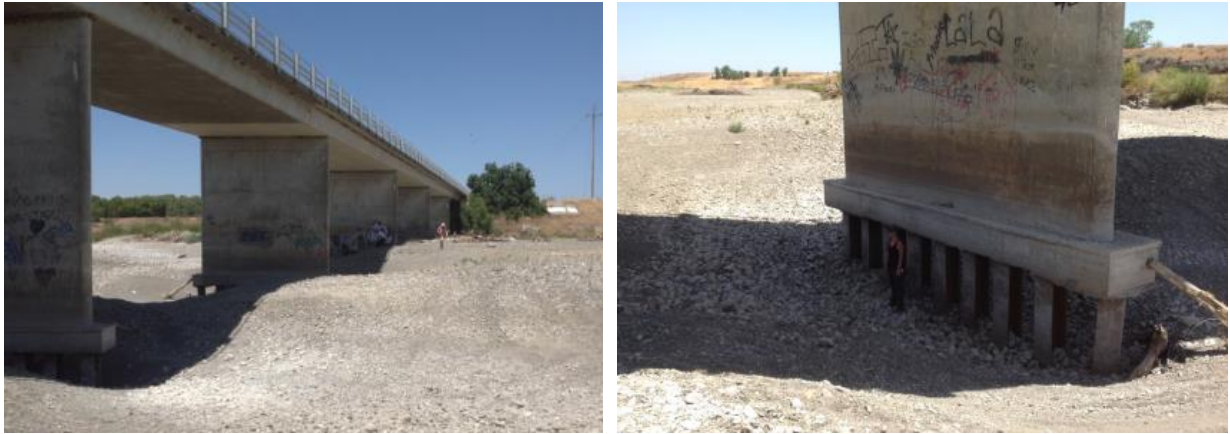
Figure 13: Photos showing undercut Esparto Bridge piers with member of County staff for scale (right photo).

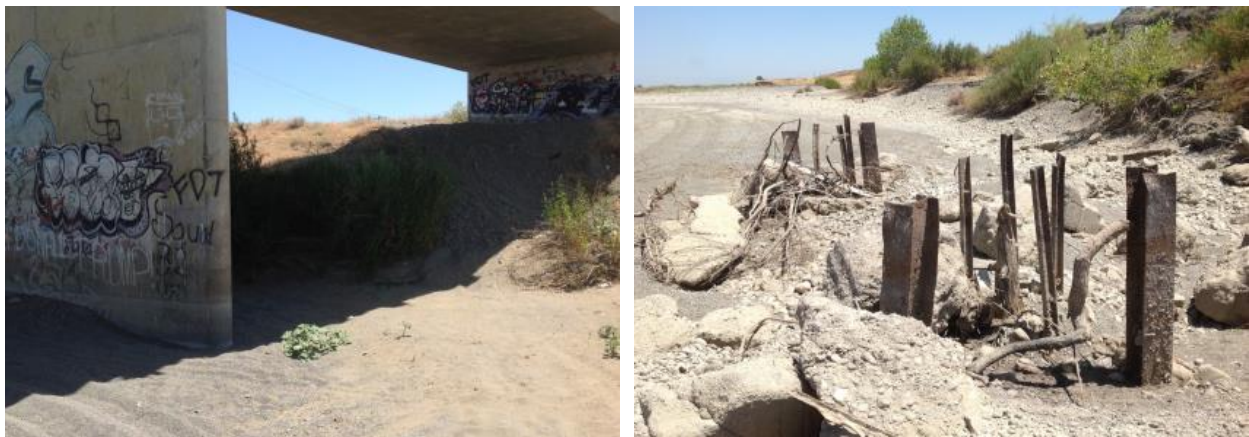
Finally, immediately downstream of the bridge, on the right side, there were approximately twelve steel I-beams protruding from the channel bed that could pose a safety hazard (Figure 14).

Figure 14: Photos showing un-scoured piers (left) and protruding steel piles immediately downstream of Esparto Bridge (right).

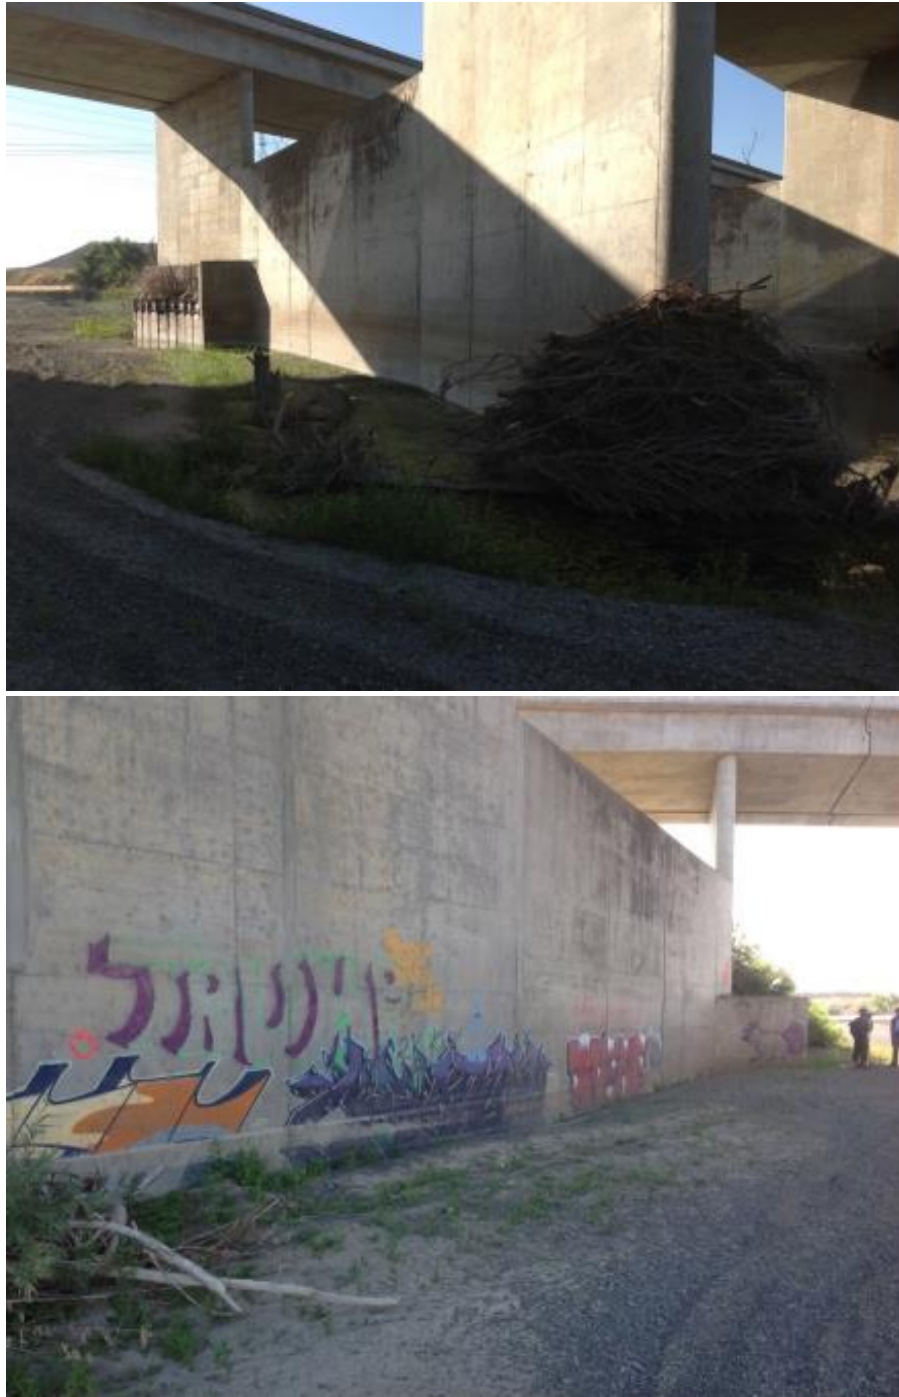
There was significant debris accumulation at the I-505 Bridge, particularly on the upstream ends of piers (Figure 15). Much of the streambed was cleared of vegetation by flows during the winter and no undercutting of pier bottoms was observed.

Figure 15: Photos showing I-505 Bridge piers.

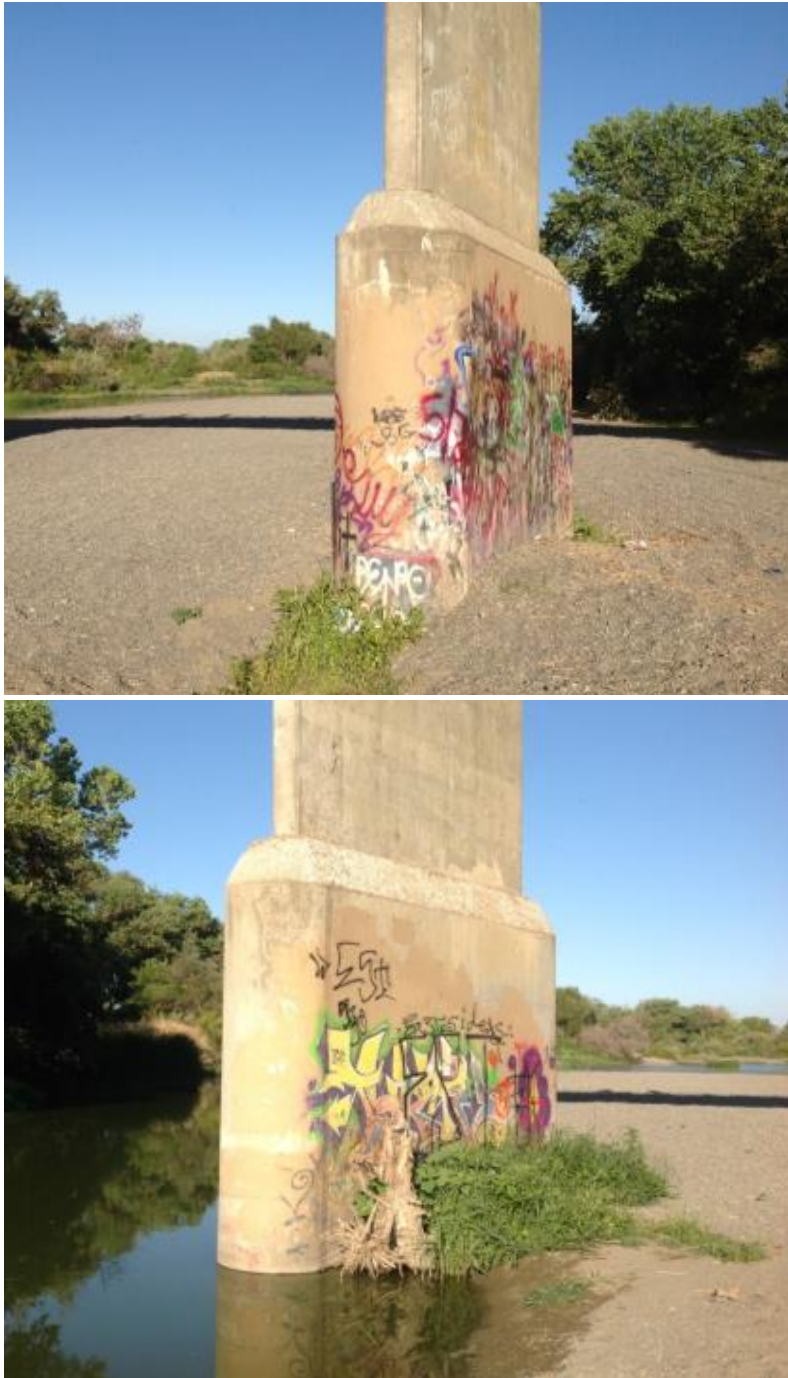
The channel bed at the Stephens Bridge showed clear evidence that winter flows in 2016-2017 had uprooted most all vegetation and transported significant quantities of sediment. No undercutting or other issues at piers were noted (Figure 16).

Figure 16: Photos showing Stephens Bridge piers with channel bed mostly bare after scouring.

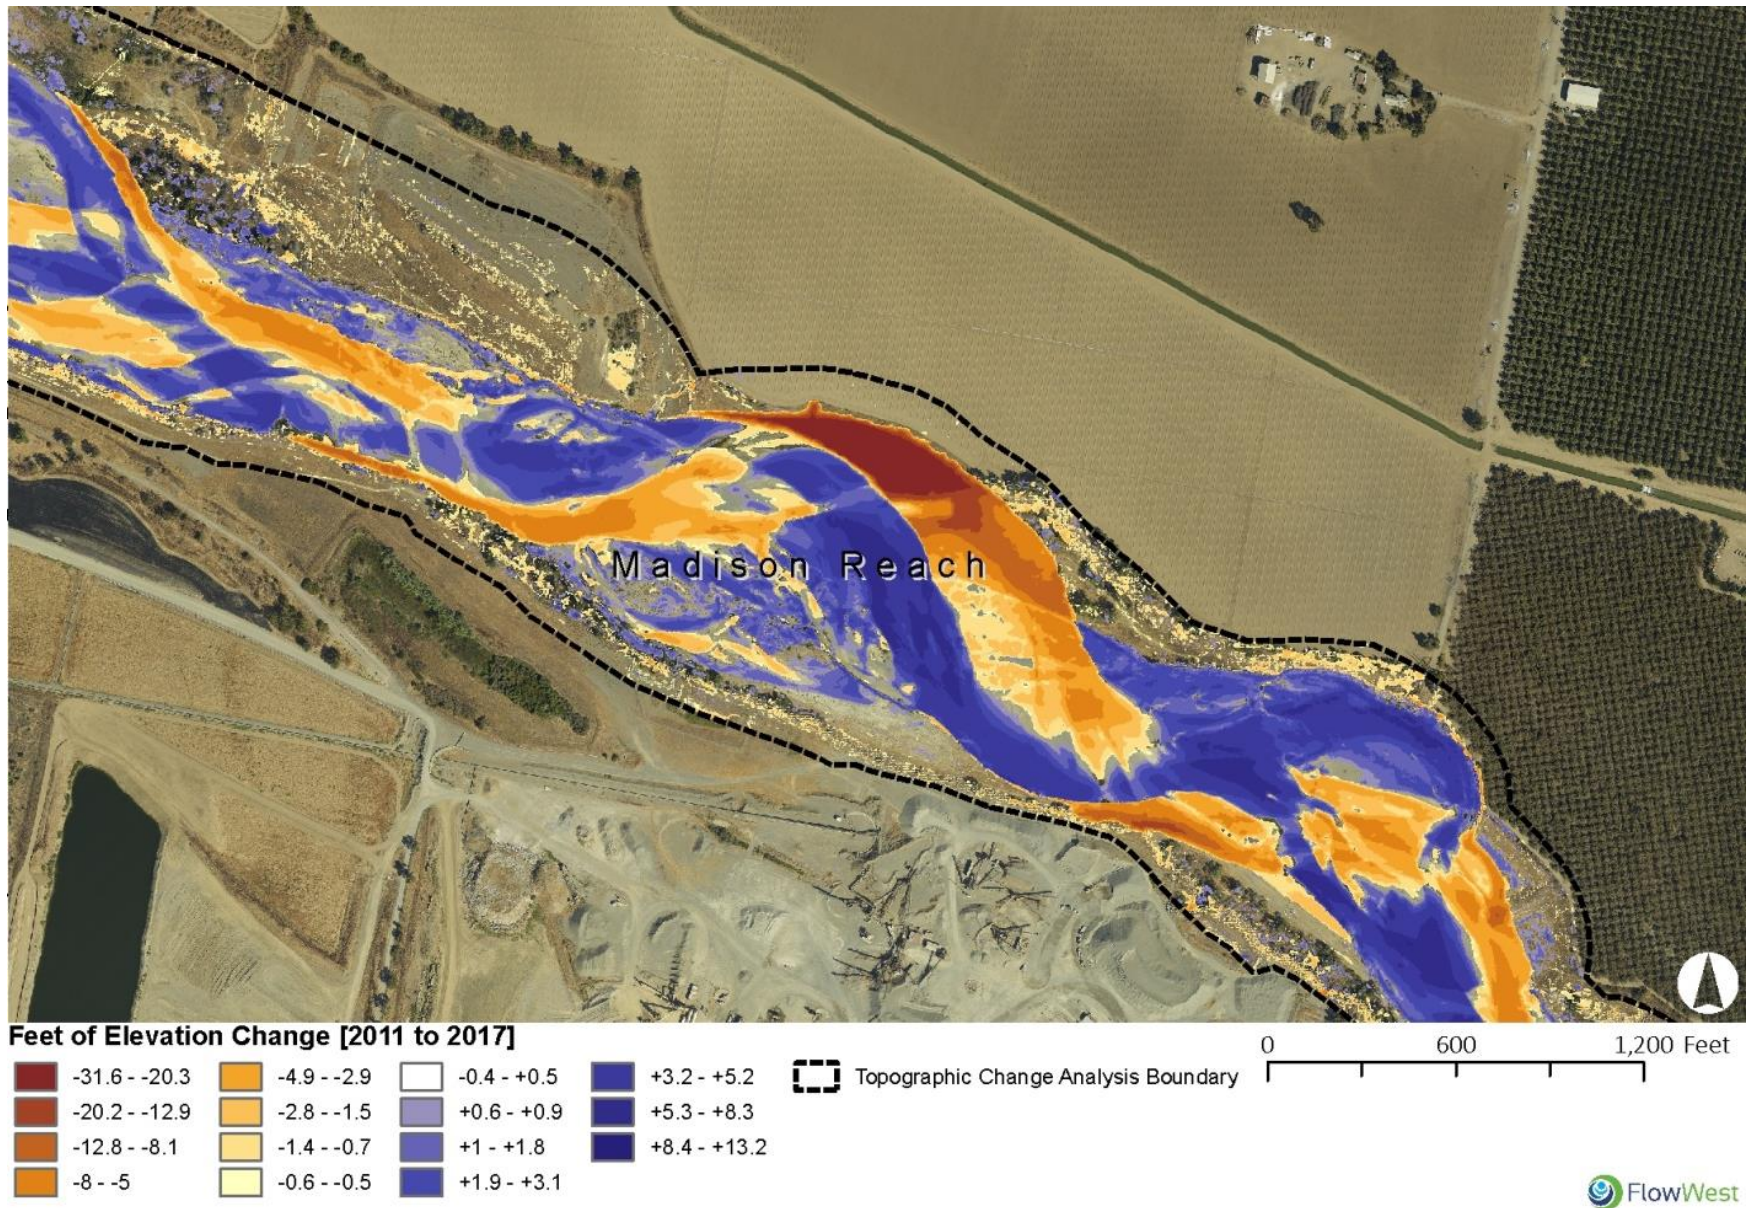
Figure 18: Topographic change in the Madison Reach showing large area of lateral bank erosion and channel migration as well as large areas of mid-channel bar deposition.

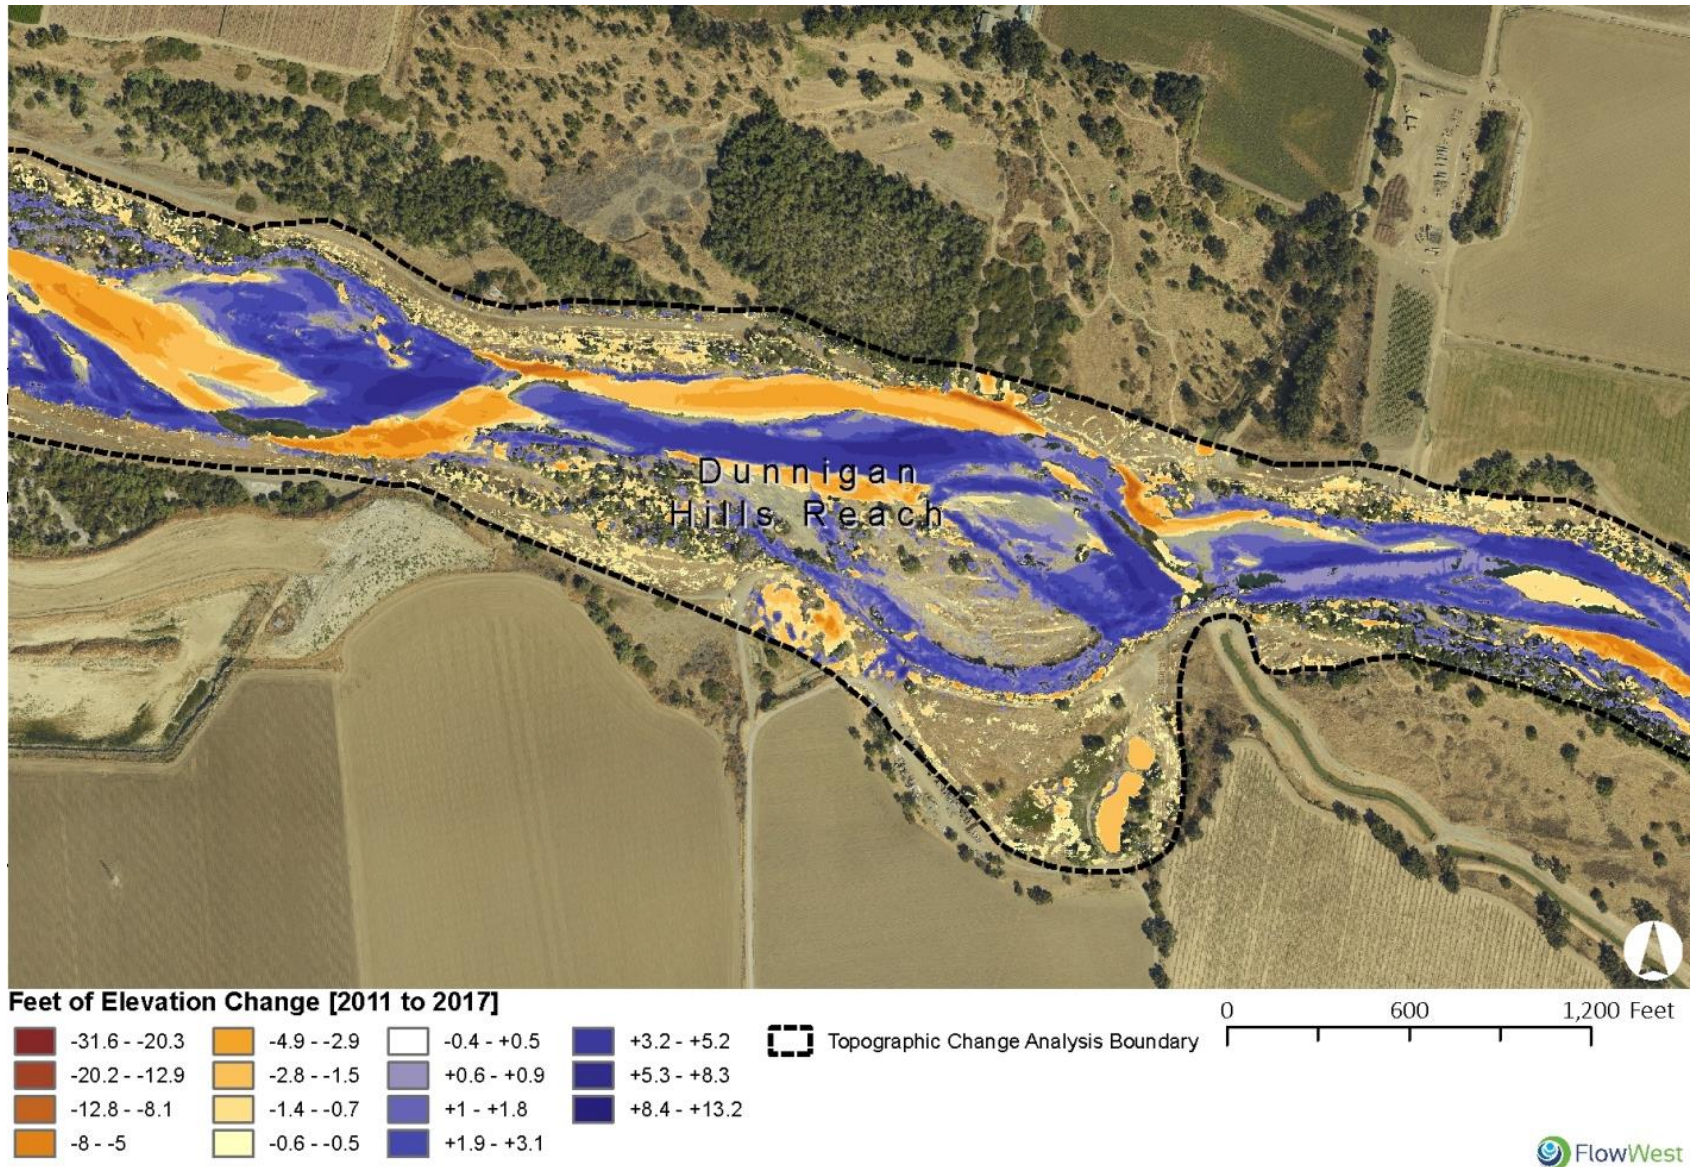
Figure 19: Topographic change in the Dunnigan Hills reach showing extensive mid-channel bar aggradation and relatively limited bank erosion or lateral channel migration.
