March 2, 2010 Job Number: 8359.006

Ms. Dianna Jensen, Principal Civil Engineer City of Davis Public Works Department 1717 5th Street Davis, California 95616

Subject: North Davis Meadows County Service Area - Groundwater and Well Assessments

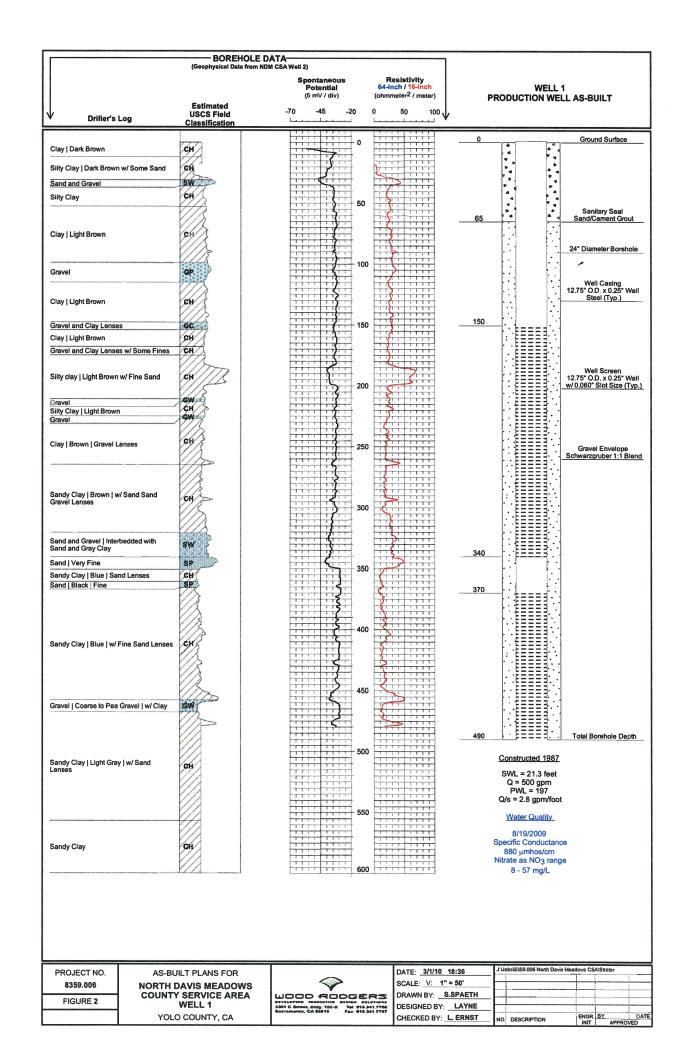
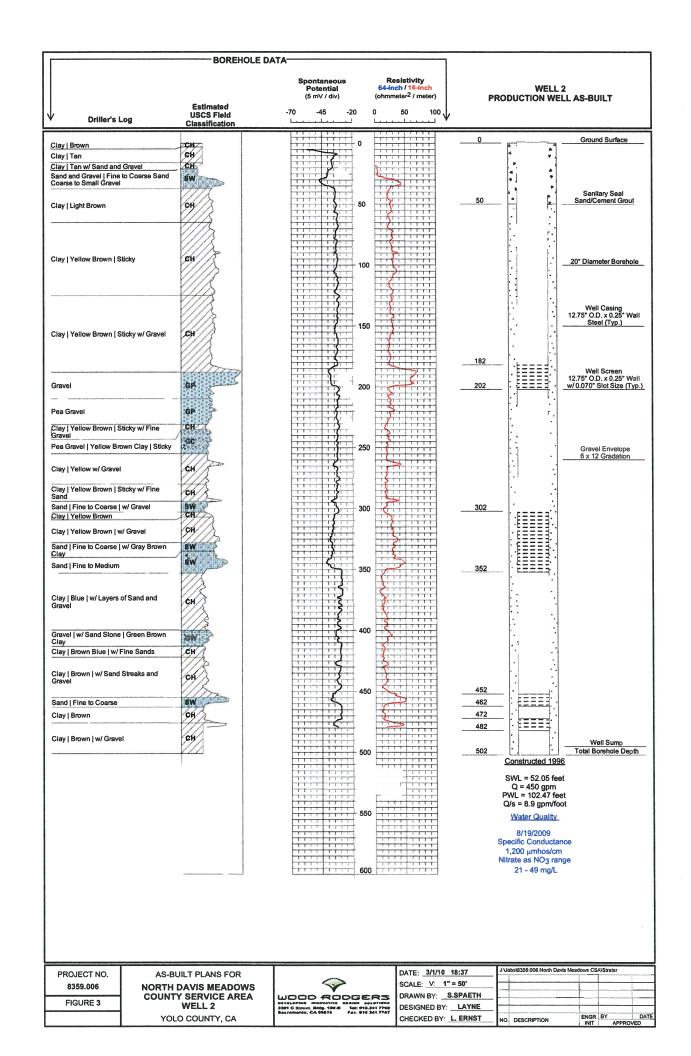
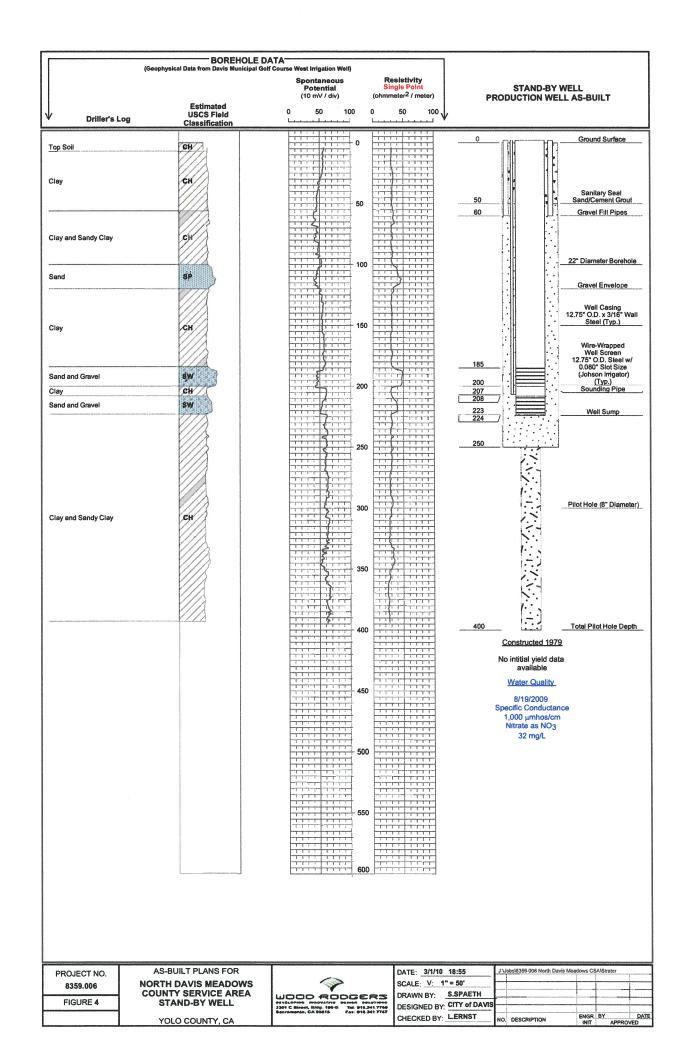
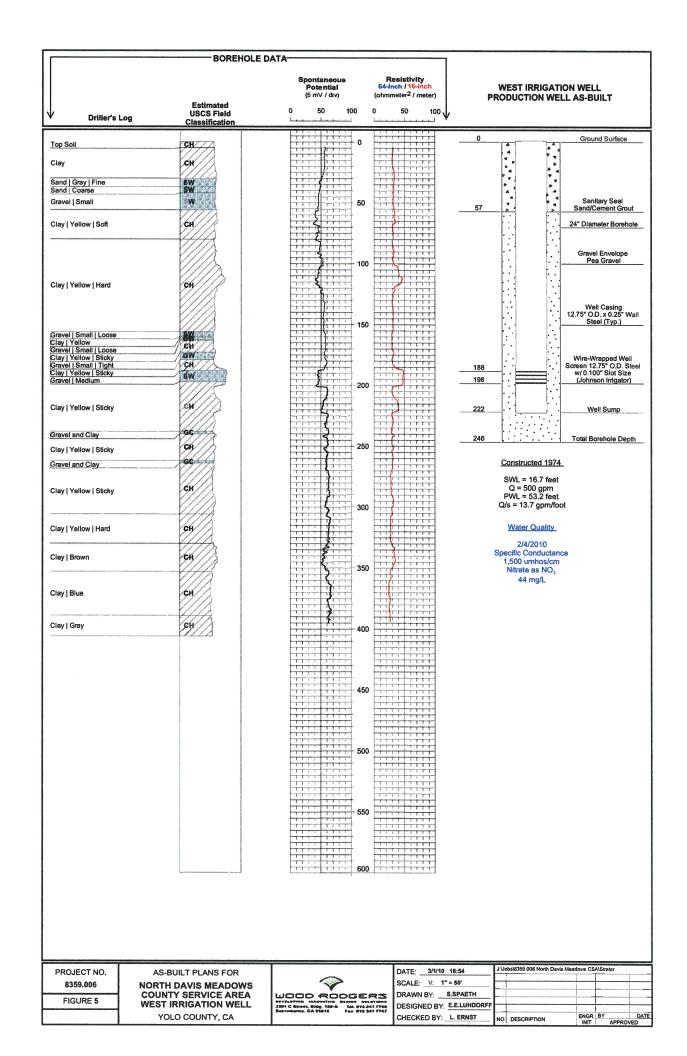
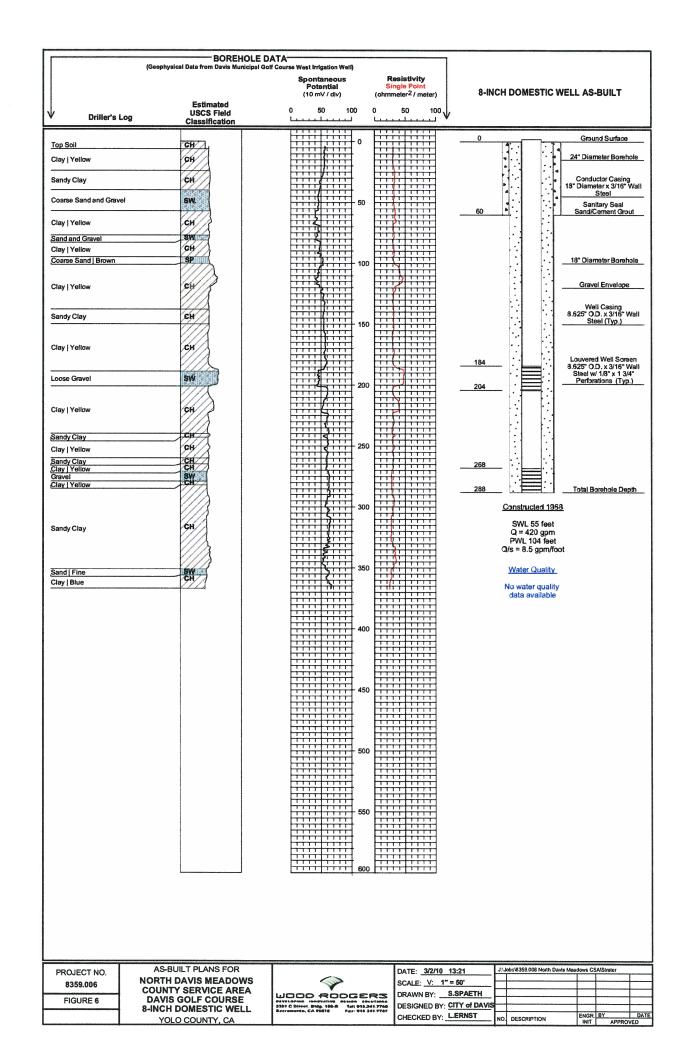
(Figure 1). Well profiles of the five NDMCSA wells are shown in Figures 2 through 6. Each profile includes well construction information from existing well records and selected water quality summaries. All five NDMCSA wells have relatively shallow (50 to 65 foot) sanitary seals and all draw water from an aquifer located between 188 and 198 feet below ground surface (bgs). Wood Rodgers also reviewed geophysical logs from three natural gas wells and two domestic wells drilled near NDMCSA, also shown on Figure 1. Well construction information for the NDMCSA wells and the City of Davis Well 27 are shown in Table 1 below.

The geophysical logs, combined with the well construction and water quality data for each well, suggest that water quality with regard to nitrates and specific conductance both improve with depth until you reach a depth of approximately 1,000 feet bgs. Below 1,000 feet the nitrate concentrations remain low, however the specific conductance gradually begins to increase. The west irrigation well is completed in a single aquifer from 188 to 198 feet bgs. This aquifer appears to have unacceptable concentrations of both nitrates and specific conductance as shown in Table 1. The other four NDMCSA wells are a composite of the 188 to 198 foot aquifer and deeper aquifers that likely have water quality with lower specific conductance and nitrate concentrations. Possible reasons for the large variances in water quality observed for Well 1 and 2 are:

- There could be mixing of the aquifers when these wells are idle causing water with high nitrate concentrations to move into the deeper aquifers causing interaquifer mixing of water.
- Holes could exist is the upper portions of the well casings below the annular seal, but above the current perforations, allowing sporadic amounts of water with very high nitrates to enter the well casings.

Wood Rodgers recommends proceeding with the investigative work to determine if Wells 1 or 2 are good candidates for well rehabilitation. Upon completion of these assessments, we could make recommendations on how, or if, to proceed with the well rehabilitations. We do not recommend rehabilitation for the other three NDMCSA wells.

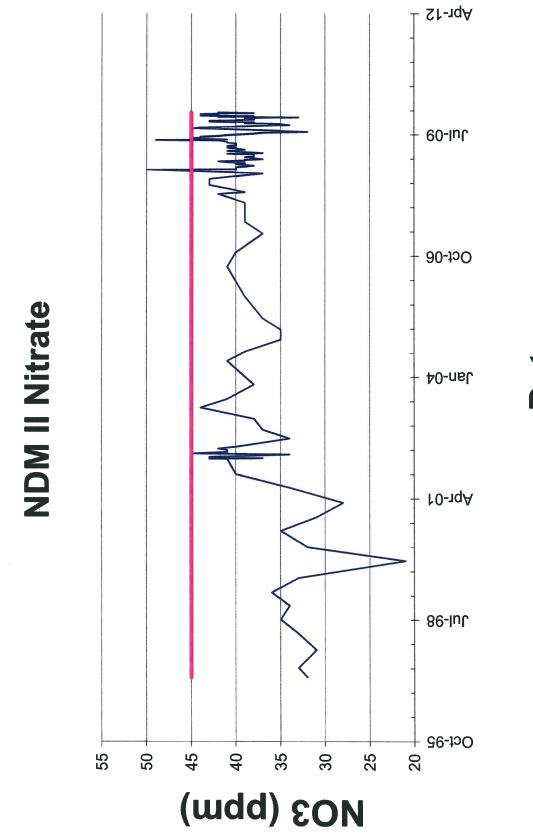
to 198 foot aguifer). The water quality improved for about a month and then the water quality returned to unacceptable levels as shown in Figure 8. The packer was changed and the nitrate concentrations again deceased for about a month and have since fluctuated between 34 and 44 mg/L. Our assessment is that this packer did not provide a consistent reduction in nitrate concentrations. There are a few possible reasons for the variation in water qualities that have been observed since this packer was installed: 1) the packer is not seated well, allowing water to pass; 2) the packer could be losing pressure allowing water to pass; 3) water of poor quality could be migrating down the gravel envelope outside the well casing; 4) holes could exist in the casing allowing alternate paths of poor water quality to migrate down the well structure; and 5) all aquifers could now have increased concentrations of nitrates. Given the rapid 33 percent decline of nitrates that occurred when the packer was first installed, and the sporadic changes in nitrate concentrations since the packer was installed, the most plausible explanation is that the packer has reduced the contribution of the upper aquifer, but not eliminated it. On January 11, 2010 this theory was proven when the City of Davis conducted a pumping test and noted that 12 feet of drawdown occurred during the test. If the packer was providing a seal, no drawdown should have occurred above the packer. Given the poor results of the packer program we do not recommend packers as a viable long-term solution to improve the NDMCSA water quality.

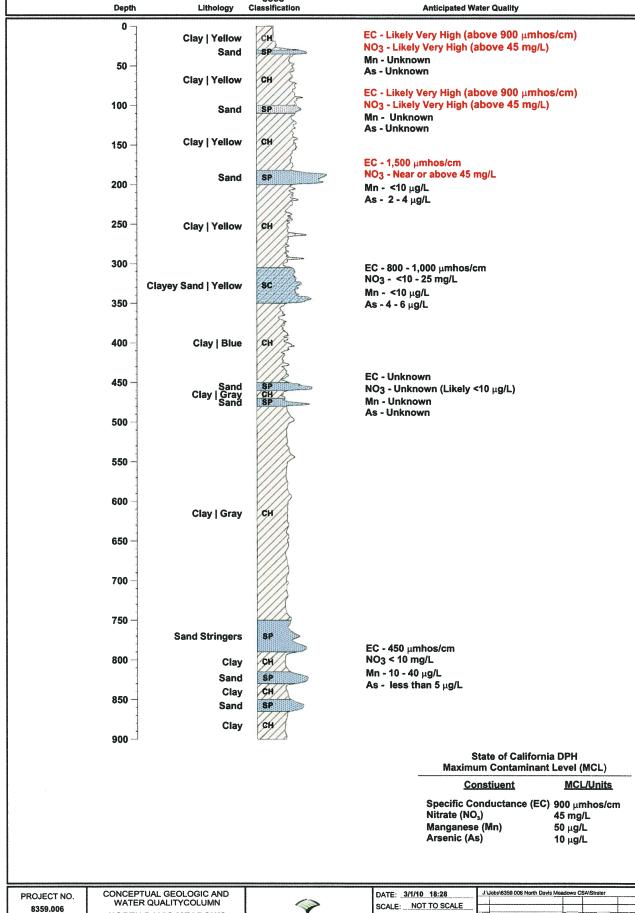
FIGURE 7

Based upon all of the data that Wood Rodgers reviewed during this study, we have developed a simplified geologic/anticipated water quality profile depicting our current understanding of the water quality in the aquifers that exist beneath NDMCSA, as shown as Figure 7. It is our opinion that the aquifers between 65 and 180 feet likely have very high concentrations of nitrates. This profile represents our estimated zone specific water quality; however these estimations should be considered conjectures, not measurements, of water quality. Monitoring well construction in specific aquifers helps increase the confidence levels for zone specific water quality, however even monitoring well construction does not guarantee production well water quality.

As NDMCSA wells are removed permanently from service, they should be properly destroyed to stop/prevent the downward migration of poor water quality. All new domestic water supply wells in the NDMCSA should have a minimum sanitary seal depth of 250 feet.
