Community of Yolo Small Community Flood Risk Reduction Feasibility Study

Appendix B Yolo Geotechnical Assessment

Draft April 2019

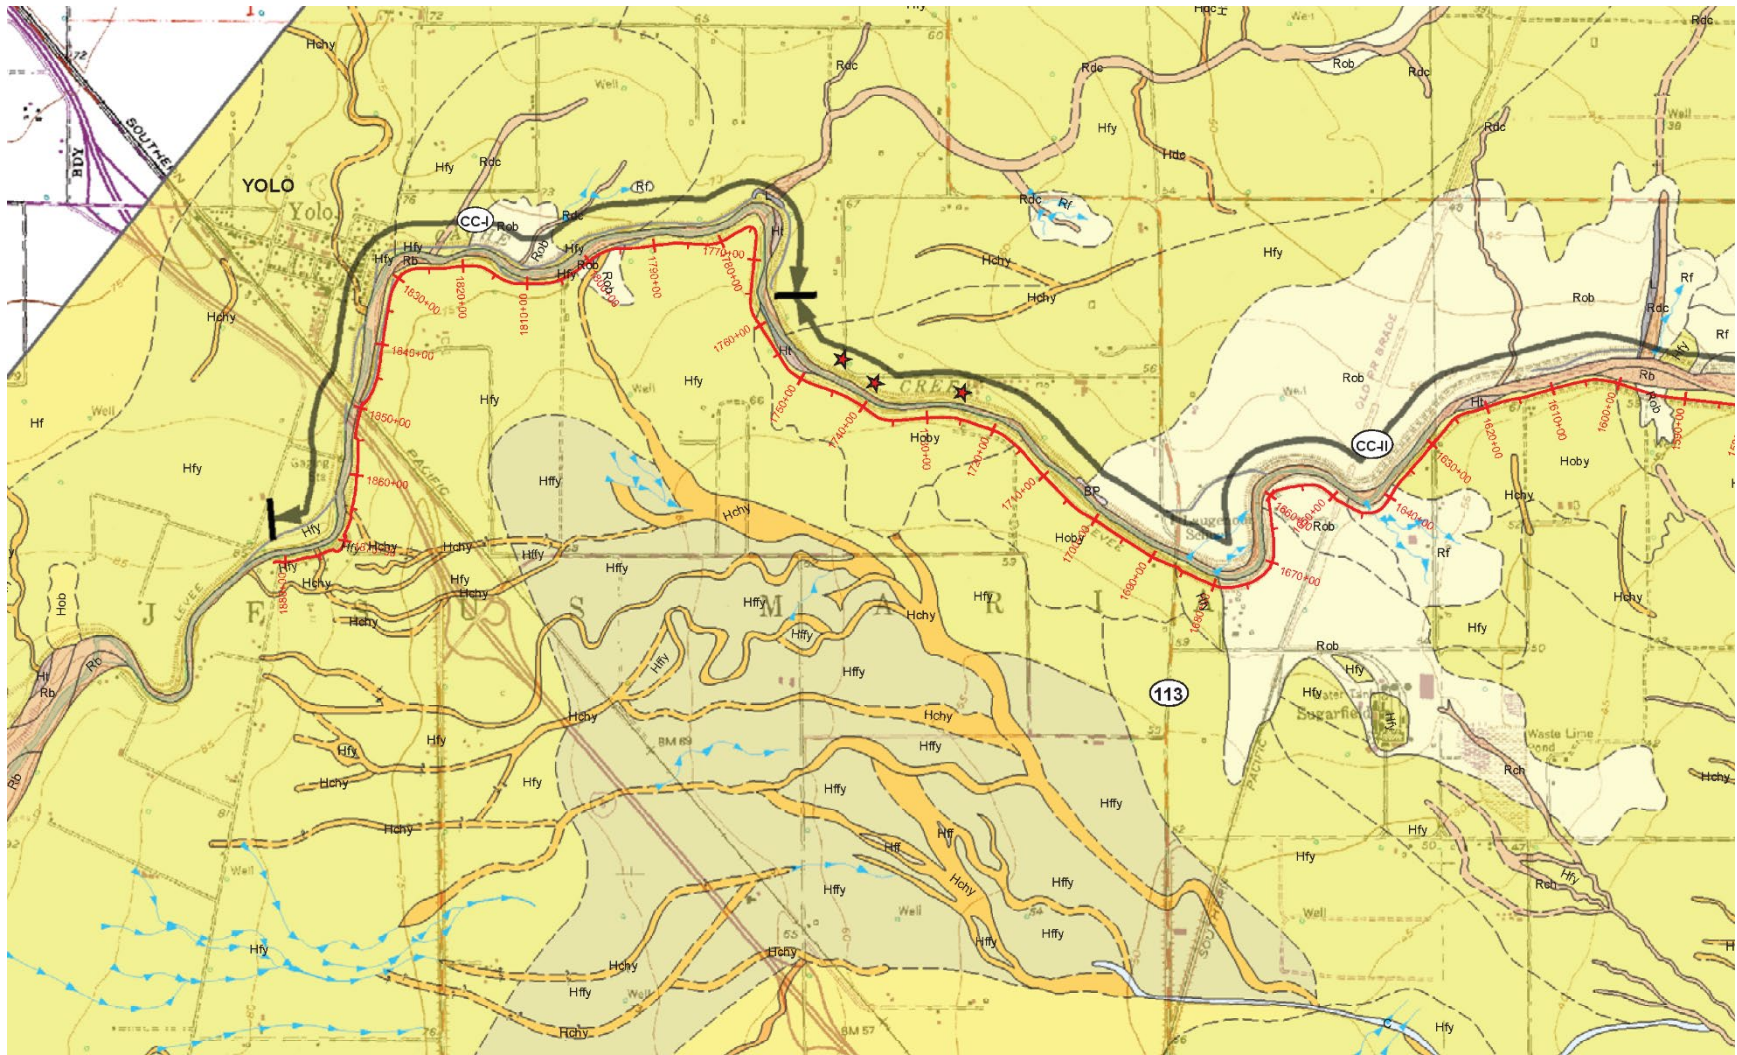
Figure B-2. ULE Geomorphology for Cache Creek near the Community of Yolo

The Cache Creek left bank levee was included in the geomorphologic mapping of the DWR Urban Levee Evaluation (ULE) project's Woodland Study Area. An excerpt of this mapping is shown in Figure B-2. As seen in the figure, the levee adjacent to the community of Yolo and much of the upstream and downstream Cache Creek left bank levee is mapped predominantly over late Holocene fan deposits (Hfy). Hfy deposits are typically coarse-grained in nature, since they are deposited under high energy environments and likely consist of poorly sorted sand, silt, and clay deposited by distributary channels on the alluvial fan. The technical memorandum prepared for the geomorphic assessment states, "fan deposits often exhibit prominent natural levees revealed by the topographic contours that form long, sinuous ridges following distributary fan channels. Relatively coarser sediments are expected to underlie portions of the fan surface between these levees and distributary channels (URS, 2013)." A late Holocene channel deposit (Hchy) is mapped beneath the levee and the community approximately halfway through Yolo and likely to be composed of well sorted sands, trace fine gravel, silt, and lesser clay. A historic distributary channel deposit (Rdc) is also mapped just upstream of Yolo. Approximately 0.2 miles upstream from the edge of the community an area of historical overbank deposits (Rob) are mapped. The Rob deposits likely consist of sand, silt, and clay deposited during high-stage water flow overtopping the channel banks. The location mapped is consistent with a location of reported past overtopping.

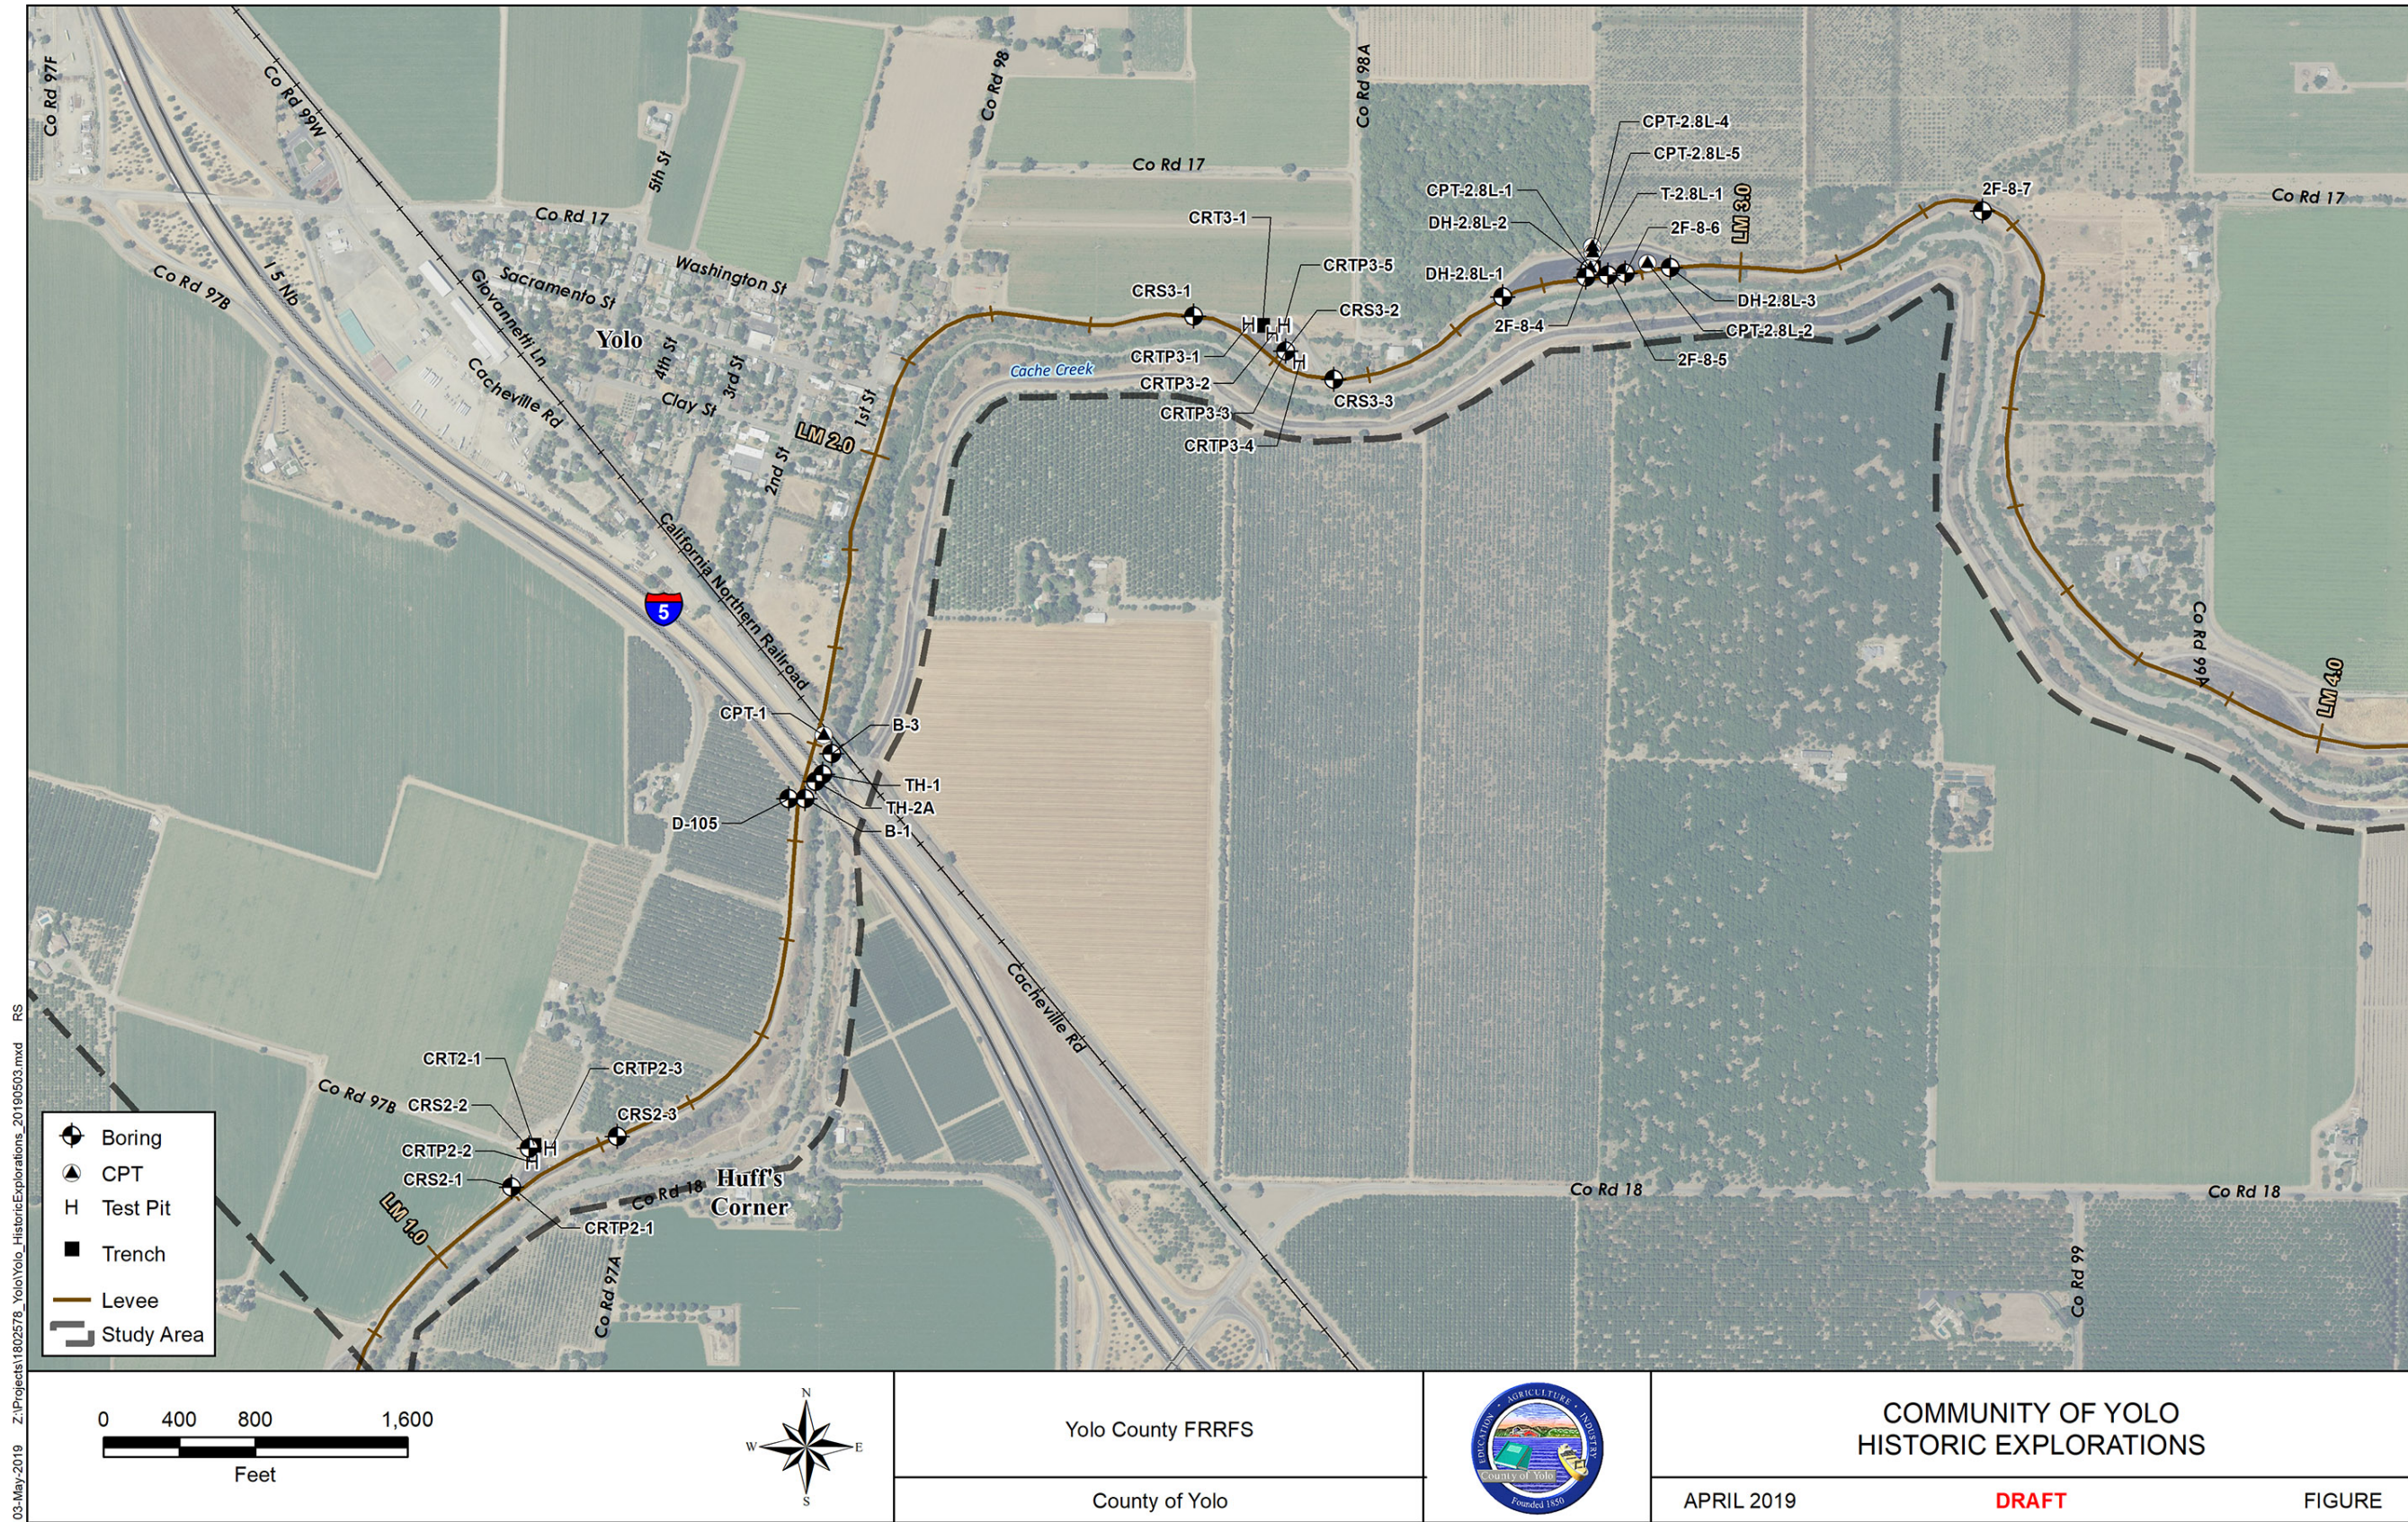
Figure B-2. Existing Subsurface Explorations near the Community of Yolo

As shown in Figure B-3, the available explorations generally fall into five areas, the explorations in each of these areas are discussed further below.

Upstream of the community of Yolo there are seven 2005 subsurface explorations available from DWR's State Emergency Erosion Repair Project site at LM 1.1. The explorations included three borings which were completed to depths of approximately 50 to 80 feet, three test pits from 3.7 to 5.5 feet deep, and a small trench excavation to 12.7 feet deep. One of the borings went through the levee crown and logged the embankment as containing clay and silt. All of the explorations found the foundation to be predominately composed of clay and silt materials. The deepest boring encountered a 10-foot thick silty sand layer beginning at a depth of 63.5 feet below the landside ground surface.

Near LM 1.7, slightly upstream of the community of Yolo, there are six bridge relate subsurface explorations. The explorations included 5 borings and one CPT and range in depth from 19 feet to 153.5 feet. A mix of fine-grained (silt and clay) and coarse-grained (sand and gravel) material was encountered in all of the explorations. Two of the borings identified a sandy shallow foundation with no fine-grained blanket at the surface. The sandy material in these borings went to depths of up to 23 feet below the ground surface. Where present, the fined-grained blanket appeared to be approximately 24 to 41 feet thick. Records reviewed did not include information on bridge abutment construction and if any treatment or improvement was made to the embankment or shallow foundation in these locations that would create different subsurface conditions at these locations than elsewhere along the nearby Cache Creek left bank levee. The two borings that identified a sandy shallow subsurface were from 1951 and 1952, prior to the Interstate 5 construction in 1956.

Downstream from community of Yolo there are nine 2005 subsurface explorations available from DWR's State Emergency Erosion Repair Project site at LM 2.5. The explorations included three borings which were completed to depths of 50 to 60 feet, five test pits to 10 to 12.5 feet deep, and a small trench excavation to 13.8 feet deep. Two of the borings went through the levee crown and identified the embankment to be composed of lean clay. A fine-grained blanket was identified in foundation all of the explorations. In most locations, the blanket thickness ranged from approximately 7 feet to 14 feet thick, but in one location the blanket thickness was up to approximately 44 feet thick. Zones of sand and often gravel were encountered below the blanket in all explorations that extended past the bottom of the blanket layer. The deepest exploration terminated in sand at 60 feet below the landside ground surface.

Further downstream of the community of Yolo there are eight 2010 and 2011 subsurface explorations available from DWR's Cache Creek Levee Setback Project site at LM 2.8. Additionally, in this area there are three 1958 USACE explorations. In total, the 11 explorations in this area included 6 borings and 4 CPTs to depths of approximately 30 to 60 feet and one small trench excavation to 14.5 feet deep. Two of the explorations encountered coarse-grained materials (sand and/or gravel) in the shallow foundation, with no fine-grained blanket above them. One of the CPT also identified a potentially sandy surface layer. The thickness of the surficial sands ranged from 5 feet to 13 feet. Two other CPTs identified likely sandy lenses in the upper 5 feet of the blanket. The remaining explorations generally identified a fine-grained blanket approximately 11 feet up to almost 50 feet thick. Two of the deeper borings, encountered

The last exploration, one of the 1958 USACE explorations, is further downstream at approximately LM 3.27. This exploration encountered surficial sands to a depth of 26.5 feet. The boring terminated at 27.5 feet and encountered clay in its final foot.
