**Property Condition and Code Compliance Assessment
for the Davis Communications Site**

County of Yolo | Parks and Recreation Department

January 29, 2008

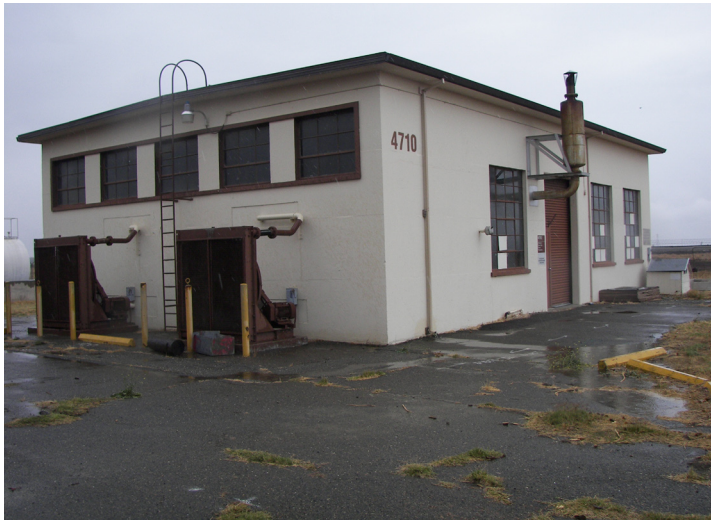
(a) Southeast Corner

The 2,200 SF emergency power building stands alone on the site and is in fair condition:

- Structural and building envelope integrity is sound.
- Steel beams are exposed to the interior spaces.
- HVAC and other mechanical and electrical systems are antiquated and should be removed/ replaced. The two diesel-fired backup generators are potentially salvageable.

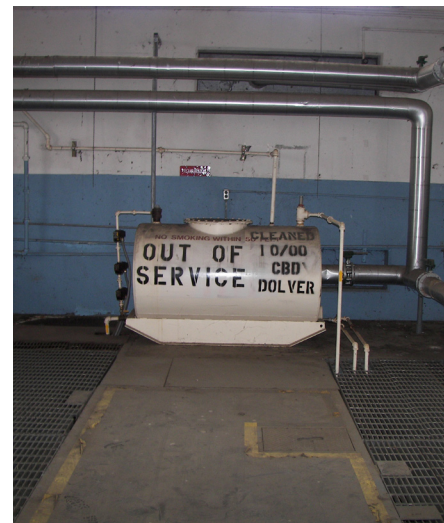
250,000 Gallon Diesel Tank in Generator Room

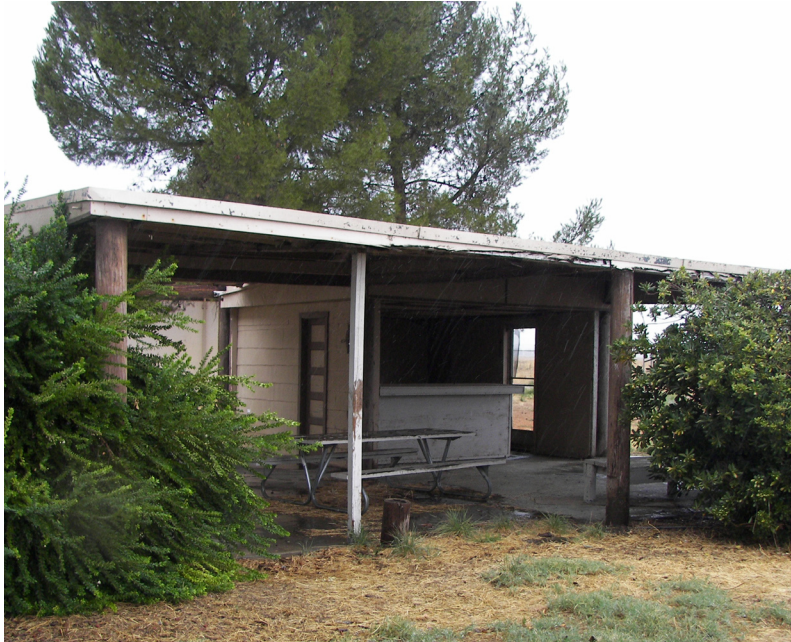
(a) **West view**

- Building 4712 – a 730 SF dilapidated picnic building and barbeque structure.
- Building 4709 – a non-potable water production well and pump house: The water production well is useful for fire water only. There are no sources of potable water at the site. Nor is it possible to drill for well water within a reasonable pumping distance (1.5 miles) of the site, due to high nitrate levels in the ground water.
- Two potentially salvageable diesel storage tanks – one at 7,000 and one at 20,000 gallons - that have already been cleaned. These tanks have sit on massive concrete pads.
- Creosote treated logs.
- No provision has been made for accessibility.

(C)	Picnic building and barbeque removal. Building is visibly damaged and represents a hazard.	1 EA	5,000	5,000
(D)	Emergency power building, shuttering of windows & other mothballing.	1,309 SF	4.00	5,236
