A bald eagle (*Haliaeetus leucocephalus*) observed in Capay Reach on 2023 Creek Walk.

Photo courtesy of Andrew Rayburn (2023)

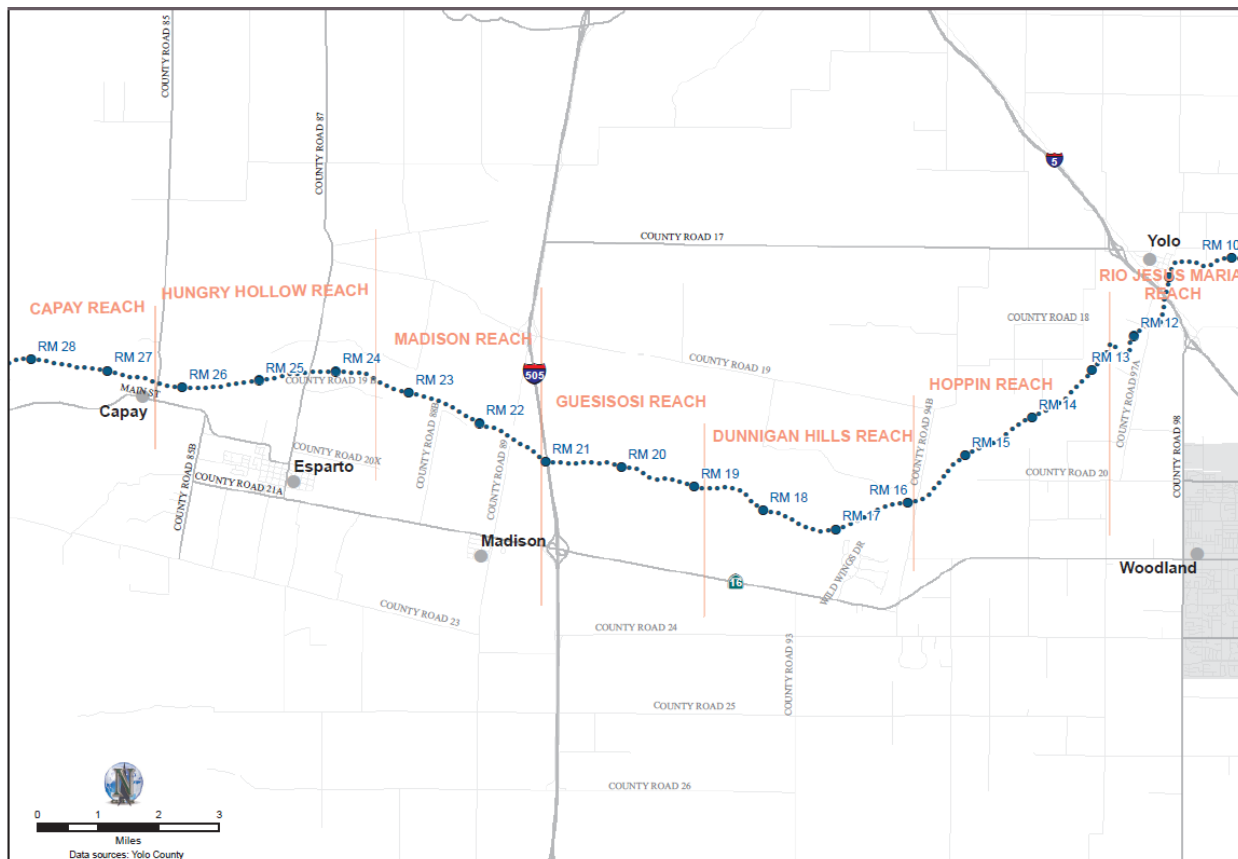
**Figure 1-2. Lower Cache Creek's river miles and reaches.**

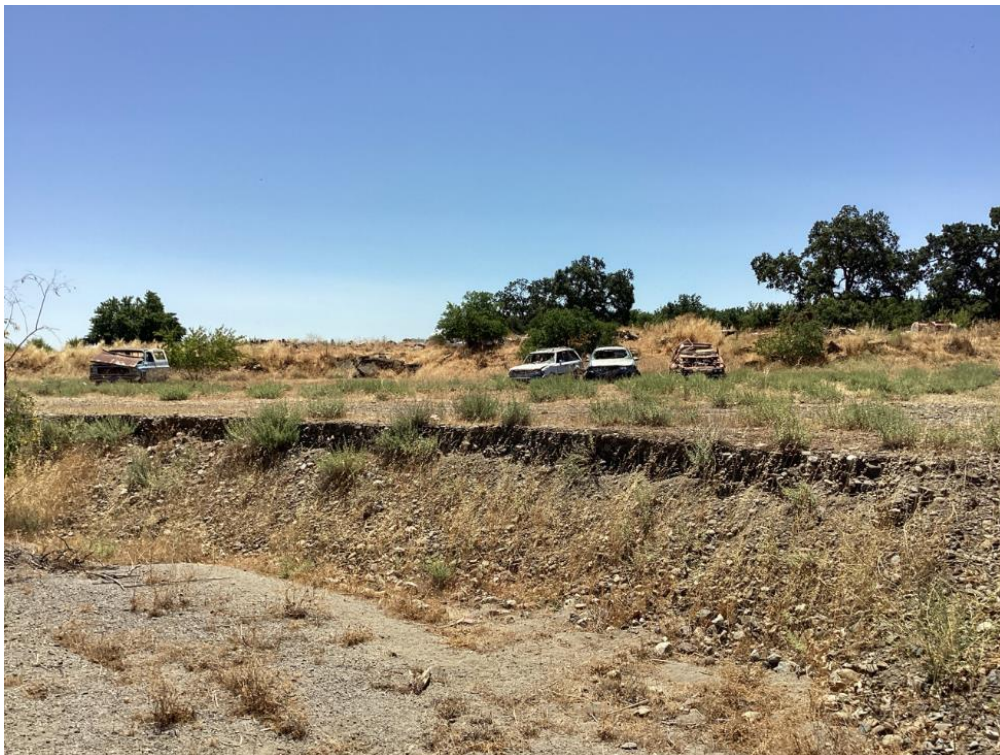
***Figure 2-11. Abandoned vehicles near RM 25.4.***

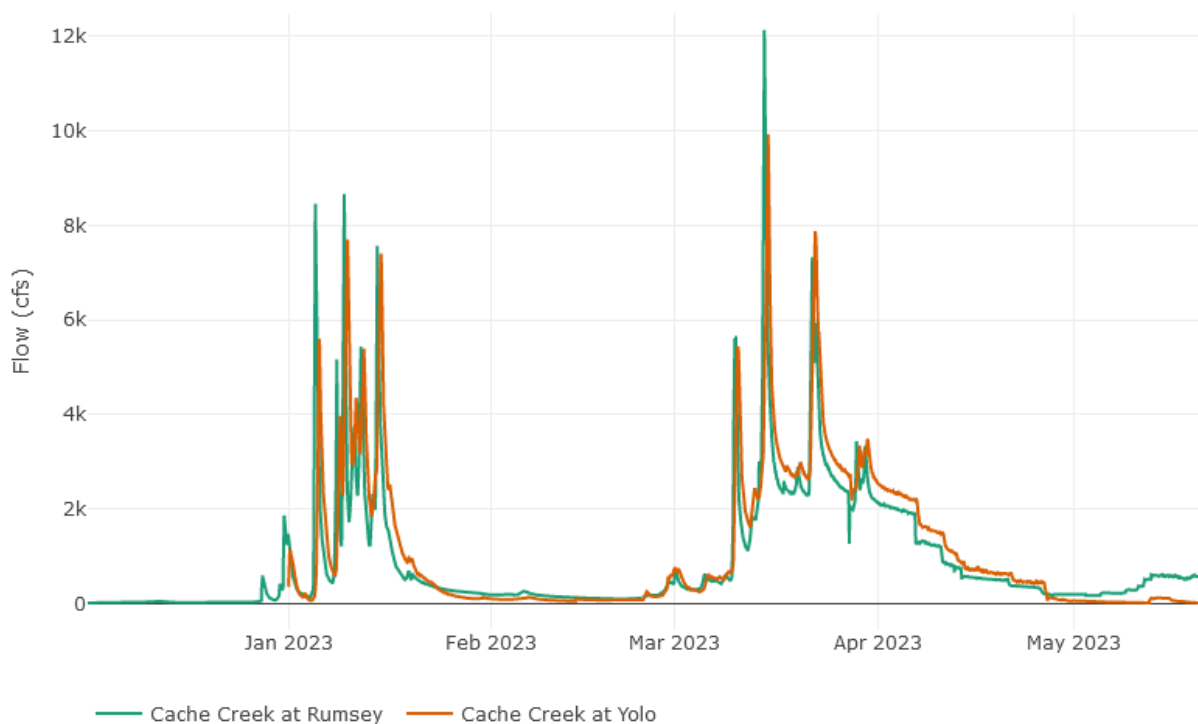
**Figure 2-12. Instantaneous flows in Water Year 2023 at Rumsey and Yolo flow gages.**

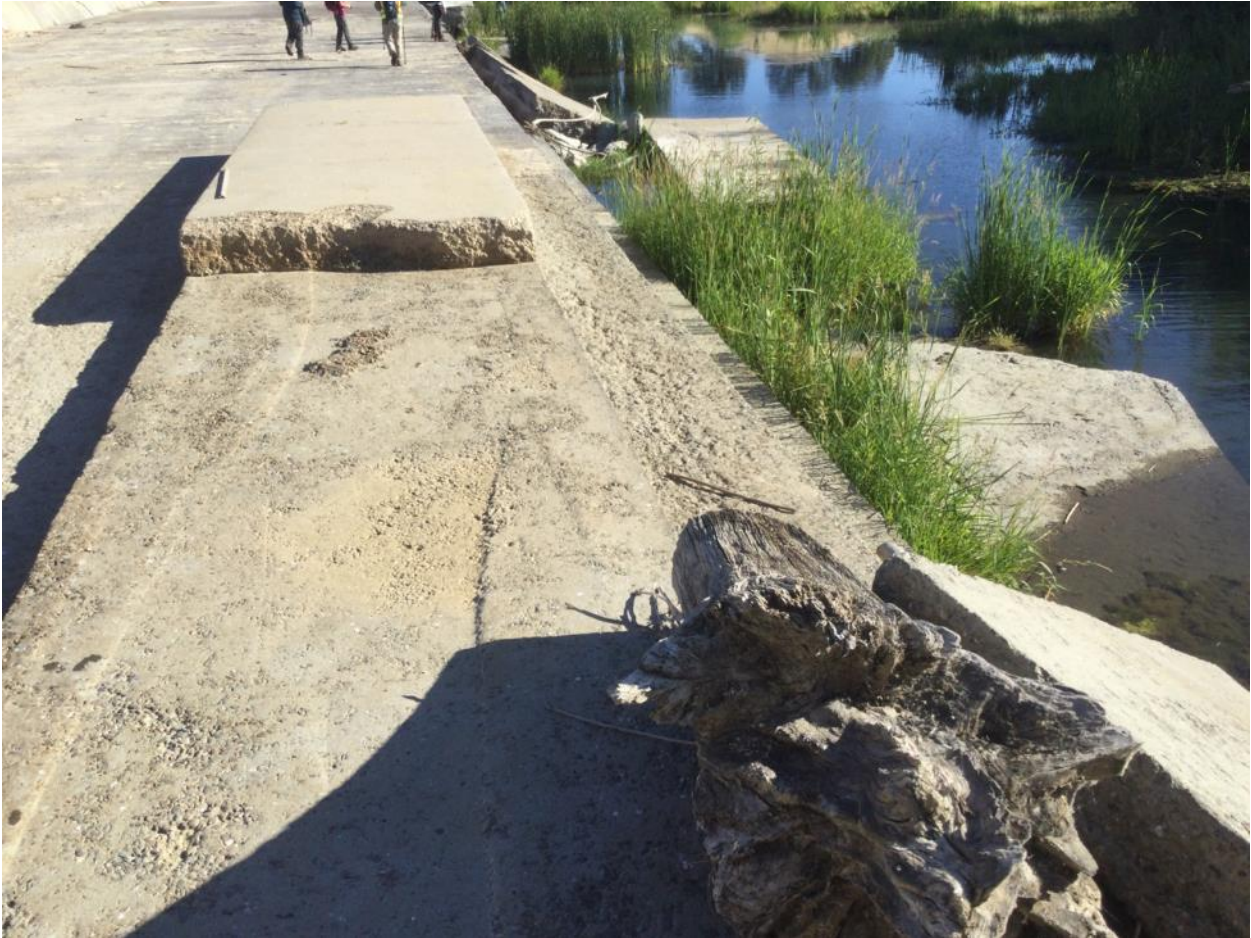
**Figure 2-13. Capay Dam and apron. (2023)**

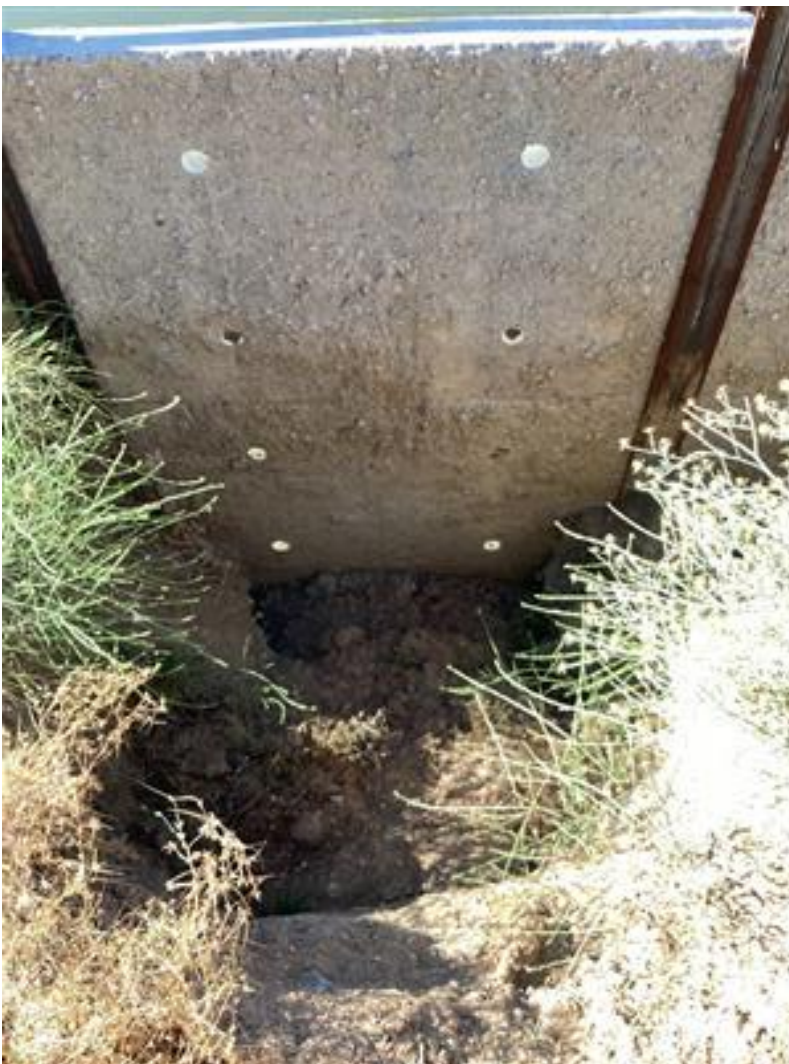
***Figure 2-14. View of soil erosion behind Bank Repair Wall at Capay Dam. (2023)***

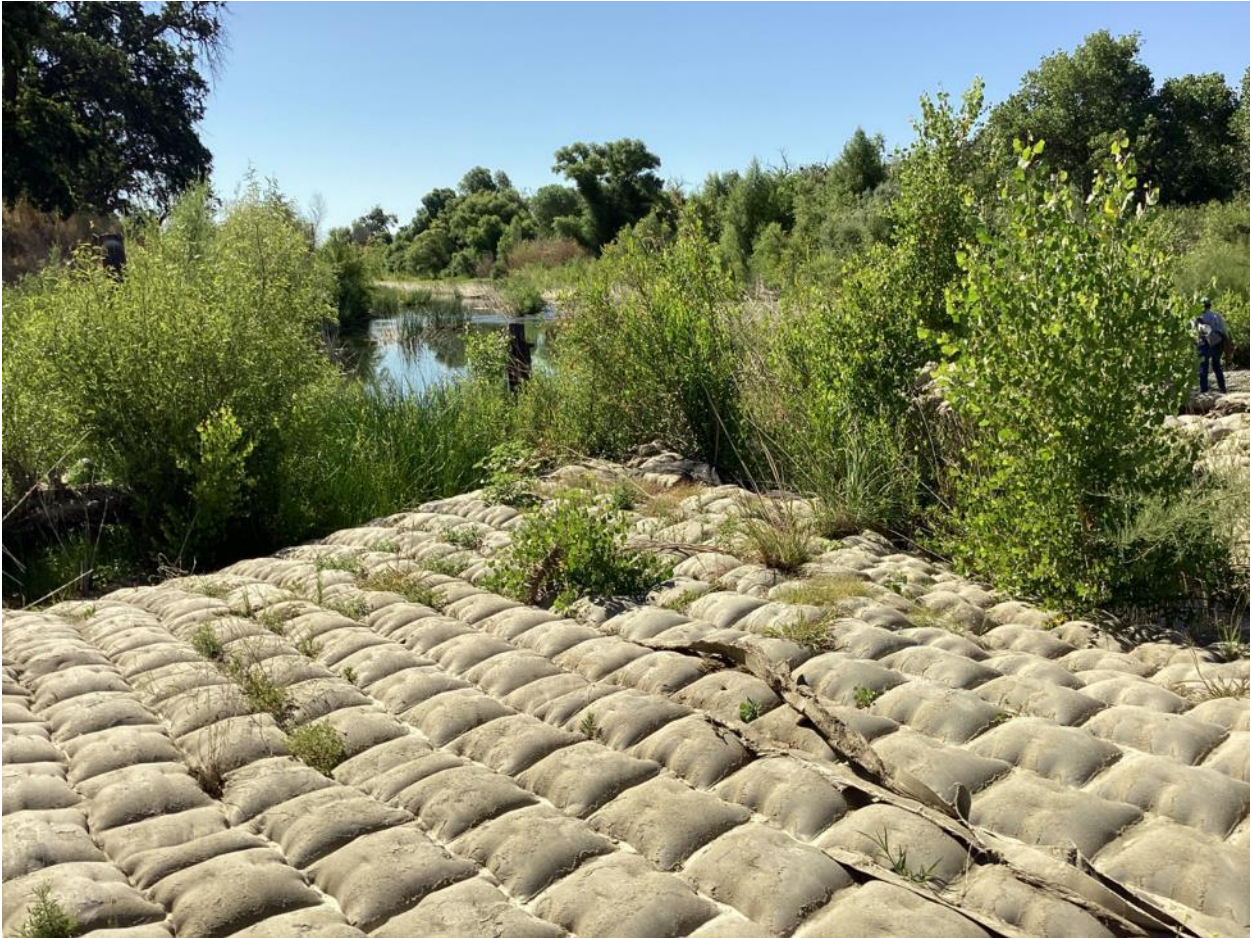
**Figure 2-15. Current state of erosion control blanket at PG&E Palisades site. (2023)**

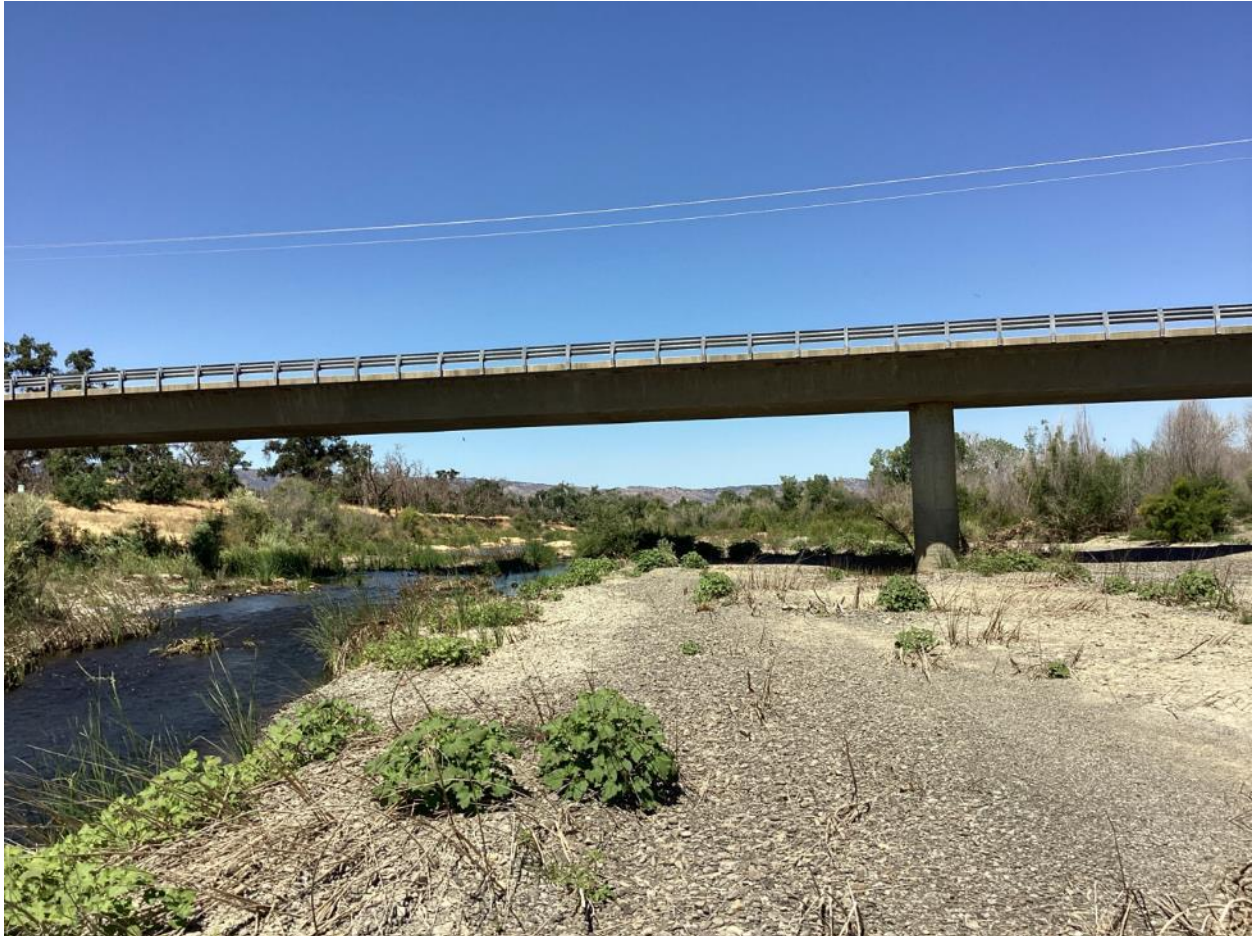
***Figure 2-16. Photo showing Capay Bridge and limited vegetation growth after elevated flows from January and March. (2023)***

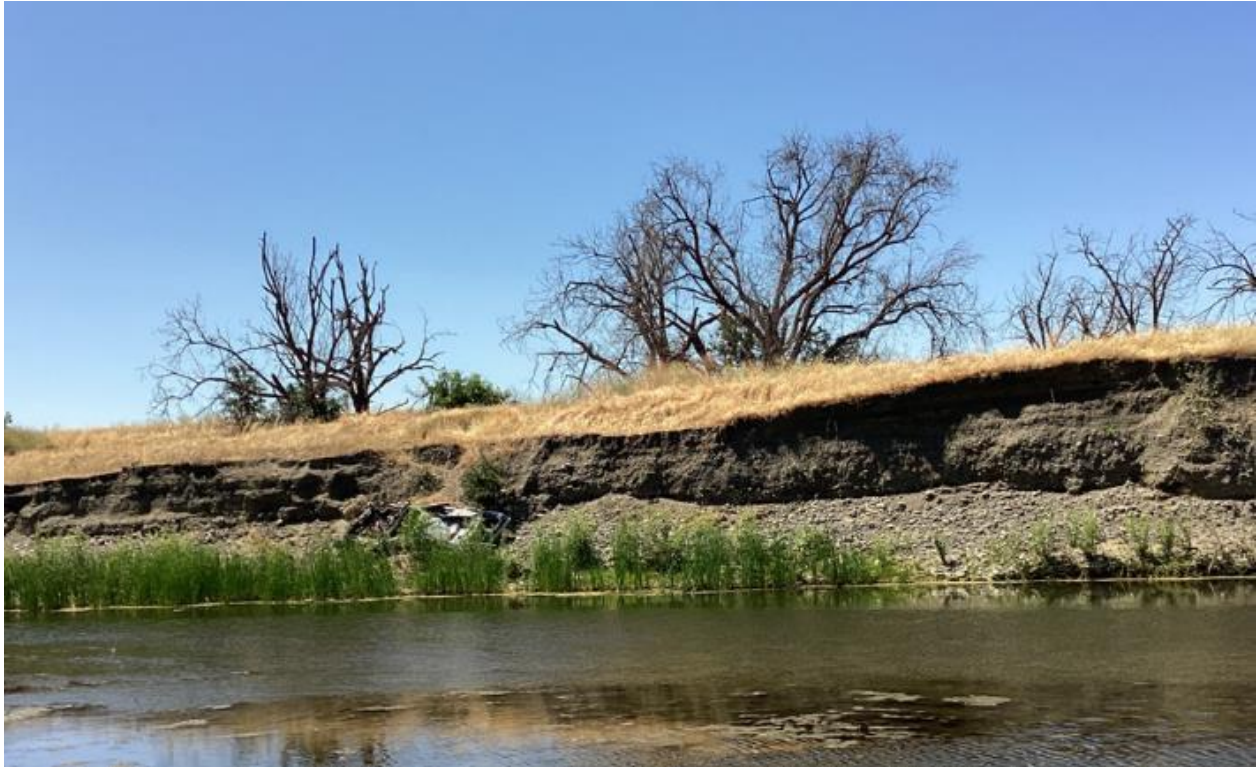
***Figure 2-17. Photo showing car in the streambank at RM 25.9. (2023)***

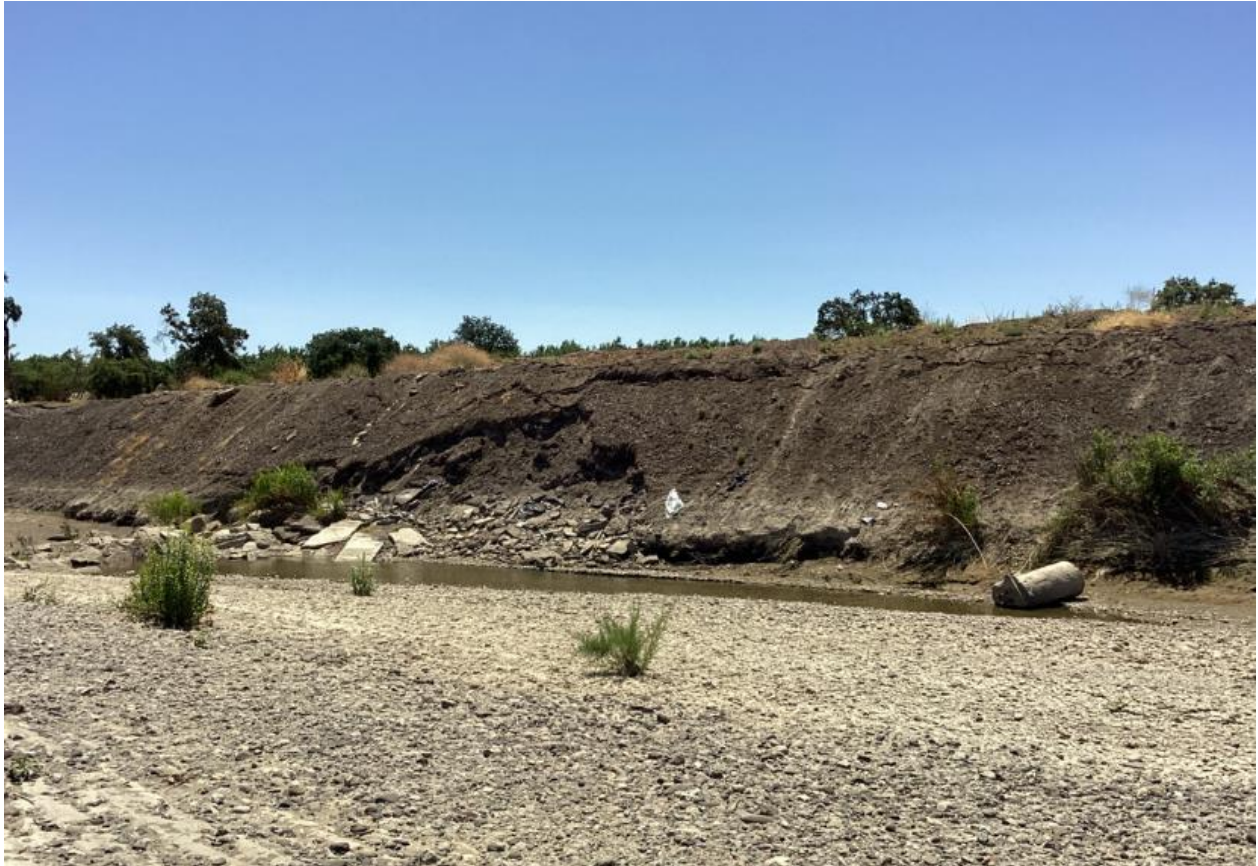
***Figure 2-18. Photo showing outside bend with staged soil stockpiles gone, and new fill on bank. (2023)***

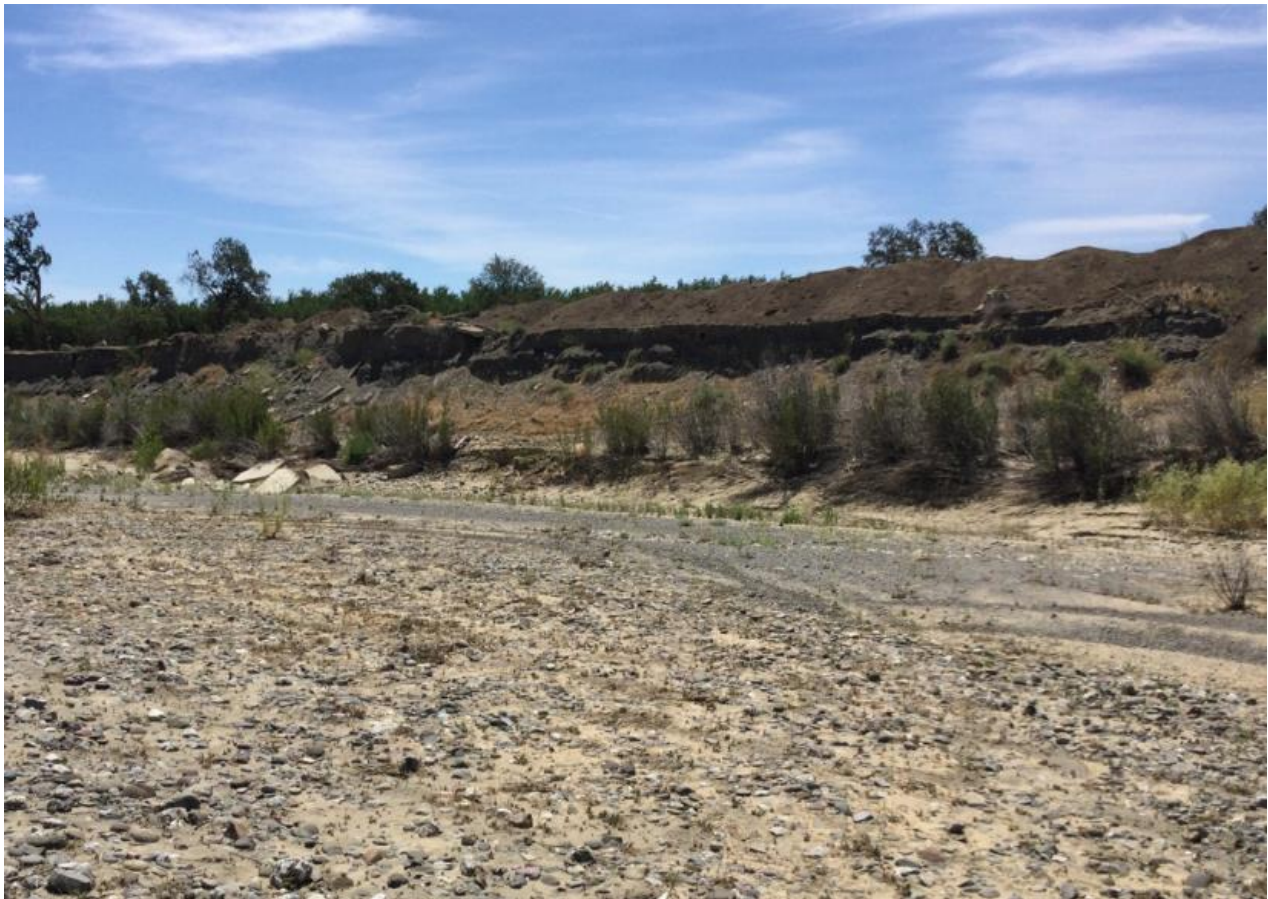
***Figure 2-19. Photo showing outside bend with staged soil stockpiles from 2022 Creek Walk.***

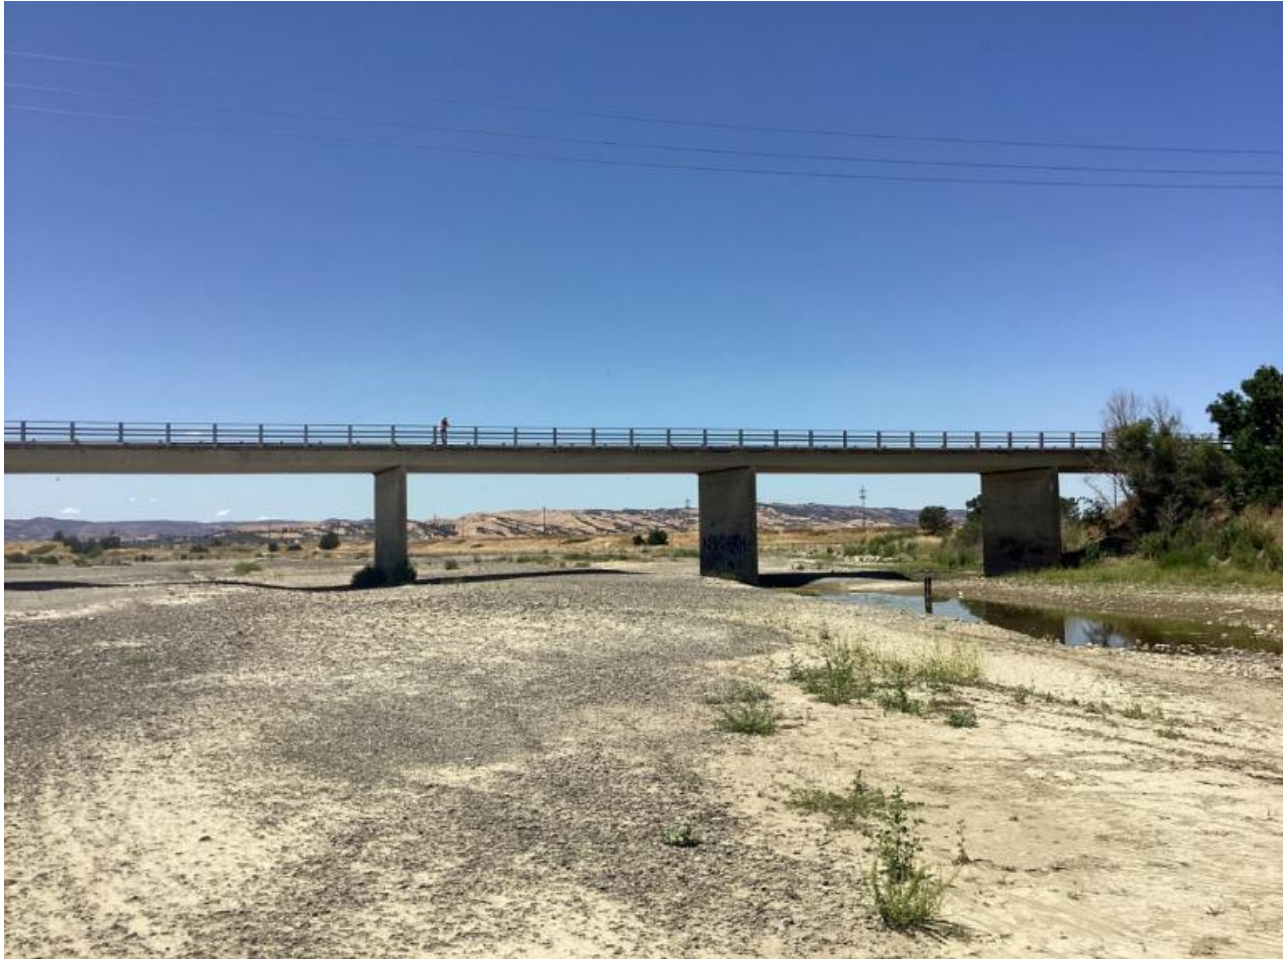
***Figure 2-21. Esparto Bridge Piers with no significant change from last year. (2023)***

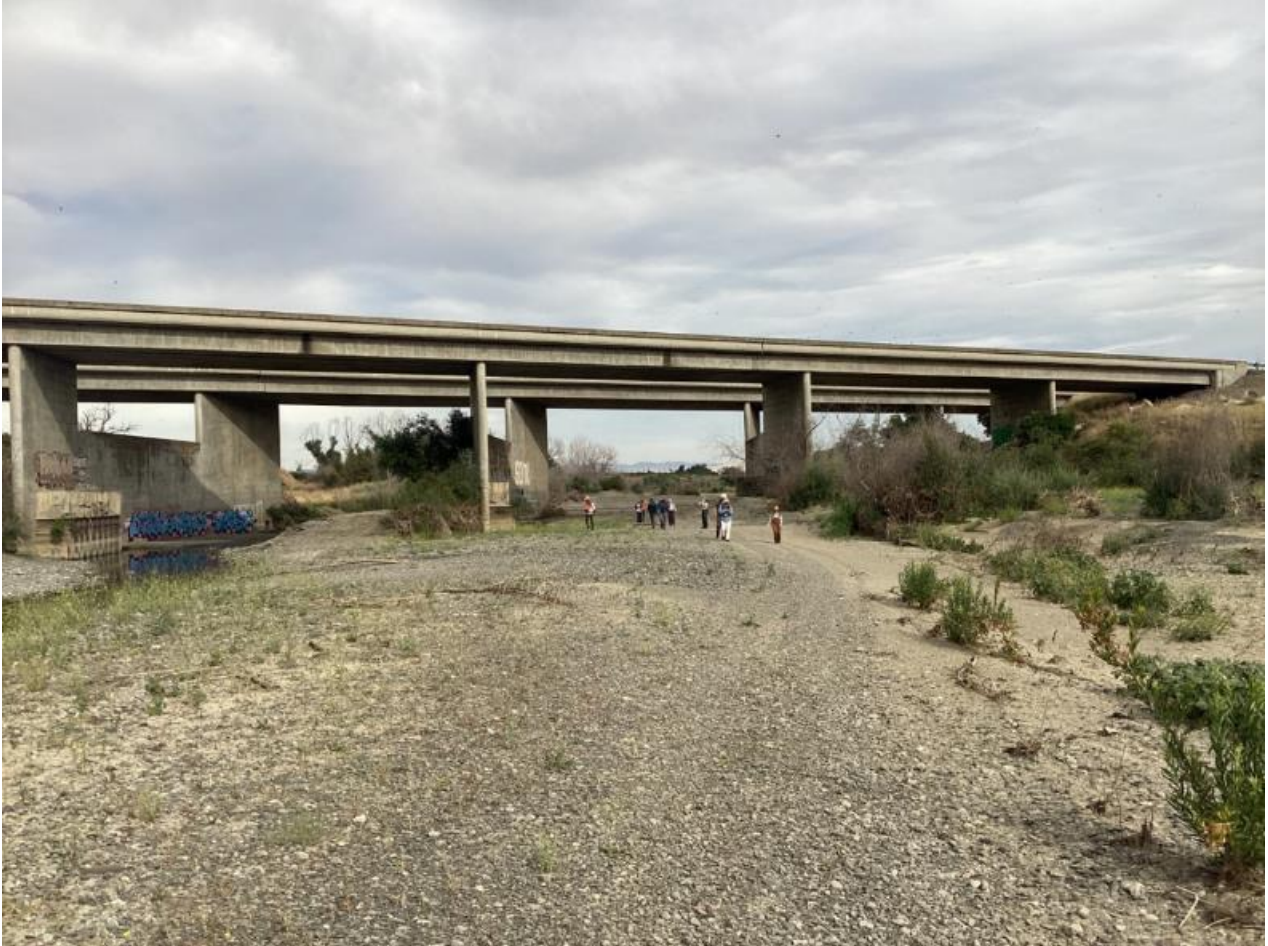
**Figure 2-23. Photo showing I-505 Bridge piers. (2023)**

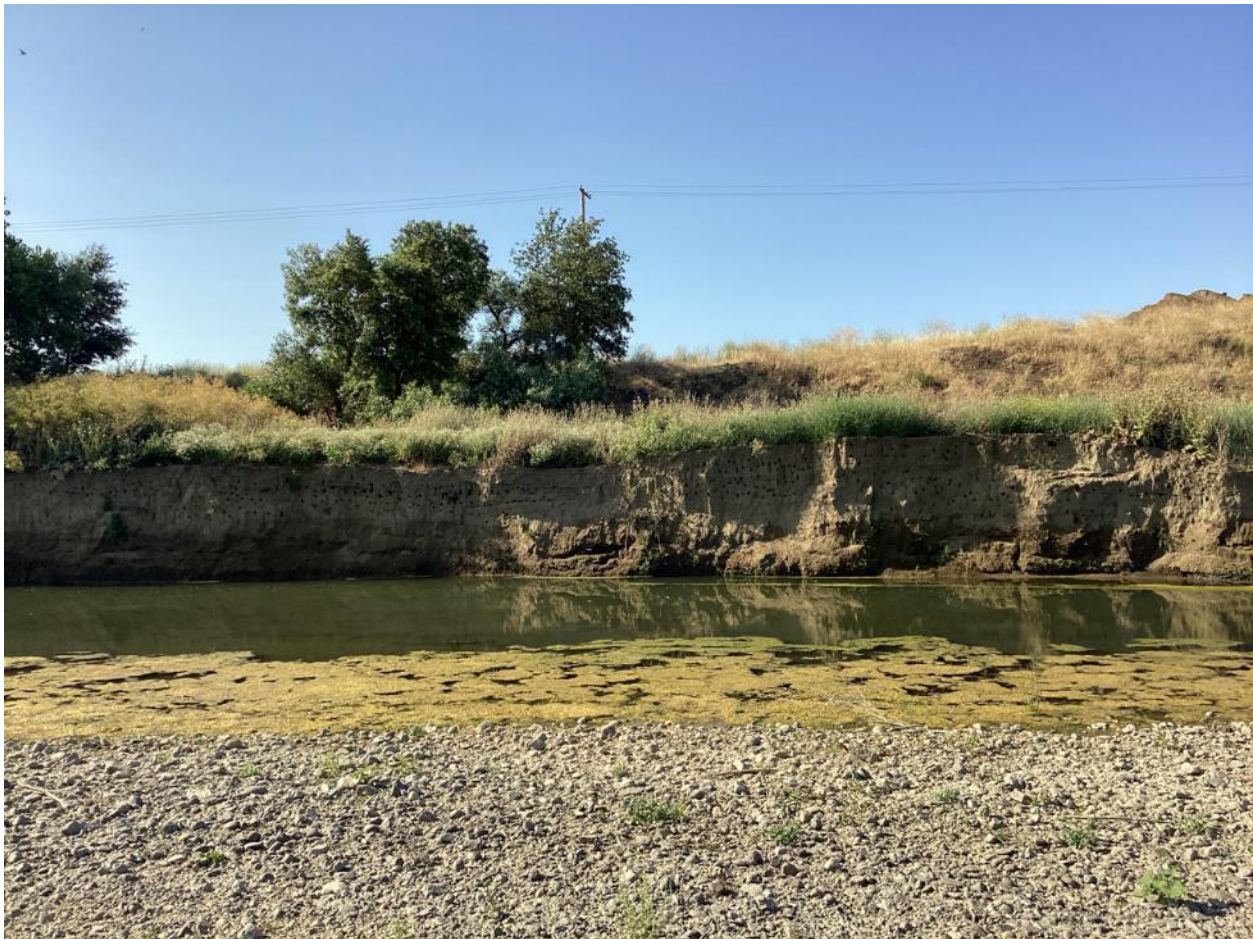
***Figure 2-26. Apparently new bank erosion and bank swallow activity. (2023)***

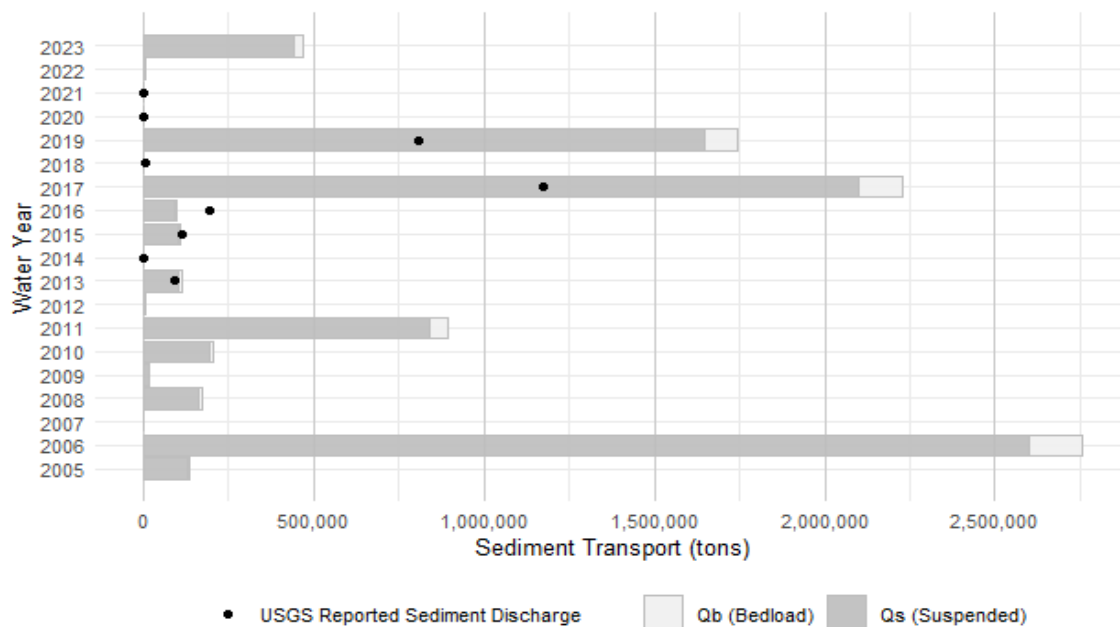
Figure 3-1. Suspended load ( $Q_s$ ) and bedload ( $Q_b$ ) in Cache Creek from Water Year 2005 through 2023.

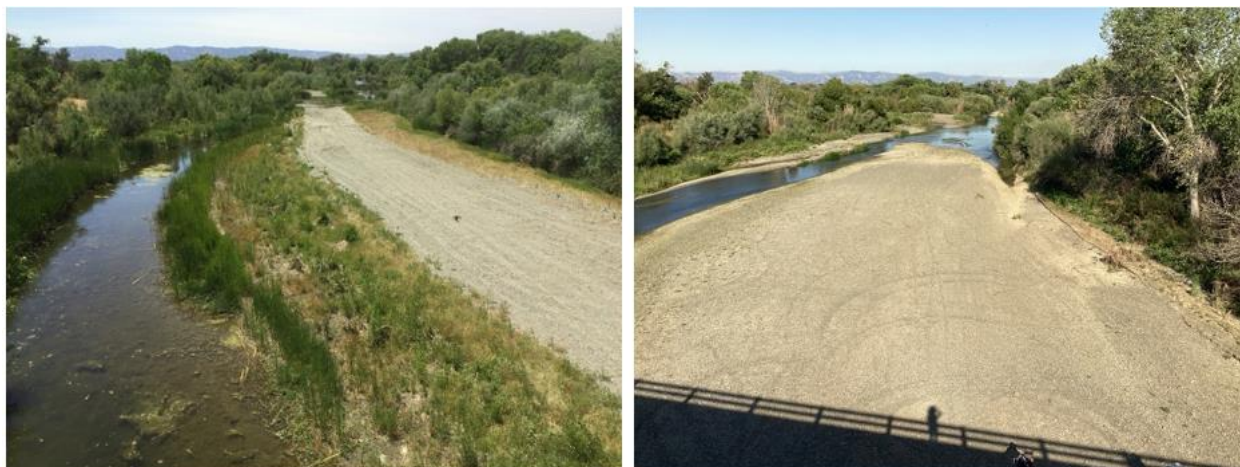
**Figure 3-2. Looking upstream of CR 94B in Water Year 2022 (left) and 2023 (right) showing typical changes in geomorphic conditions and riparian vegetation adjacent to and in the active channel.**

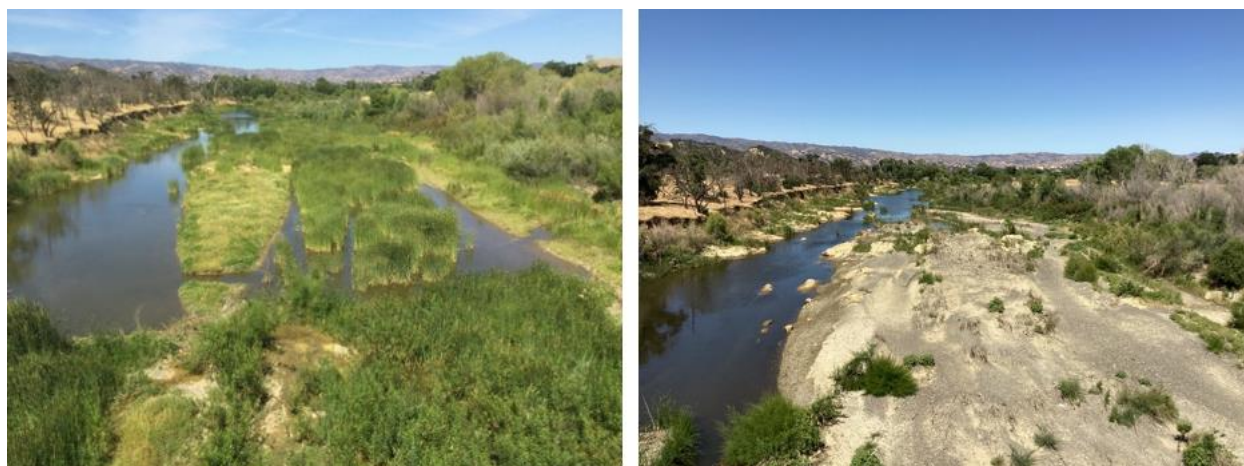
**Figure 3-3. Looking upstream of CR-85 in Water Year 2022 (left) and 2023 (right) showing loss of vegetation, sediment deposition, and minor erosion, scour, and channel migration in Water Year 2023.**

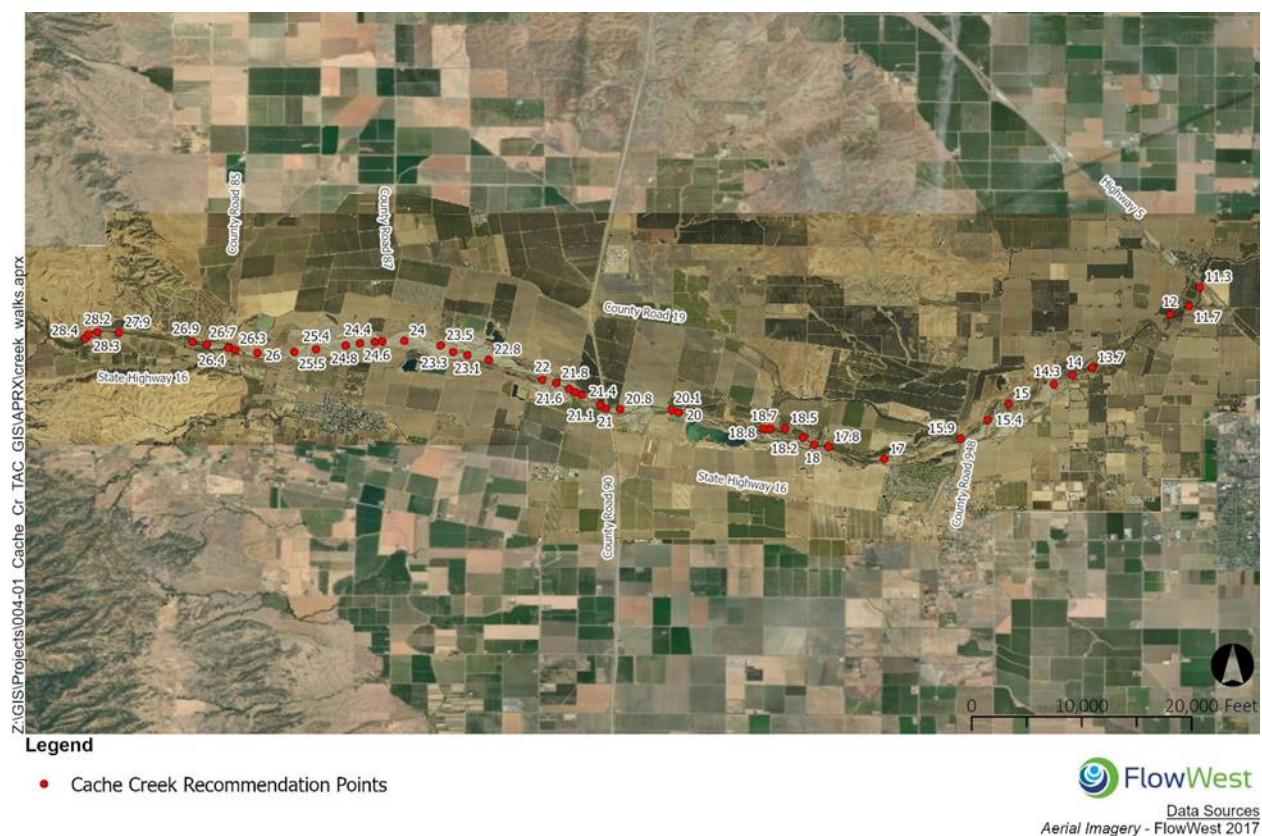
Figure 3-4. Locations of CCTAC Geomorphologist recommendations for Water Year 2023.

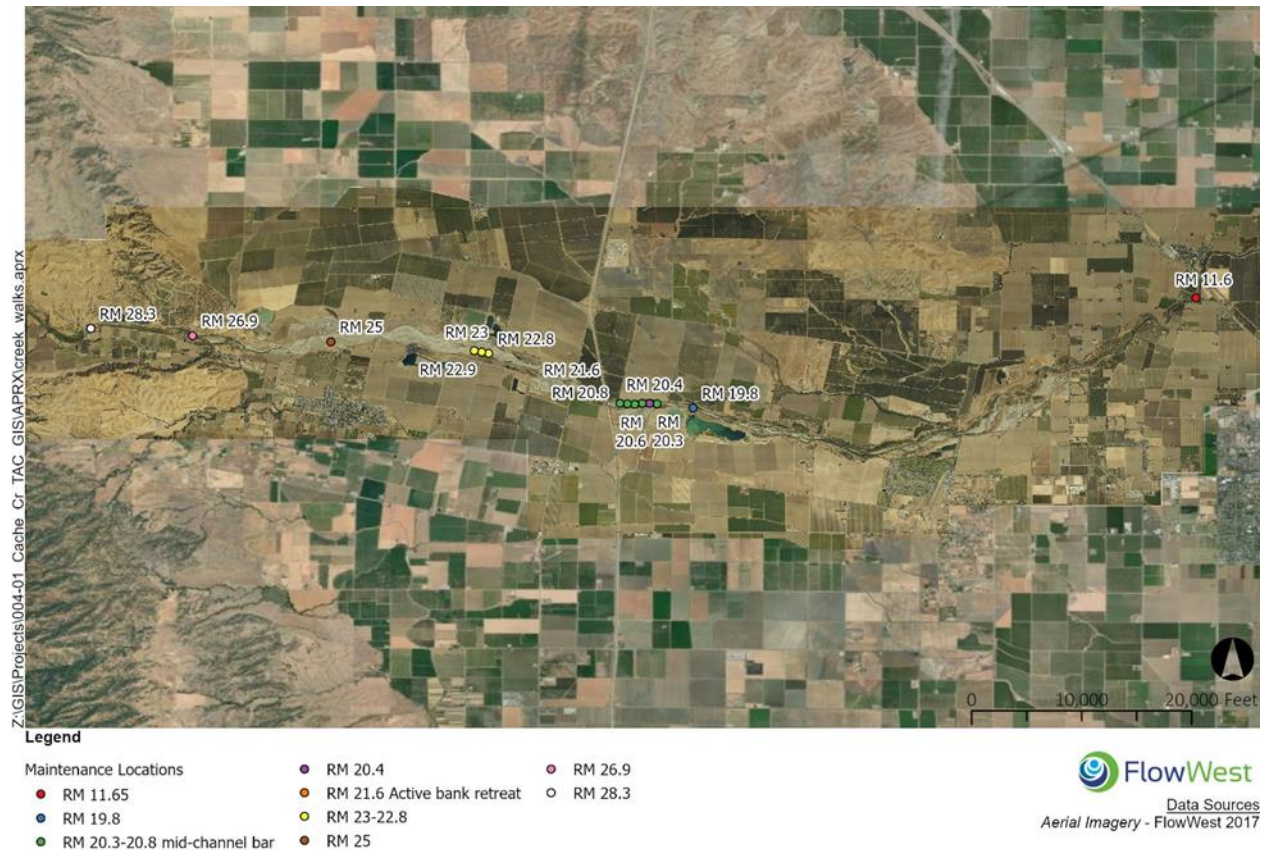
**Figure 3-6. CCTAC Geomorphologist channel maintenance locations for Water Year 2023.**

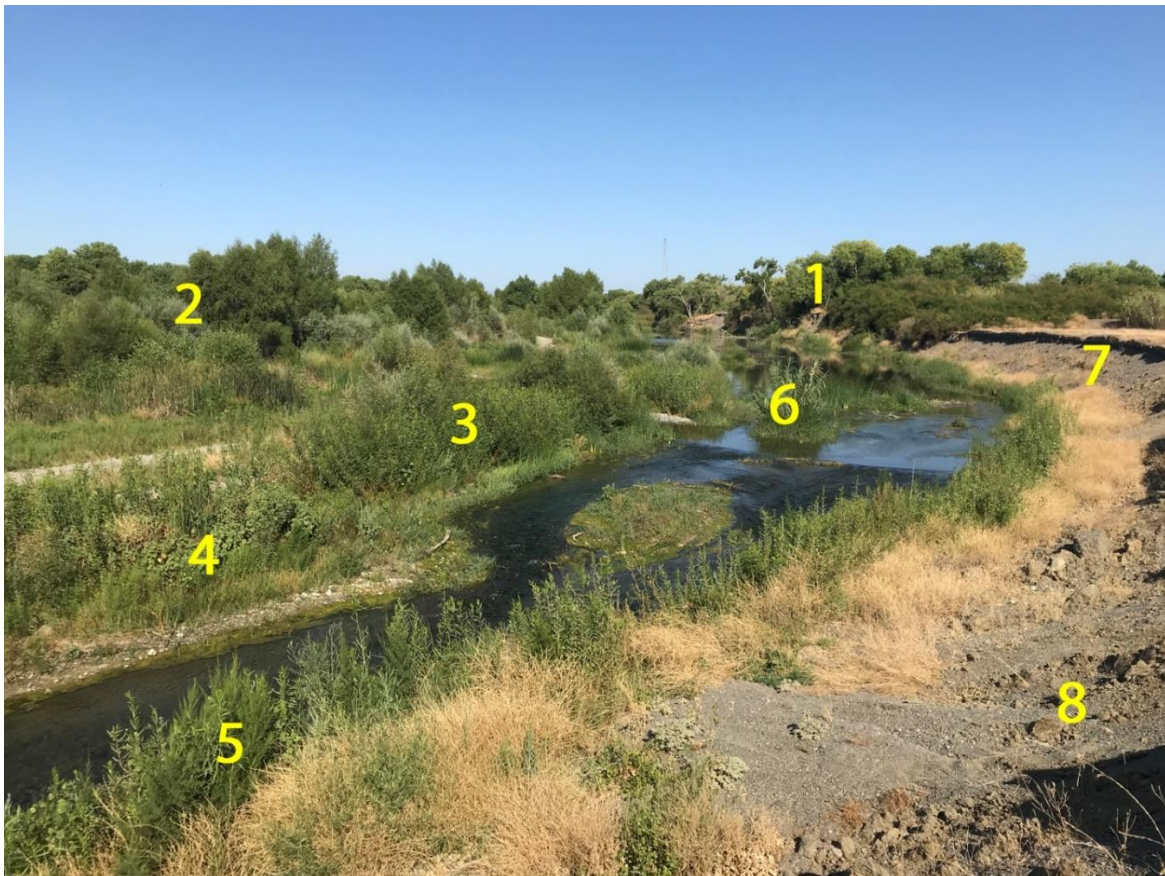
**Figure 4-1. Representative Photograph of Lower Cache Creek Channel showing a typical mix of vegetation. (2020) (1) mature riparian forest; (2) developing riparian forest; (3) dense shrub scrub; (4) establishing woody and herbaceous vegetation; (5) invasive tamarisk; (6) invasive arundo; (7) herbaceous annual vegetation above and below the slope; and (8) bare ground.**

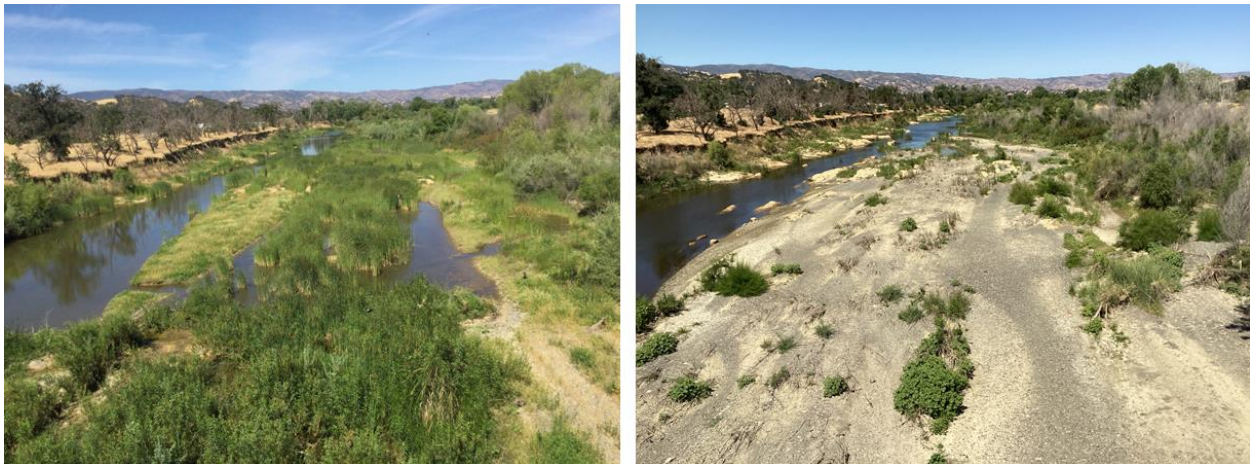
**Figure 4-2. In-channel vegetation upstream of County Road 85 bridge at RM 26.3 in the Hungry Hollow reach in 2022 (left), and in 2023 (right). Note significantly reduced vegetation in 2023 due to relatively high winter 2022-2023 flows. Note also persistent impacts of drought conditions on both north and south banks in both years.**

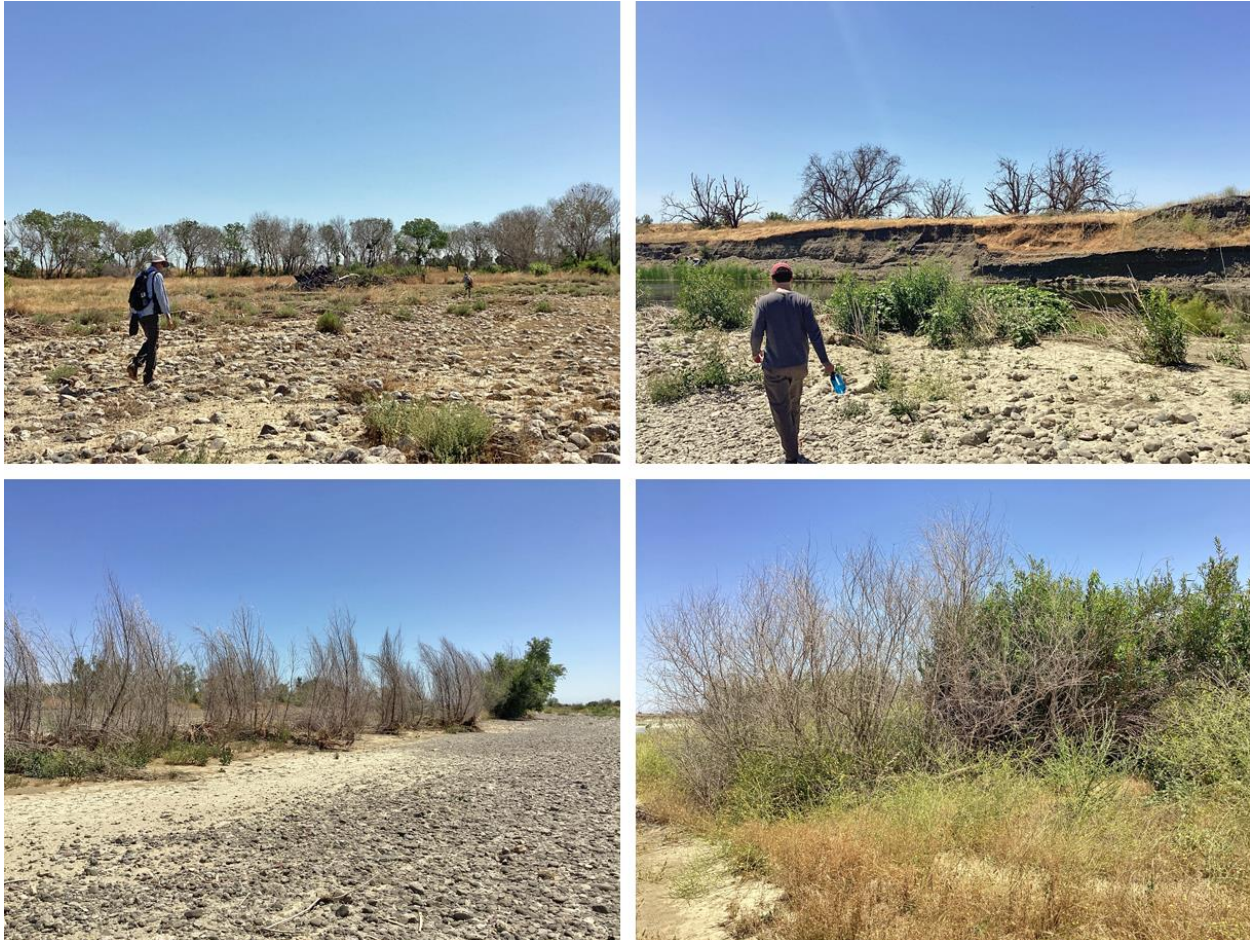
**Figure 4-3. Stressed and dying native woody vegetation, likely due to a lack of soil moisture resulting from ongoing drought conditions. Photos from RM 26.5 in the Capay Reach (upper left), RM 26.0 in the Hungry Hollow Reach (upper right), RM 25.9 in the Hungry Hollow Reach (lower left), and RM 23.8 in the Hungry Hollow Reach (lower right).**

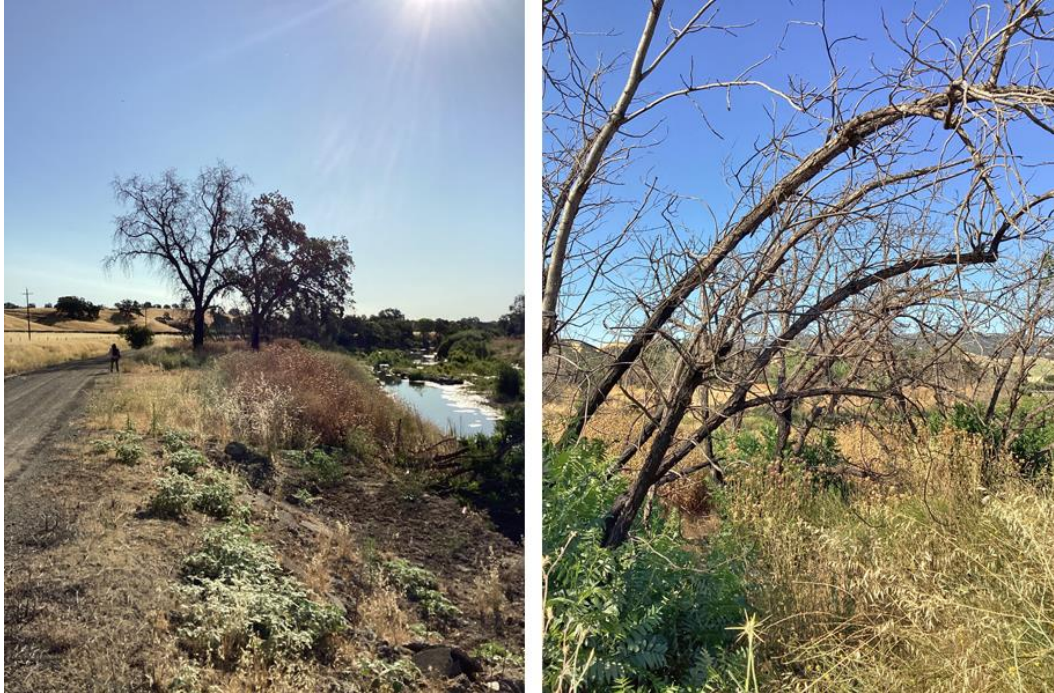
**Figure 4-4. Dead and/or severely-impacted vegetation scorched by fire on the north bank between RM 28.2–28.3 in the Capay Reach. Note the black walnuts (*Juglans californica*) beginning to resprout (right), demonstrating the resilience of native riparian vegetation to severe disturbance.**

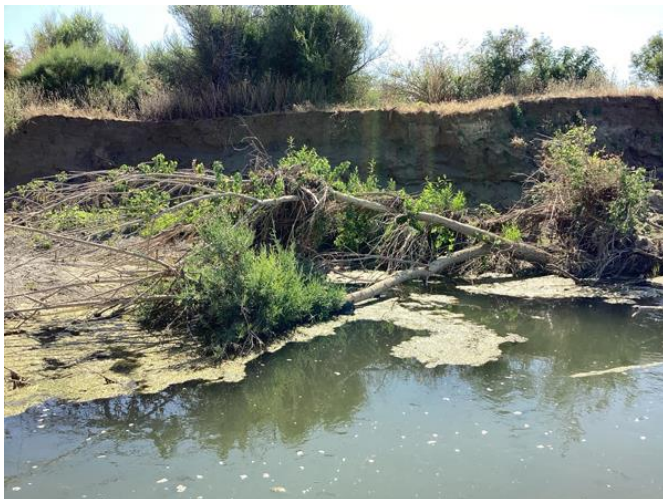
**Figure 4-5. Native cottonwood trees displaced from the south bank into the main stream channel (RM 15.1 in the Hoppin Reach) by bank erosion resulting from winter 2022-2023 flows.**

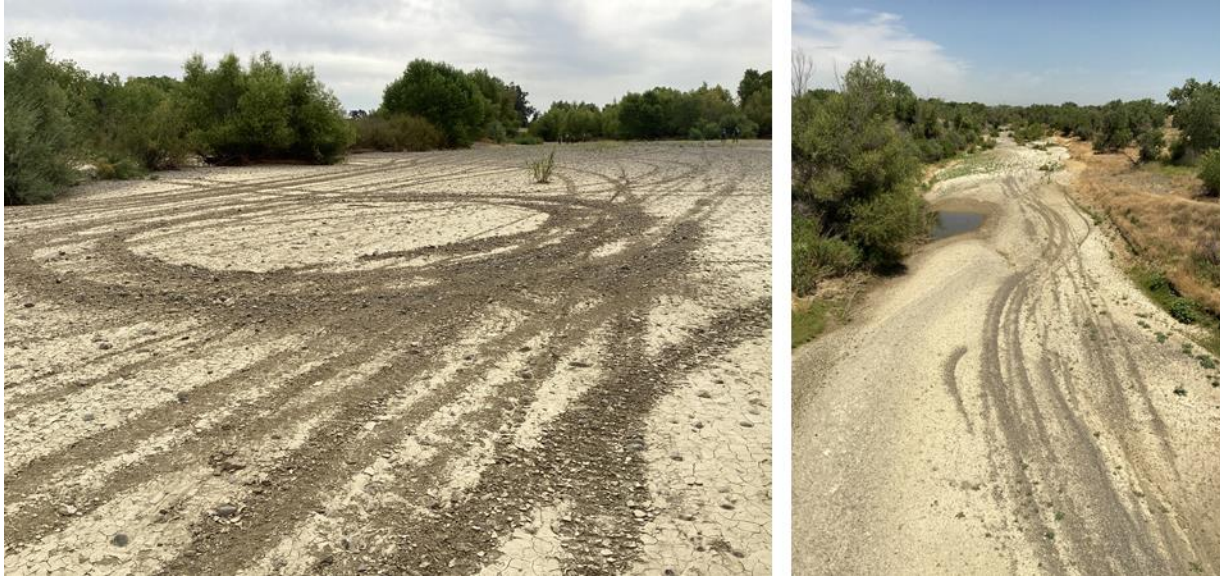
**Figure 4-6.** OHV tracks observed in the Dunnigan Hills Reach during the 2023 Creek Walk at RM 18.4 (left) and at RM 16.5 (right).
