A bald eagle (*Haliaeetus leucocephalus*) observed in Capay Reach on 2023 Creek Walk.

Photo courtesy of Andrew Rayburn (2023)

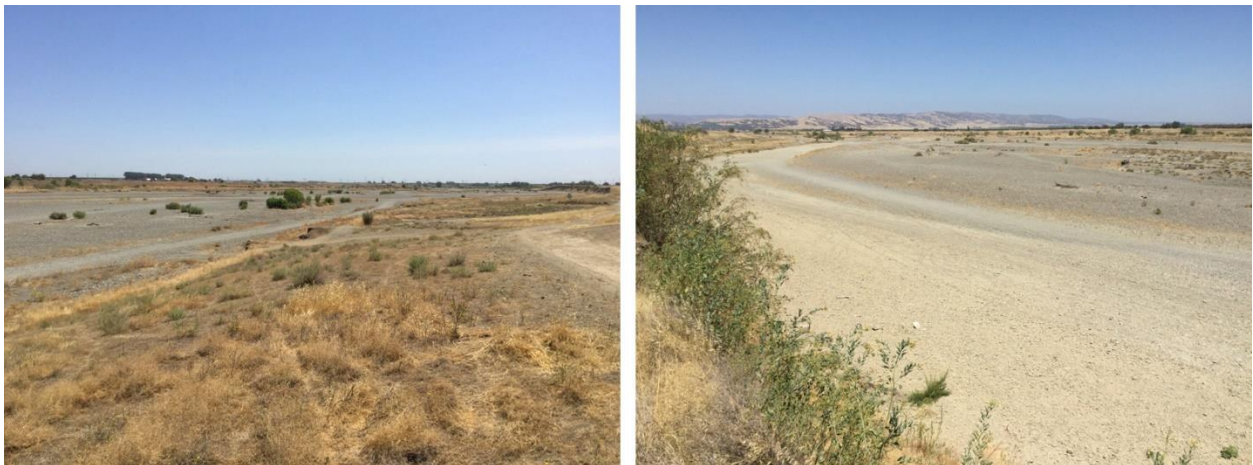
**Figure 4-7.** Representative photographs of two locations at which establishment and persistence of native vegetation is severely constrained by site conditions. (left: downstream of County Road 87 bridge in the Hungry Hollow reach; right: Madison Reach). Photos from 2020; sites were in a similar condition in 2021, 2022, and 2023.

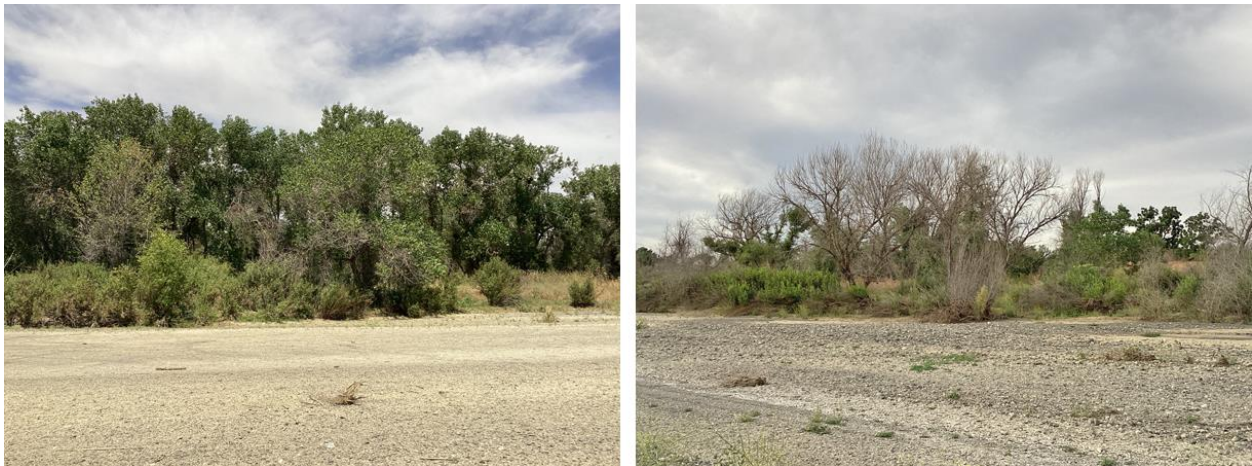
**Figure 4-8.** Healthy, stable mature riparian forest on the north bank at RM 17.2 in the Dunnigan Hills Reach (left), and drought-stressed mature riparian forest on the south bank at RM 21.1 in the Guesisosi Reach (right).

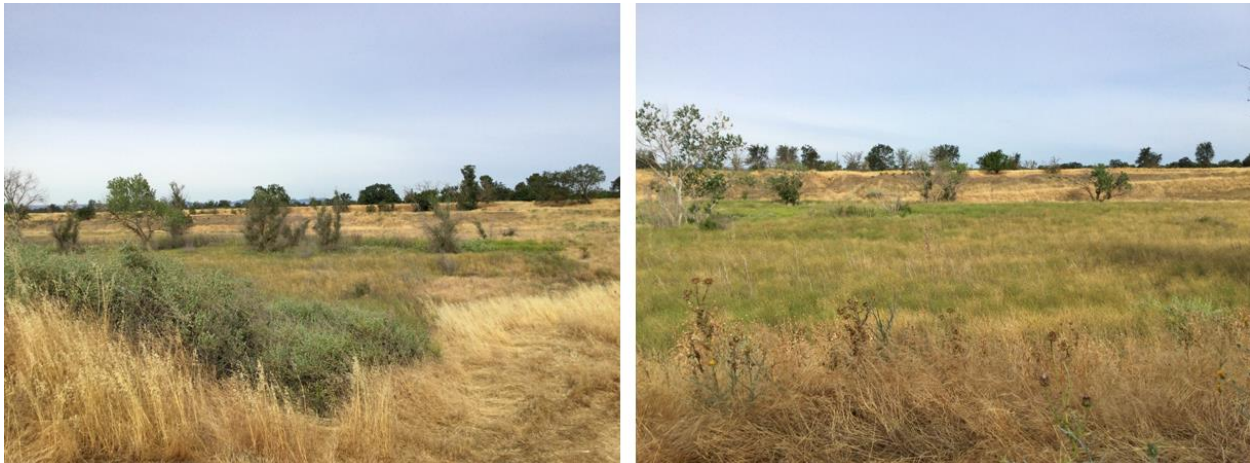
**Figure 4-9. Potential restoration sites at off-channel mining pits on the north bank from RM 15.0–15.4 in the Hoppin Reach. Photos are from 2022 and show view upstream (left) and downstream (right). Conditions were essentially unchanged in 2023.**

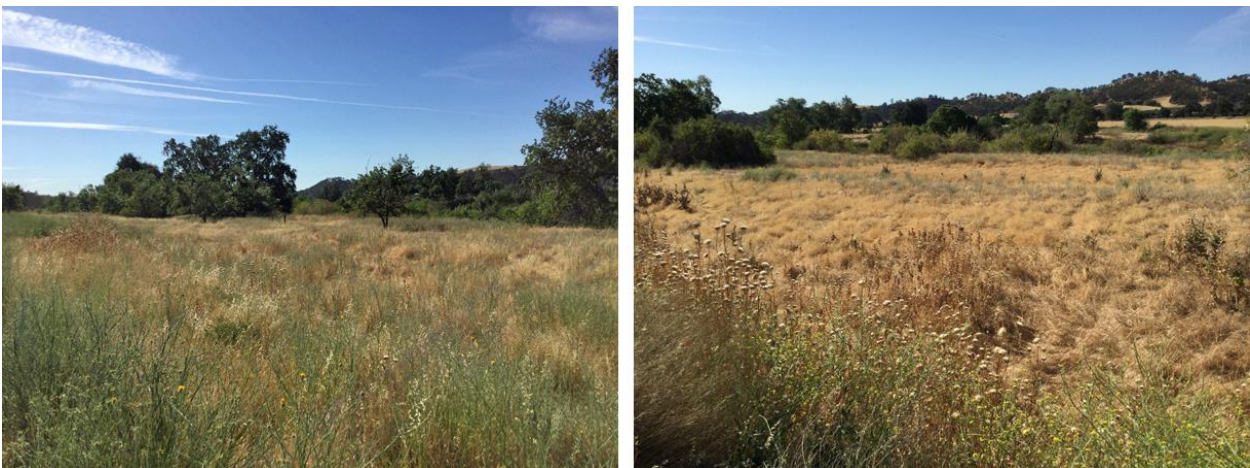
**Figure 4-10.** Potential restoration sites on upland portions of the north bank at RM 27.5 (left) and RM 27.8 (right) in the Capay Reach. Photos are from 2022, and conditions were essentially unchanged in 2023.

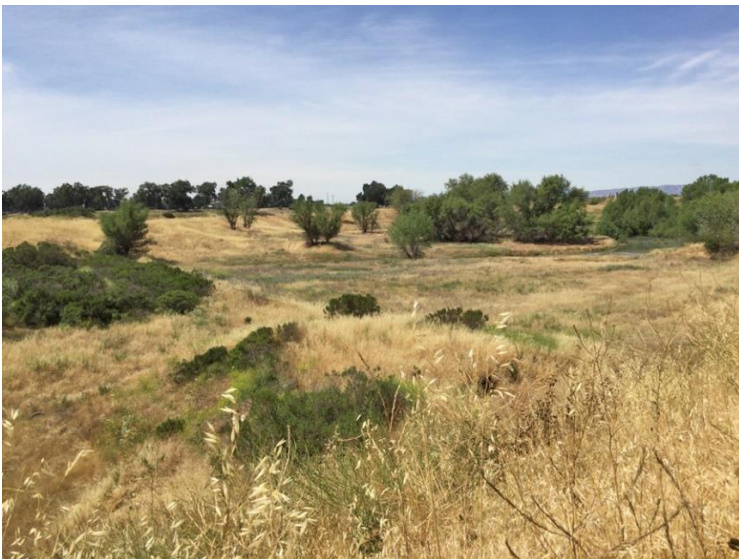
**Figure 4-11.** Potential restoration site at the Correll-Rodgers pit on the south bank at RM 13.9 in the Hoppin Reach. Photo is from 2022, and conditions were essentially unchanged in 2023 with exception of increased soil moisture and more robust understory vegetation.

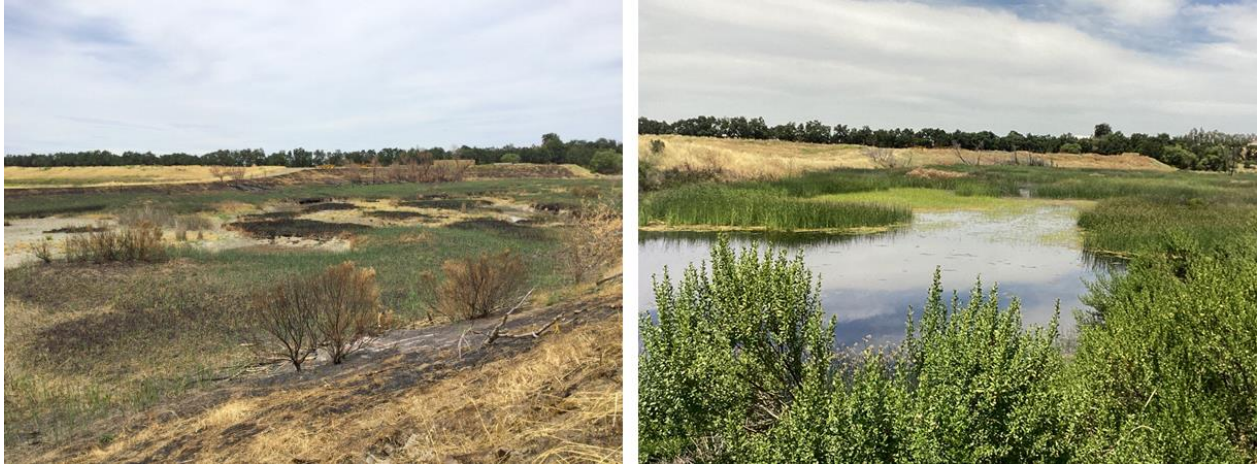
**Figure 4-12. The results of a prescribed burn of wetlands at the Cache Creek Nature Preserve at RM 16.5 in the Dunnigan Hills Reach in 2022 (left) and a year later in 2023 (right).**

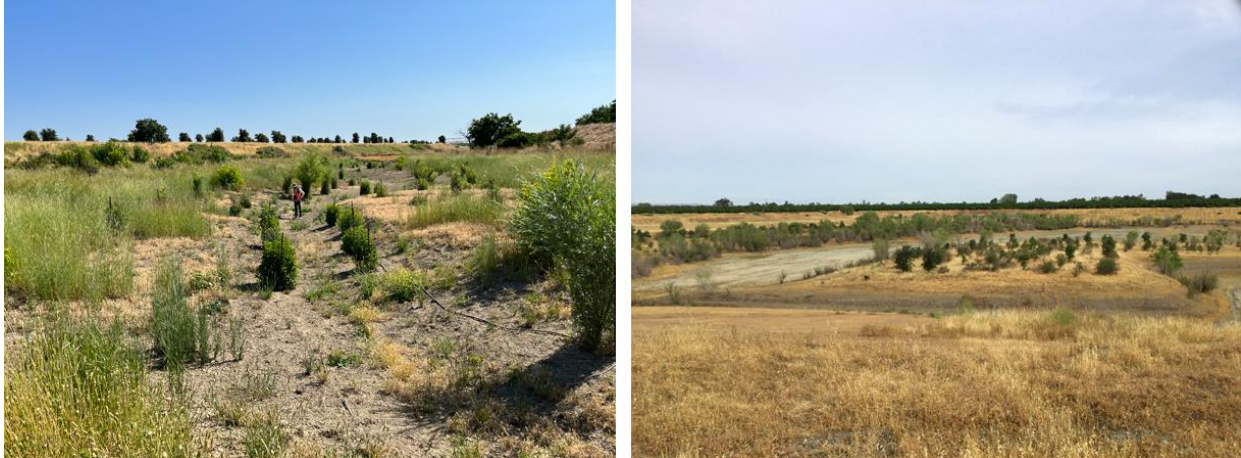
**Figure 4-13. Teichert-led restoration projects in the Hoppin Reach: the four-year old Haller/Muller Habitat Enhancement Project at RM 15.1 (2023 photo; left), and the Teichert “Muller 90” site just to the northwest (2022; right). Planted native vegetation on both project sites is persisting through sustained drought conditions.**

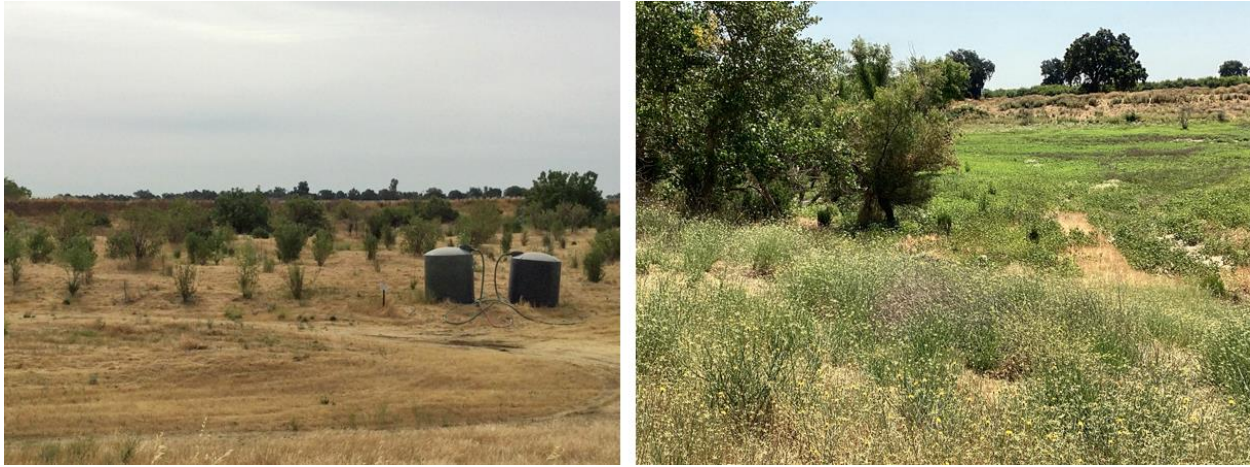
**Figure 4-14.** Elderberry mitigation sites at RM 14.5 (left; planted in 2020 and photo from 2022) and at RM 13.7 (right; planted in late 2021, and photo from 2023).

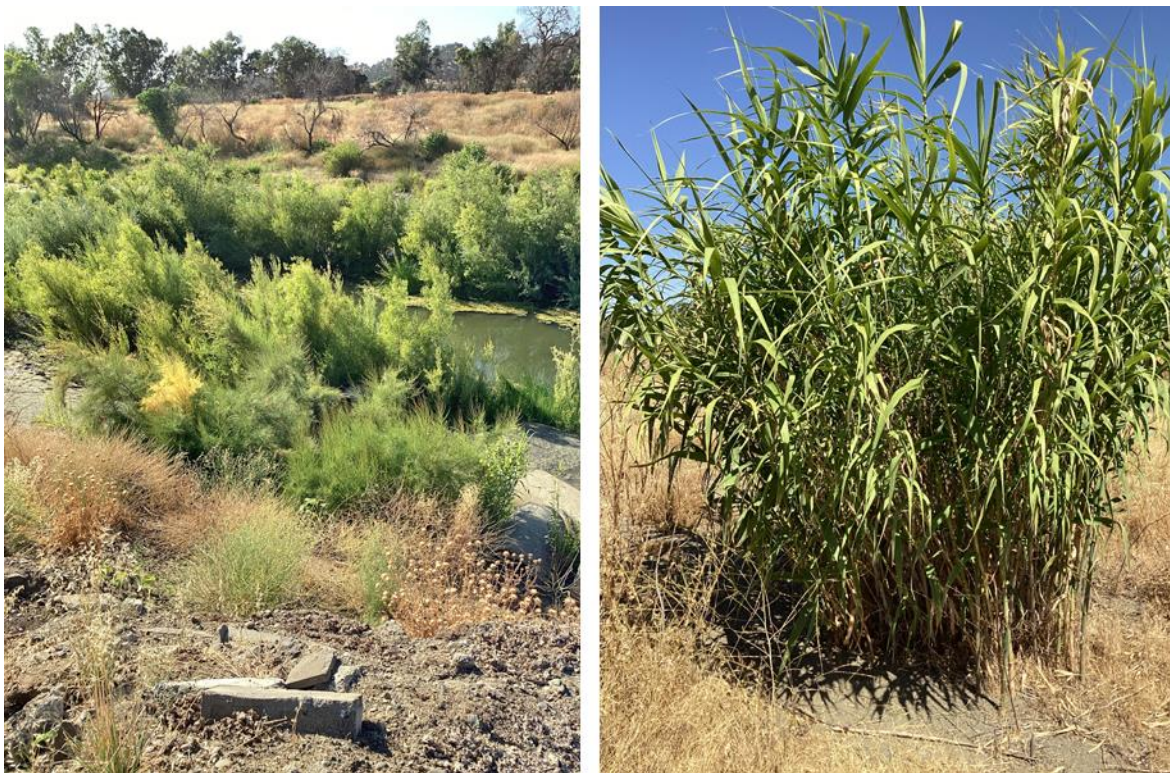
**Figure 4-15. Stands of invasive tamarisk at RM 28.3 (left) and Arundo at RM 26.5 (right) in the Capay Reach.**

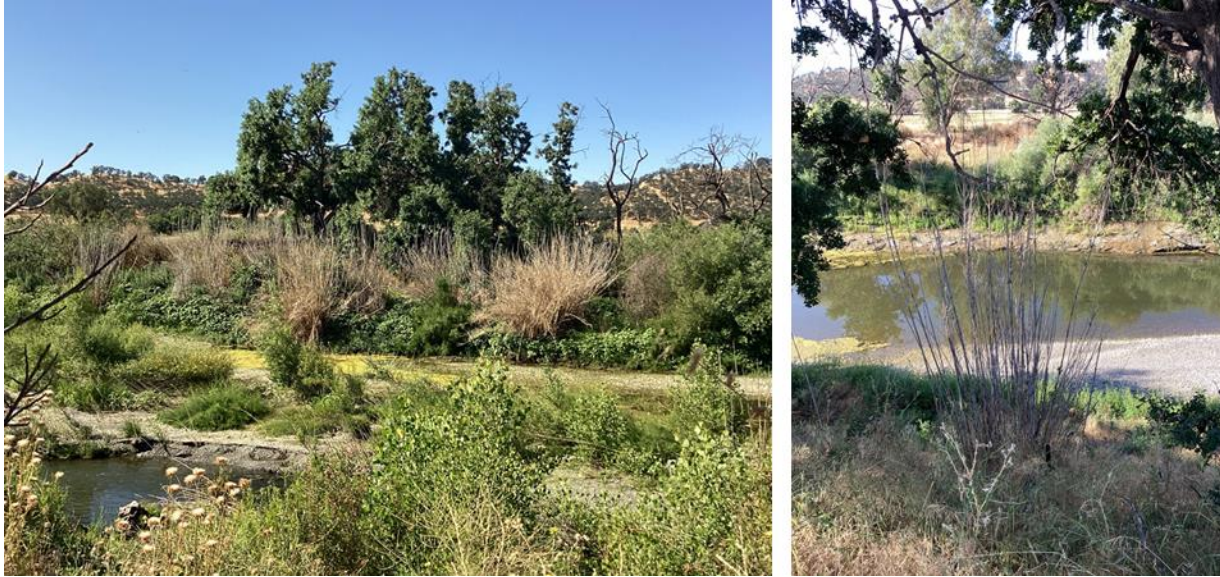
Figure 4-16. Treated strands of invasive arundo at RM 28.1 (left) and RM 27.4 (right) in the Capay Reach.

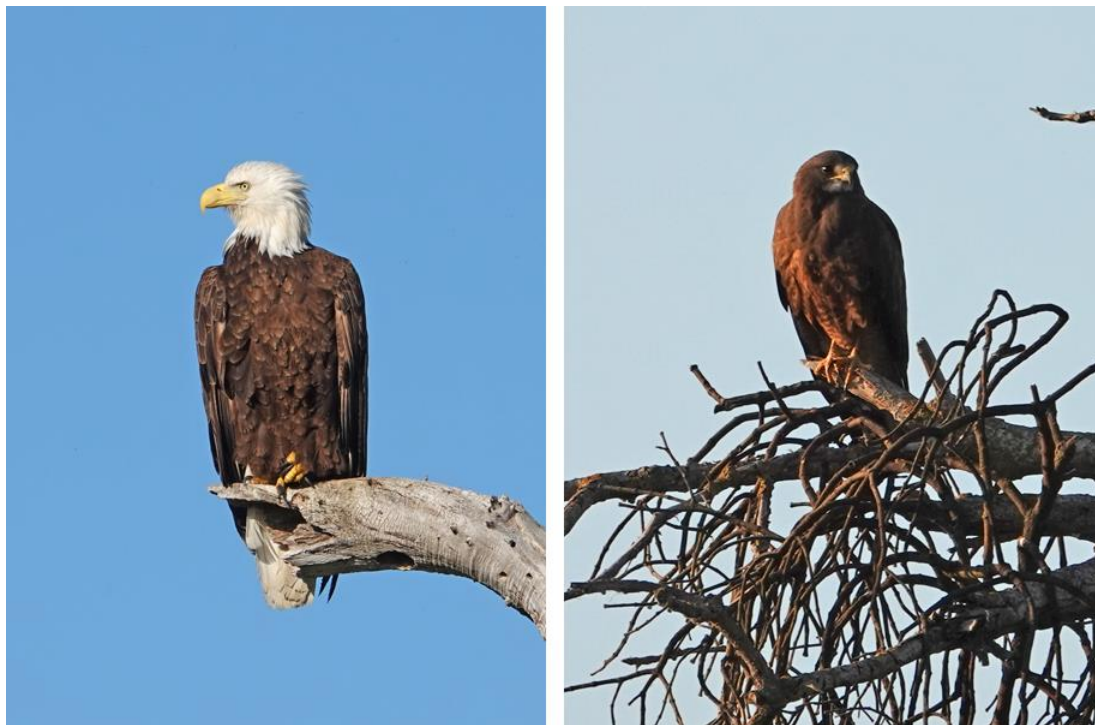
**Figure 4-17. Special-status species observed during the 2023 Creek Walk included bald eagles (*Haliaeetus leucocephalus*; left) and Swainson’s hawks (*Buteo swainsoni*; right).**

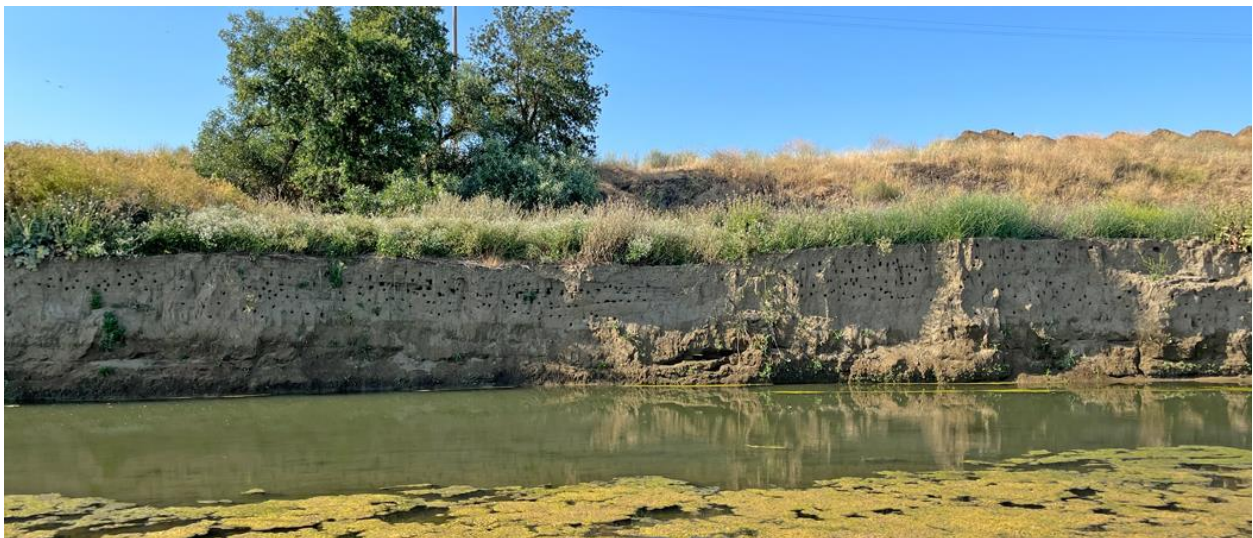
**Figure 4-18. A large, active bank swallow (*Riparia riparia*) colony on the south bank at RM 15.7 observed during the 2023 Creek Walk.**

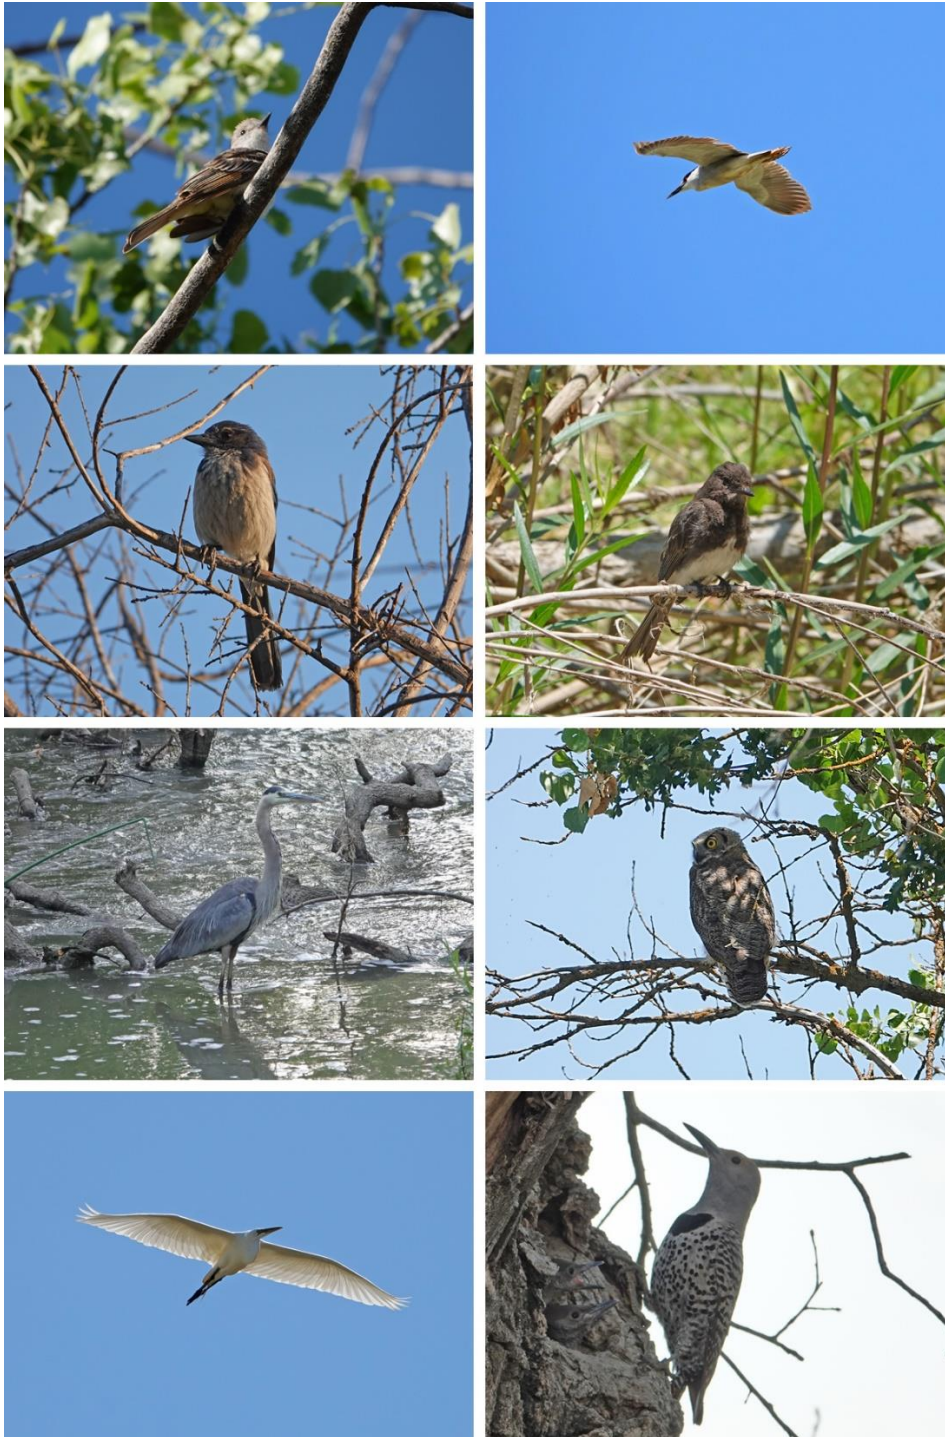
**Figure 4-19. Various native bird species observed during 2023 Creek Walk. Left column, top to bottom: ash-throated flycatcher (*Myiarchus cinerascens*), California scrub jay (*Aphelocoma californica*), great blue heron (*Ardea herodias*), and great egret (*Ardea alba*). Right column, top to bottom: black-crowned night heron (*Nycticorax nycticorax*), black phoebe (*Sayornis nigricans*), great horned owl (*Bubo virginianus*), and northern flicker (*Colaptes auratus*) feeding young.**

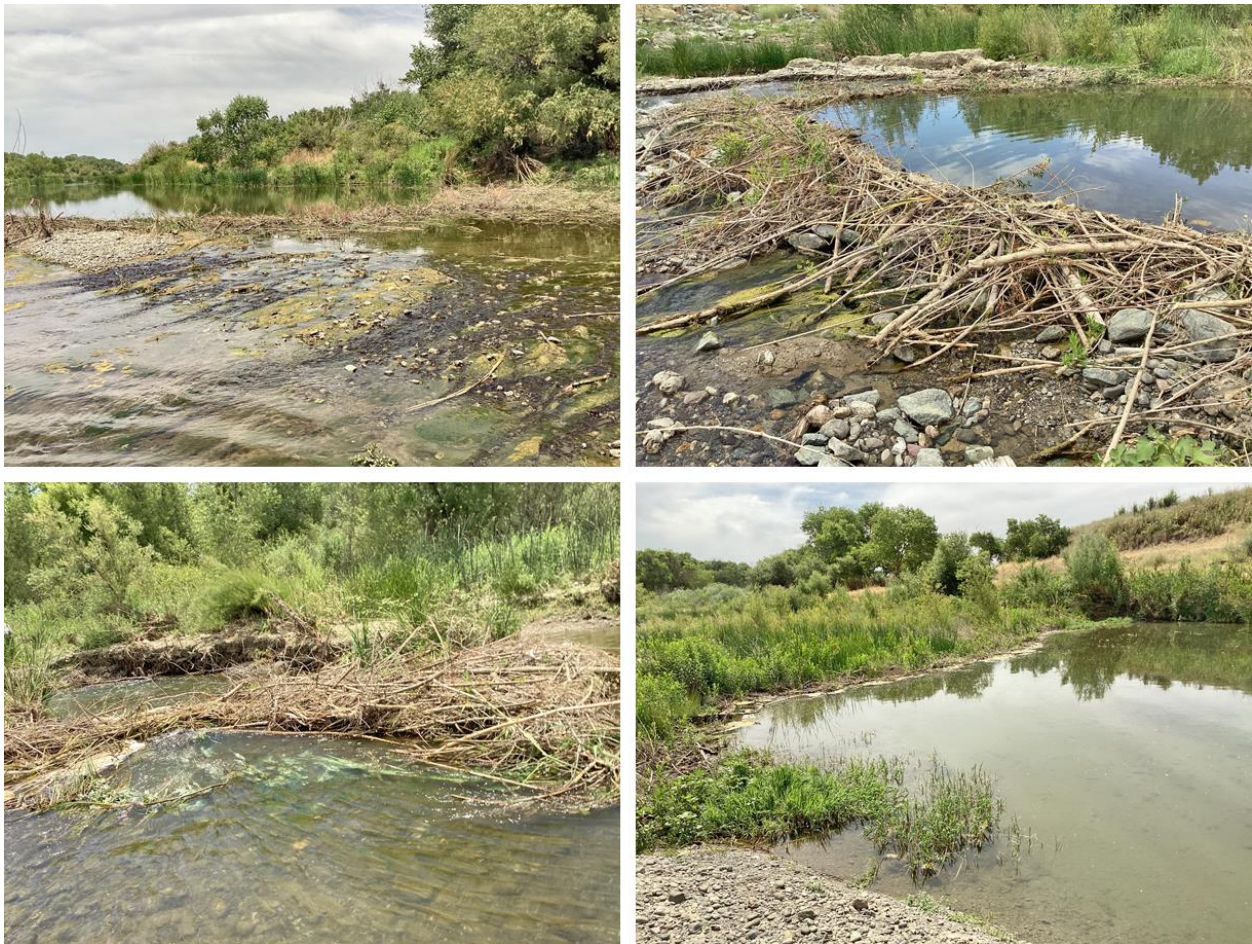
**Figure 4-20.** Beaver dams and resulting pools observed during the 2023 Creek Walk at RM 17.3 (upper left), RM 17.8 (lower left) RM 18.0 (upper right) and RM 18.6 (lower right) in the Dunnigan Hills Reach.

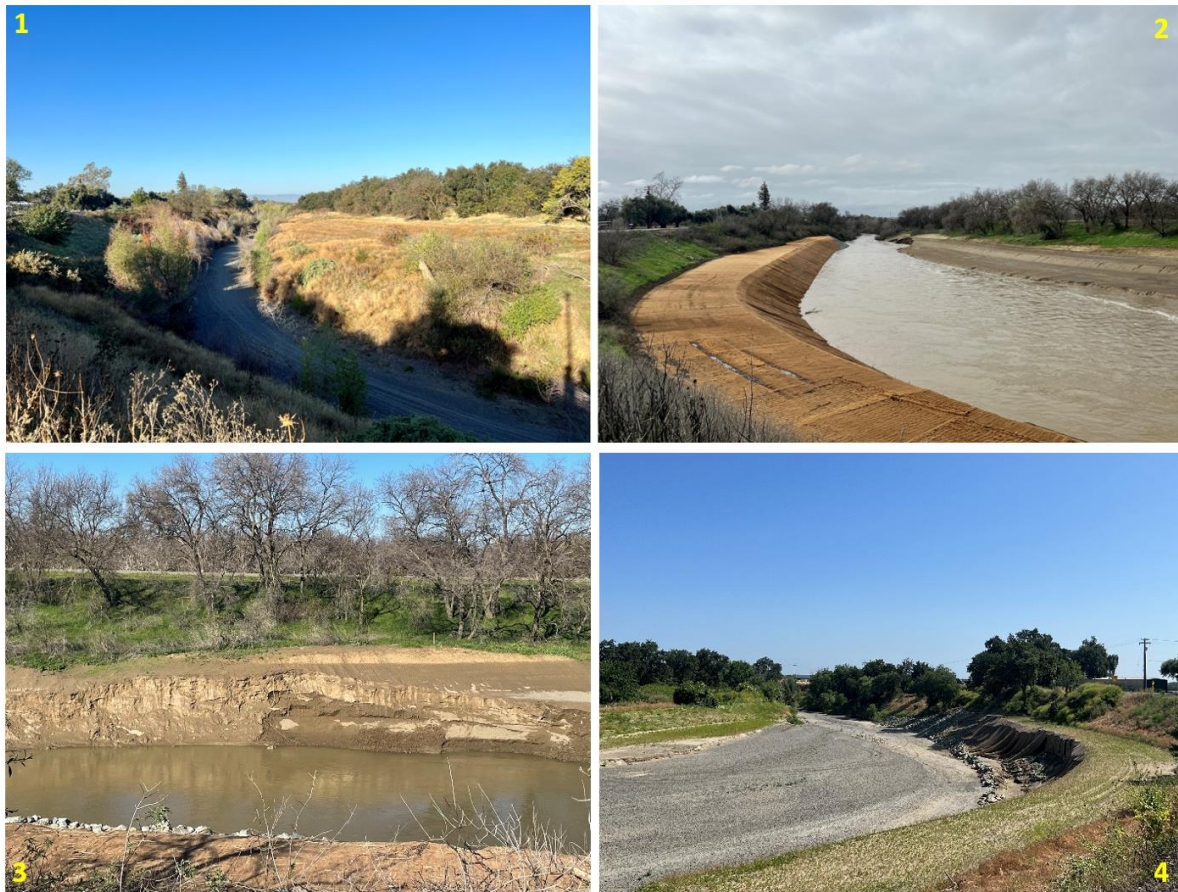
Figure 3. "Pre" and "Post" construction photos (Photo 1 – taken 10/04/22; Photo 2 – taken 01/06/23) and representative photos showing project damages from the 2022-2023 Winter Storms (Photo 3 – taken 01/20/23; Photo 4 – taken 06/02/23).

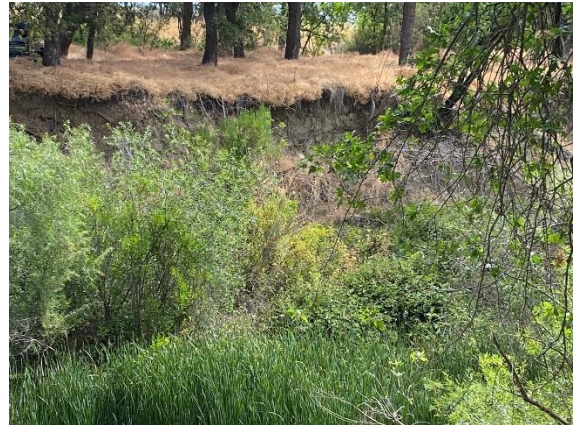
**Specifics.** The damage was along the Salisbury Spillway channel and north levee. An estimated loss of 1, 456 cubic yards of soil occurred over

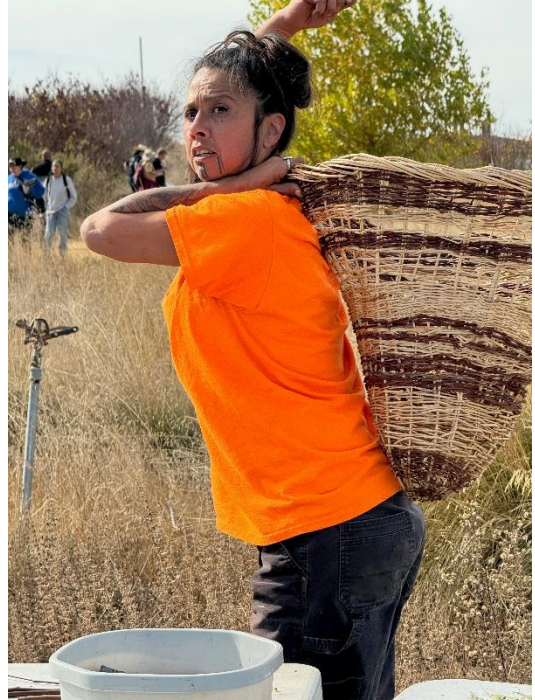
*Ali Meders-Knight demonstrates how one type of basket would be carried as part of the cultural presentations during the 2023 Leok Po workshop. Photo by Christine Golden.*

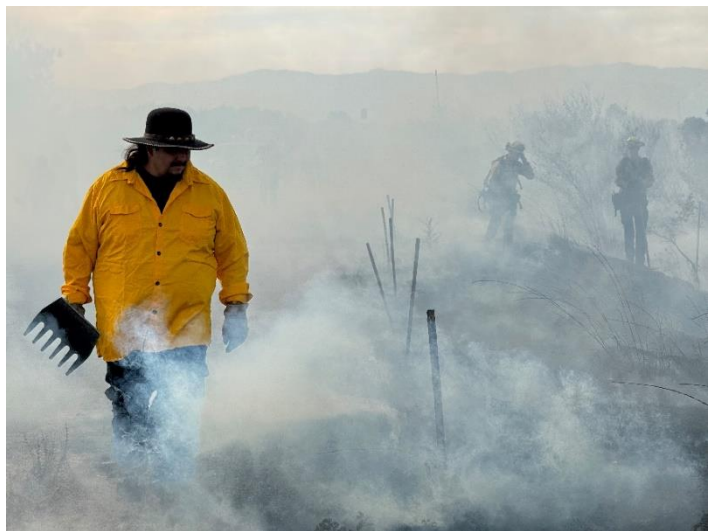
*Danny Manning, Mountain Maidu and professional wildland firefighter, oversees burning the levee behind the Tending and Gathering Garden. Photo by Christine Golden.*

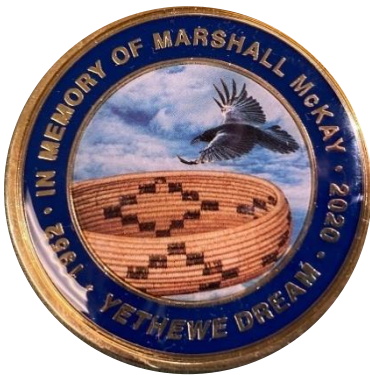
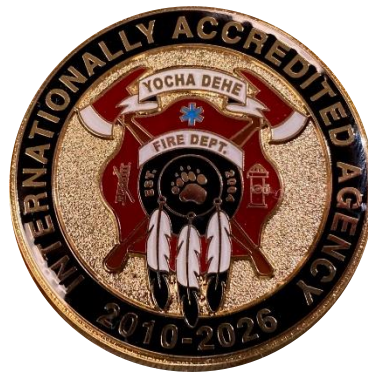
*Both sides of the Yocha Dehe Fire Department Challenge Coin presented to Cache Creek Conservancy on November 12, 2023.*

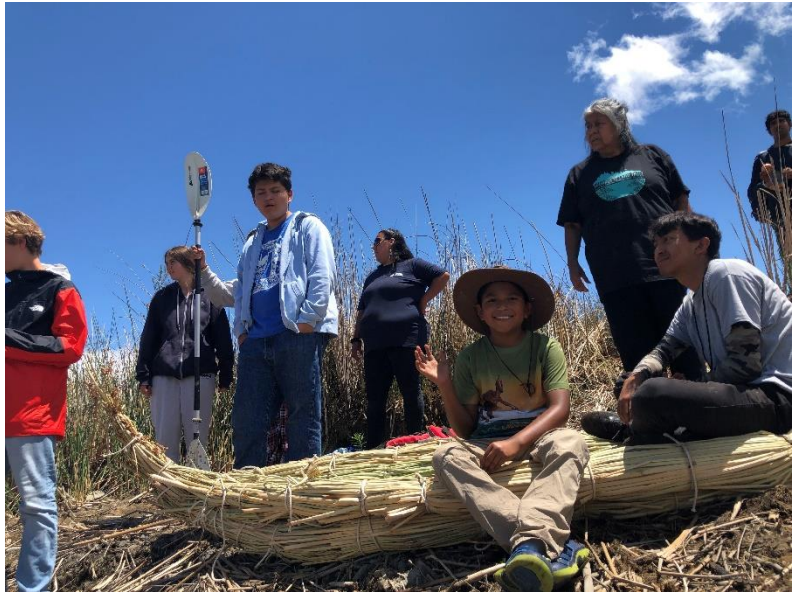
*Students enjoy the tule boat they built during their TGG-TEK class at the Cache Creek Nature Preserve.*

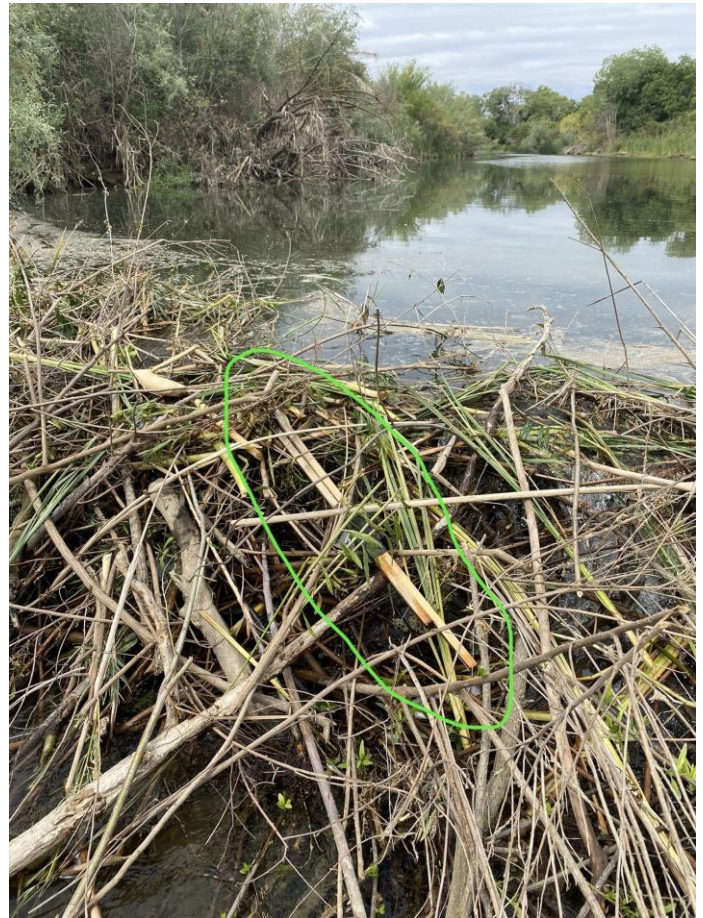
During the summer, the CCC noticed new beaver dams in creek. The beavers are extremely industrious and have made quick progress in rebuilding their dams that washed away.

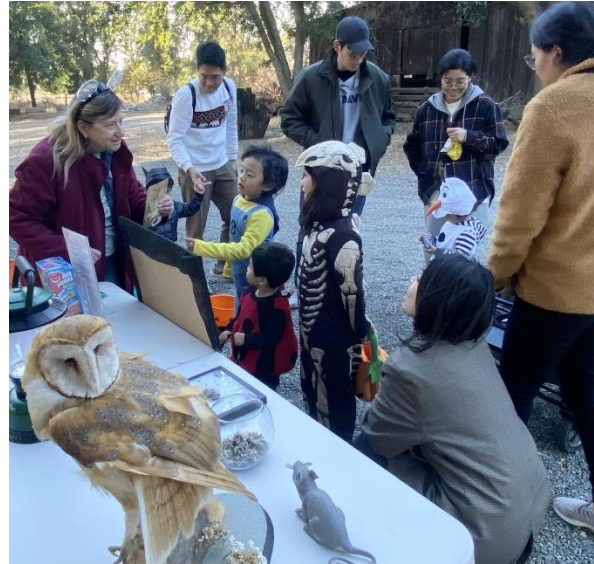
*Tree-trunk or treaters lined up to answer owl questions and receive treats at this year's Tree-Trunk or Treat event.*
