2008 Creek Walk Summary

YOLO COUNTY

Parks and Resources Department

2008 CREEK WALK SUMMARY

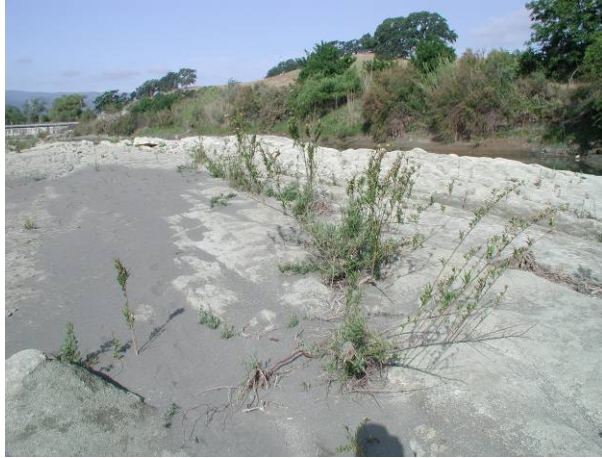
sediments. The seeps seem to sustain vegetation development in this reach and have been observed within the reach during every previous Creek Walk. These seeps are caused by extensive surface irrigation that results in interflow at the base of the soil profile, along the top of the less permeable bedrock boundary. On the north bank an extended terrace supports a mixed stand of Northern

Figure 4. Seeps at the base of the soil profile in the Capay Sub-Reach caused by irrigation and drainage from the West Adams Canal.

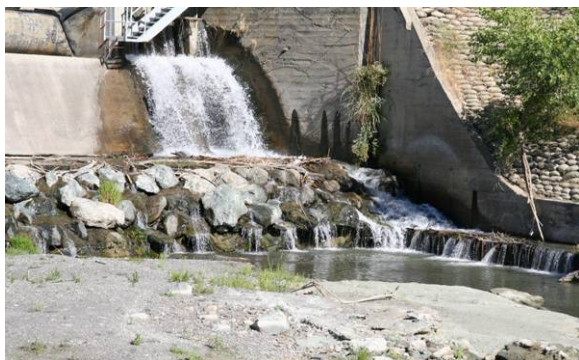
Figure 5. Scour along north bank below Capay diversion dam.

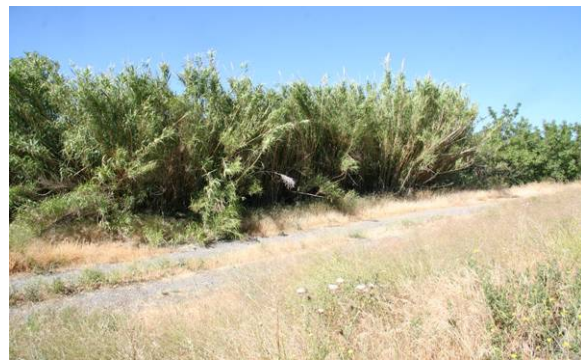
Figure 9. *Arundo donax* along left bank levee at RM 27.6.

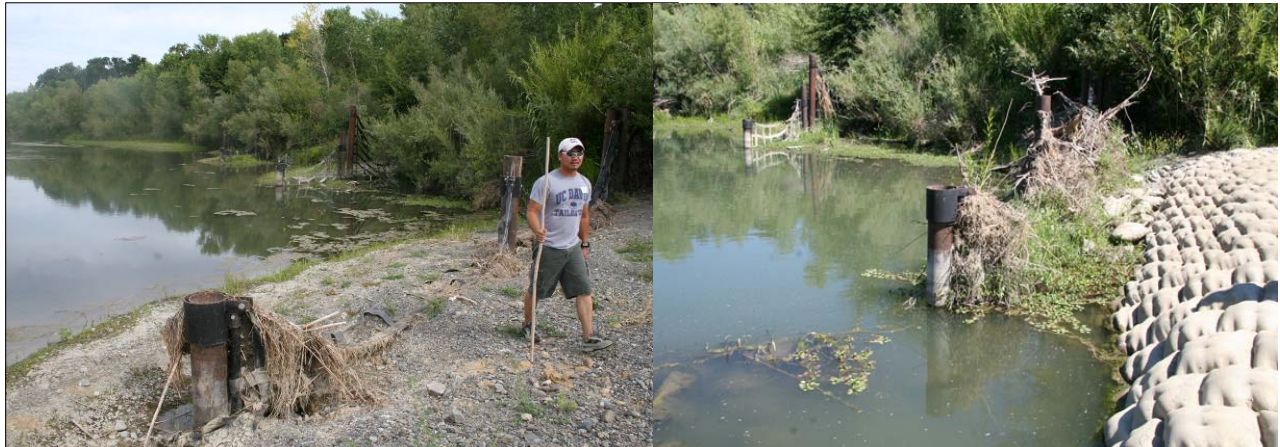
Figure 10. Prior to 2008 (left photo), sediment had been effectively trapped at the steel piles and nets next to the concrete pillow blanket. In 2008 (right photo), this sediment had been eroded away.

Significant changes have occurred since the 2007 Creek Walk. Sediment has collected in new areas, erosion patterns have changed, and beavers have raised the water level upstream from the pillow blanket. A beaver dam is attached to the pillow blanket along the south bank. The beavers utilized the solid abutment of the pillow blanket and eroded clay bedrock as anchor points. Comparing photos between years there is no significant difference in the water levels before and after the beaver dam was created. The scour found at the Palisades is probably unrelated to the beaver dam. Any sediment deposition

1. A long-term solution is needed for the concrete blanket and the international pipeline crossing Cache Creek. Repair work was completed in 2006 and there is significant erosion to the blanket only two years after this work was completed. PG&E should be contacted in order to discuss maintenance and long-term solutions for this area.
2. Monitor the nick point and estimate its travel speed. Anticipate any issues that it may cause. For example, what will happen when the five-foot incision of the nick point reaches the dam?

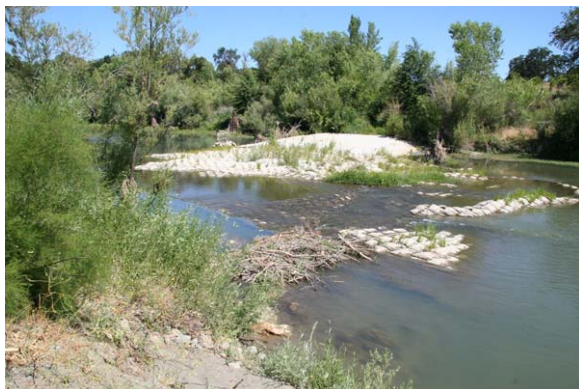
Figure 11: Beaver dam at Pacific Palisades pillow blanket.

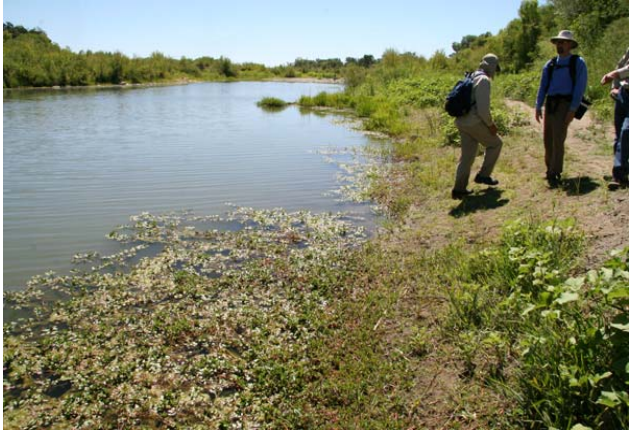
Figure 13: Red Sesbania at RM 26.8.

the Palisades project should consider nearby landforms and stream processes. Soil exposure and erosion in this area has caused the soil to dry out and trees to die from exposure and attrition. In 2006, it was noted that dead, mature trees from the top of the bank continue to fall into the channel as the area gradually erodes, providing large woody debris to the local stream environment. This large woody debris enters the channel and is moving downstream. Invasive Red Sesbania (*Sesbania punicea*) is common along the creek margin at RM 26.8.

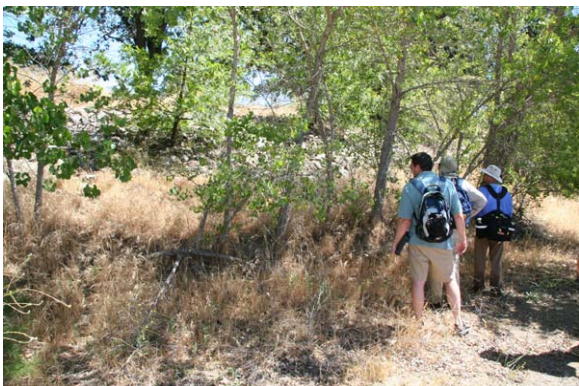
Figure 14: Bank protection boulders upstream from Highway 85.

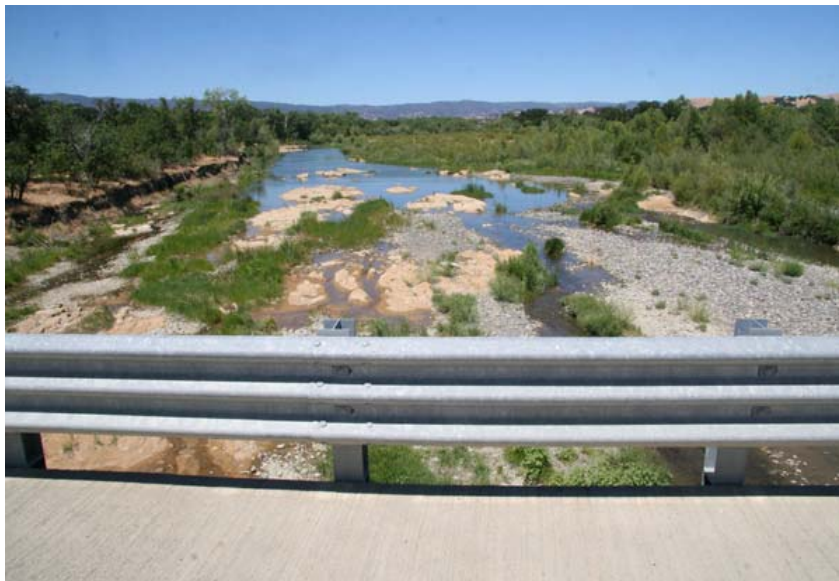
Figure 15: Bedrock exposure upstream from CR-85 Capay Bridge.

1. A meander that is developing along the north bank may pose an erosion hazard to the north ramp of the Capay Bridge. This could be addressed with control structures along the north bank, upstream from the Bridge. Recommendations included continued monitoring of the meander position and lateral erosion. It would also be instructive to compare the current configuration compared to past years.
2. Monitor the riparian vegetation downstream from the spur dikes.
3. Monitor mid-channel aggradation.
4. Consult with PPW and Caltrans on management and inspection of bridges crossing the Creek. There may be a need for channel reorientation and/or sediment removal to address the adverse orientation of the low flow channel that is a potential erosion hazard to the Capay Bridge abutments.

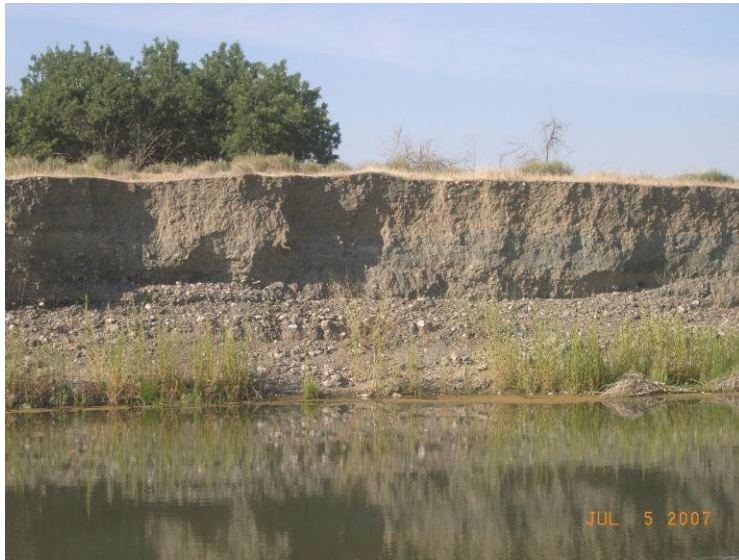
Figure 21. Craig Property eroding bank due to Creek meander.

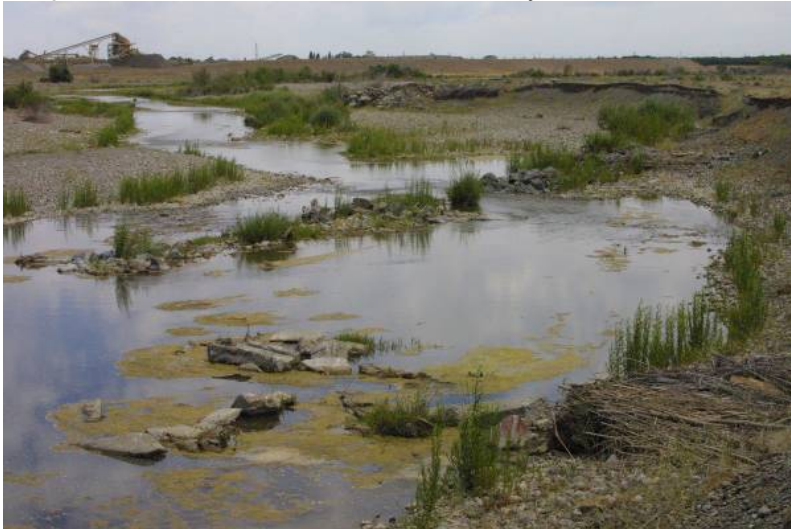
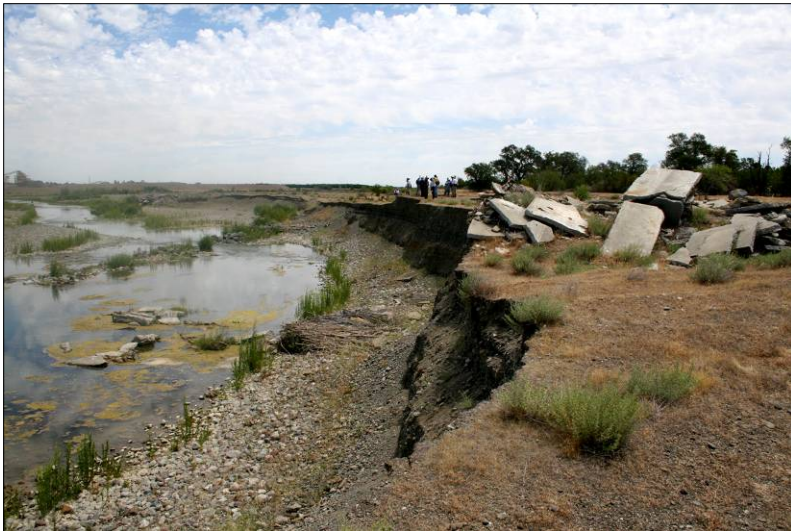
Figure 22 (above) and 23 (below). Creek meander eroding bank and concrete posed to fall into the Creek.

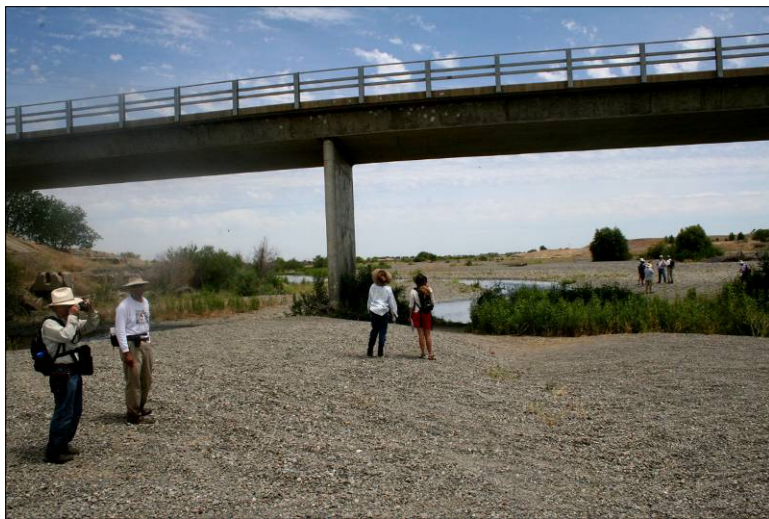
Figure 27. The CR-87 Esparto Bridge abutments.

Rip-rap boulders and slabs from an older bridge are visible along the north and south banks on the downstream side of the bridge. The bridge structure seems to have sufficient hard points (spur dikes) and structural control to maintain the current channel configuration, although the gravel bed stream is

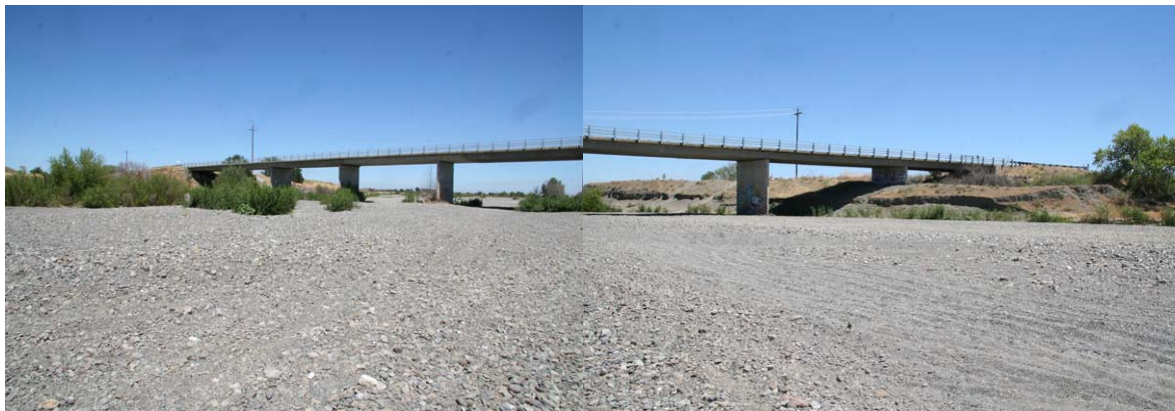
Figure 28. Mid-channel vegetation and gravel bar deflects low flows to the sides upstream from the Esparto CR-87 bridge.

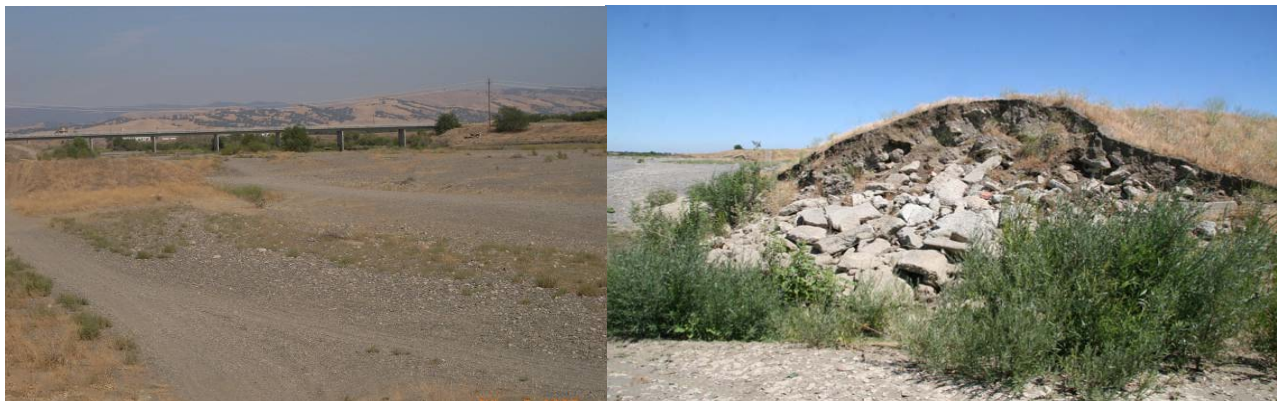
Figure 30 (left) and 31 (right). At RM 24, Sediment deposition between Syar spur dikes and scour at toe of spur dikes.

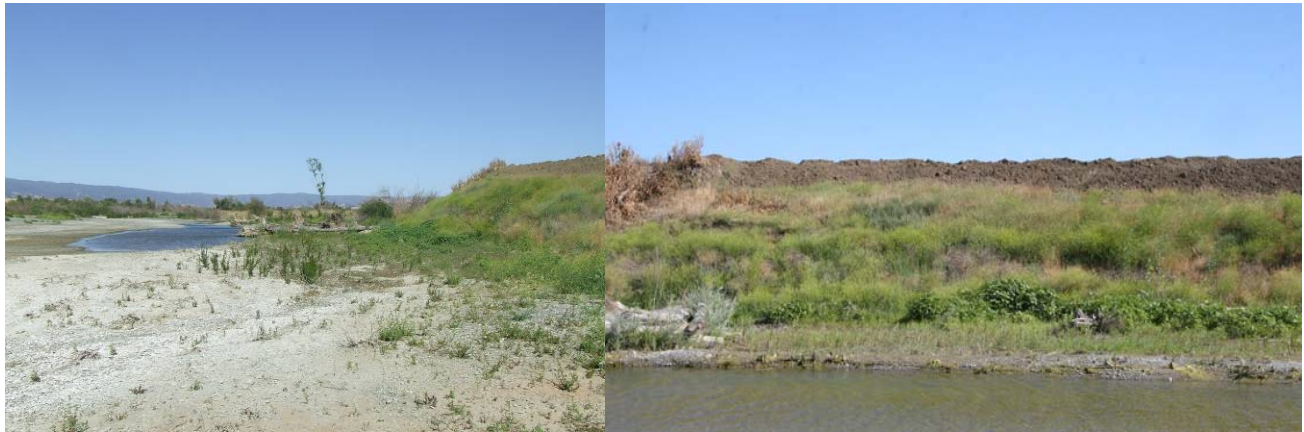
Bank erosion occurred at this Teichert site after the floods of 2006. Several protection measures were implemented, including root wads, restoration, and coir fabric placed on the slope. Questa Engineering designed a series of cabled-together root wads to redirect the flows. One hundred fifty meters of cabled oak root wads were added on the downstream end of the project in 2006. Root wads were tied together with cables and placed in the channel at RM 22.8, but they are too far from the base of the levee to provide protection during high flows. Several of these root wads have scour holes on the downstream sides, and cattails are growing in low, marshy ponds that surround the root wads. The root wads have failed to protect the

Figure 38 (left) and 39 (right). Teichert bank protection with scour behind root wads and loose soil on top of levee.

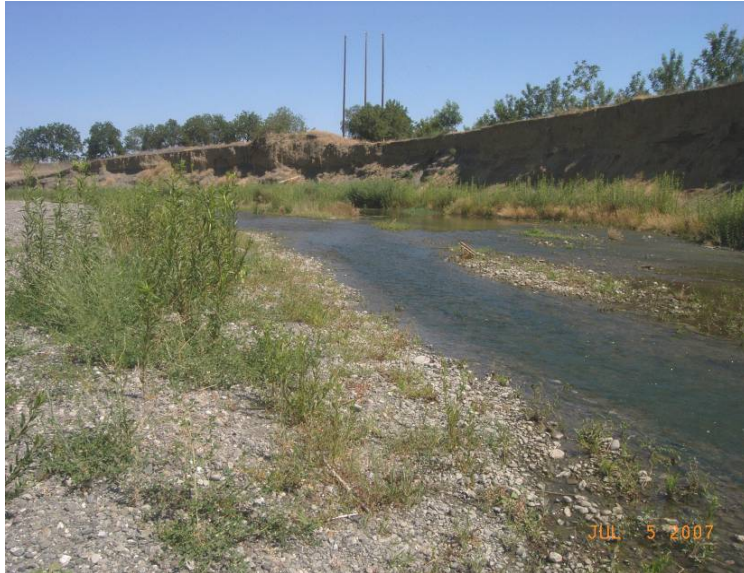
Figure 41. Bank erosion at the outside bend of the meander at the Scheuring property.

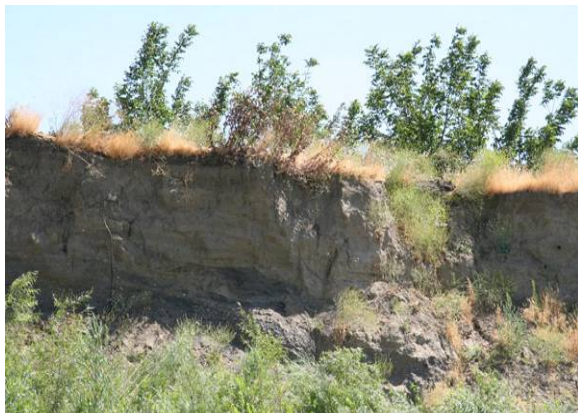
Figure 42: Active erosion at RM 21.6 north bank.

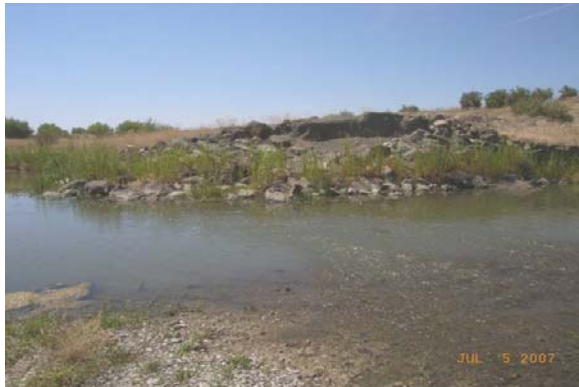
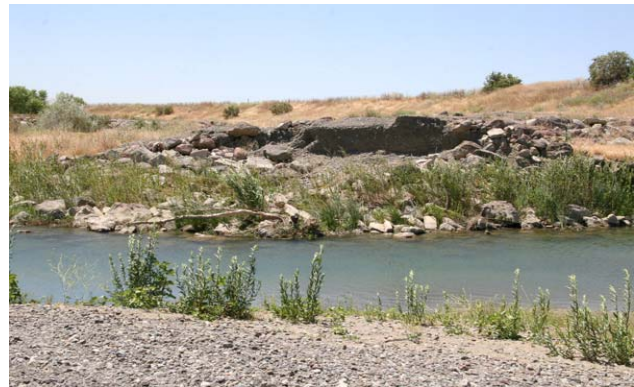
Figure 43: Erosion at upstream (south bank) spur dike, RM 21.3 in 2007 (left) and 2008 (right).

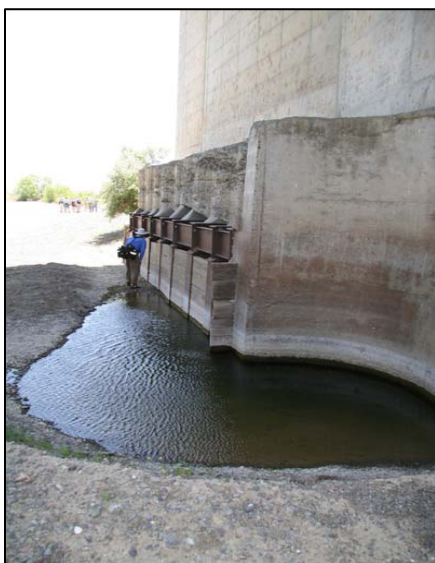
Figure 46: Scour along support vane under I-505 Bridge.

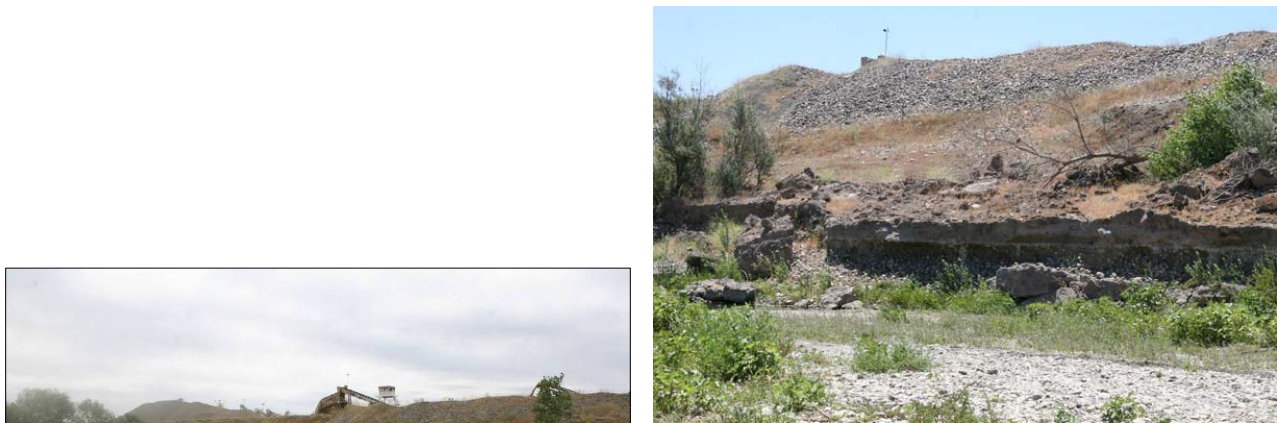
Figure 49. Lateral erosion of the south bank levee toe and gravel spill along the Rinker Inc. property in 2007 and again in 2008 (RM 20.5)

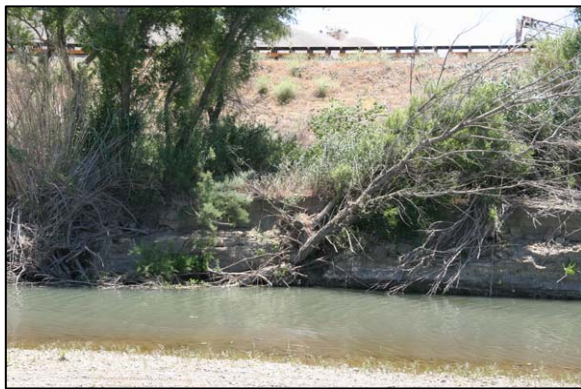
Figure 50. Meander undercuts the levee at RM 20.45.

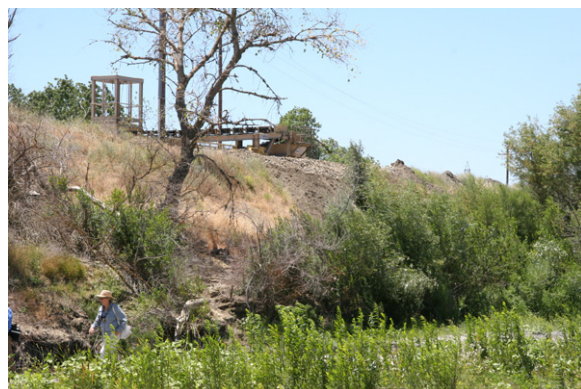
Figure 51: Gravel spill below conveyor transfer site at RM 19.7.

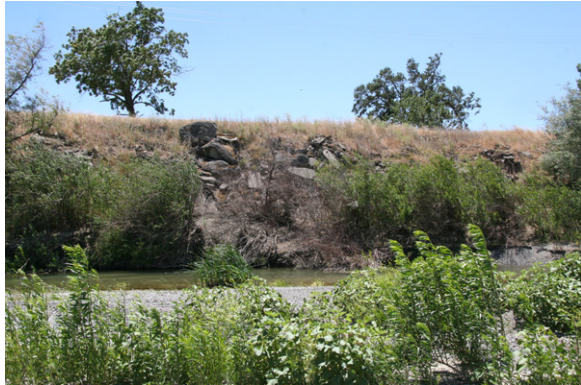
Figure 53: Low, oversteepened bank with loose blocks at RM 19.4.

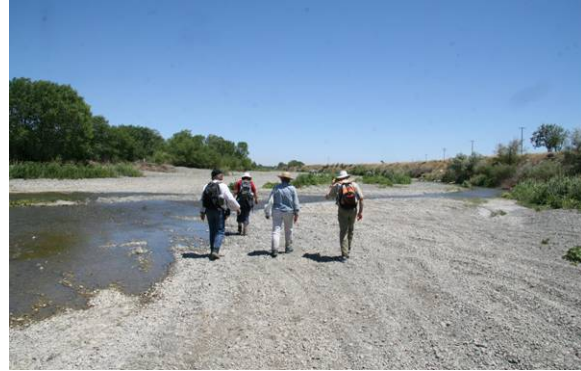
Figure 54: Broad vegetated north bank, steep bare south bank at RM 19.4.

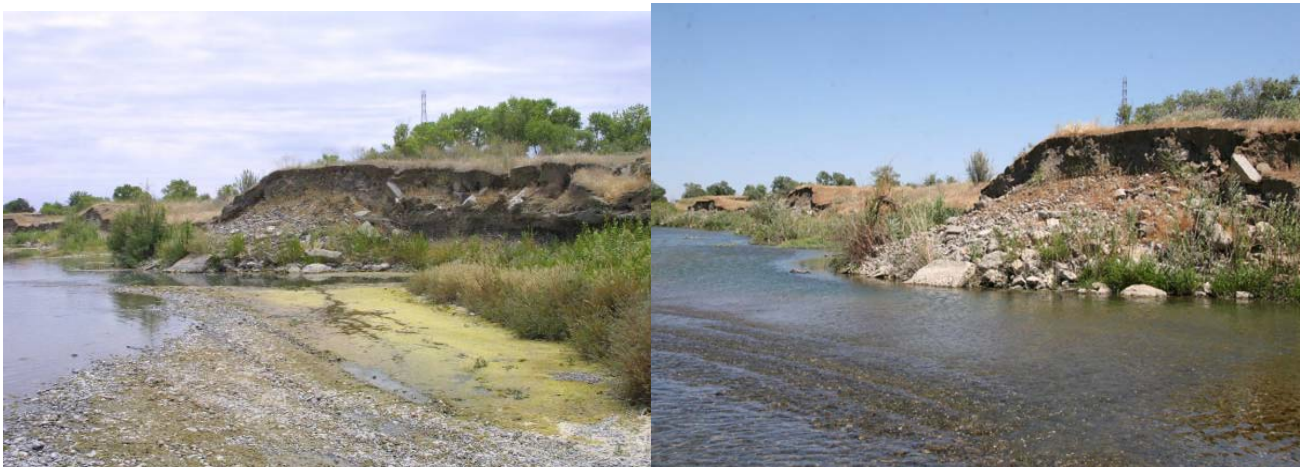
Figure 58 and 59. Eroded spur dikes at RM 18.6, south bank in 2007 (left) and 2008 (right).

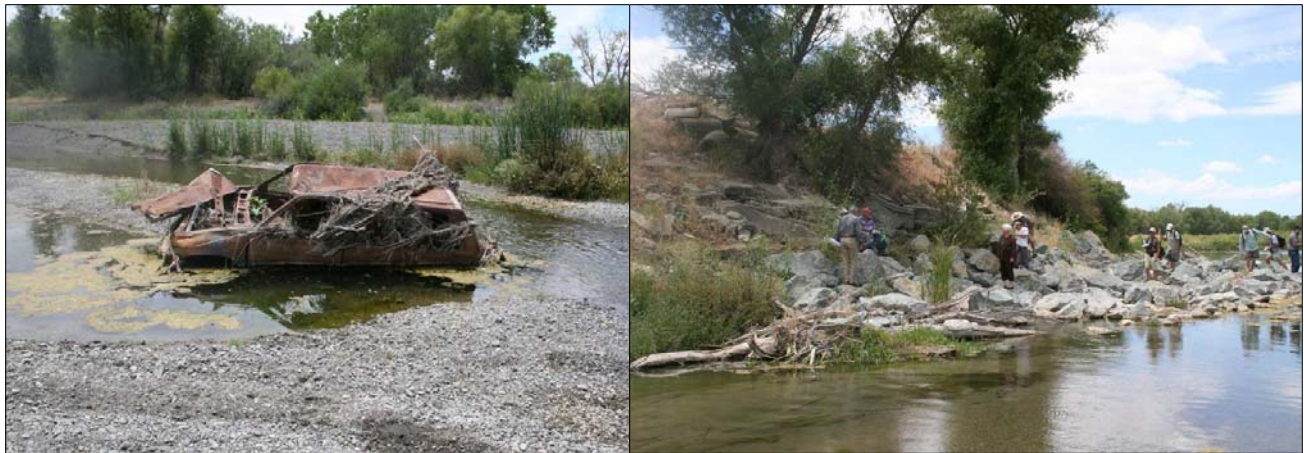
Figure 60 and 61. Burnt car in the Creek needing to be removed from Creek (left), Moore Siphon (right).

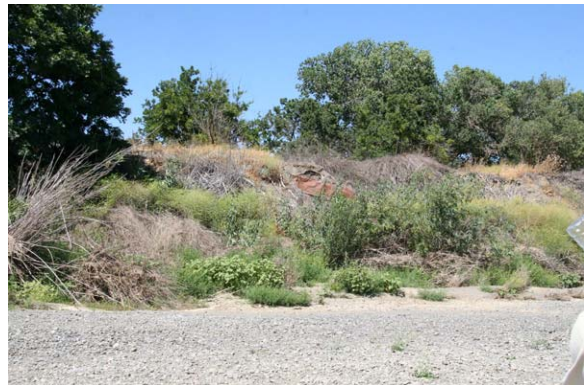
Figure 63. Crushed car stabilizes the bank at RM 17.8.

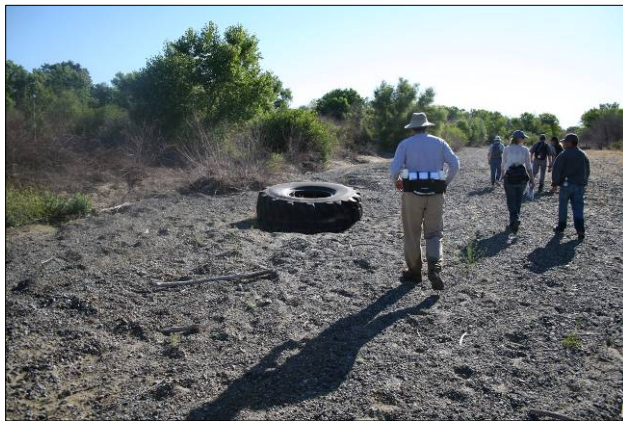
Figure 68. Tires need to be removed from Creek.

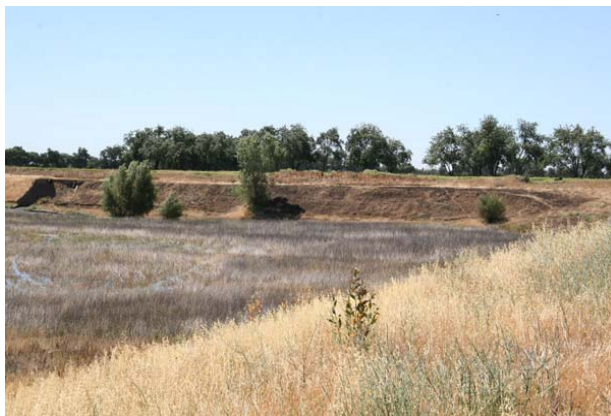
Figure 76. Rodgers pit with controlled burn at south edge and failed Magnolia pipe.

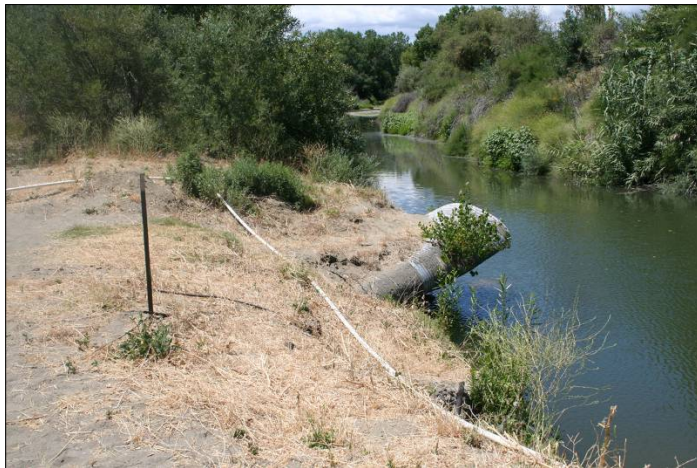
Figure 80. Drain pipe with unknown source.

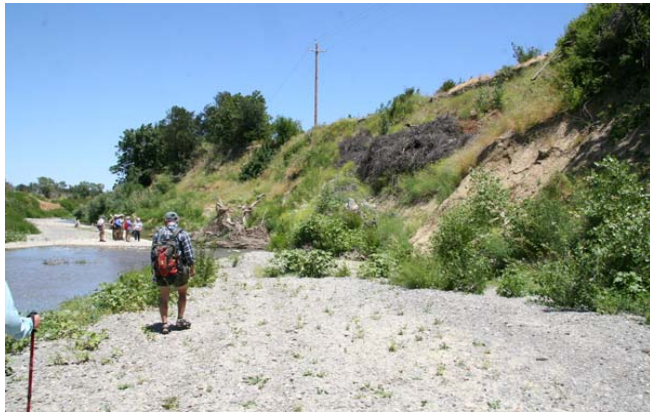
Figure 82. Slash pile on south bank at RM 12.8.

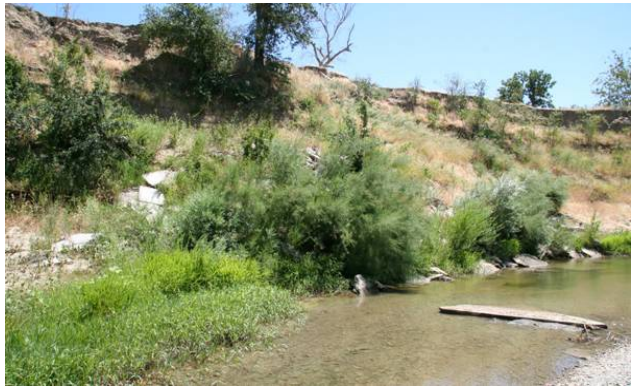
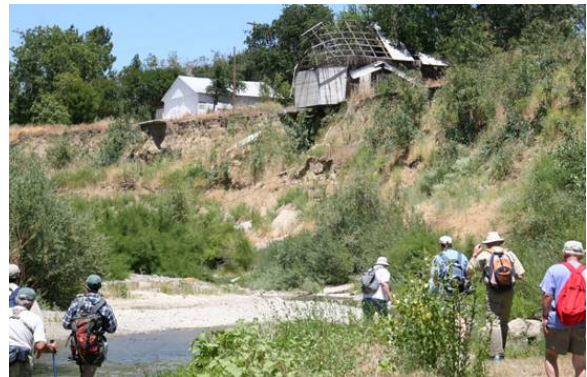
Figure 83 and 84. Concrete slabs in creek at RM 12.35 and Reynolds Barn collapsing into Creek.

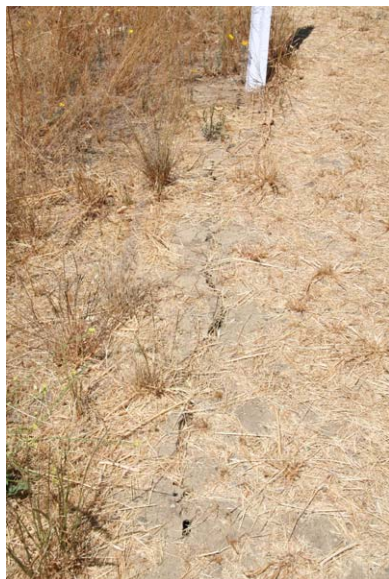
Figure 88: Cracks in soil at the edge of the road (Huff's Corner) show that the south bank is unstable.
