March 2, 2010

Job Number: 8359.006

Subject: North Davis Meadows County Service Area - Groundwater and Well Assessments

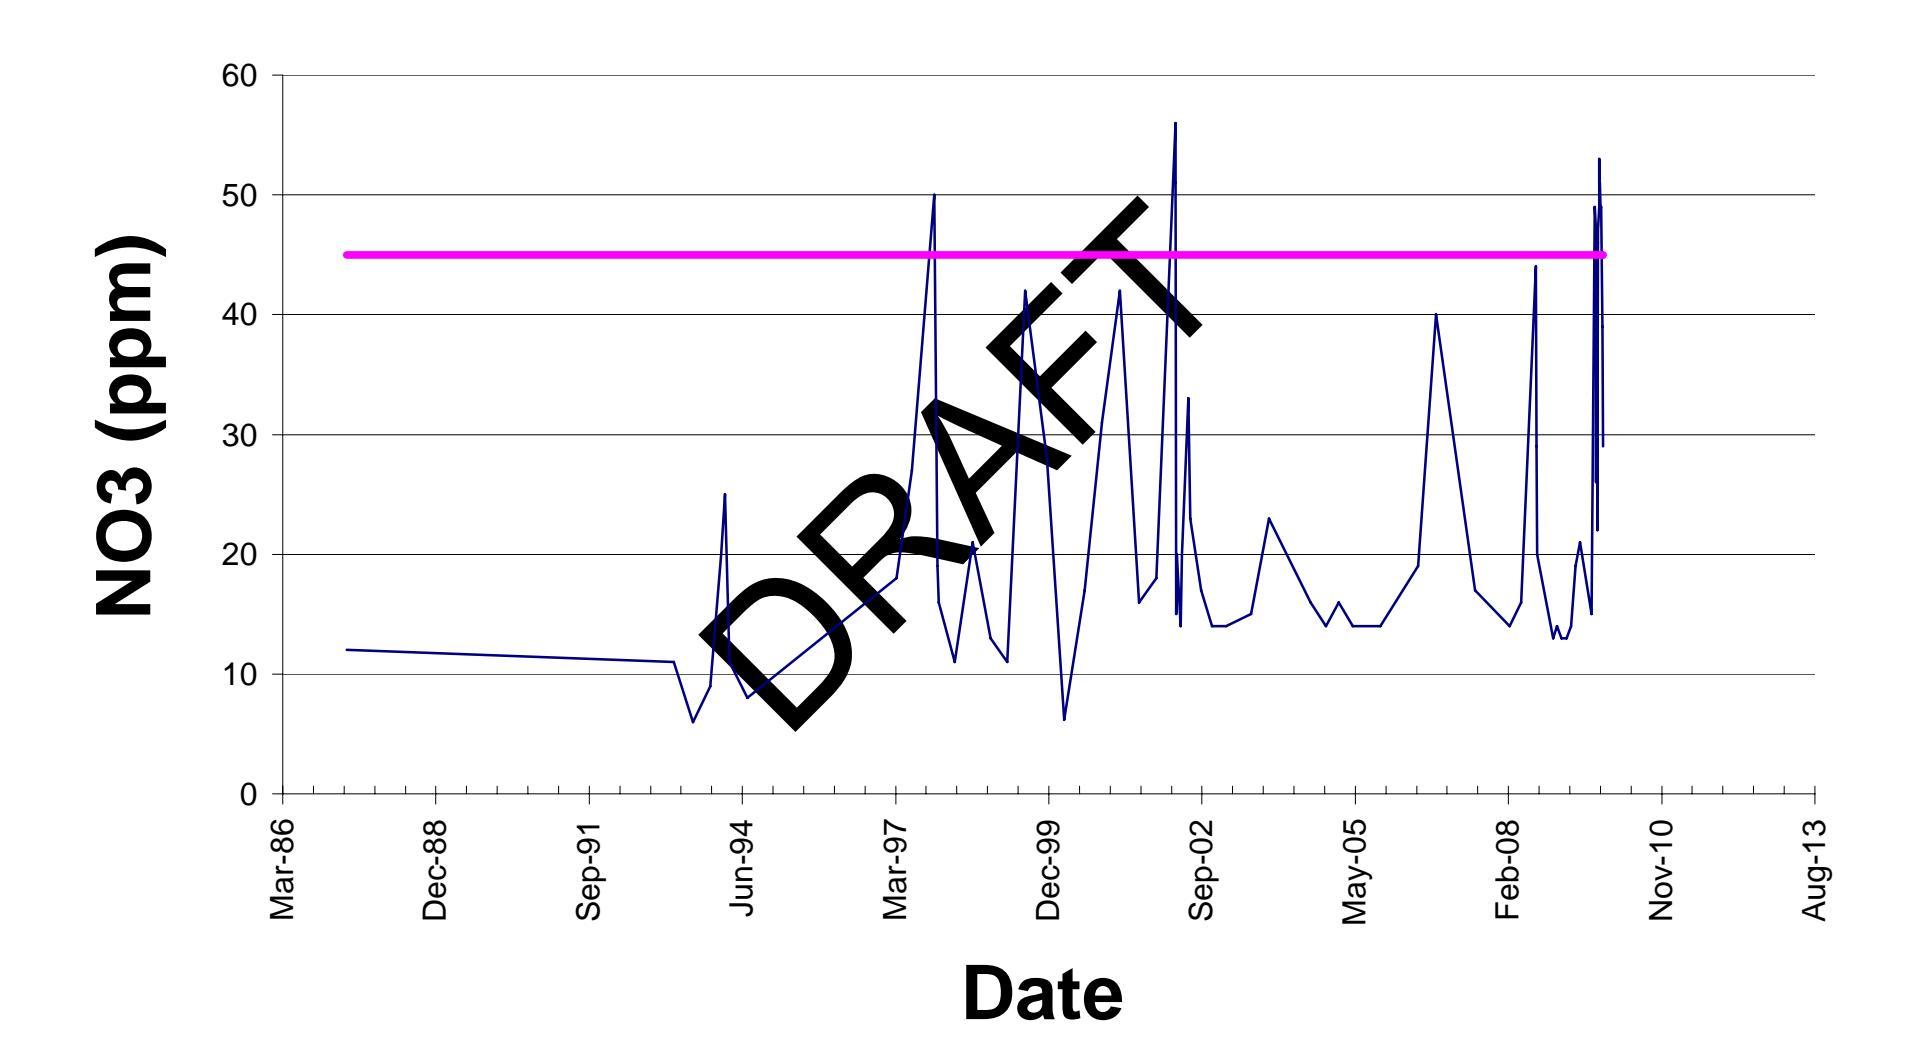
NDM I Nitrate

At this time we do not have sufficient information to prepare a preliminary well modification for Well 1. Well 1 is now 33 years old and is reported to be producing some sand. The yield (specific capacity) of this well has always been less than Well 2, likely because the upper 188 to 198 foot aquifer is not very permeable at this location (based on the driller's report). This is likely why this well has had lower nitrate concentrations. The spikes in nitrate levels for this well may be related to a shallow hole in the casing. A hole in the casing could also explain why this well is producing sand and why the specific capacity of this well has become higher (over double from when it was new). Repairs for this well may be as simple as installing a casing

patch over a hole at a cost of less than \$20,000 or could require a complete liner program as described for Well 2.

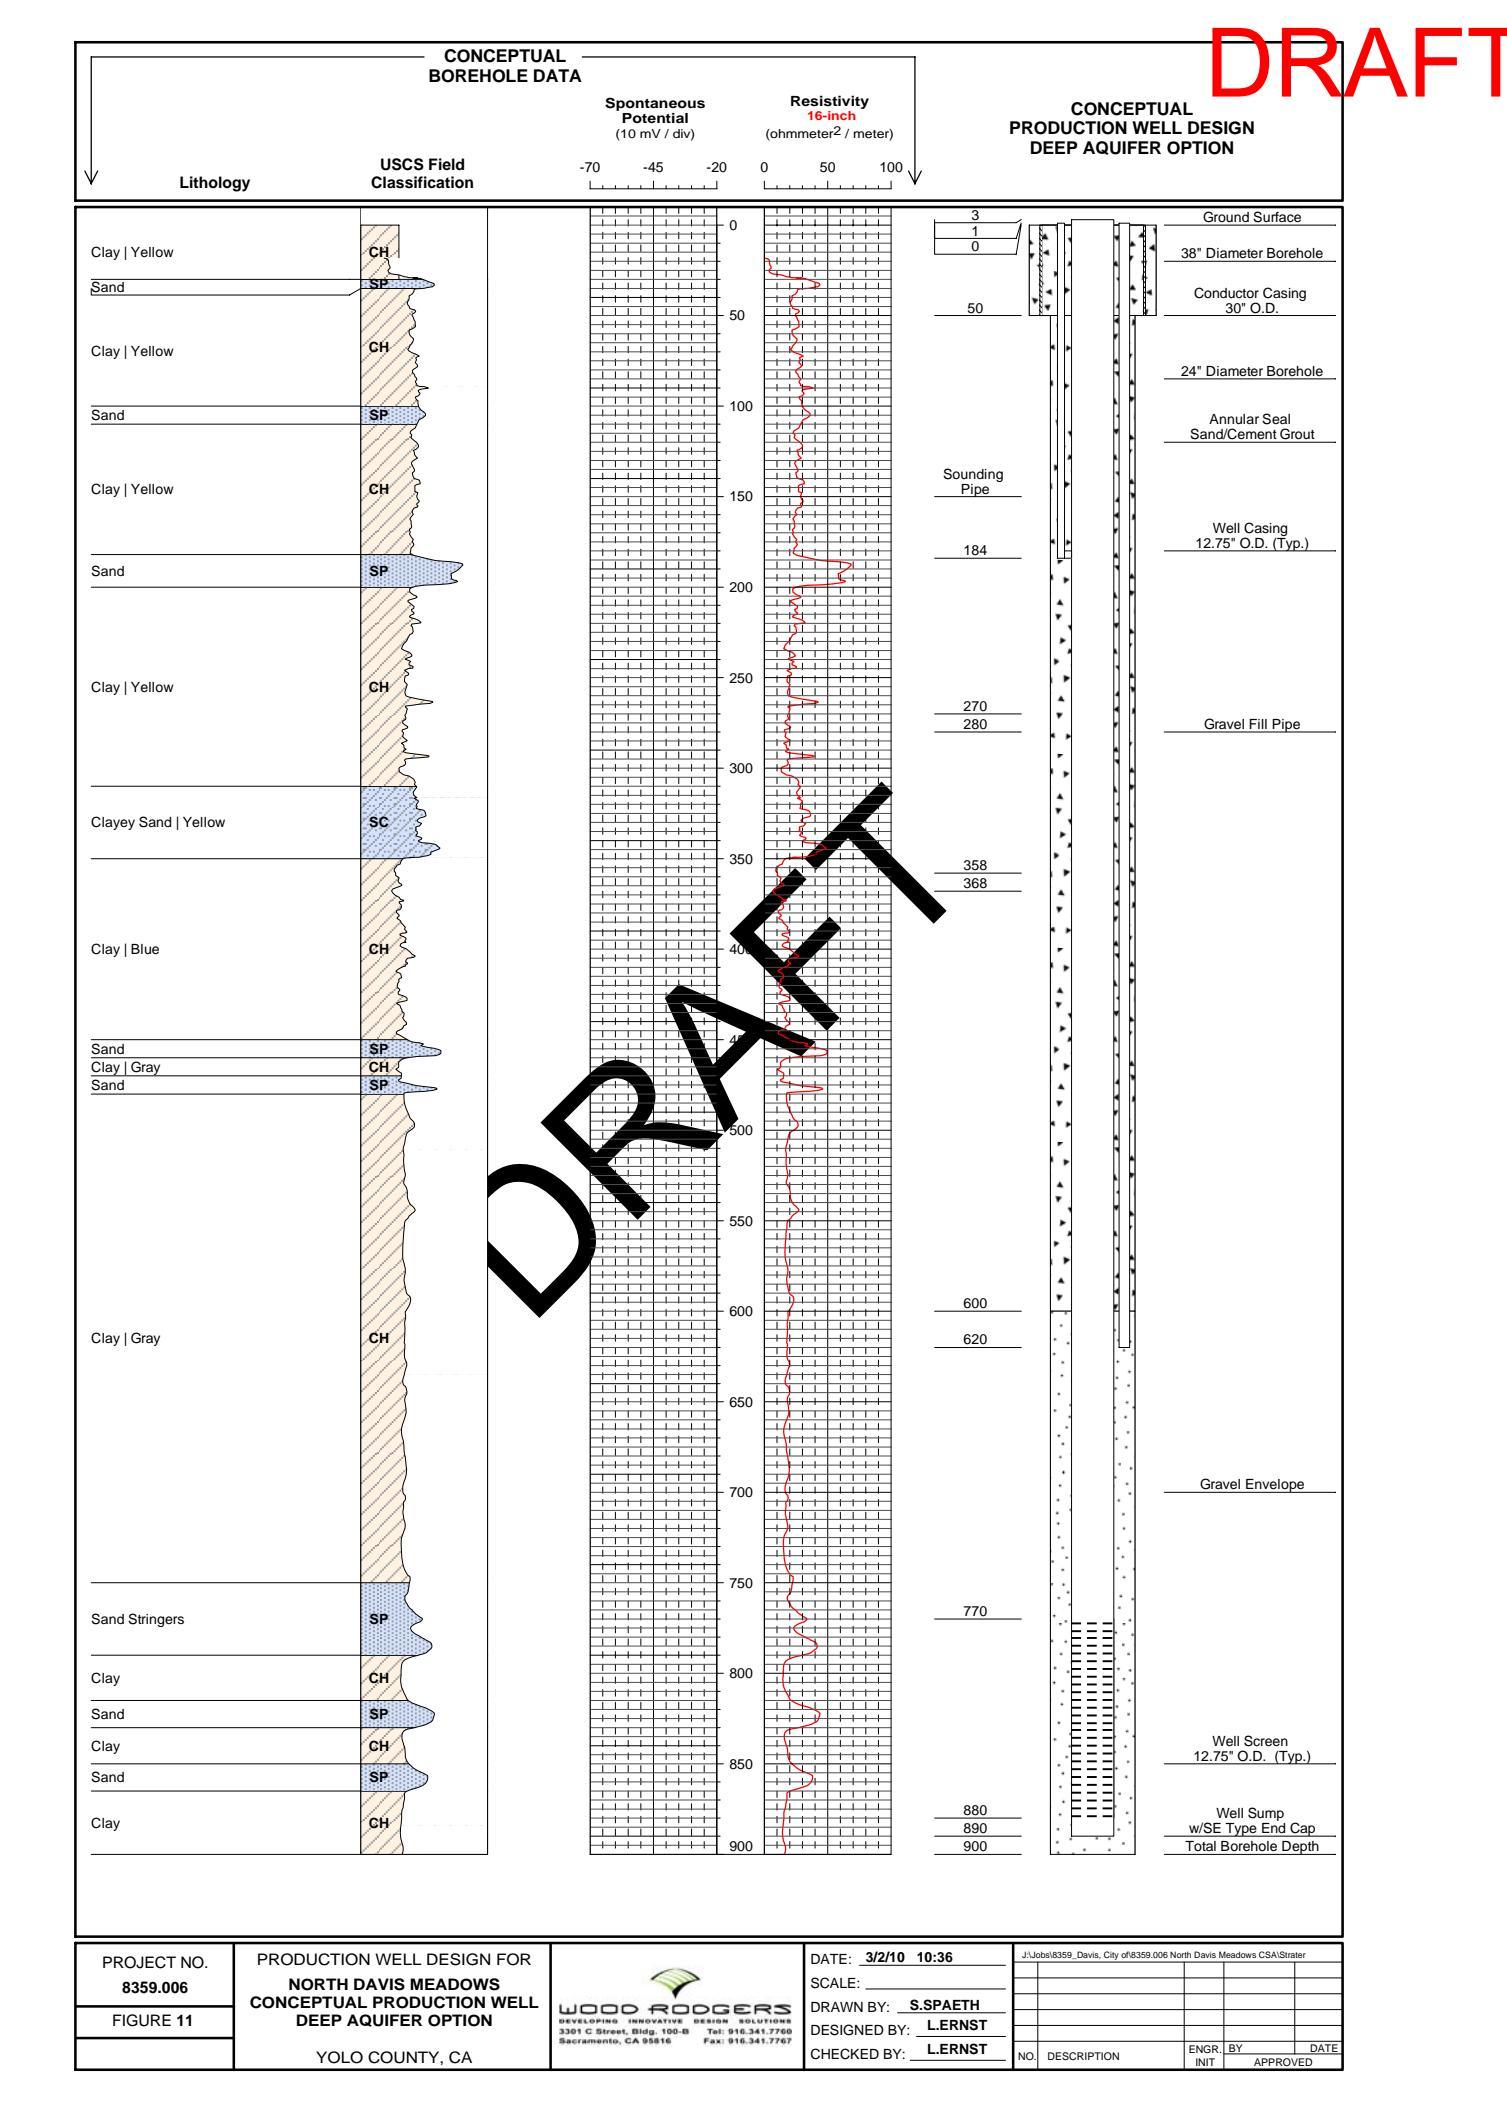
New wells are initially more expensive than well rehabilitations, however they will likely also provide better long-term results and value to NDMCSA. Wood Rodgers has provided two well conceptual design options as shown in Figures 10 and 11. Figure 10 includes a design to complete the intermediate aquifers between 300 and 500 feet while Figure 11 includes a deeper well design option that completes the aquifers between 770 and 880 feet. New wells should include deep continuous annular seals to help prevent the downward migration of water with high nitrate concentrations. The intermediate aquifer well design would also include annular seals to help isolate this well from the blue clay layer that could be associated with high concentrations of manganese. One potential draw back to new wells is that we do not currently have zone-specific water quality data for any aquifer below 200 feet under the NDMCSA. While projections of water quality data from the City of Davis Well 27 and 31 seem encouraging, a monitoring well at a proposed new well site would help provide site specific data that may help preferentially select the aquifers with the best water quality prior to committing the resources for production well construction. For planning purposes, new wells and pump stations for the intermediate well option would cost \$520,000 while the deep aquifer well option would cost \$630,000 as shown in Tables 2 and 3 respectively. A monitoring well, as shown in Figure 12, would add an additional \$80,000 to a new well project. If a new well can be located at an existing well site, the pump station construction cost estimates may reduce depending on how much of the existing infrastructure can be reused for the new pump station.
