# CORRELL RODGERS POND ENHANCEMENT PLAN

Prepared For:  
Yolo County Parks and Recreation  
November 30, 2007

**FOOTHILL ASSOCIATES**

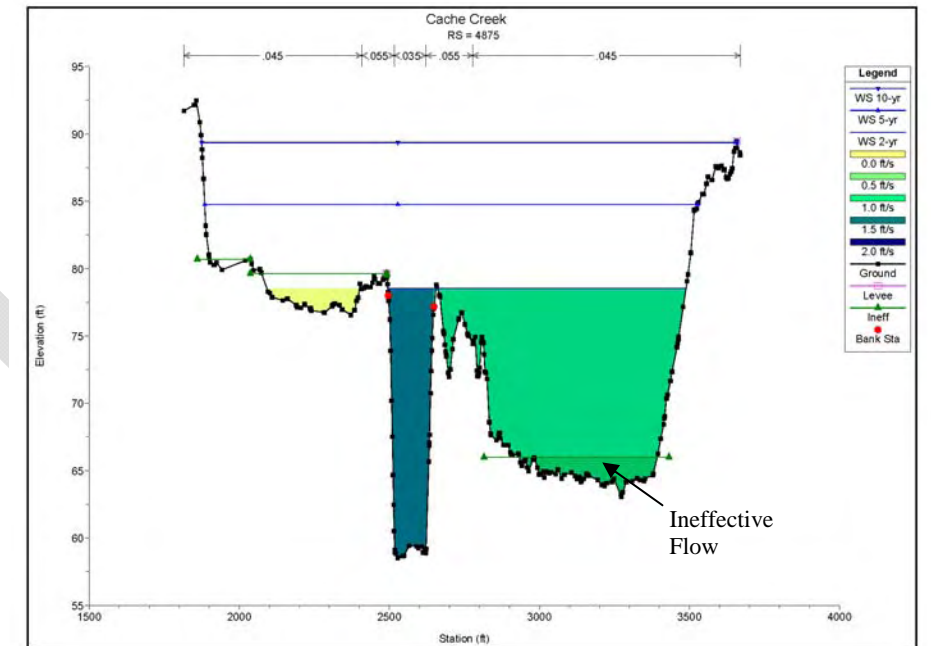
Figure 9 Typical Section with Floodplain Inundation

The existing conditions HEC-RAS model was modified to simulate the preferred alternative topography. Cross-sections were modified at locations where the berm is to be removed, allowing effective flow to pass through the project sites. In areas where the berm is to remain, it is lowered and flow is conveyed on both sides, therefore increasing the overall conveyance of the system. Since the Correll and Rodgers sites have bottom elevation ranging from 59.5’ to 66’ and since the downstream bank elevation tying back into the channel is at elevation 66+/-, flow below the downstream bank elevation is considered ineffective (See Figure 9). All flow above the bank elevation is effective and is included in the total flow conveyed downstream. An average manning’s roughness coefficient of 0.045 was used for the modified floodplain through the proposed project site.

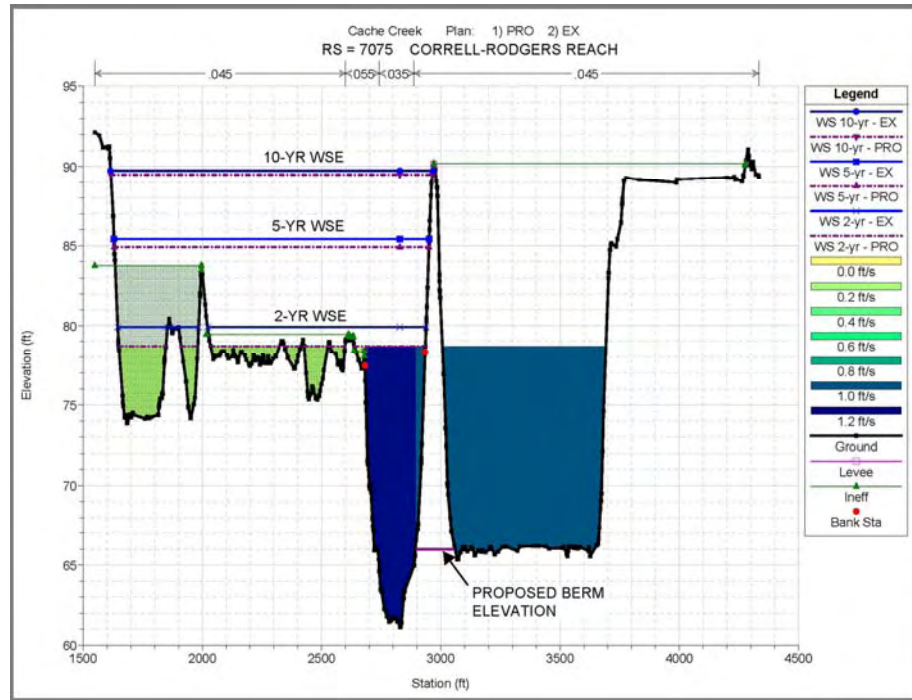
**Figure 10 Cross Section Showing Existing (EX) and Proposed (PRO) WSE's**

As would be expected, allowing the flow to spread out across a larger floodplain reduces the water surface elevations (WSE) through and upstream of the project site (Figure 14). The 2-year flow has the greatest decrease in WSE which occurs toward the upstream limit of the project. Figure 10 provides a graphical example of how the proposed alternative will decrease the WSE at section 7075. Table 5 displays a comparison of the existing and proposed conditions WSE’s at the upstream, center and downstream limits of the project for the 2, 5, & 10-year event.

Hec-Ras Section	Existing Condition	Proposed Condition	Deviations(ft)
<i>Upstream Project Limit (Station 70+75)</i>			
2-year	79.9'	78.7'	-1.2
5-year	85.4'	84.9'	-0.5
10-year	89.7	89.5'	-0.2
<i>Mid-Reach (Station 59+00)</i>			
2-year	79.6'	78.6'	-1.0
5-year	85.1'	84.8'	-0.3
10-year	89.4'	89.3'	0.1
<i>Downstream Project Limit (Station 44+00)</i>			
2-year	78.4'	78.4'	0.0
5-year	84.7'	84.7'	0.0
10-year	89.3'	89.3'	0.0
