Slope Stability Evaluation
GRANITE ESPARTO
Yolo County, California
WKA No. 5871.06
August 9, 2007

Slope Stability Evaluation

GRANITE ESPARTO

Southwest of the intersection of West Adams Canal and County Road 87
WKA No. 5871.06

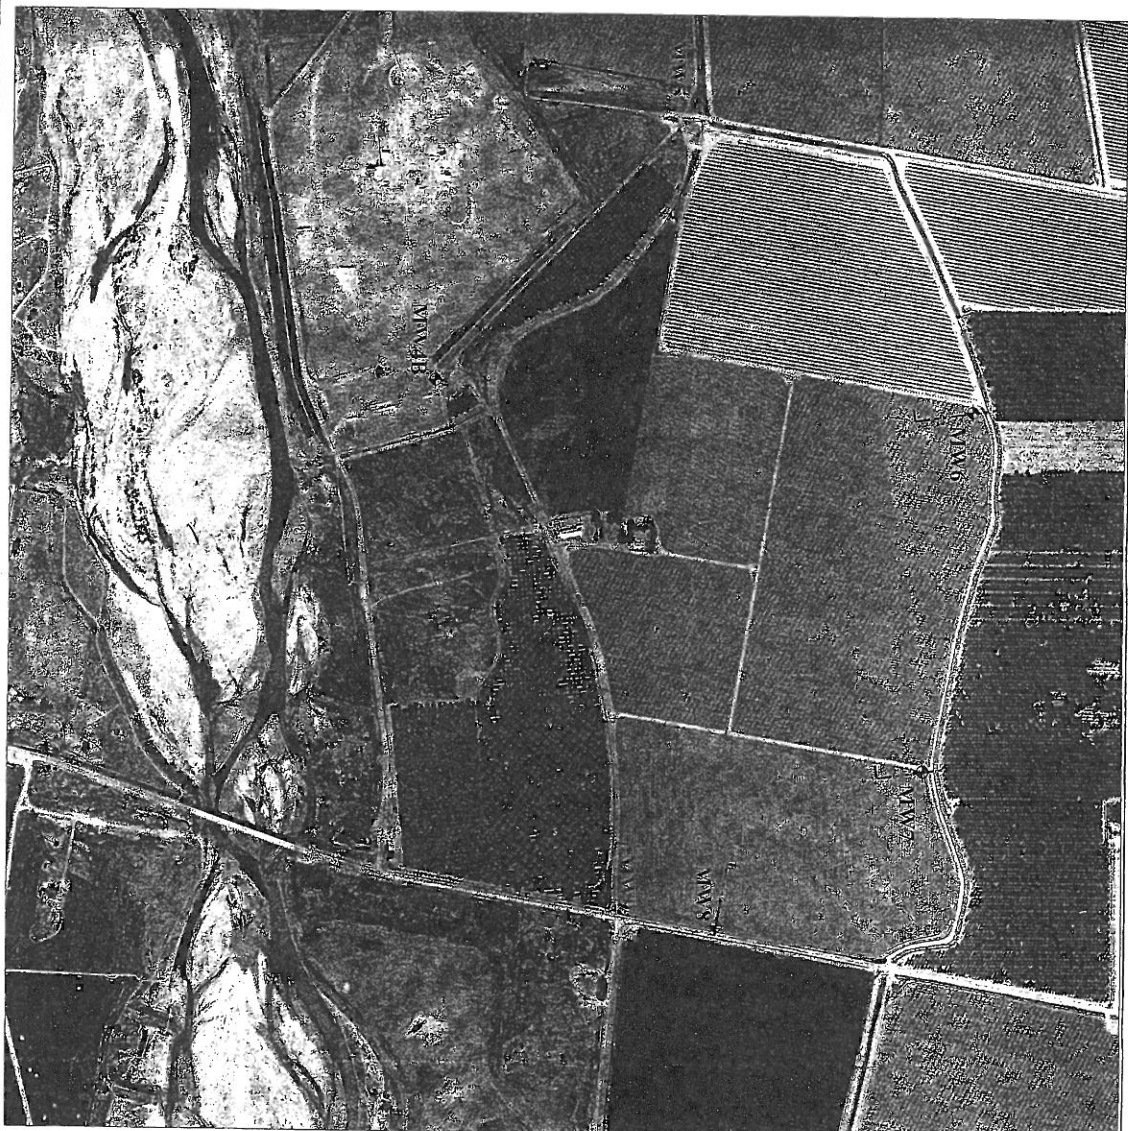
| FIGURE | 1 |

Legend:
 ◆ Approximate location of monitoring well
 |---| Location of Stability Cross Sections

SITE PLAN
 GRANITE CAPAY FACILITY
 Esparto, California

The site consists of approximately 390 acres of agricultural land that lies within a rural/industrial area of Yolo County. The West Adams Canal bounds the site to the northwest and north. County Road 87 bounds the site to the east. The stream channel for Cache Creek bounds the site to the south (Figure 1). The existing Granite Construction Company Capay facility (aggregate operation) is located to the west and southwest of the site.

The locations of the monitoring wells, MW-5 through MW-9, and the schematic location of the stability cross sections are illustrated in Figure 1.

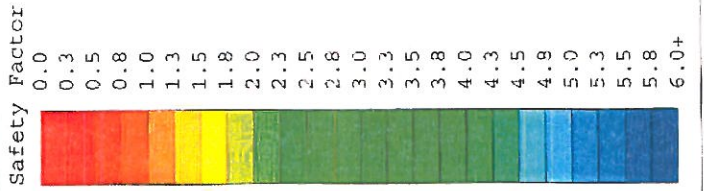
Granite Esparto - MW-8 Pseudo-static, Non-circular spencer

1.2

| Profile | Slope Gradient | | Search Routine | Factors of Safety | |
|---|---|---|---|---|---|
| MW-8 | 2:1 | 2:1 | Non-circular | 1.6 | 1.2 |
