CACHE CREEK ANNUAL STATUS REPORT 2010

Cache Creek Technical Advisory Committee:

October 11, 2011

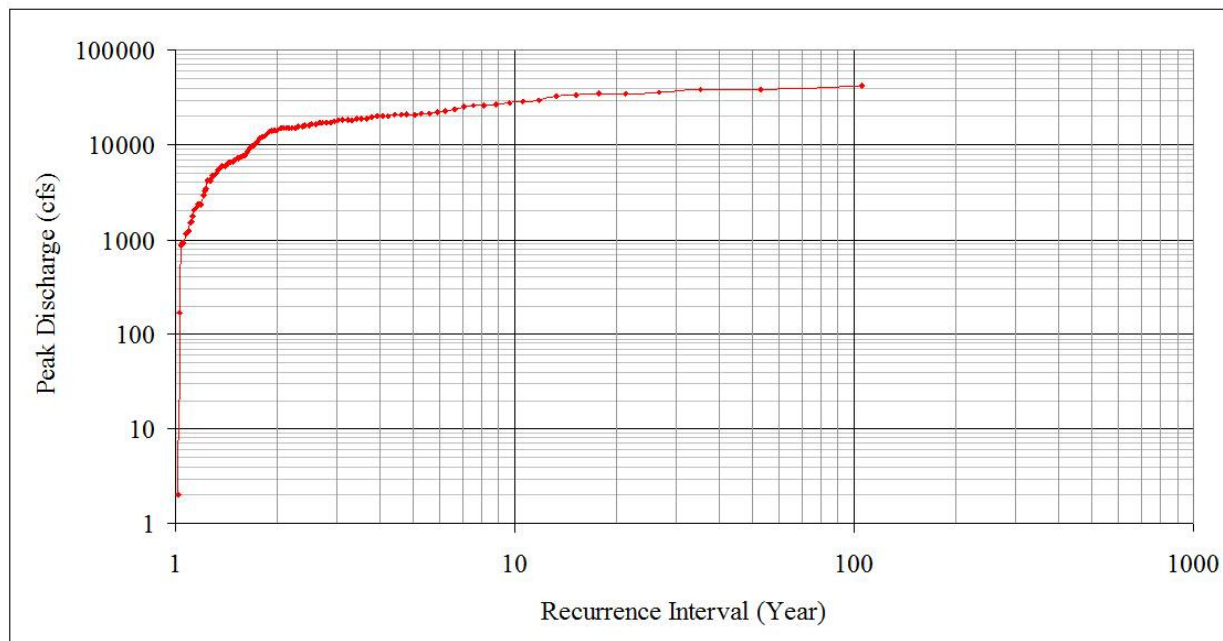
Figure 2.1.a: Recurrence interval for flows at the Yolo gauge, from Leathers (2010).

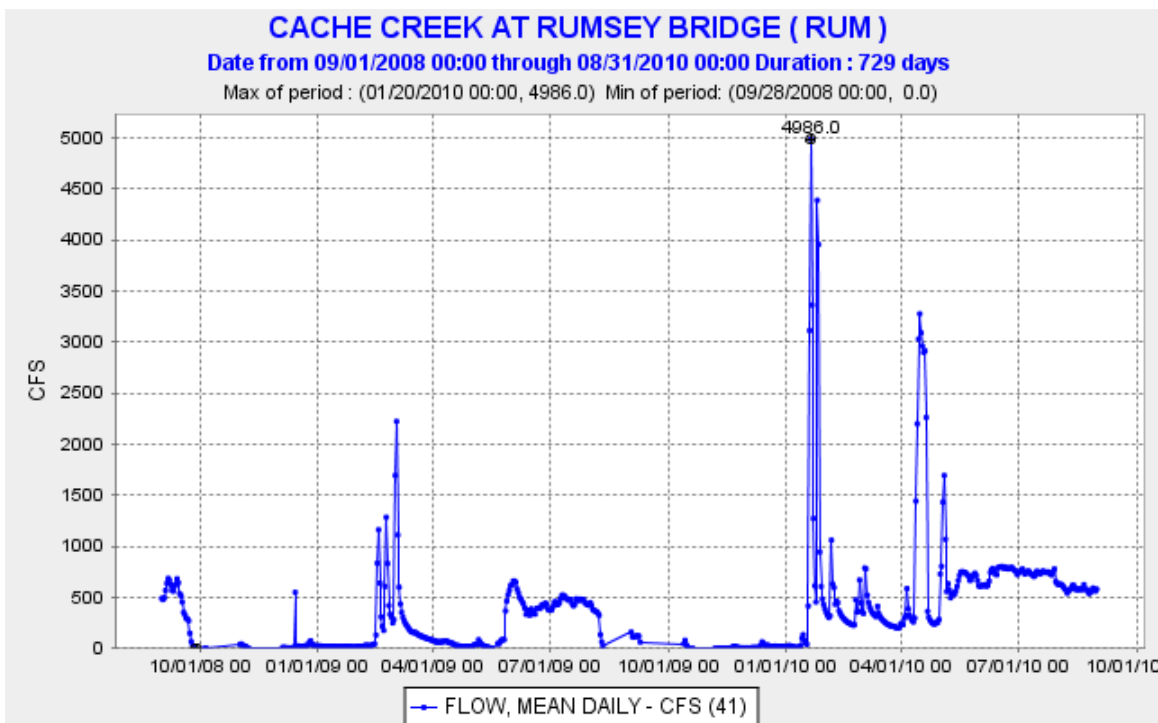
The upstream (Rumsey) and downstream (Yolo) gauges respond differently to low flow events (Figures 2.1.b, 2.1.c). Small upstream events are recorded at the Rumsey gauge, but these events are sometimes damped or missing from the downstream Yolo gauge. This is caused in part by agricultural diversions from Capay Dam, a major diversion point for irrigation water that is located between the two gauges. The downstream Yolo gauge is often dry during the hot summer months, when agricultural diversions are at their highest level and creek flows are at their lowest level.

Figure 2.1.b: Hydrograph showing two years of river flow at the Rumsey gauge, located approximately 18 miles upstream from the CCRMP study area. From the California Data Exchange web site, June 2011.

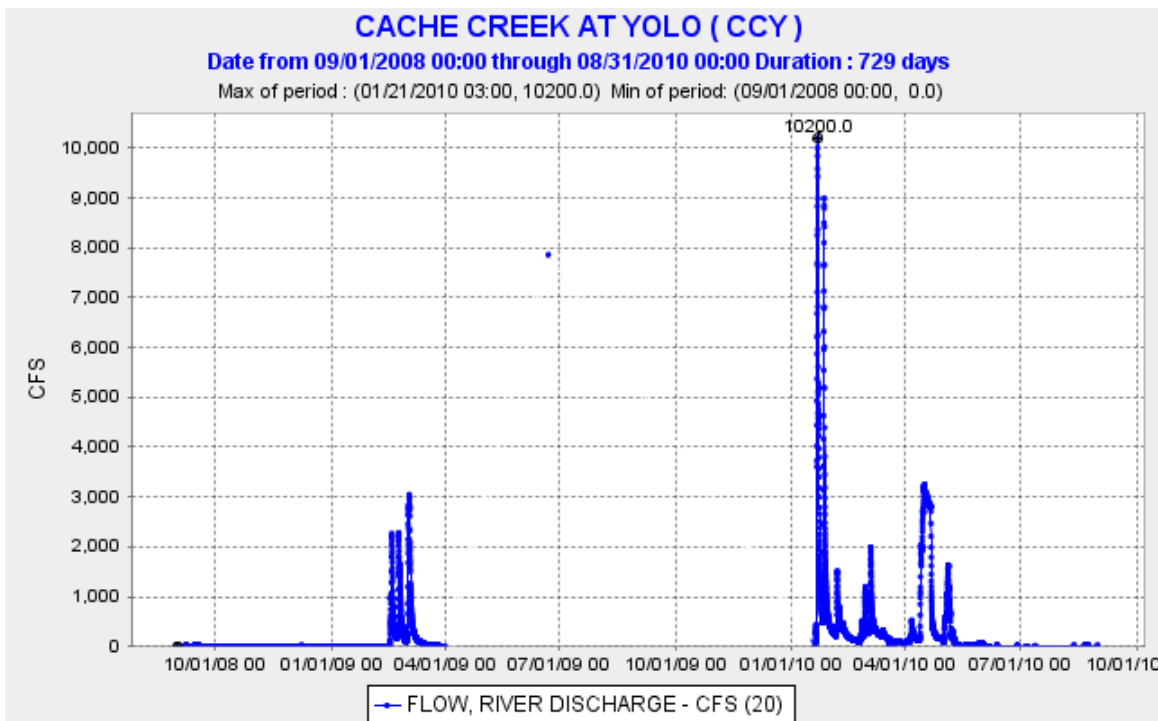
Figure 2.1.c: Hydrograph showing two years of river flow at the Yolo gauge (I-5 Bridge), located at the downstream end of the CCRMP study area. From the California Data Exchange web site, June 2011.

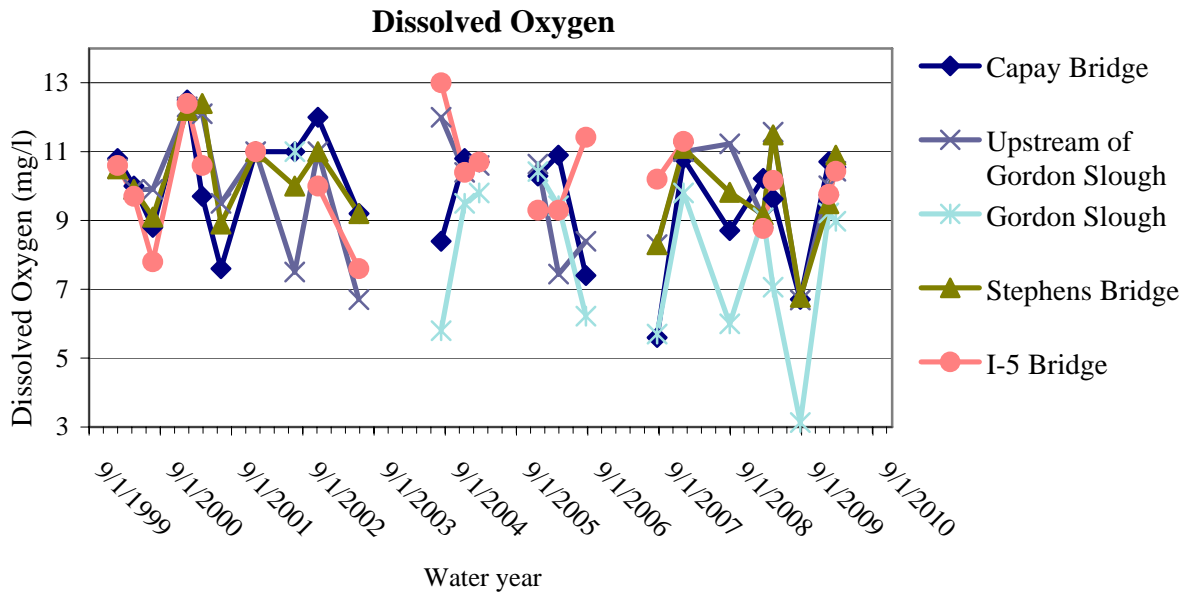
Gordon Slough has lower D.O. values, and this is consistent with the muddy, slower moving water that passes through the slough. Warm, slow-moving water maximizes the production of algae, and decomposition of the algae consumes oxygen. This becomes a concern because low oxygen conditions are also a factor in the production of methylmercury.

Figure 2.1.d: Dissolved oxygen levels at monitoring sites in the CCRMP area.

Dissolved Oxygen recommendation: No action is recommended for the low dissolved oxygen values, except to continue monitoring work near Gordon Slough.

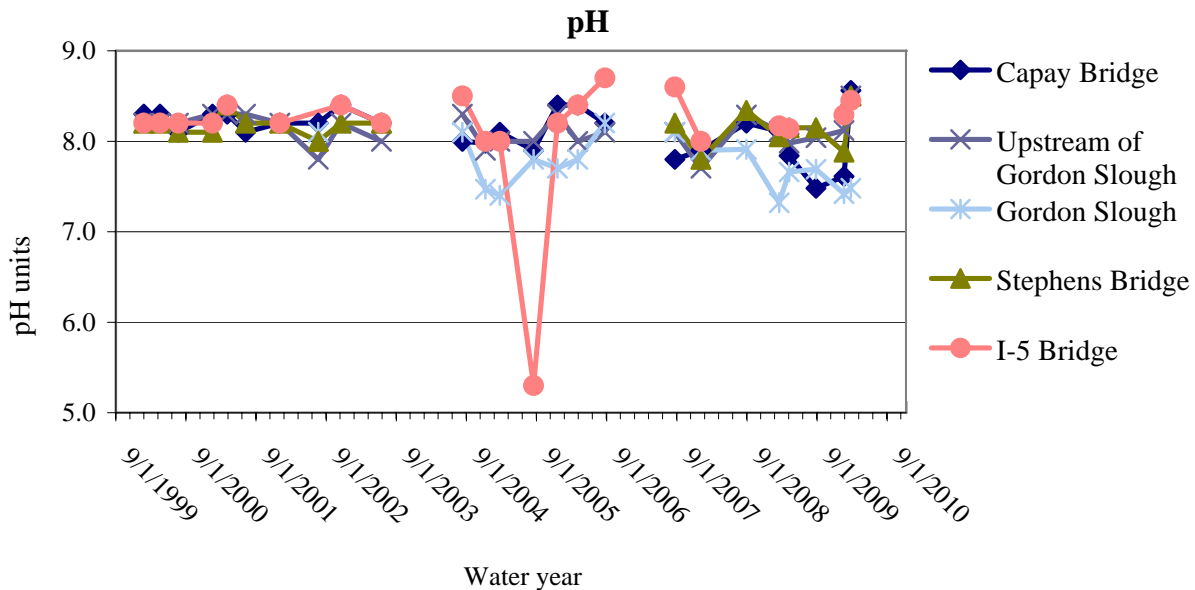
The pH values from surface water in Cache Creek are slightly basic (Figure 2.1.e). This is typical of many rivers in California, and is a minor water quality issue. The underlying geology and dissolved constituents in surface water contribute to pH, and rivers can be either slightly basic or slightly acidic. A single acidic sample from the I-5 Bridge site on 8/17/05 looks like an anomaly, and may be a sampling or equipment error. Gordon Slough samples tend to have lower pH, and the pH has dropped slightly at Gordon Slough in the last two years. This trend toward more neutral conditions (lower pH) is probably a result of the decomposition of organic matter in the muddy, organic-rich runoff that flows through Gordon Slough.

Figure 2.1.e: pH values at monitoring sites in the CCRMP area.

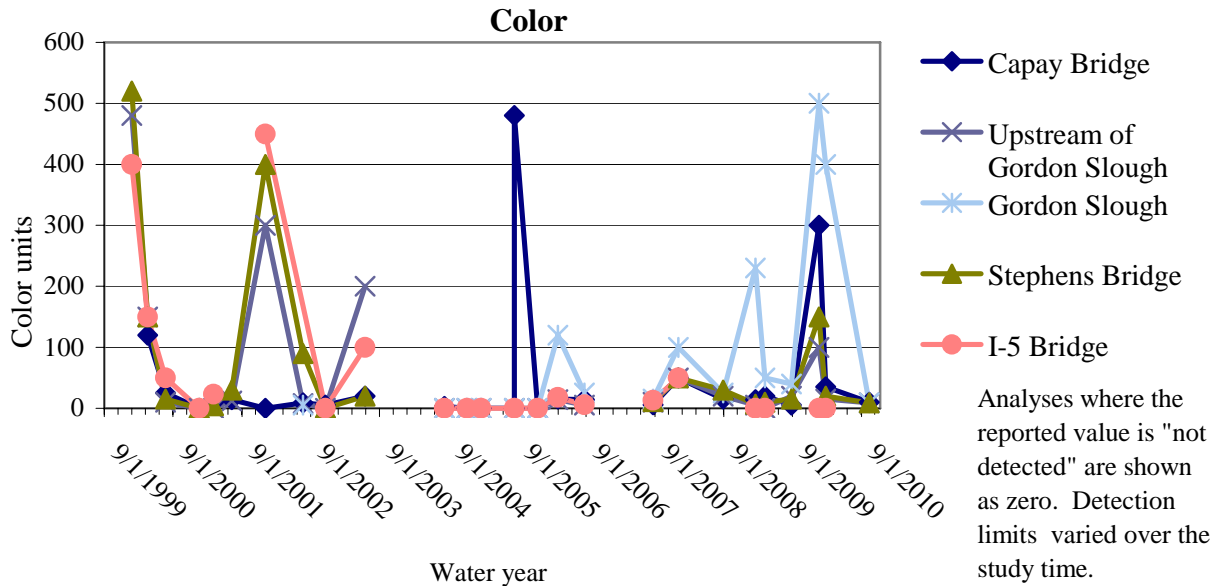
other sampling site in the CCRMP study area for any given sampling event (Figure 2.1.g). This is caused by the high suspended load in sediment that flows through Gordon Slough. The spike at the Capay Bridge site in August 2005 is probably a localized issue, and may be from algal growth in a stagnant pool.

Figure 2.1.g: Color measurements at monitoring sites in the CCRMP area.

Color recommendation: No action, because Cache Creek is not used as a drinking water source.

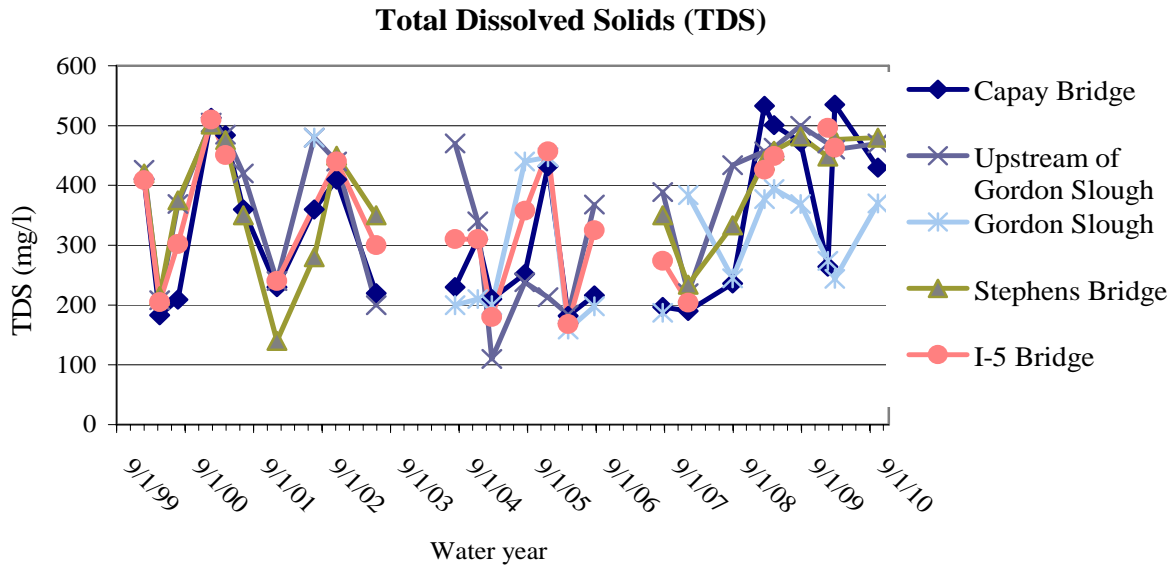
Total dissolved solids are related to flow, and often increase during low flow conditions when there is more time for sediment/water interaction. High flows tend to dilute the system and reduce TDS concentrations, although this relationship is not always true. Residence time, solubility of the sediment, and composition of the bedrock are complicating factors. Guidelines for TDS have a complex sliding scale based on salinity, and the RWQCB states that TDS should not "... cause nuisance or adversely affect beneficial uses." Cache Creek usually has TDS values below the State Department of Health Services (DHS) recommended level of 500 mg/l, but this is not an enforceable guideline. Incursions as high as 1500 mg/l may be allowed depending on flow. Values of TDS observed in the CCRMP area during the past two years approach or exceed the 500 mg/l level (Figure 2.1.h), and may be undesirable from a habitat standpoint.

Figure 2.1.h: Total Dissolved Solids (TDS) values at monitoring sites in the CCRMP area.

Total Dissolved Solids recommendation: TDS could be reduced by limiting sediment load to the creek (limiting flow from tributaries or effluent pipes) or increasing stream flow. However, at this time this is not a high priority item compared to other identified issues in this report. No action is recommended this year; this will be reexamined next year.

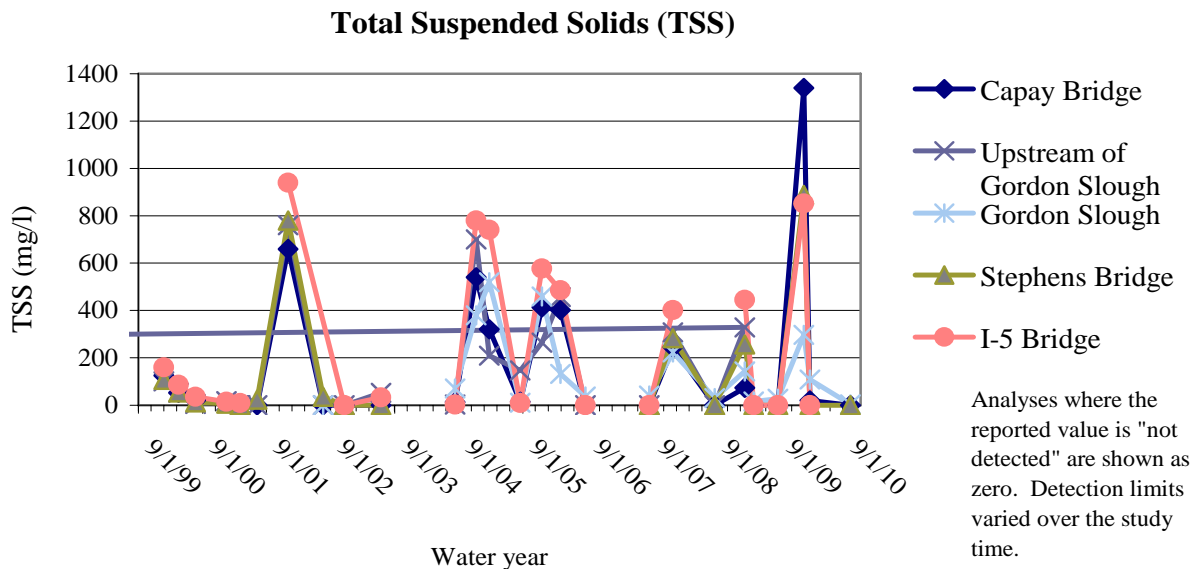
Figure 2.1.i: TSS (Total suspended solids) values at monitoring sites in the CCRMP area.

Total suspended solids recommendation: No new actions are recommended because continuous turbidity monitoring will soon take the place of TSS monitoring.

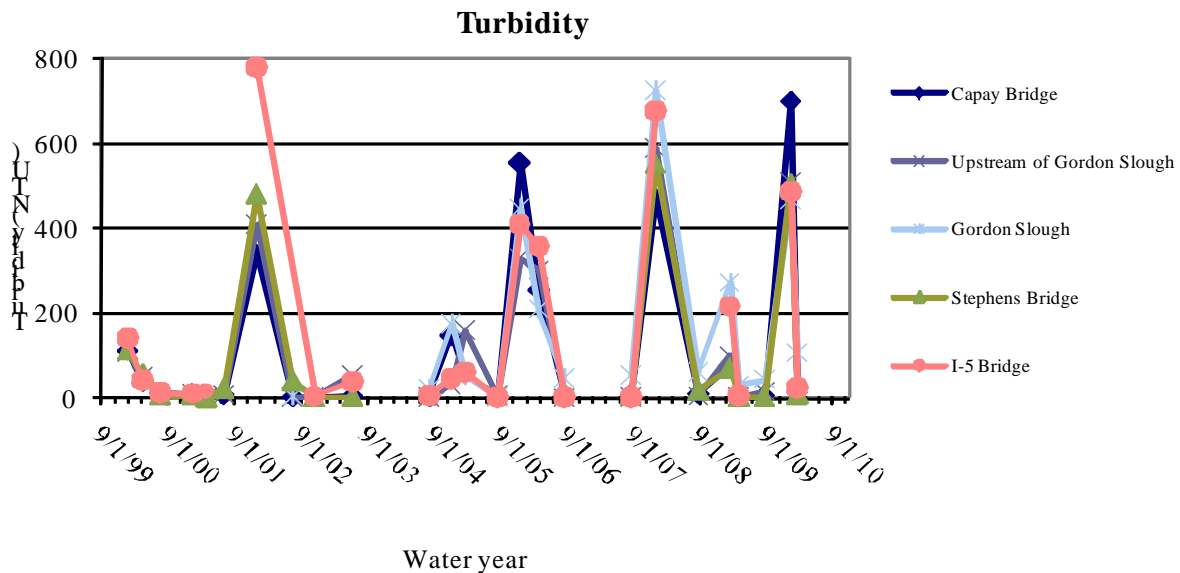
Recommended maxima for turbidity range from 5 NTU (Nephelometric Turbidity Units) for drinking water to a sliding scale developed by the RWQCB that allows for increases of 10- 20% above background levels. Turbidity levels on Cache Creek often exceed 5 NTU or 20% above background levels (Figure 2.1.j). Turbidity maxima are often more than two orders of magnitude above recommended levels. High turbidity is a serious water quality problem on Cache Creek, but the current sampling method does not show all of the variability.

Figure 2.1.j: Turbidity measurements at monitoring sites in the CCRMP area.

Turbidity monitoring recommendation: Turbidity monitoring methods should be upgraded to include continuous turbidity monitoring. This newer technology will allow better tracking of sediment and contaminant loads. Yolo County should continue to work with the USGS, DWR and YCFWCWD to obtain a continuous turbidity record at the upstream and downstream ends of the CCRMP area. This will provide a baseline for future regulatory actions. This is part of the changing regulatory world, and wasn't envisioned in the original CCRMP or CCIP documents. Turbidity monitoring is more important now than it was in 1996 because of the link between mercury transport and sediment transport.

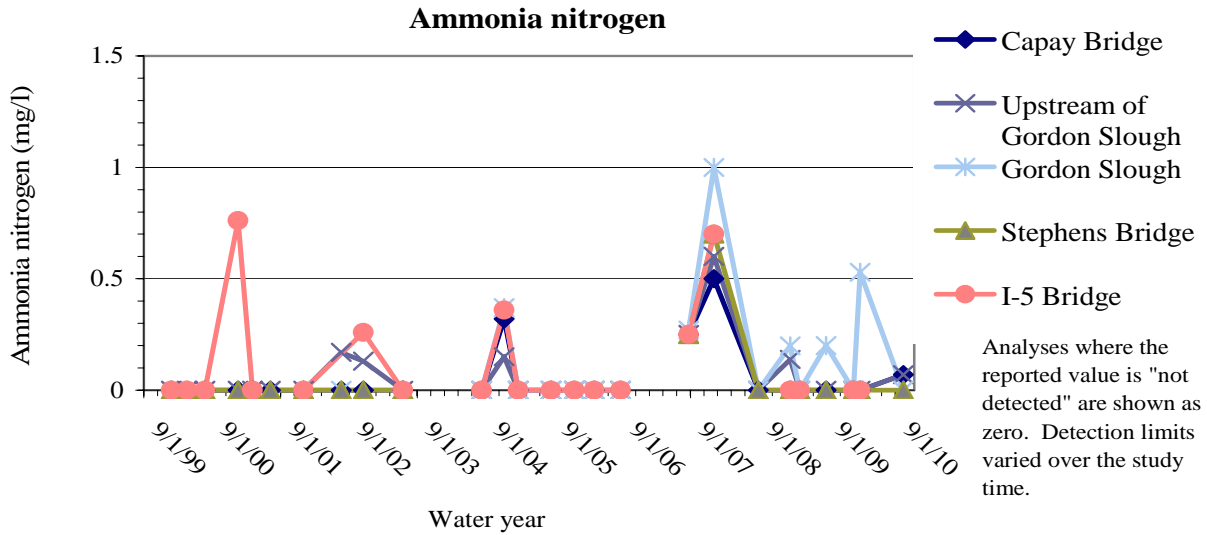
Ammonia is highly variable in the CCRMP area and many peaks in ammonia correlate with the first flush that occurs in winter (Figure 2.1.k). Early ammonia measurements (1999 - 2004) often had maximum values at the downstream I-5 sample site. Based on detailed sampling that began at Gordon Slough in 2004, there is likely an ammonia source near or upstream from the Gordon Slough drainage. Ammonia is often related to agricultural sources, with ammonia delivered to farm fields as a bioavailable source of nitrogen. Ammonia nitrogen is not regulated by the RWQCB, although the US EPA guidelines for aquatic life have a sliding scale for ammonia maxima that ranges from 0.3 - 0.5 mg/l. Ammonia levels discharged from Gordon Slough have at times exceeded this recommended maximum. High levels of available nitrogen in the form of ammonia also promote algal growth in Cache Creek during the hot summer months.

Figure 2.1.k: Ammonia concentrations at monitoring sites in the CCRMP area.

Ammonia Nitrogen recommendation: Resolution of this issue likely falls outside of the CCRMP boundaries and the TACs purview. Continue to monitor ammonia levels and determine an appropriate course of action.

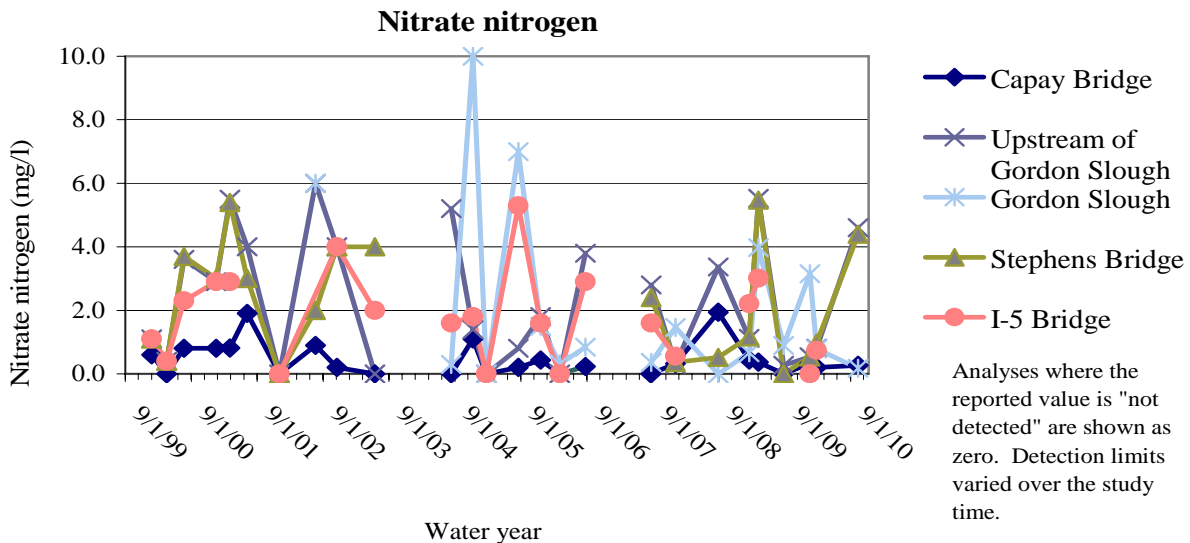
Nitrate nitrogen is a component of the nitrogen cycle and forms easily from ammonia, sewage, animal waste or naturally occurring nitrogen sources. Nitrate forms under oxidizing conditions in near-surface environments, and is regulated by the EPA and RWQCB. These agencies have limits of 10 mg/l and 45 mg/l respectively, although the reporting method is slightly different. The adverse health effects of nitrate on humans are well documented. All measured nitrate levels in the CCRMP area are below 10 mg/l (Figure 2.1.l), although nitrate levels are elevated. Nitrate is a nutrient source for algae and the steady background levels of 1-4 mg/l nitrate probably contribute to algal blooms during the warm, low flow summer months.

Figure 2.1.l: Nitrate nitrogen concentrations at monitoring sites in the CCRMP area.

Nitrate nitrogen recommendation: Continue to monitor nitrate nitrogen, no additional action.

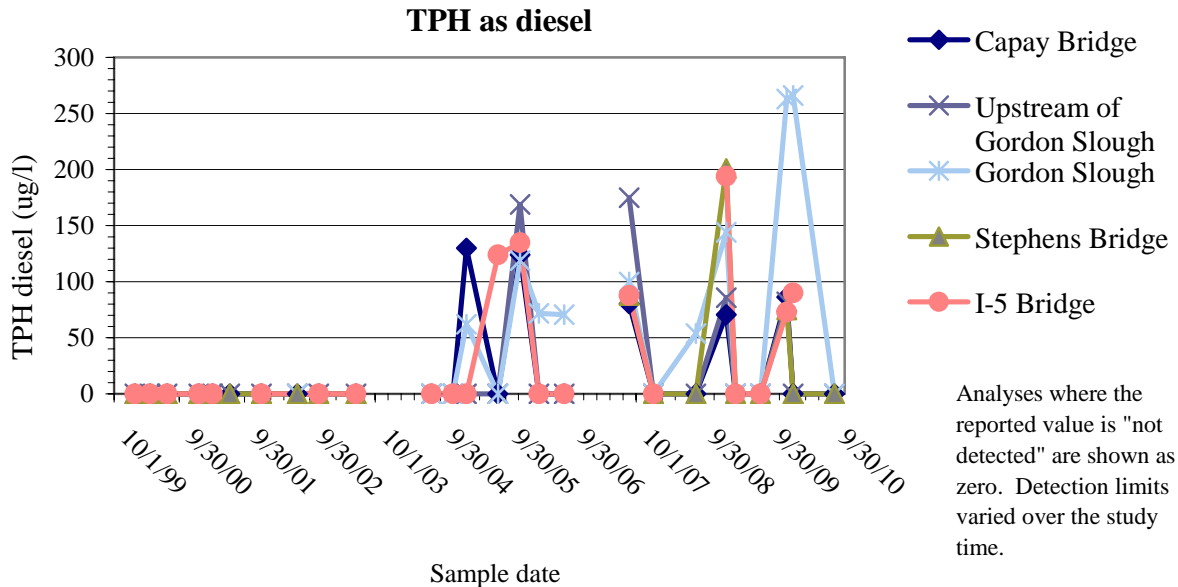
TPH (Total Petroleum Hydrocarbon) as diesel concentrations were noted as a water quality problem in 2008 and this problem continues through the 2009 and 2010 sampling events (Figure 2.1.r). Upstream sites tend to have the lowest values. Gordon Slough has the highest values in the CCRMP study area for 2010. The highest TPH as diesel concentrations occur during the first flush and peak flow samples, and correlate with high flow on Cache Creek. Low flow summer sampling events do not usually detect significant concentrations of diesel in surface water samples. TPH was not detected in significant amounts in the CCRMP area prior to 2004. Lower values before 2004 could be an artifact of a different lab or sampling method, although this is speculative. The source may also have been introduced since 2004. Possible sources of diesel fuel include leaky diesel pumps near drainages, leaky storage tanks, heavy equipment in or near the creek, or surface runoff through equipment yards. Diesel is not a common fuel for OHV vehicles, so OHV trespassers are not likely to be the source.

Figure 2.1.r: Total petroleum hydrocarbon (TPH) concentrations as diesel, measured at monitoring sites in the CCRMP area.

TPH as diesel recommendation: Seek to identify the source of diesel fuel in Cache Creek and determine an appropriate action.

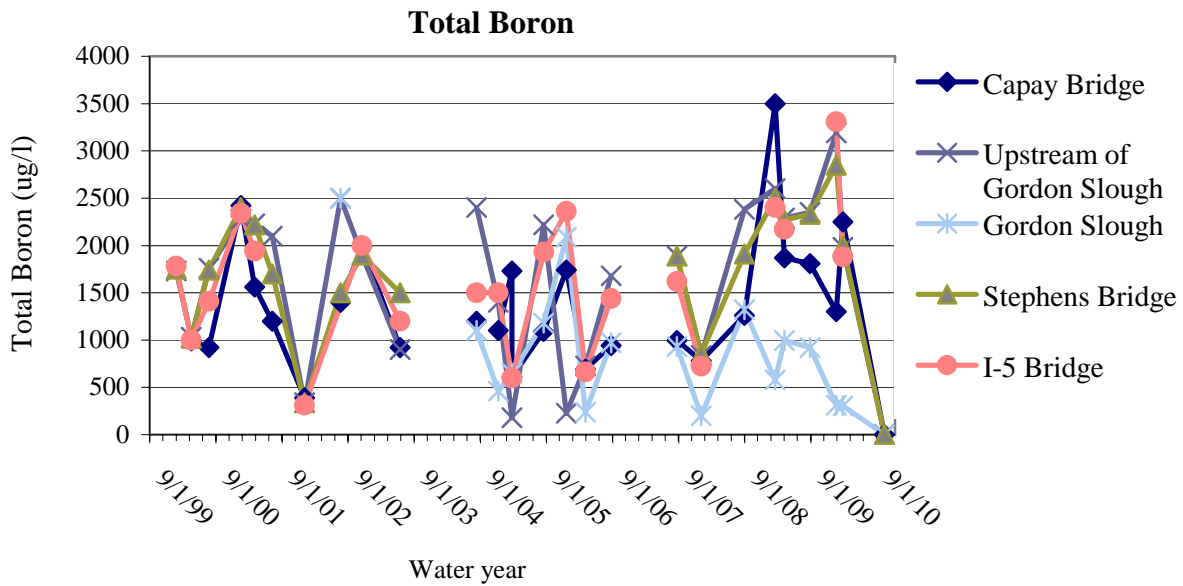
Figure 2.1.s: Total boron concentrations at monitoring sites in the CCRMP area.

Boron recommendation: Although boron is a pollutant and problem, there are no practical solutions to the problem, and this is not a water quality issue that needs to be addressed at the present time.

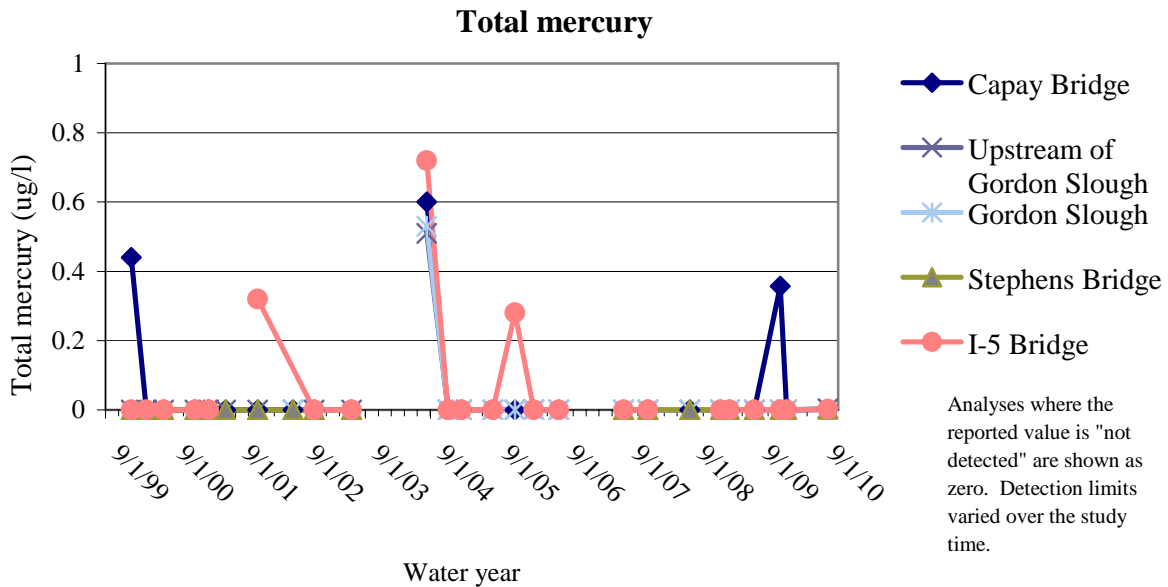
Figure 2.1.u: Total mercury concentrations at monitoring sites in the CCRMP area.

Total Mercury recommendation: At the present time regulatory agencies do not have a total mercury standard. All recent total mercury samples from Cache Creek have had total mercury levels below detection limits (Figure 2.1.u), so no action is recommended.

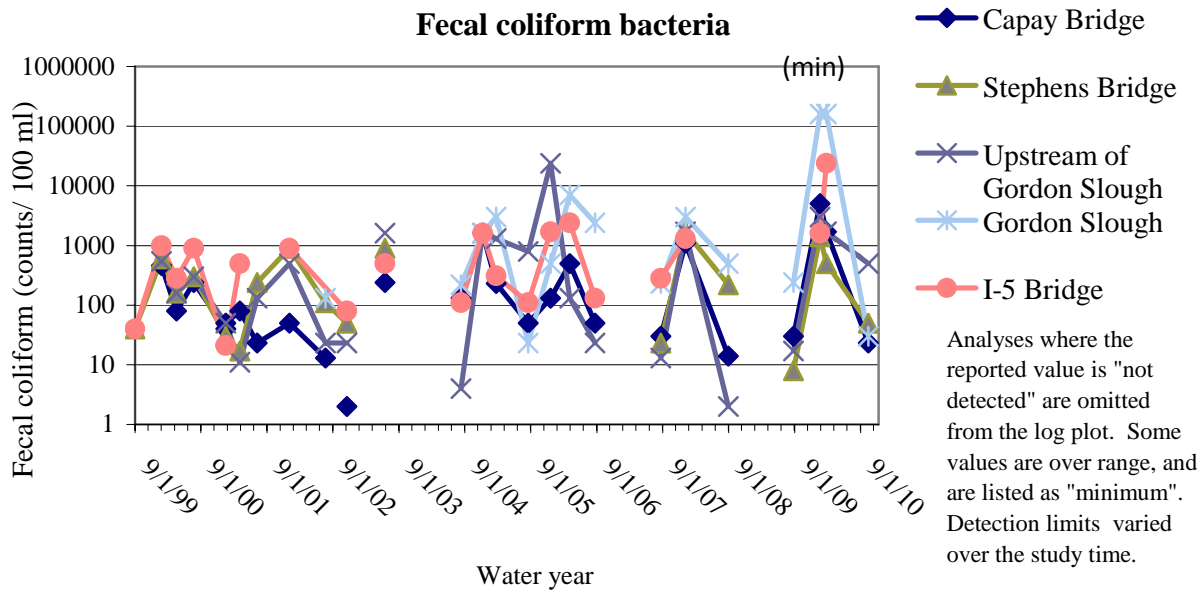
Figure 2.1.v: Fecal coliform bacteria counts at monitoring sites in the CCRMP area.

Fecal coliform recommendation: Seek to identify the source of the problem. Cache Creek will be significantly cleaner if the source of fecal coliform bacteria is identified and eliminated. Standing water allows the bacteria to breed, so one possible solution is to increase flow.

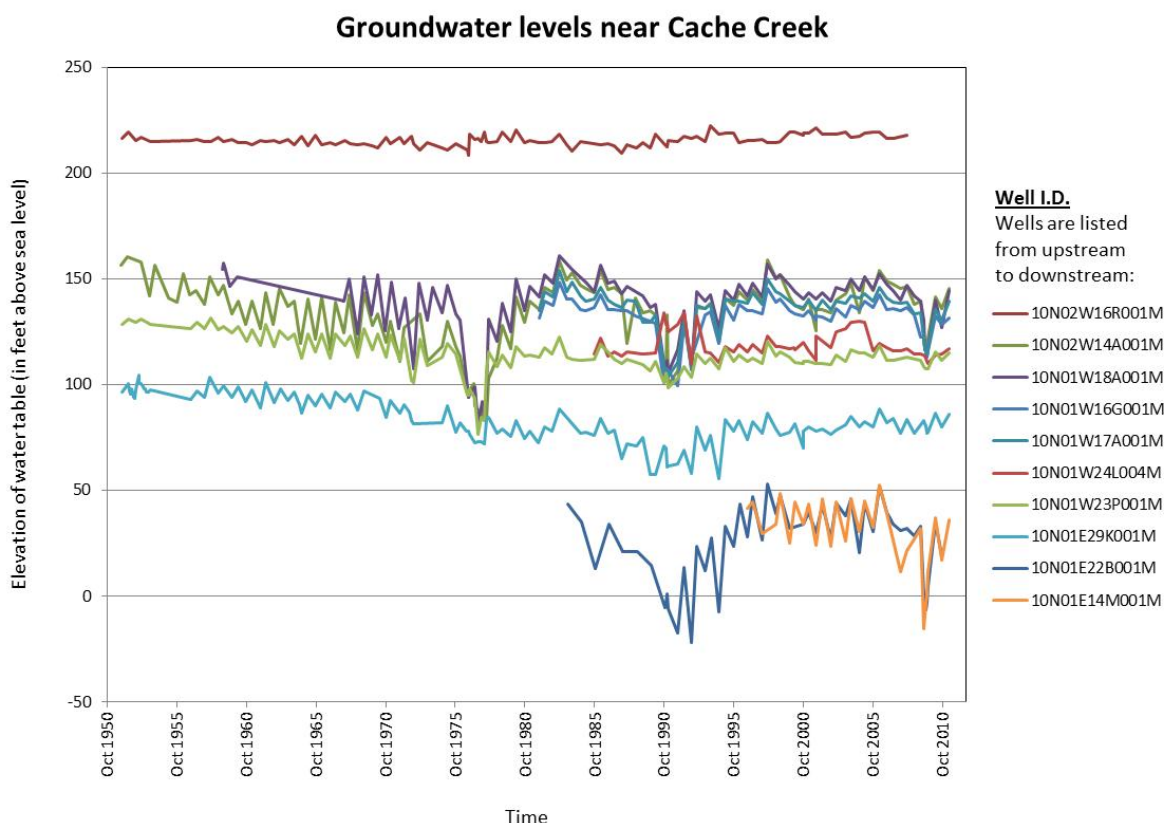
Water levels were plotted as elevation above sea level, so there is a common datum for comparison of groundwater information (Figure 2.5.b). The groundwater table is almost 200 feet above sea level along the upstream or western edge of the CCRMP study area. The land surface elevation is also higher here, so depth to water in most western wells is tens of feet below the land surface. The land surface and the water table both decline gradually toward the east. Wells in the center of the CCRMP study area have groundwater elevations ranging from 150 to 120 ft above sea level. The elevation of the groundwater table continues to decline downstream, and at the eastern or downstream end of the CCRMP area, groundwater levels and the land surface elevation approach sea level. This puts the water table just below the land surface, at the eastern edge of the CCRMP area.

Figure 2.5.b: Groundwater levels (elevation of the water table) for ten wells near Cache Creek. Wells are listed from upstream to downstream in the key. Groundwater levels rise downstream.

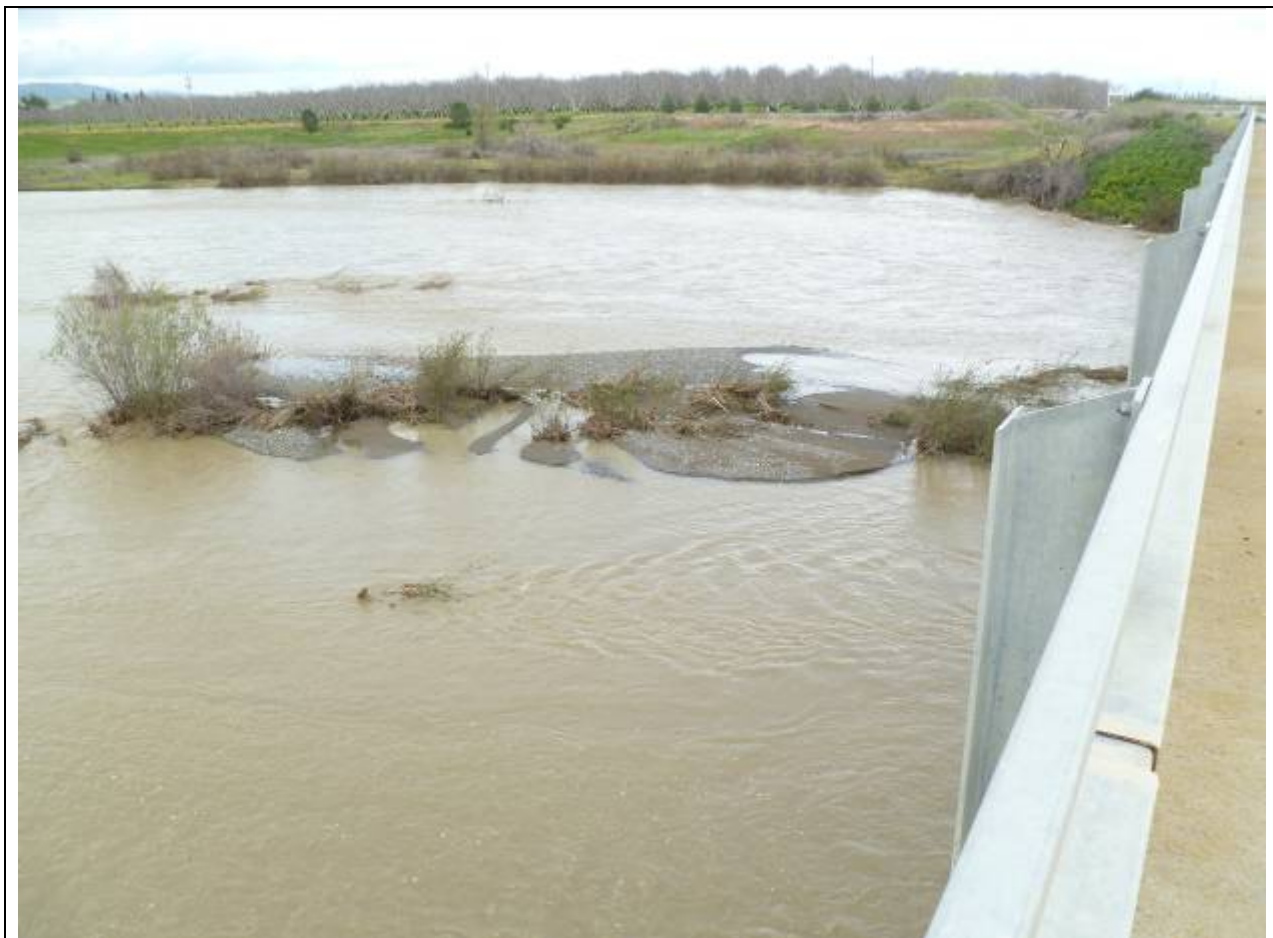
Figure 1 Photo of new channel deposits from Esparto Bridge County Rd 87 at flows of 5,000 to 6,000 cfs

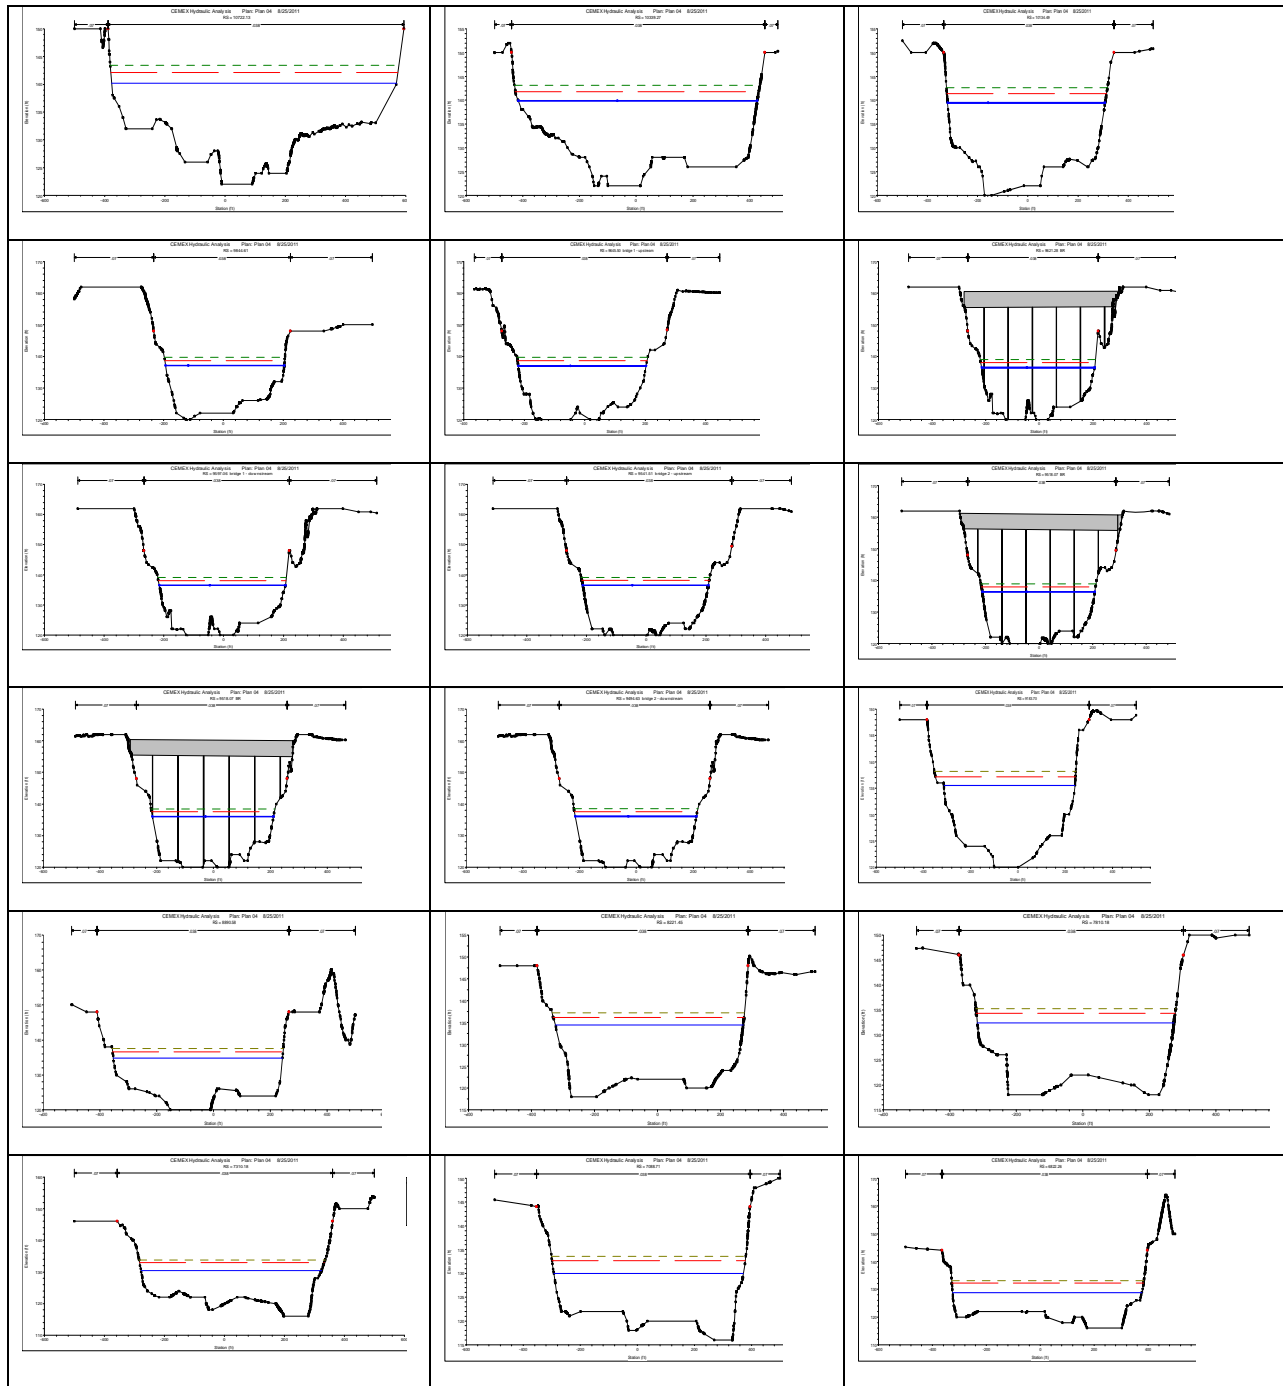
Figure 3 HEC RAS plots showing the cross section bed profile and flood elevations

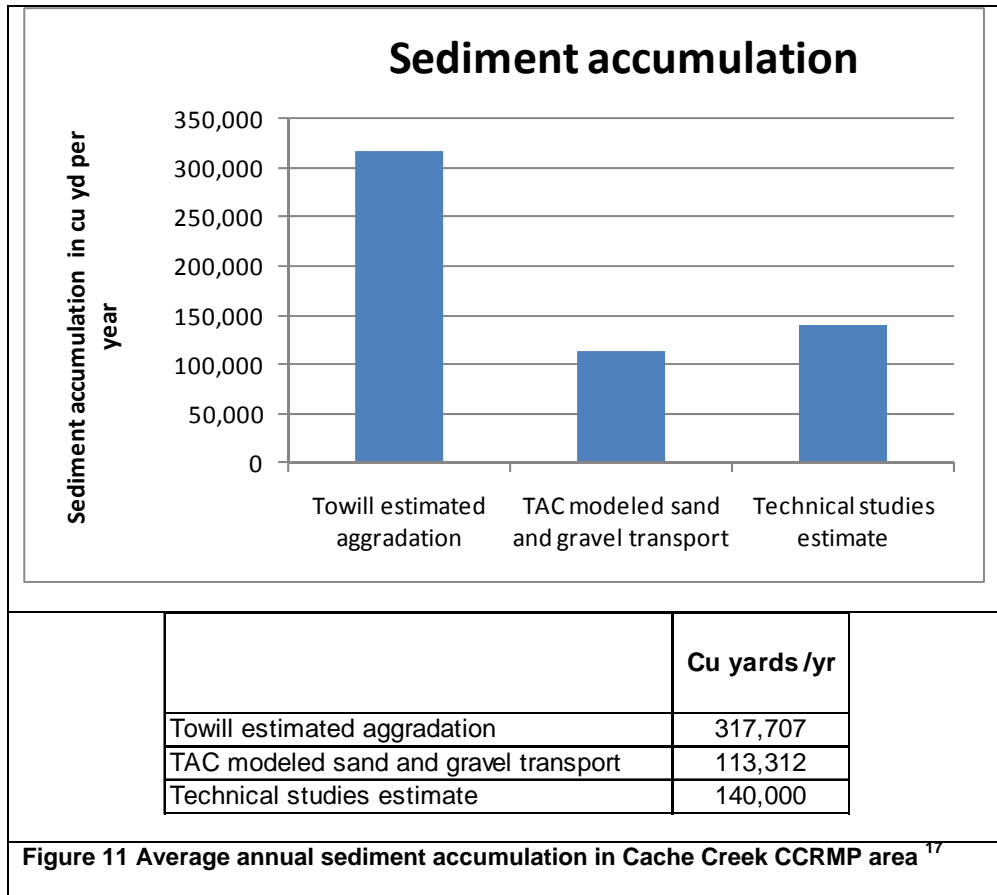
Figure 11 Average annual sediment accumulation in Cache Creek CCRMP area ¹⁷

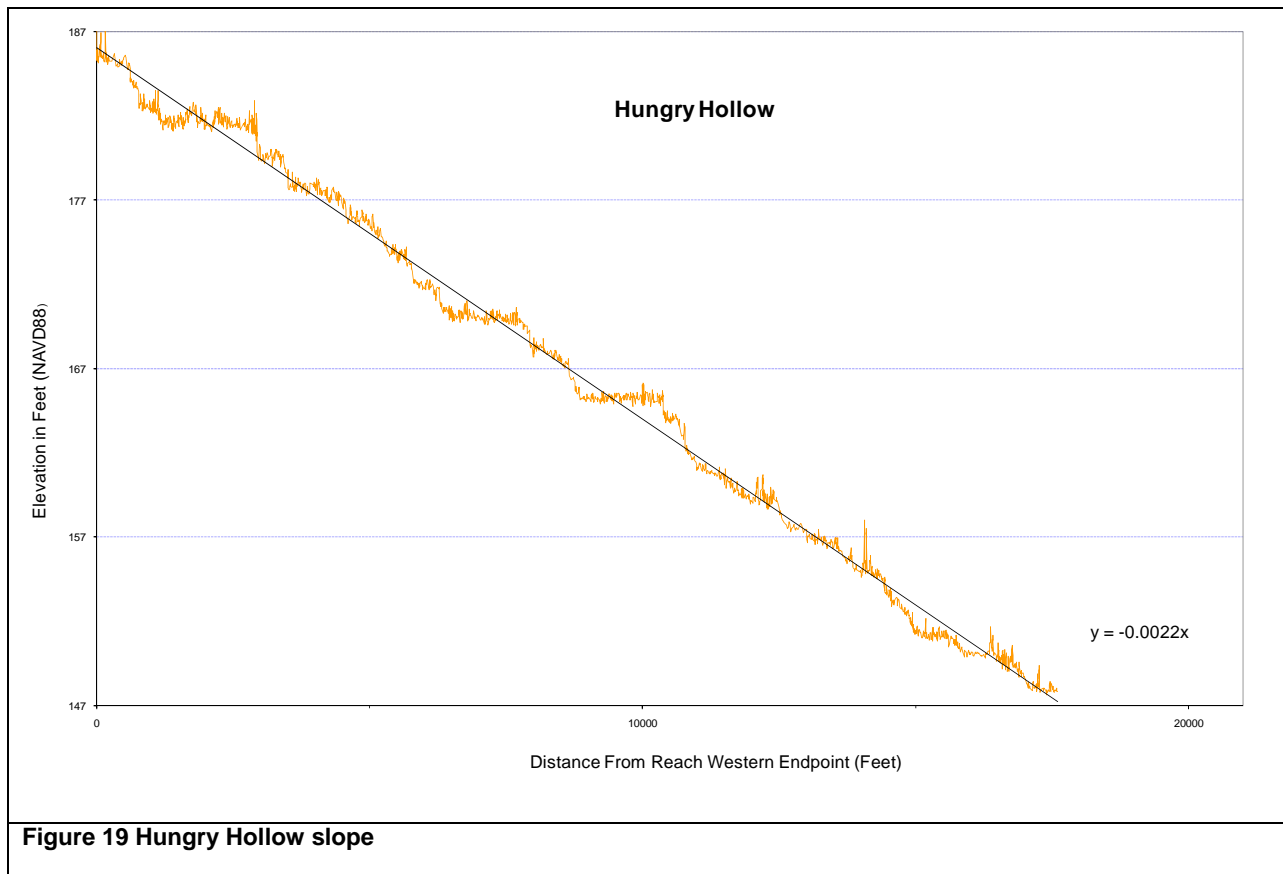
The longitudinal profile (Figure 19) shows that there are three areas where the profile is essentially flat, with steeper sections of relatively uniform slope in between.

Figure 19 Hungry Hollow slope
