**Watershed-Based Assessment of Hydrologic and Geomorphic
Conditions in Cache Creek through Capay Valley**

Yolo County, California

Yolo County Resource Conservation District

May 19, 2010

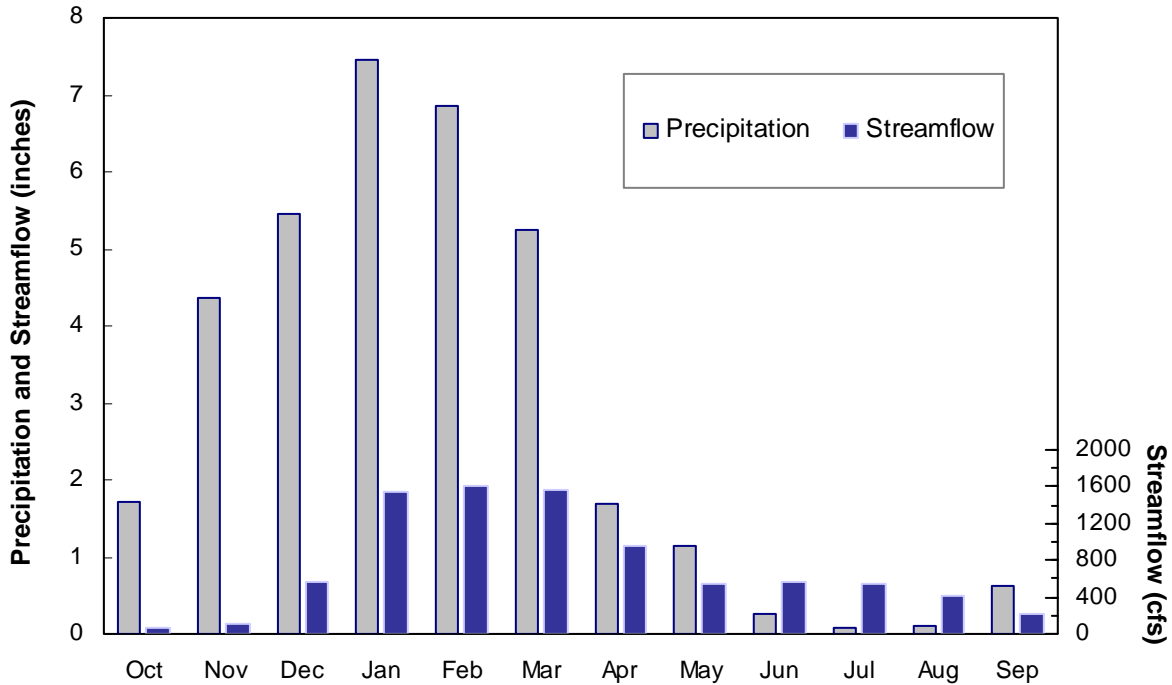
Figure 3-1. Mean monthly precipitation for the Cache Creek basin and mean monthly streamflow for Cache Creek at Rumsey, 1943-2007. Precipitation data from Clearlake (National Weather Service Cooperative Network) is increased by a factor of 1.22 based on the difference between mean annual precipitation at the station (28.7 inches) and the estimate of spatially averaged mean annual precipitation for the basin (35 in.).

Hydrology of the Cache Creek basin is characterized by large seasonal and inter-annual variability. The seasonal pattern of streamflow in Cache Creek generally shows a peak between January and March, followed by a period of moderate flows through August, and a decline to very low flows in October and November (Fig. 3-1). Wet season flows are primarily derived

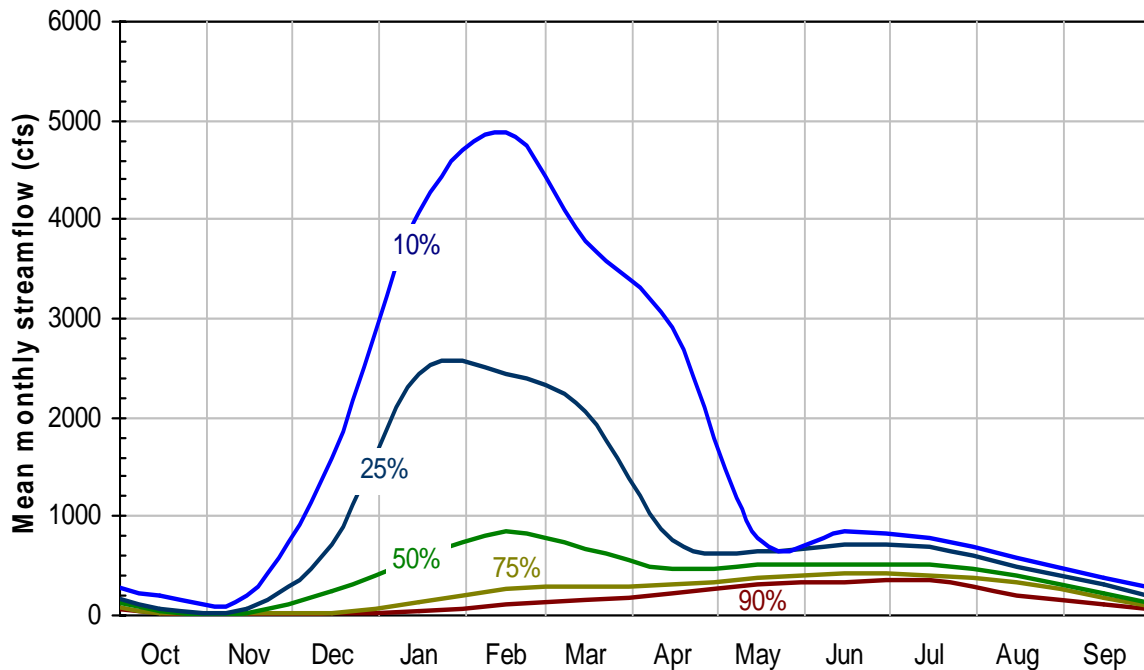
Figure 3-2. Monthly probability hydrographs for Cache Creek at Rumsey show the seasonal trend and inter-annual variability of streamflow during the period 1943-2007. Percentiles represent the exceedance probability, or likelihood that the mean monthly discharge will be exceeded in any given year, of the indicated streamflow value.

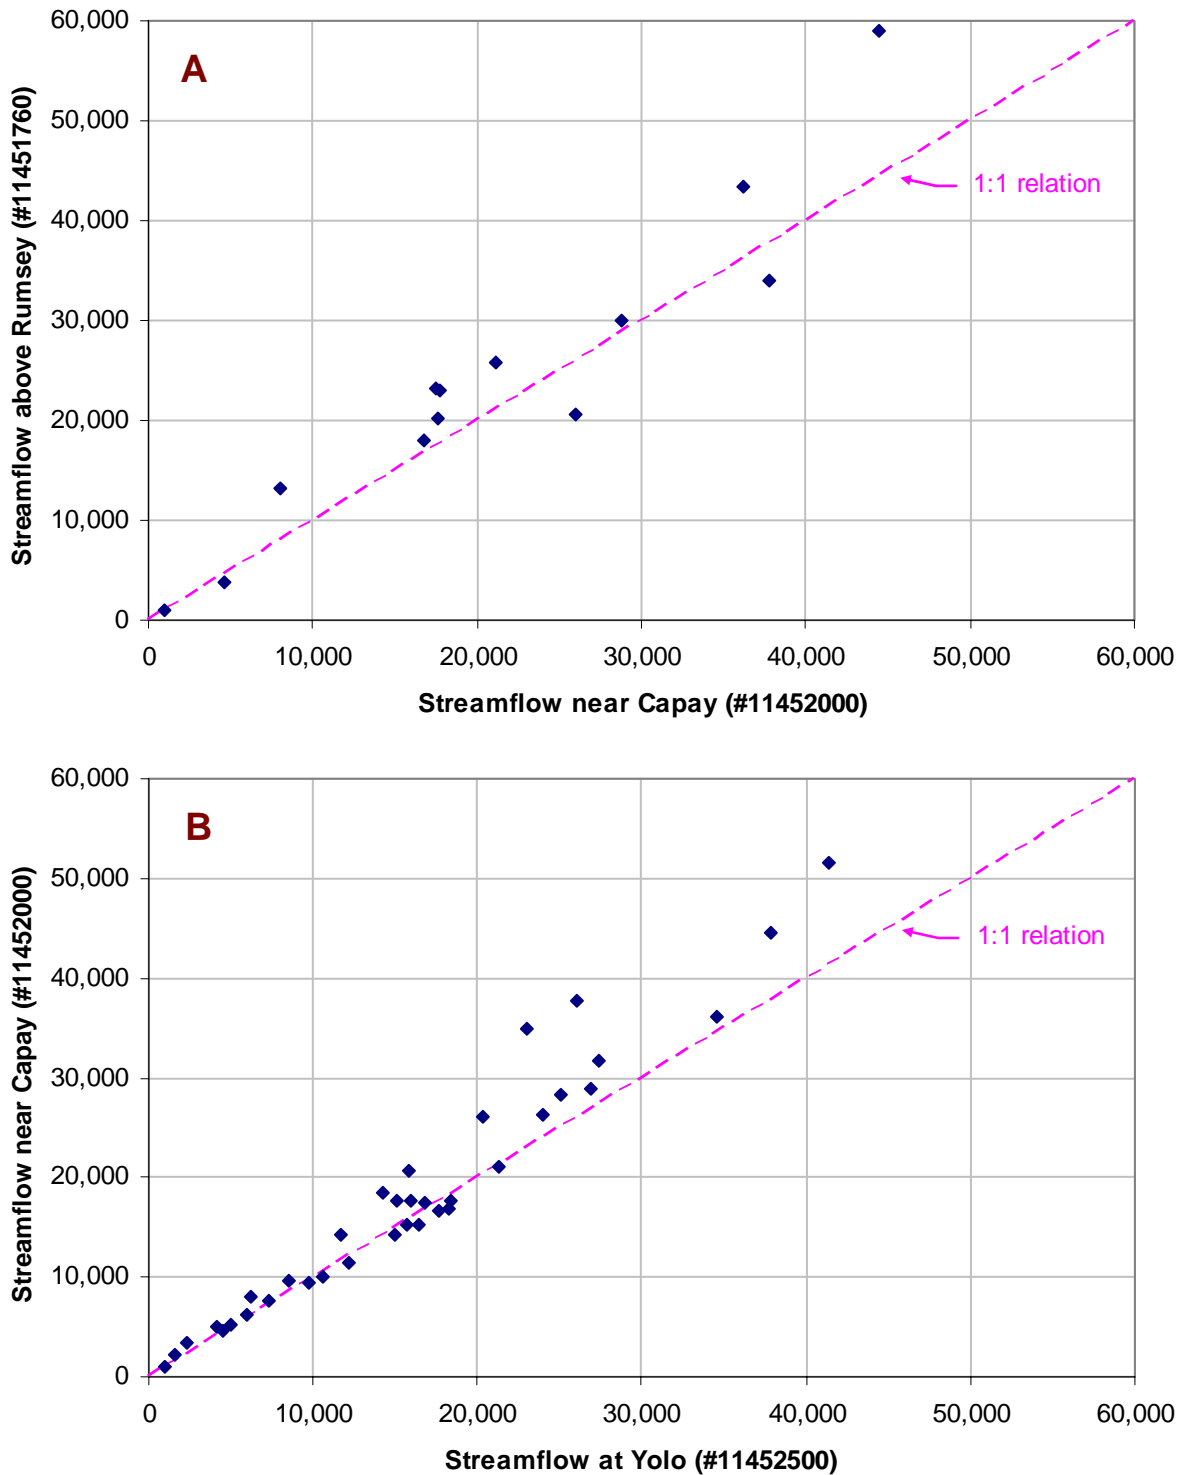
Figure 3-6. Matched-pairs of peak streamflow for periods of overlapping data. Panel A (top) plots the peak streamflow above Rumsey and the corresponding peak flow near Capay (n = 20 years). Panel B (bottom) plots the peak streamflow near Capay and the corresponding peak flow at Yolo (n = 35 years). The dashed line indicating a 1:1 relation is the theoretical position that would indicate that concurrent flood peaks were equal between the two sites in a given year.

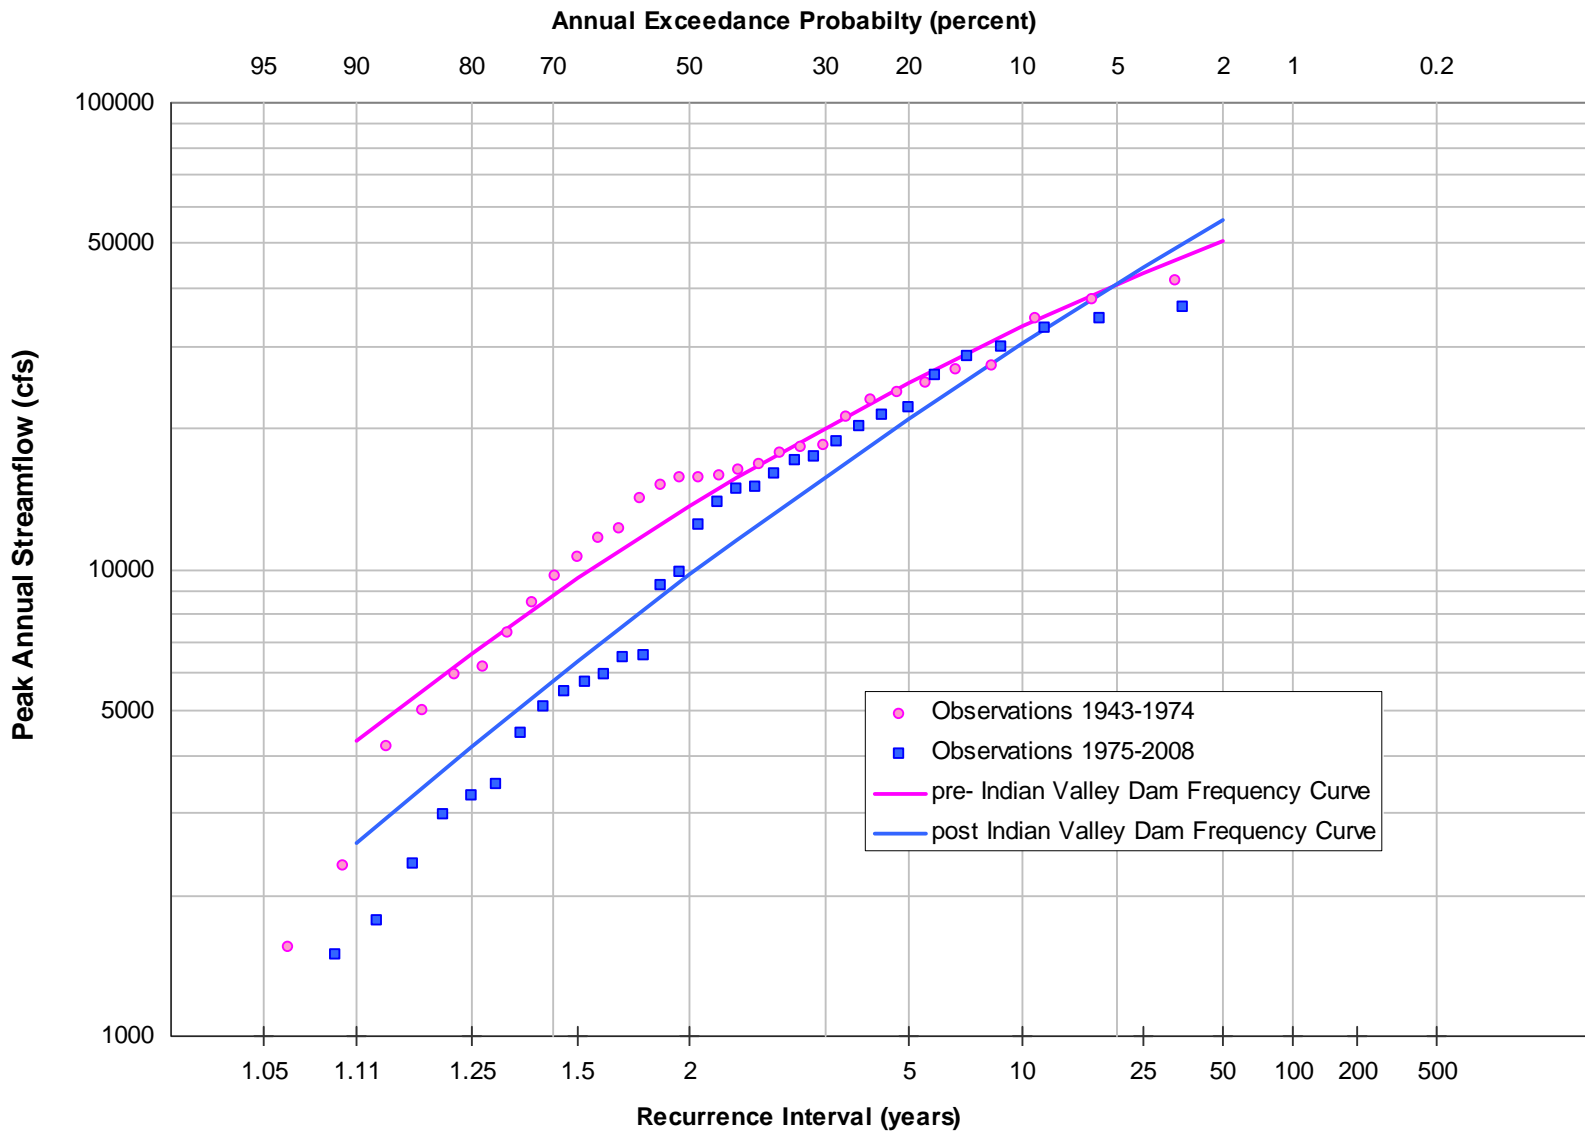
Figure 3-10. Comparison between flood frequency curves for the periods 1943-1974 (pre-Indian Valley Dam; flow regulation from Cache Creek Dam only) and 1975-2007 (post-Indian Valley Dam).

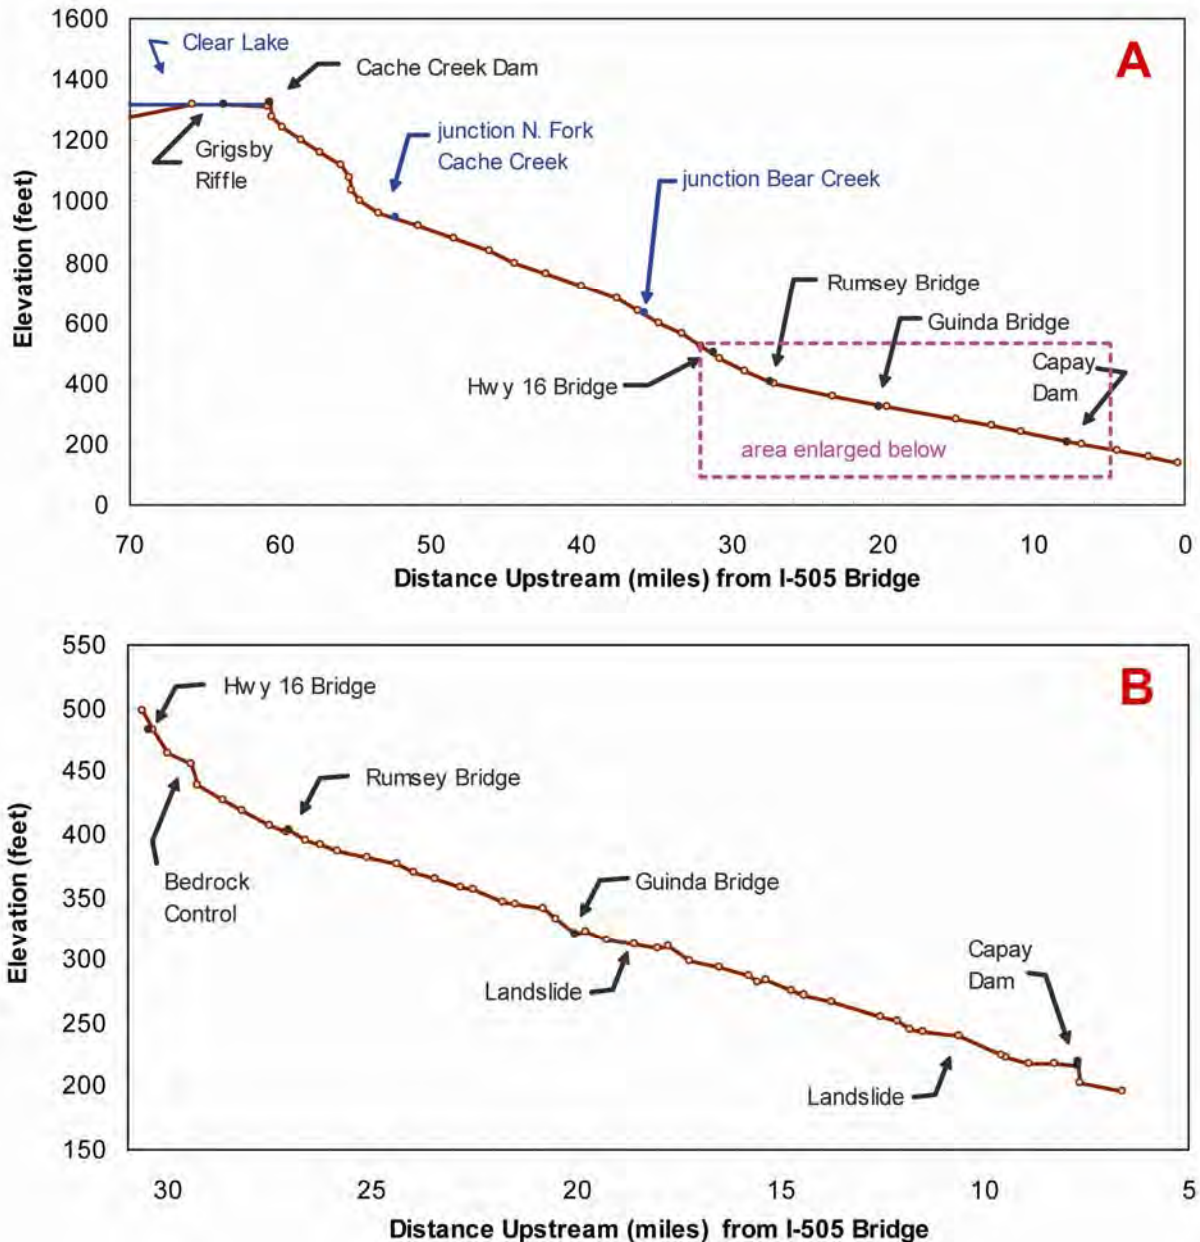
Figure 4-2. Longitudinal profiles of Cache Creek. Panel A shows the channel profile for a length that extends to the origin of Cache Creek at the Clear Lake outlet and is digitized from USGS 7.5' topographic maps. Panel B shows a more detailed profile of the Capay Valley segment that was digitized from the 1983 channel survey presented by data in SLA (1987) and by Harmon (1989).

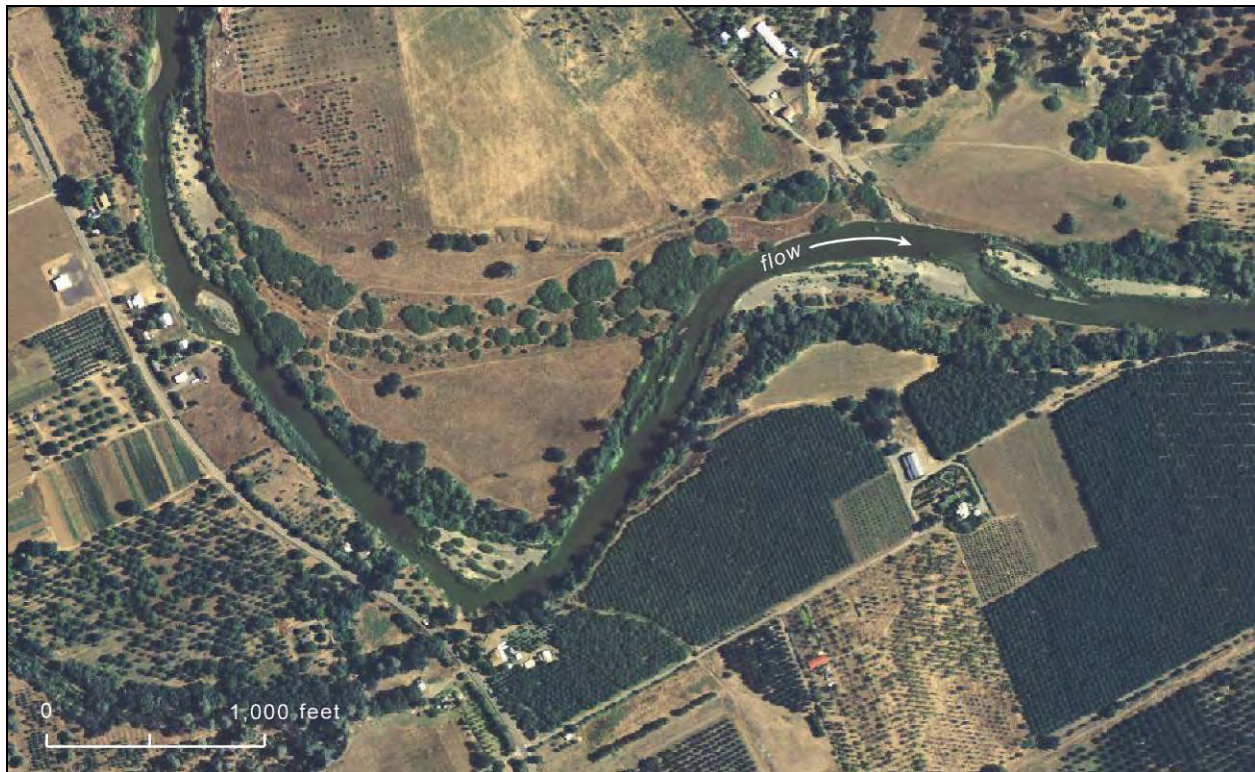
Figure 4-3. The channel pattern is characterized by a primary channel directed around gravel bar surfaces at low to moderate flow. Flow is split around incipient bar surfaces in localized areas. Source: USDA (2005).

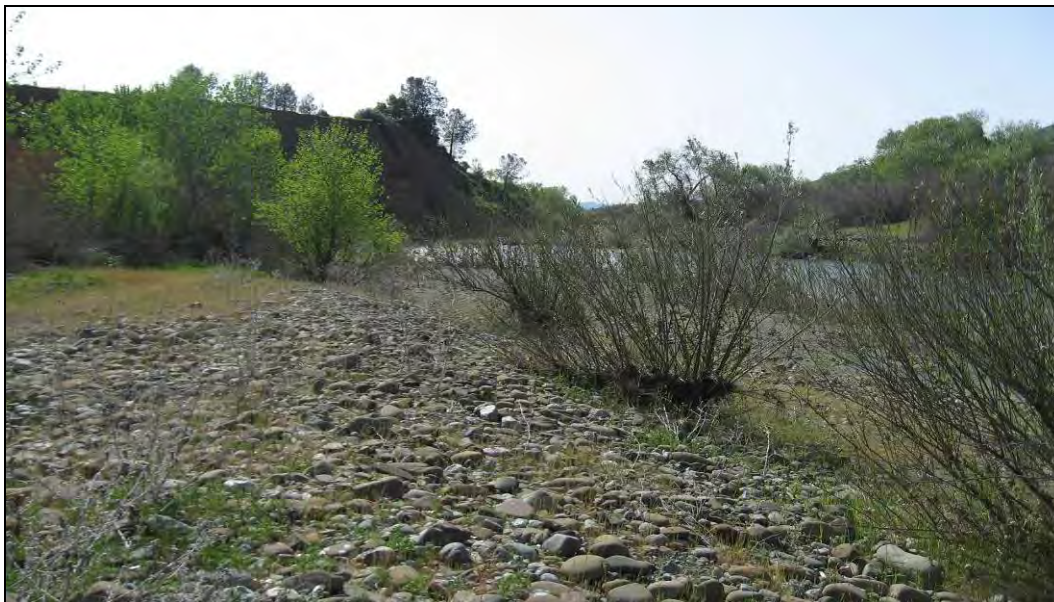
Figure 4-5. Photograph of the gravel bar surface at XS-37 (view is looking downstream). The upper surface in the foreground and left side of the image is used to morphologically define the height of the floodplain. The break in slope at the edge of the upper surface delineates bankfull stage and defines the bankfull channel.

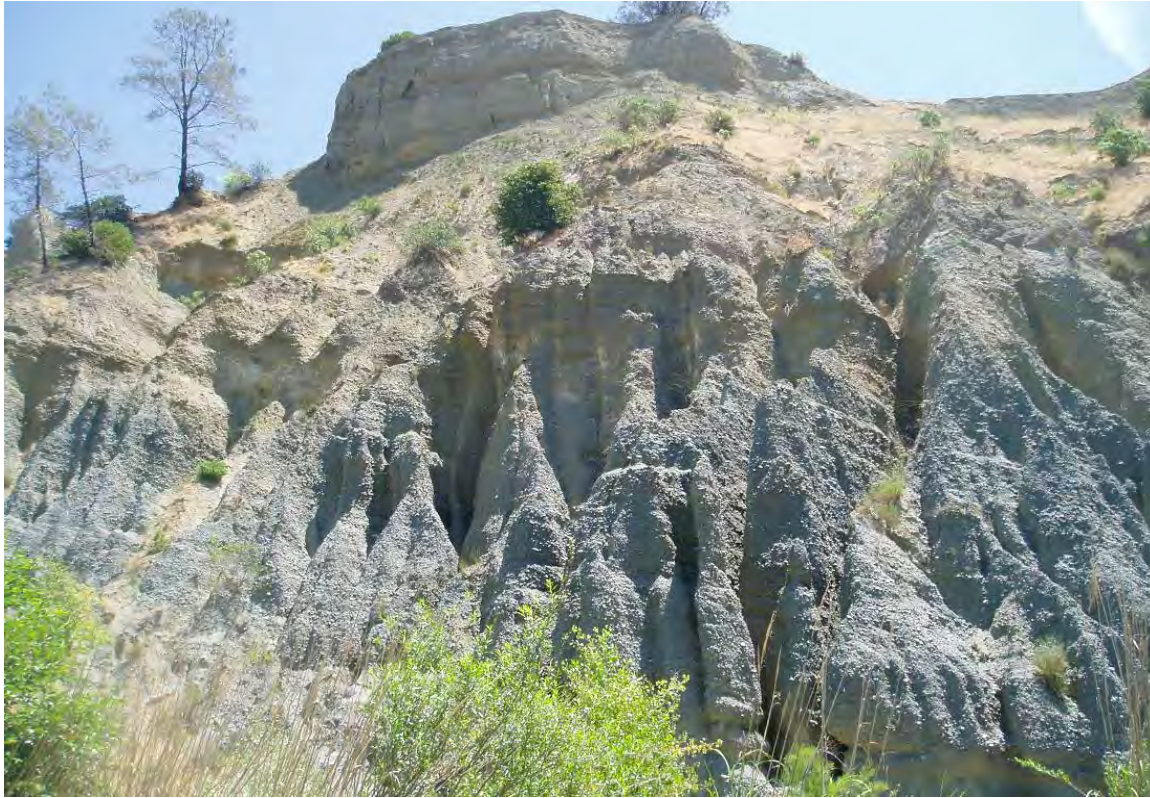
Figure 4-6. Photo of highly erodible surficial deposits creating a badland-type topography that contributes large volumes of sediment to Cache Creek.

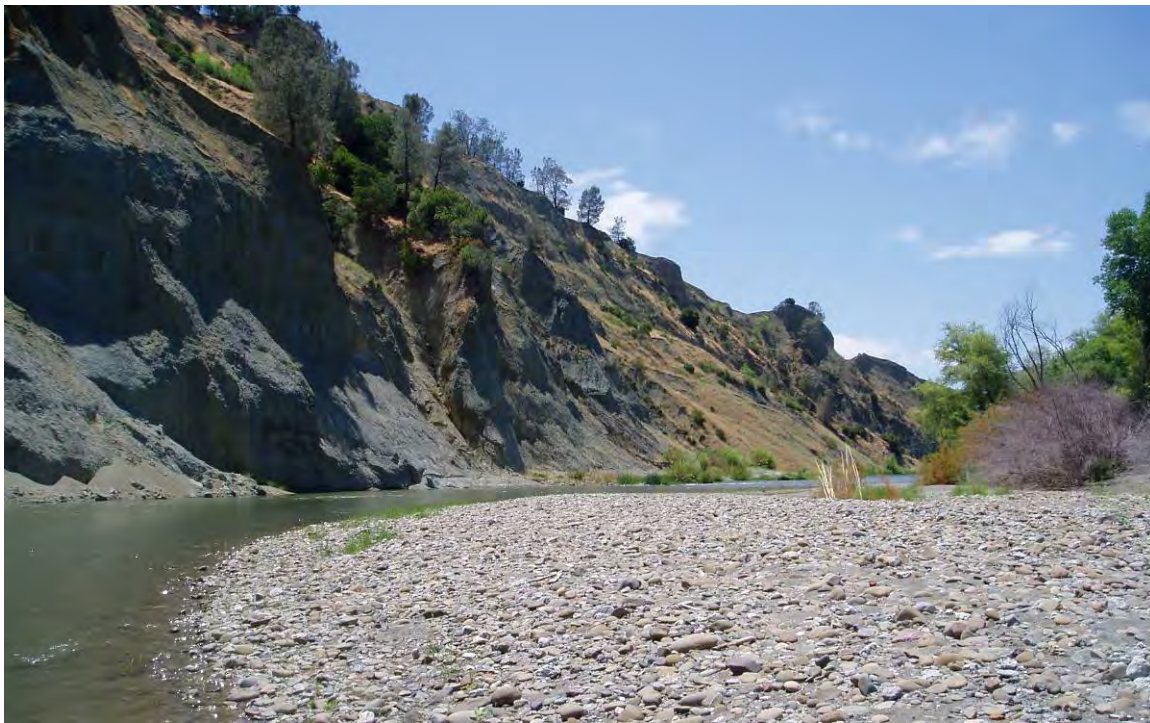
Figure 4-7. Photo of a point bar surface showing the streambed composed primarily of gravel- and cobble-sized sediments.

Streambed material in the Capay Valley segment of Cache Creek is primarily composed of coarse gravel and small cobbles (fig. 4-7). Samples of the channel substrate in the Capay Valley segment of Cache Creek were described by Simons, Lee, and Associates (SLA, 1987) and Harmon (1989). Of the samples taken from 45 locations along Cache Creek during the period 1984-1986, 12 percent of the bed-material analyzed was sand, 63 percent was gravel, and 23 percent was coarser than gravel (Fig. 4-8). The median grain size for the samples included in Harmon's (1989) investigation ranged between 5 and 86 mm. The longitudinal variation in grain-size from these samples reveals considerable scatter in the downstream direction, however, a slight trend towards a downstream decrease in grain size is evident. A distinct change to finer-grained bed material occurs in the pool upstream of the Capay Diversion Dam.

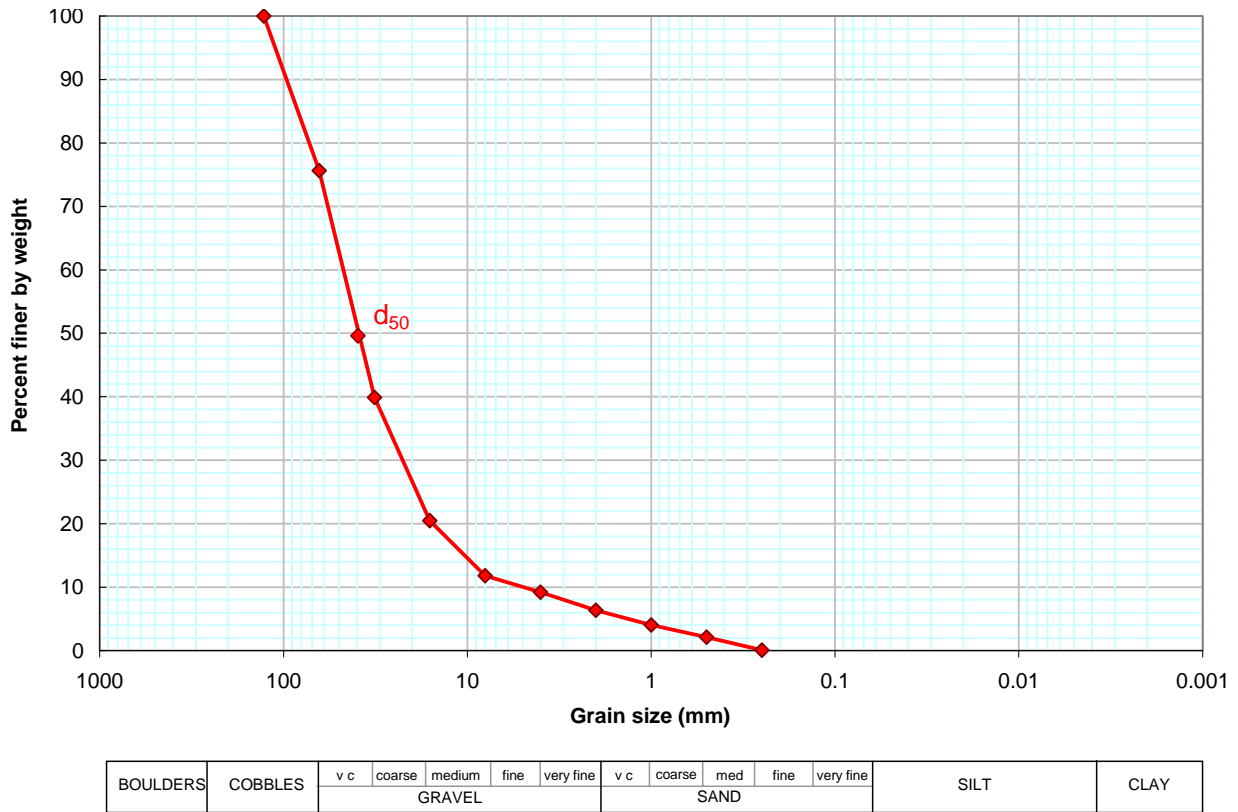
Figure 4-8. Grain size distribution for streambed sediments at cross section 19A. Source: Harmon (1989)

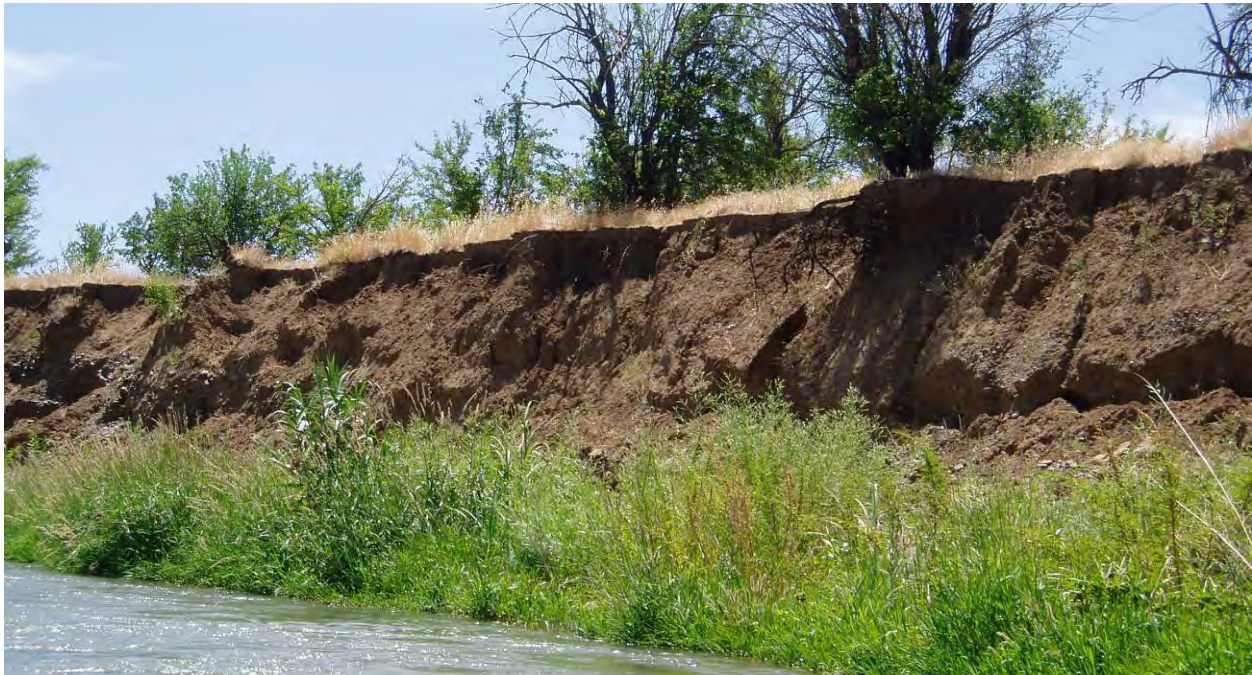
Figure 5-2. Photograph of eroding streambank along the outside of a meander bend. The bank is nearly vertical near the top and debris piles have accumulated at the toe.

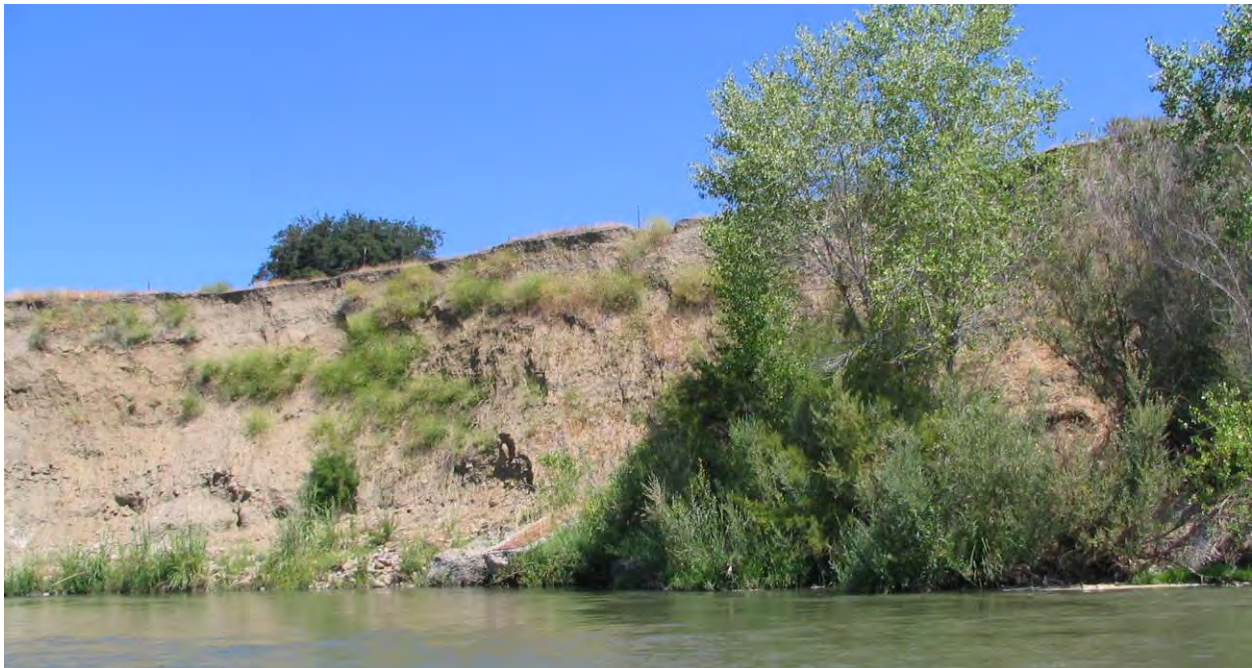
Figure 5-4. Photograph of eroding bluff along the left bank at XS-38.

Site 38 (River Mile 50.4). The present channel alignment at XS-38 shows a steep bluff that is about 40 feet high along the left bank (Fig. 5-4). The channel has been migrating laterally and has streambank erosion has required the road position to be moved back. Approximately 1,000 linear feet of the left bank has eroded since 1937. At the apex of the meander bend bank erosion has exceeded 250 feet during the historical period. On average, this relates to a rate of three to feet per year, however, the actual rate in any given year is expected to vary greatly from the average with years of high flows experiencing more rapid rates of erosion. The 1937 imagery shows that upstream of this location the channel formerly followed a different alignment that included split flow around a relatively stable island. Shifting the main channel towards the northern alignment has shortened the overall flow path of the channel in this location. This shift may be related to the incision of the channel bed noted for this reach (section 5.1). It appears that the channel shift has created a state in which the creek maintains an excess of energy and is eroding the bank at XS-38 in effort to increase its sinuosity and dissipate energy. Erosion at this location is likely to continue at approximately the same rate as the historical period.

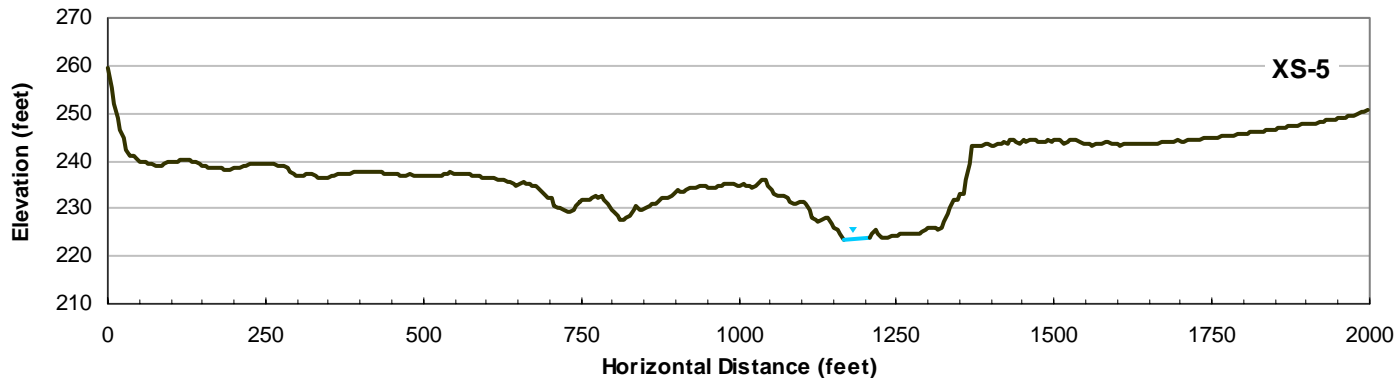
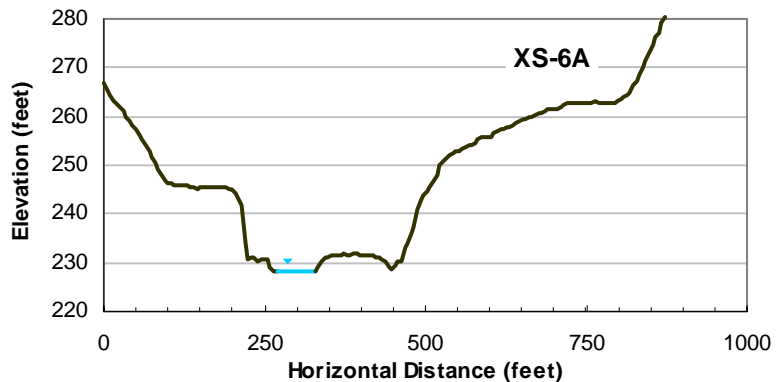
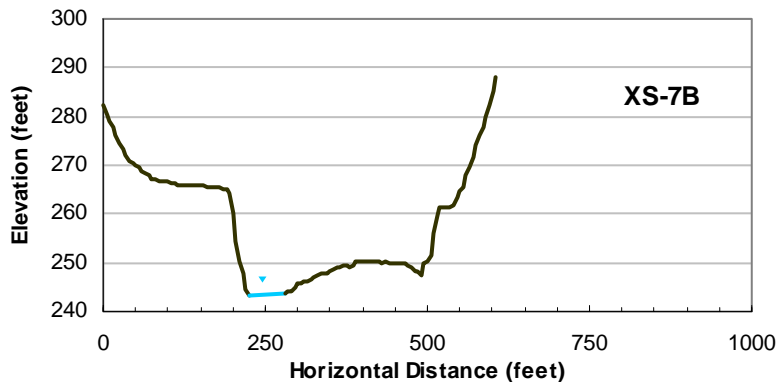
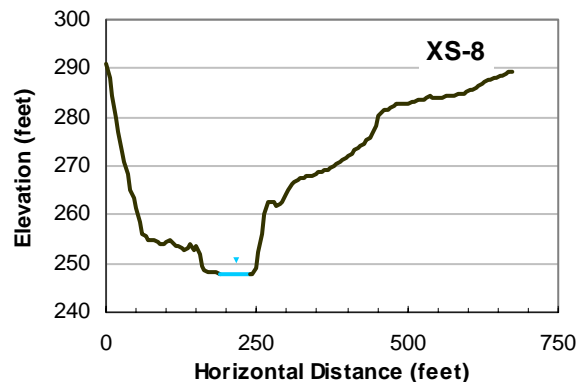
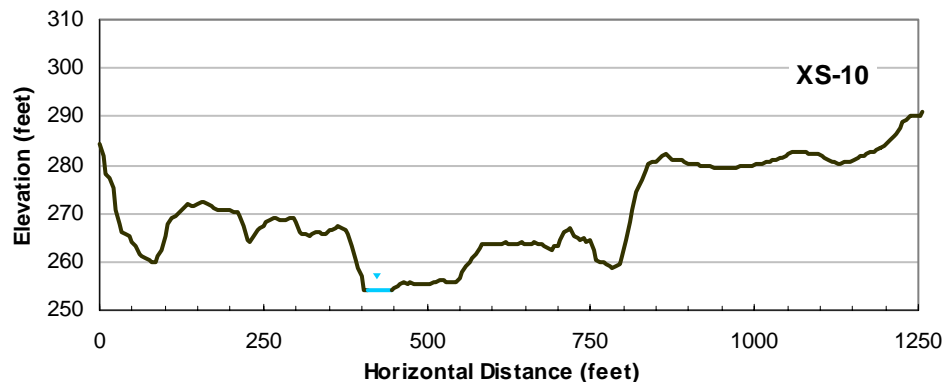
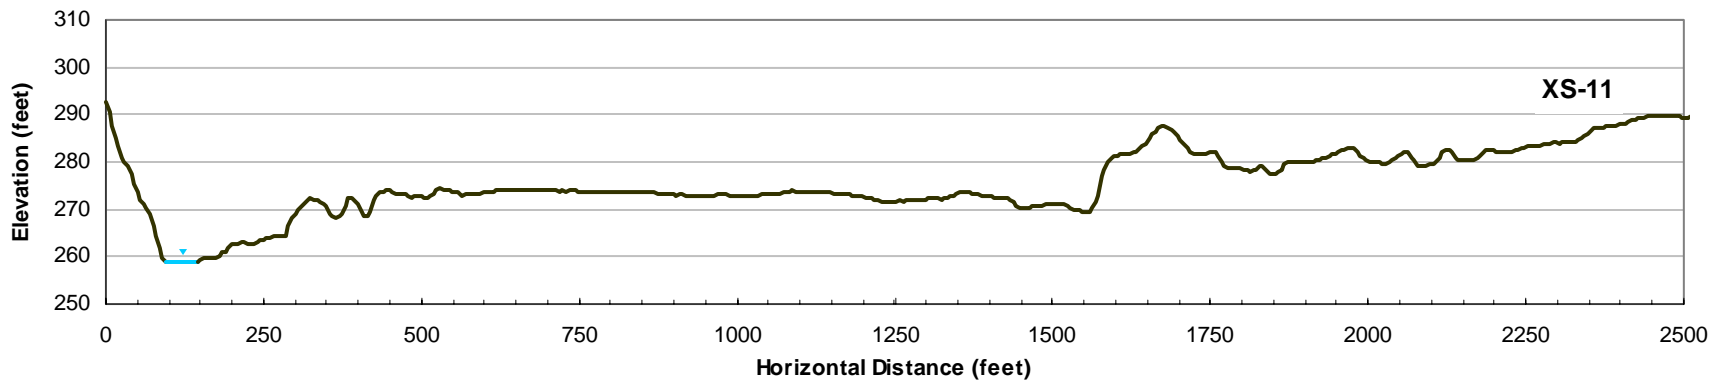
The LIDAR terrain data collected in the 2008 omits the subaqueous portions of the stream channel because the LIDAR pulses do not penetrate the water surface. As such, the cross-sectional profiles are truncated at the elevation of the water surface on the day data were collected. Most of the Capay Valley data was collected on March 27, 2009. The streamflow reported by the DWR gage at the Rumsey Bridge was less than 150 cfs. The water surface is shaded light blue in the cross-sectional profiles to indicate that it is not the ground surface. The active channel of Cache Creek is wide and shallow and riffle bars are likely to have a residual water depth of less than 1 foot at the time data were collected. Although the low flow channel characteristics are not fully described, the profiles provide a useful illustration of the topographic relations between gravel bar, floodplain, and terrace surfaces.

Cross section ID's are based on a numbering scheme for cross-sectional profiles surveyed by USGS in 1984 (Harmon, 1989). The exact endpoints of the USGS cross sections remain unknown; however, the general locations are indicated by a map in Harmon's (1989) open-file report and by a series of maps presented with the SLA report (1987). The 2008 cross-sections were drawn in the same general location as the earlier surveys, however, the alignment was altered in places to remain perpendicular to the stream channel and the profile lines were extended a greater distance from the stream bank to include more information about the overbank areas. A few of the profiles from the 2008 data set are positioned in locations that the earlier USGS data did not survey. In such instances the profile was given a new ID by adding the suffix "B" (e.g. XS-14B) to the nearest cross-section profile ID.
