**APPENDIX F**  
**Draft Hydrualic Technical Memorandum**

# Technical Memorandum

**RE: Hydrology and Hydraulic Analysis for the existing County Road #41 Bridge over Cache Creek, Yolo County, California**

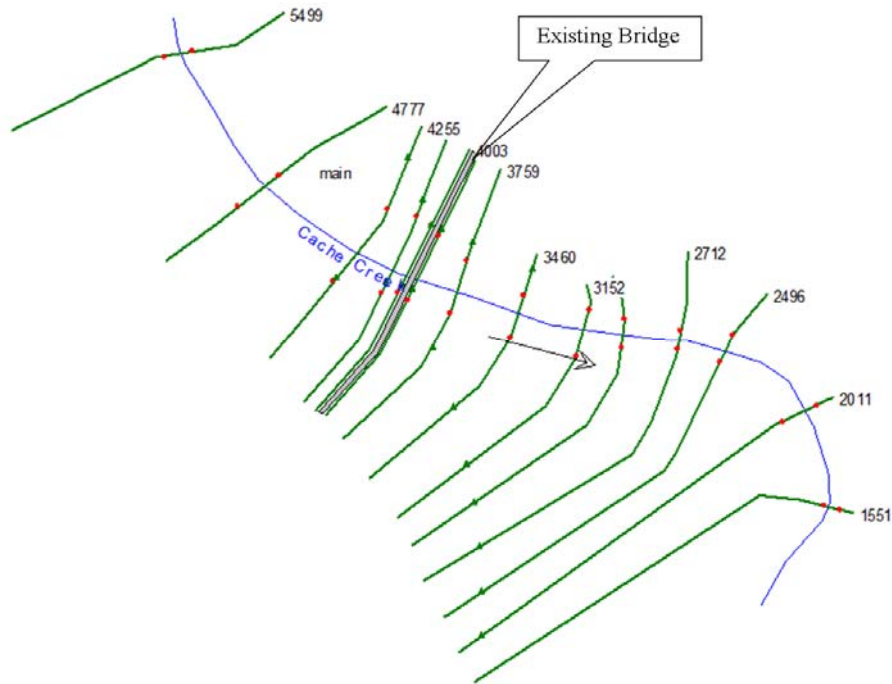
Figure 2: Plan view of HEC-RAS cross section

Hydraulic parameters (water surface elevations and velocity) were modeled using the U.S. Army Corps of Engineers HEC-RAS (Hydraulic Engineering Center River Analysis System) version 4.1.0 model. The model utilized data from the following sources: 1) survey information supplied by QEI on February 6, 2013, 2) as-built data provided by QEI, and 3) a field investigation conducted by Avila and Associates on January 31, 2007. Cross-sections surveyed for the HEC-RAS model are shown Figure 2:

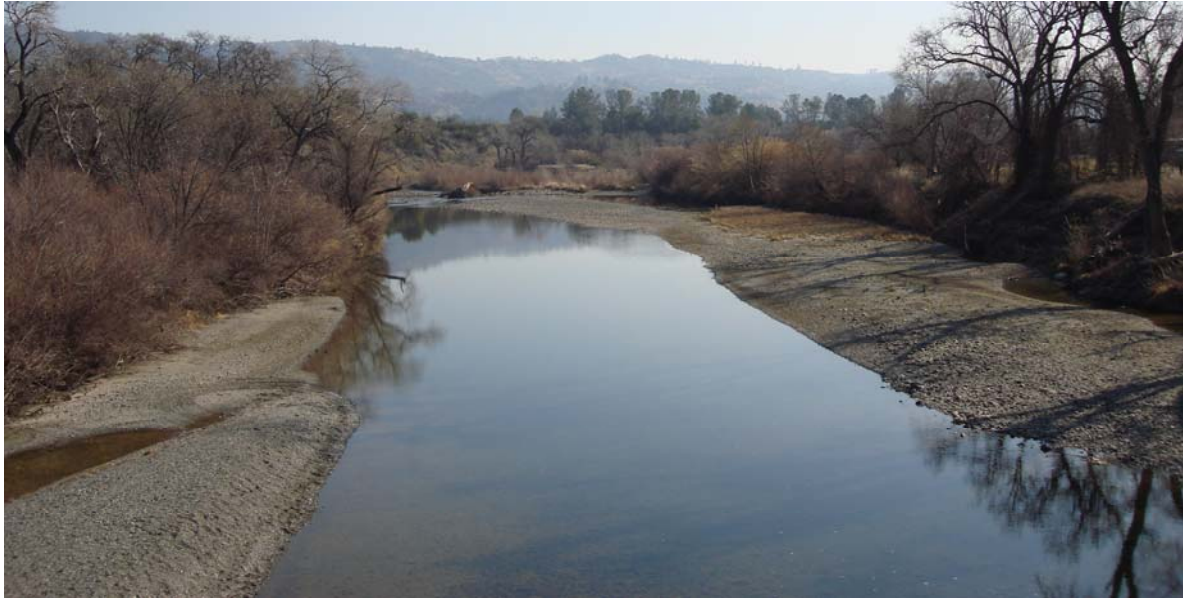
*Figure 3: Looking at the existing bridge. The channel is sparsely vegetated*

Manning's "n" values of 0.035 for the channel and 0.04 for the overbanks were used in the model. These are consistent with the field reviews by Avila and Associates as shown in Figure 3. The existing bridge was input into the HEC-RAS model as shown in Figure 4. The results are shown in Table 3. The water extents for the 100-year discharge are shown in Appendix B

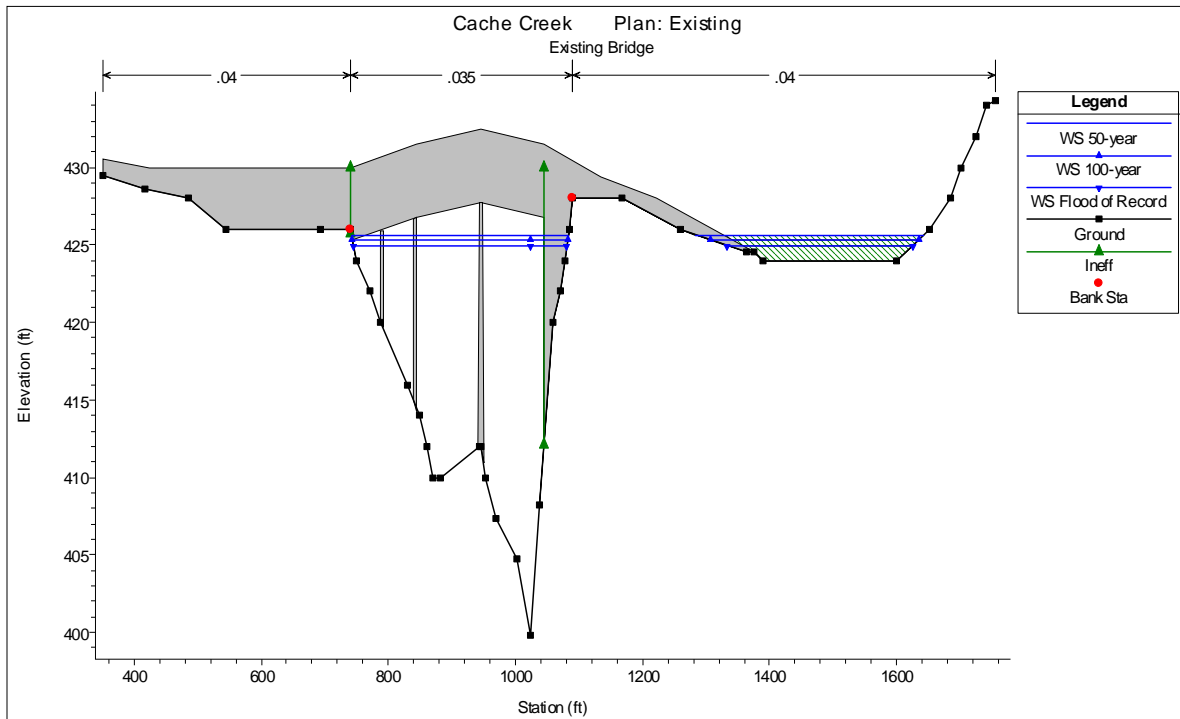
*Figure 4: Existing Condition from HEC-RAS model*

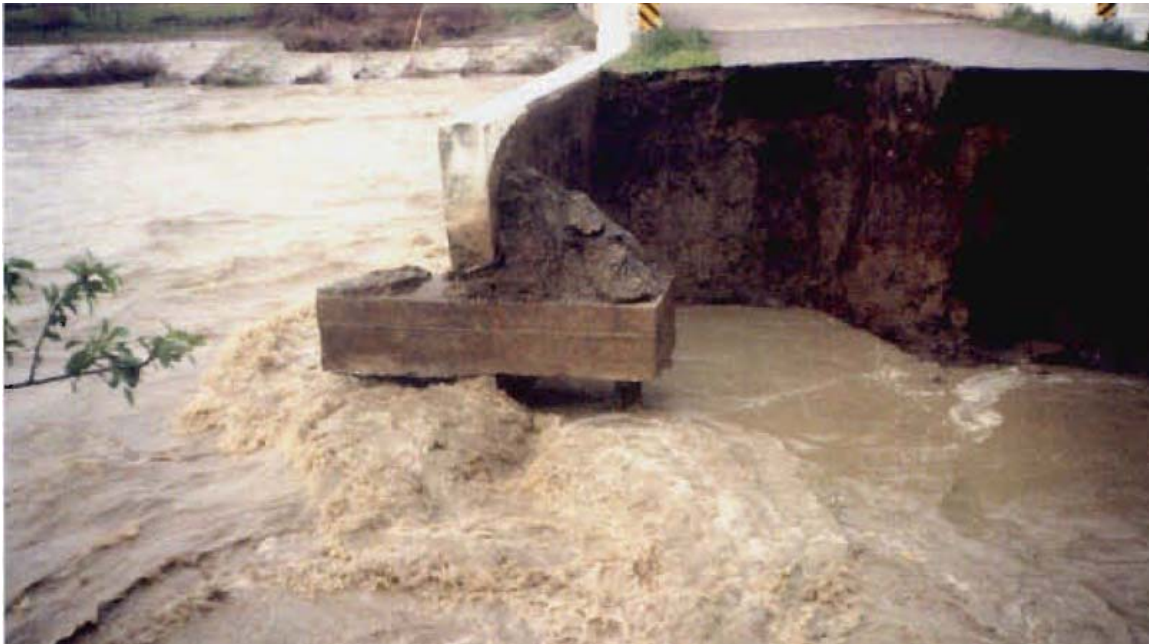
Figure 5: Wingwall prior to failure (from nbc, 1995)

The bridge was rated scour critical by Caltrans as part of the National Bridge Inventory System rating of the Item 113 (Scour) in 2001. As noted in the maintenance records (Caltrans, 2010), the 1995 flood damaged Abutment 1 causing the failure of the upstream wingwall as shown in Figure 5 and almost outflanking the bridge as shown in Figure 6.

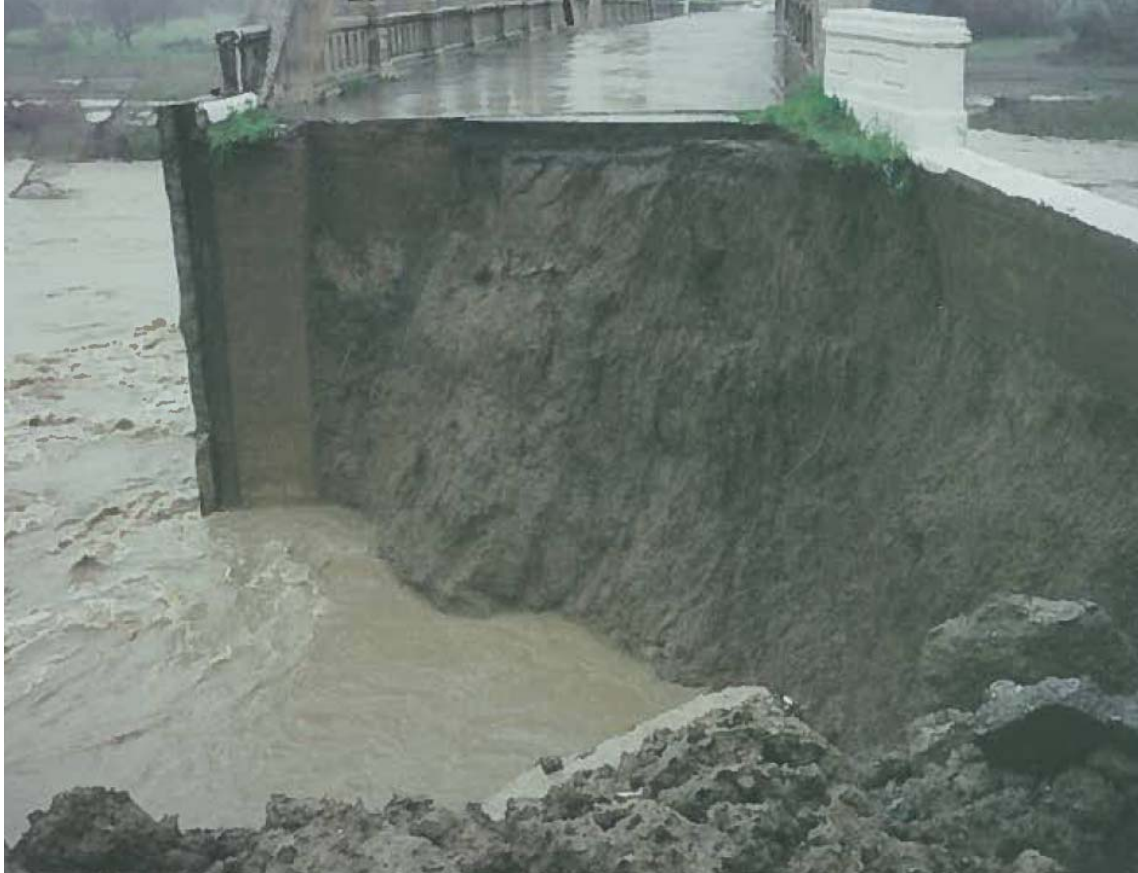
*Figure 6: Erosion at Abutment during March 1995 storms (photo from QEI)*

During the 1995 storms, the embankment fill around Abutment 1 almost washed out completely (see Figure 6). For the purposes of the abutment scour analysis, it is assumed that the downstream wingwall would also wash out if Abutment 1 were ever completely outflanked (as almost occurred in 1995). It is unlikely, however, that the outflanking would occur due to 1) the construction of a series

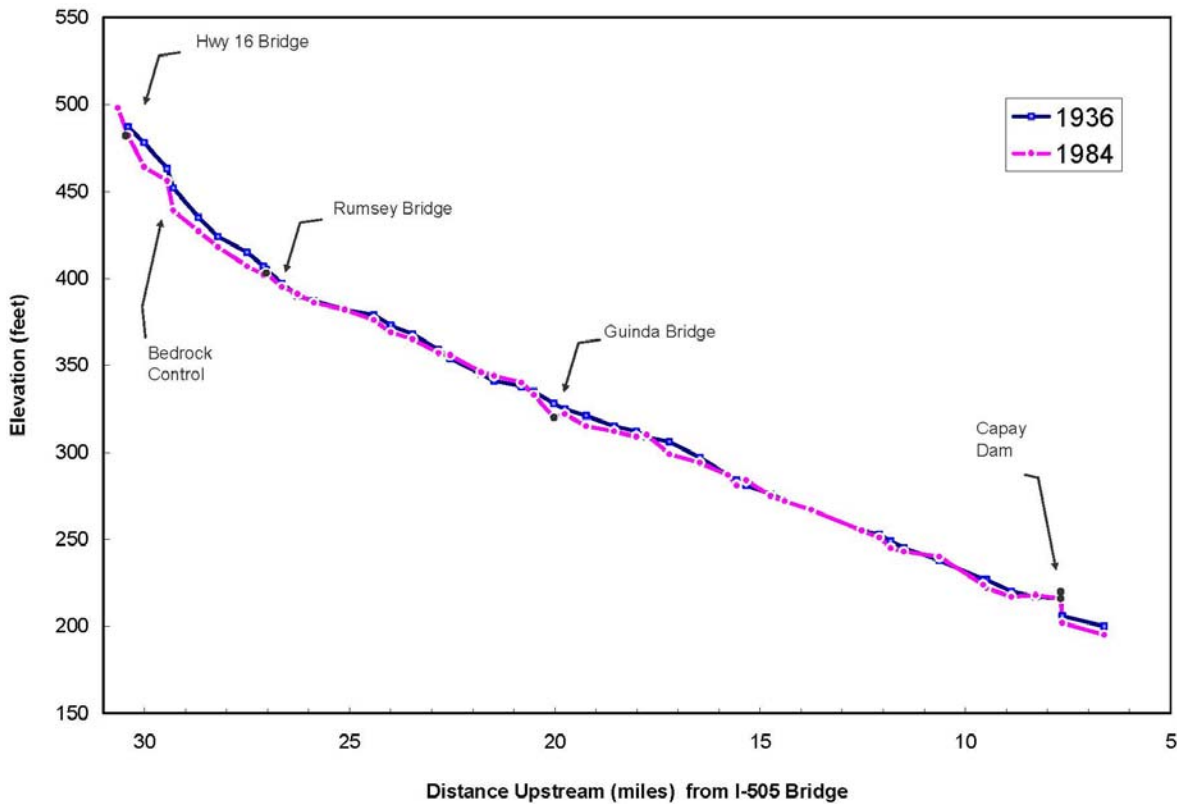
Figure 8: Longitudinal profiles from 1935 and 1983 (from Kamman, 2010)

The channel sections available at the bridge for 1964 and 2001 do not indicate significant channel bed degradation as shown in Figure 7. In addition, a recent geomorphology report for the region (Kamman, 2010) that compared surveys by the USGS in 1935 to 1983 surveys by Simons Li and Associates found no significant changes at the Rumsey Bridge as shown in Figure 8.

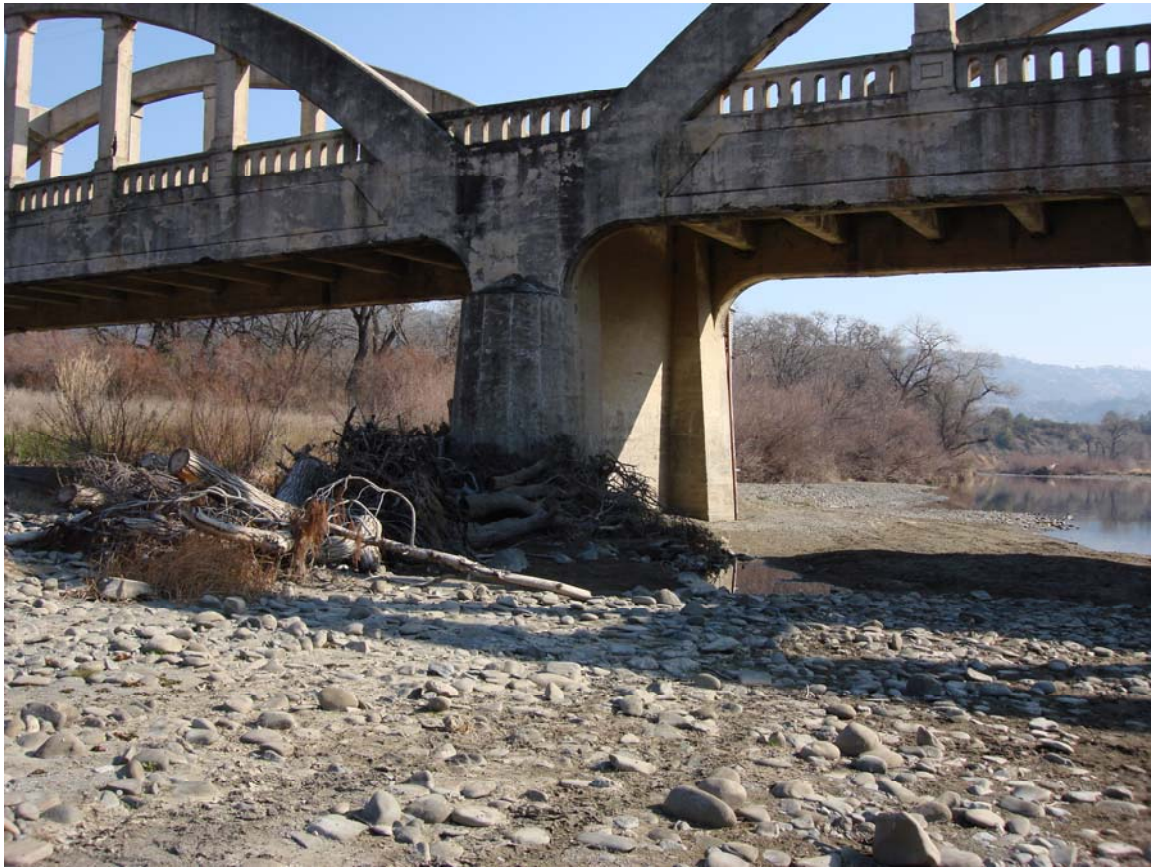
*Figure 9: Debris buildup at Pier 2 (from 2007 field review)*
