# 2017 TECHNICAL STUDIES AND 20-YEAR RETROSPECTIVE FOR THE CACHE CREEK AREA PLAN

Yolo County Administrator's Office  
625 Court Street  
Woodland, CA 95695

March 17, 2017

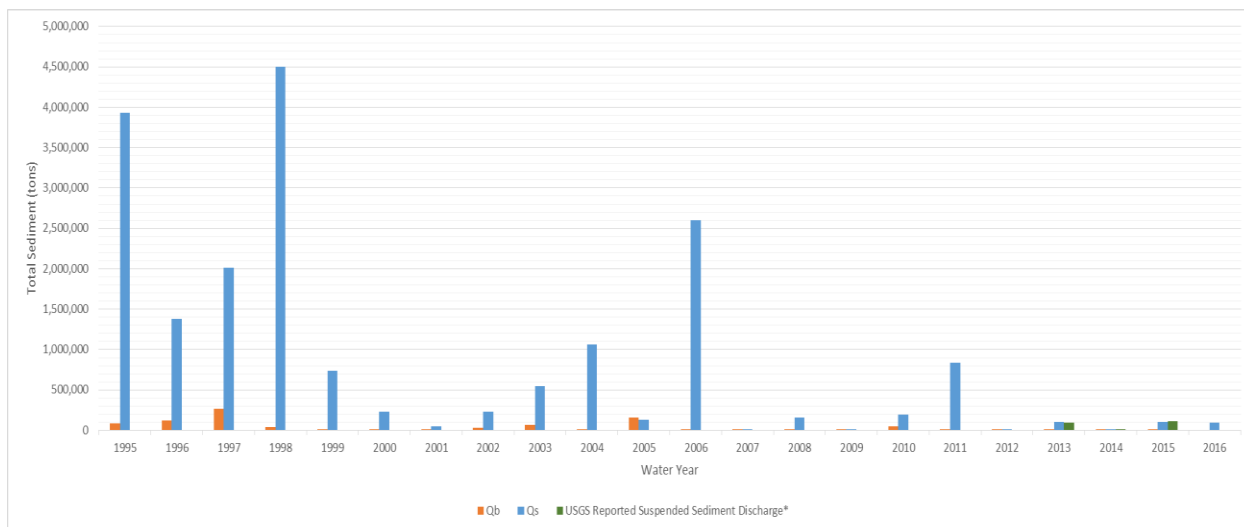
Figure 1.3 shows total sediment transport through the CCRMP area between Water Year 1995 and Water Year 2016 calculated using a regression equation based on suspended sediment measurements at the USGS Yolo flow gage. It is clear that the majority of sediment transport occurred in the late 1990s, with very low sediment transport over the last sixteen years. This is important because the majority of sediment delivered to Cache Creek over the last twenty years occurred immediately before or immediately after in-channel mining ceased. Over eighteen million tons of sediment was transported during this period, with a peak annual transport of 4.5 million tons and an average annual transport of 860,000 tons.

FIGURE 1.3: ESTIMATED SUSPENDED (QS) AND BEDLOAD (QB) SEDIMENT TRANSPORT IN THE CCRMP AREA WITH USGS MEASURED SEDIMENT TRANSPORT WHEN AVAILABLE.

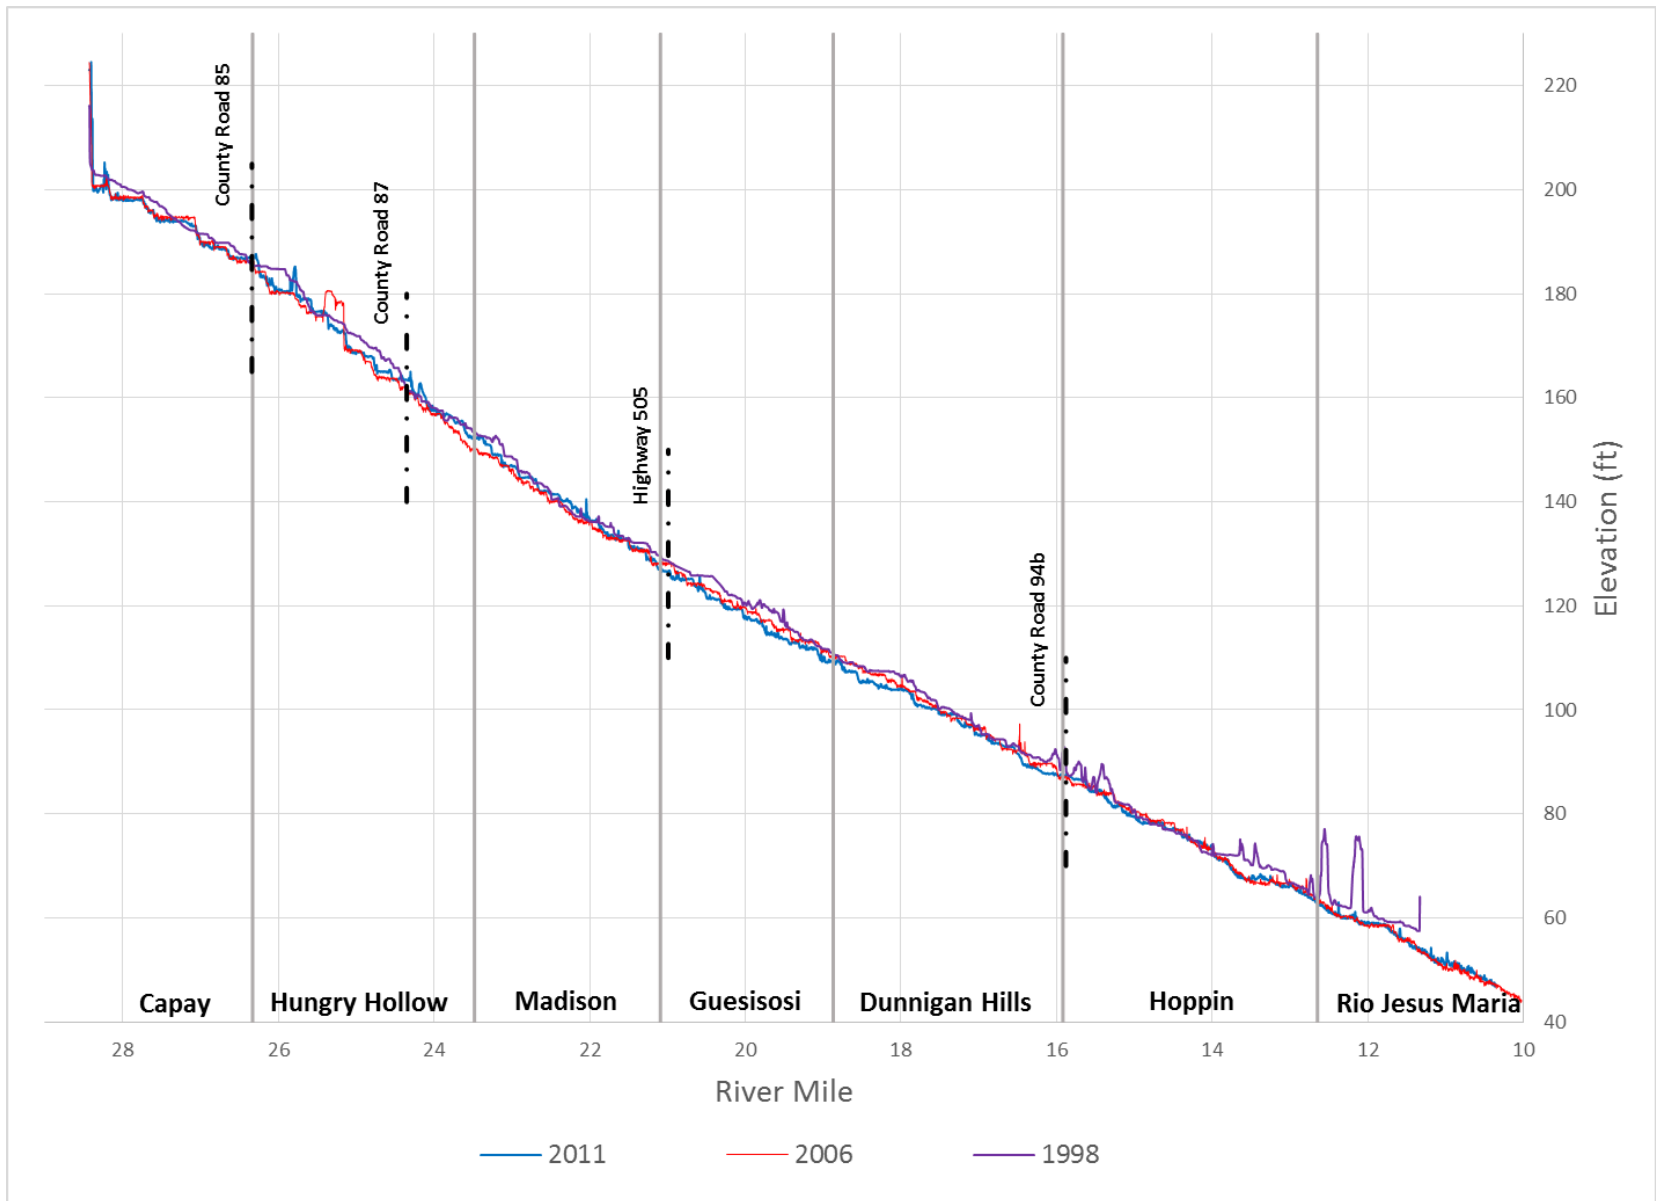
Figure 1.4 shows channel thalweg elevation profiles for the entire CCRMP area in 1998, 2006, and 2011. The trend of elevation change over this time period is not consistent across all CCRMP reaches. Over long distances the channel thalweg elevation has remained about the same since 1998. However, there are areas where the channel thalweg elevation has increased or decreased significantly since 1998. This indicates that the significant sediment deposition throughout the CCRMP area is not yet raising the base channel elevation in Cache Creek. Rather, the deposition is occurring in a spatially distributed way on channel bar features that have increased in size and extent over the past twenty years. This phenomena is discussed in more detail in the reach-specific results that follow.

FIGURE 1.4: CHANNEL THALWEG PROFILES IN THE CCRMP AREA IN 1998, 2006, AND 2011.

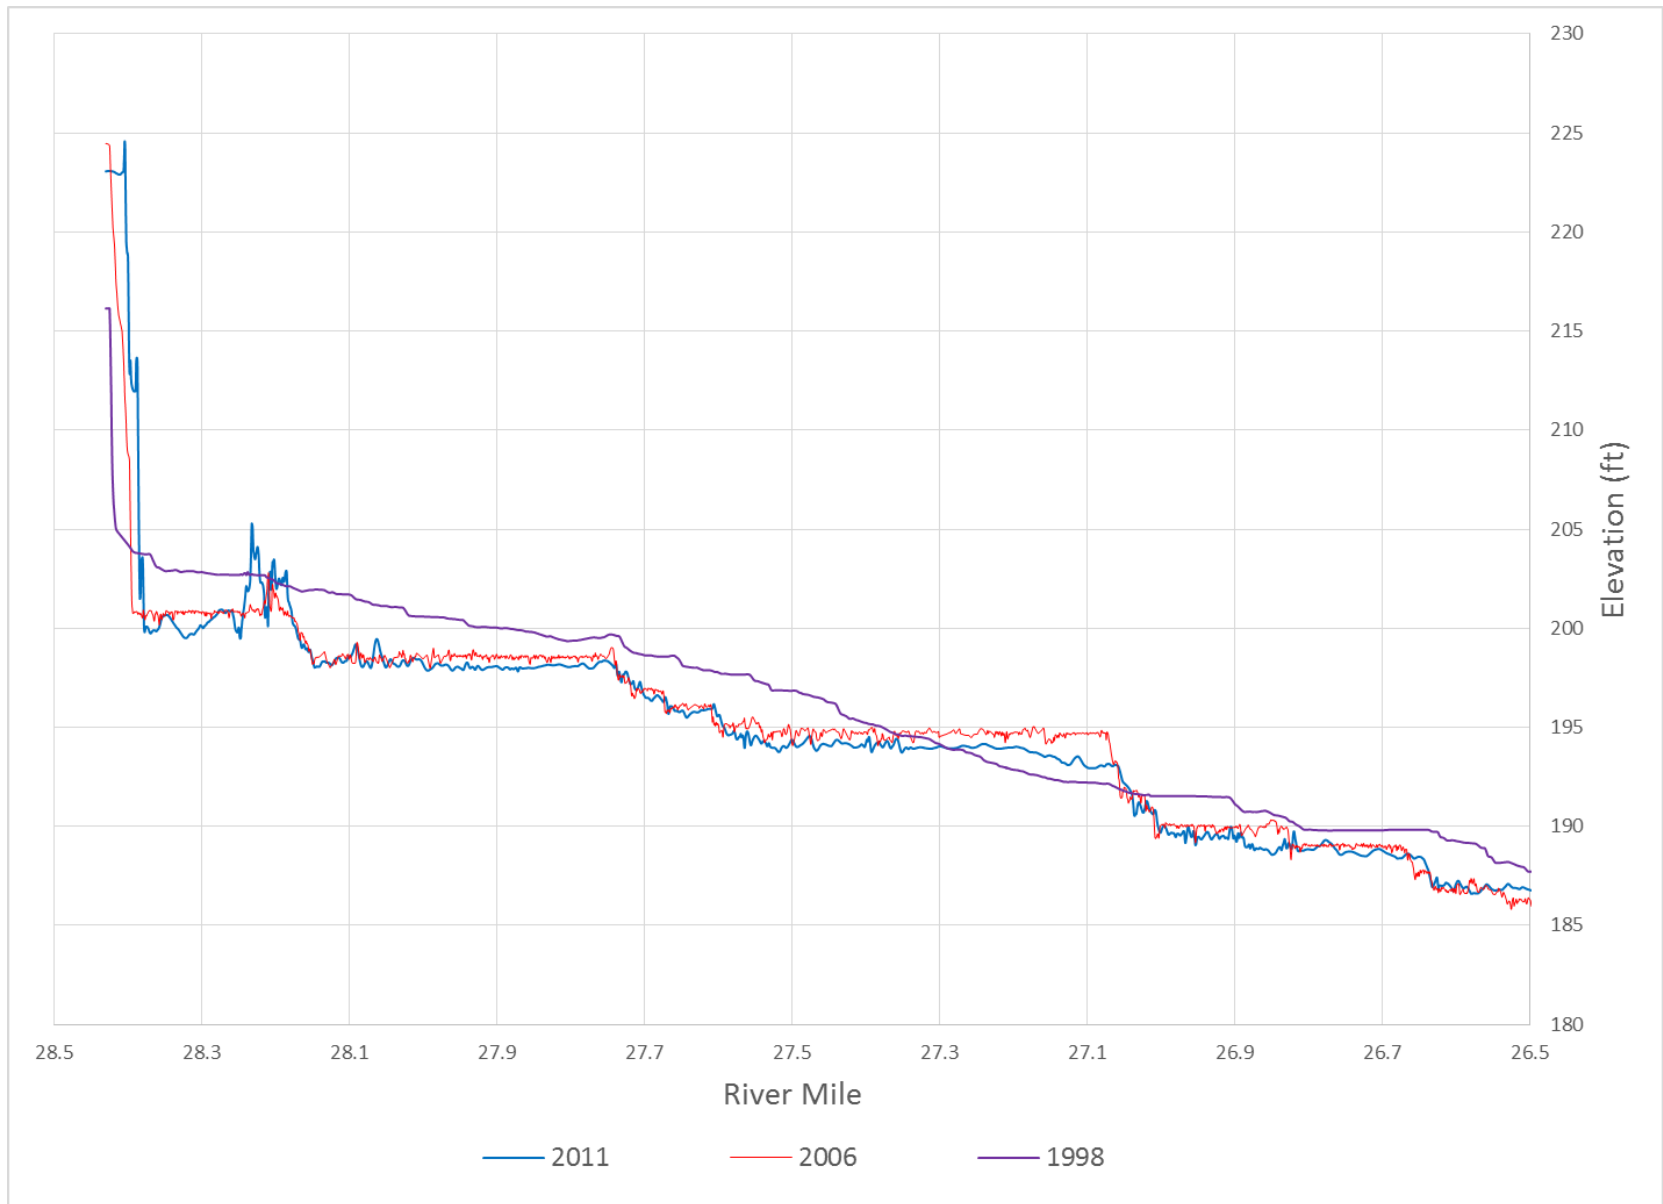
The Capay Reach channel has been mostly stable laterally since 1996, with minimal lateral migration occurring only near the downstream end of the reach during peak flows exceeding 30,000 cfs. This reach has experienced approximately 424,000 tons of net deposition between 1996 and 2011, with small volumes (tens of thousands of tons) of inter-annual erosion. Figure 1.5 is a channel migration map showing the location of the active channel as it migrated between 1996 and 2015. The only area of significant channel migration is the large left bank channel bar near the downstream end of the reach. Most of the net deposition on this reach occurred on this bar. Figure 1.6 is a map of the deposition and erosion that has occurred throughout this reach, and Figure 1.7 is a plot of the channel thalweg profile in 1998, 2006, and 2011. While the thalweg elevation has decreased in the upstream half of the reach and both increases and decreases in the downstream half of the reach, the deposition and erosion maps shows mostly areas of relatively minor deposition, with the only significant erosion adjacent to the significant deposition of the bar feature at the downstream end of the reach that has pushed the primary active channel to the south.

FIGURE 1.5: ACTIVE CHANNEL LOCATIONS IN THE CAPAY REACH IN 1996, 1998, 2005, 2006, 2011, AND 2015.

FIGURE 1.6: AREAS OF EROSION (REDS) AND DEPOSITION (GREENS) BETWEEN 1996 AND 2011.

FIGURE 1.7: APPROXIMATE CHANNEL THALWEG ELEVATION PROFILES IN THE CAPAY REACH IN 1998, 2006, AND 2011.

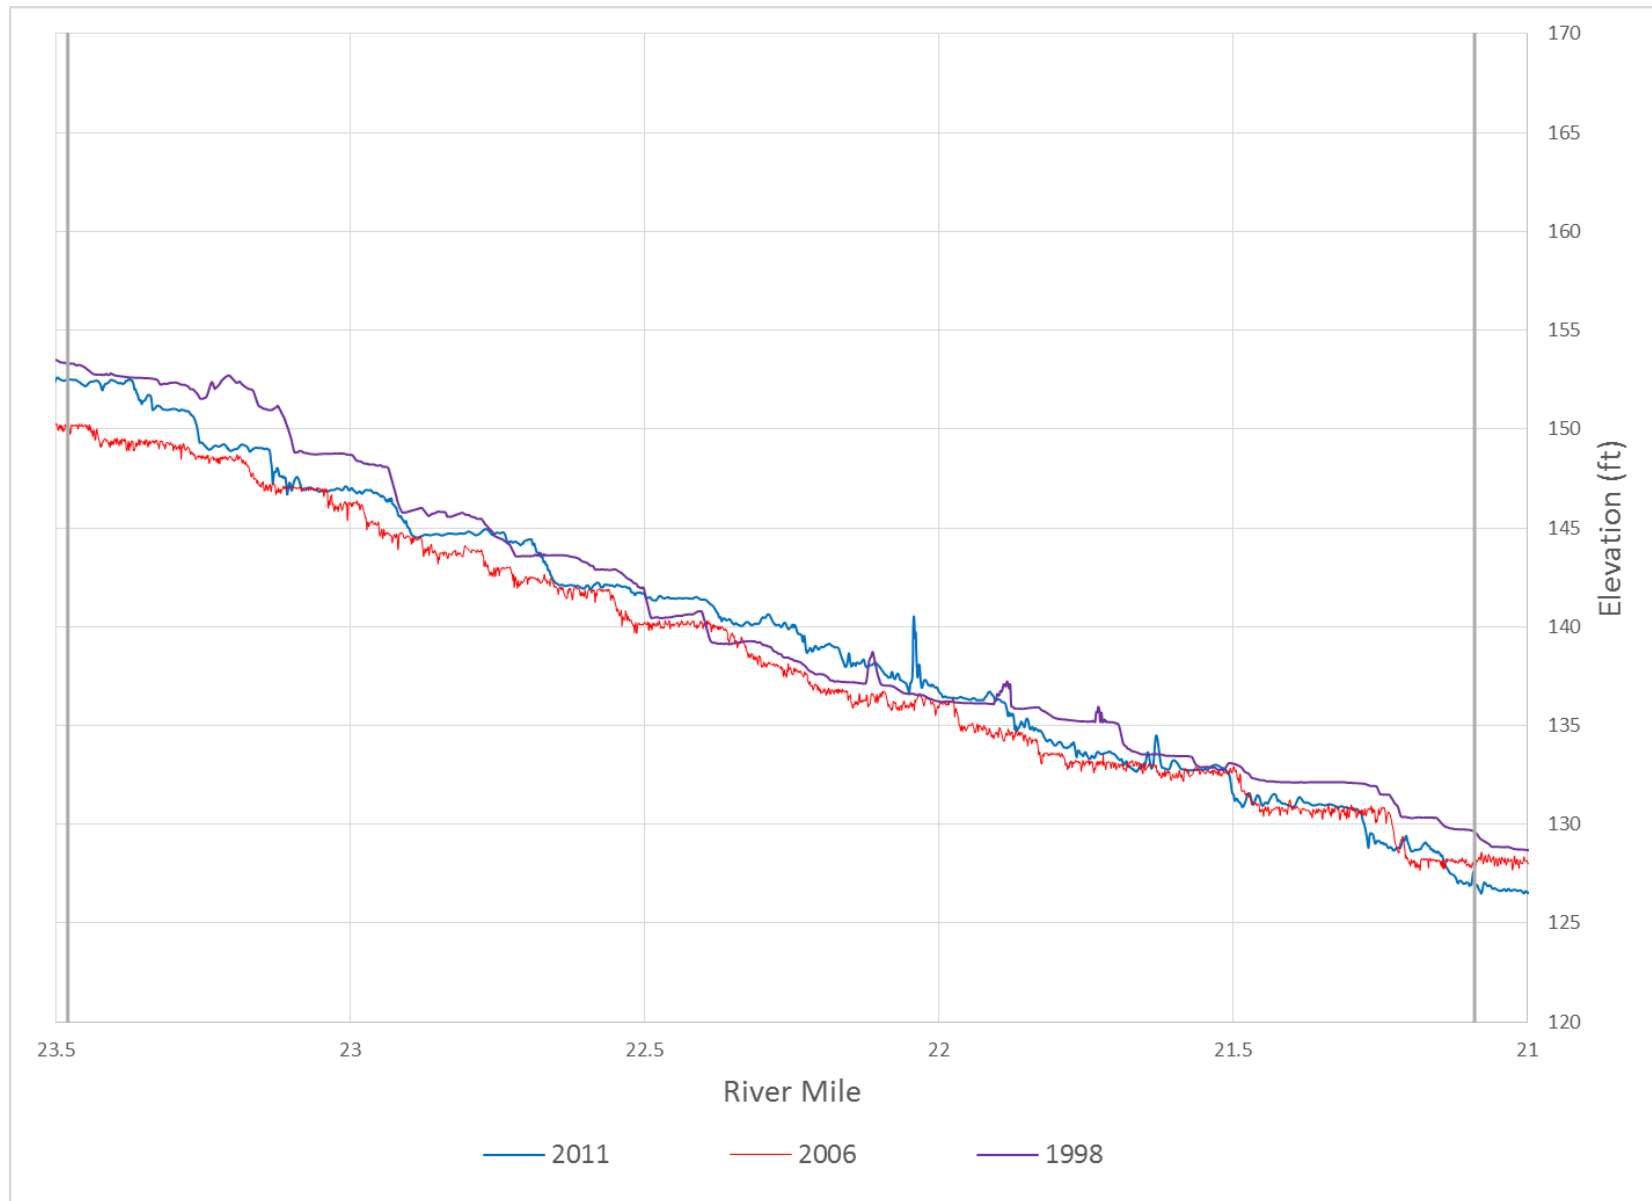
The Madison reach channel is dynamic, with moderate lateral migration occurring throughout the reach during peak flows as low as 15,000 cfs. This reach has experienced approximately 1.9 million tons of net deposition between 1996 and 2011, with smaller volumes (hundreds of thousands of tons) of inter-annual deposition and erosion. Figure 1.11 is a channel migration map showing extensive migration in the upstream half of the reach between 1996 and 2015, and more limited migration in the downstream half of the reach that has progressed into and through the Test 3 Boundary. As in the Hungry Hollow Reach, channel migration has been accompanied by significant sediment bar deposition, primarily in the upstream half of the reach. Figure 1.12 is a map of the deposition and erosion that has occurred throughout this reach, and Figure 1.13 is a plot of the channel thalweg profile in 1998, 2006, and 2011. The thalweg elevation has mostly increased in the upstream half of the reach, and mostly decreased in the downstream half of the reach. The large volume of deposition in this reach may be increasing the base elevation of the channel thalweg in the upstream half of the reach, but not in the downstream half of the reach. Therefore, deposition in this reach appears to be occurring both in the active channel and on channel bars.

FIGURE 1.11: ACTIVE CHANNEL LOCATIONS IN THE MADISON REACH IN 1996, 1998, 2005, 2006, 2011, AND 2015.

FIGURE 1.12: AREAS OF EROSION (REDS) AND DEPOSITION (GREENS) BETWEEN 1996 AND 2011.

FIGURE 1.13: APPROXIMATE CHANNEL THALWEG ELEVATION PROFILES IN THE MADISON REACH IN 1998, 2006, AND 2011.

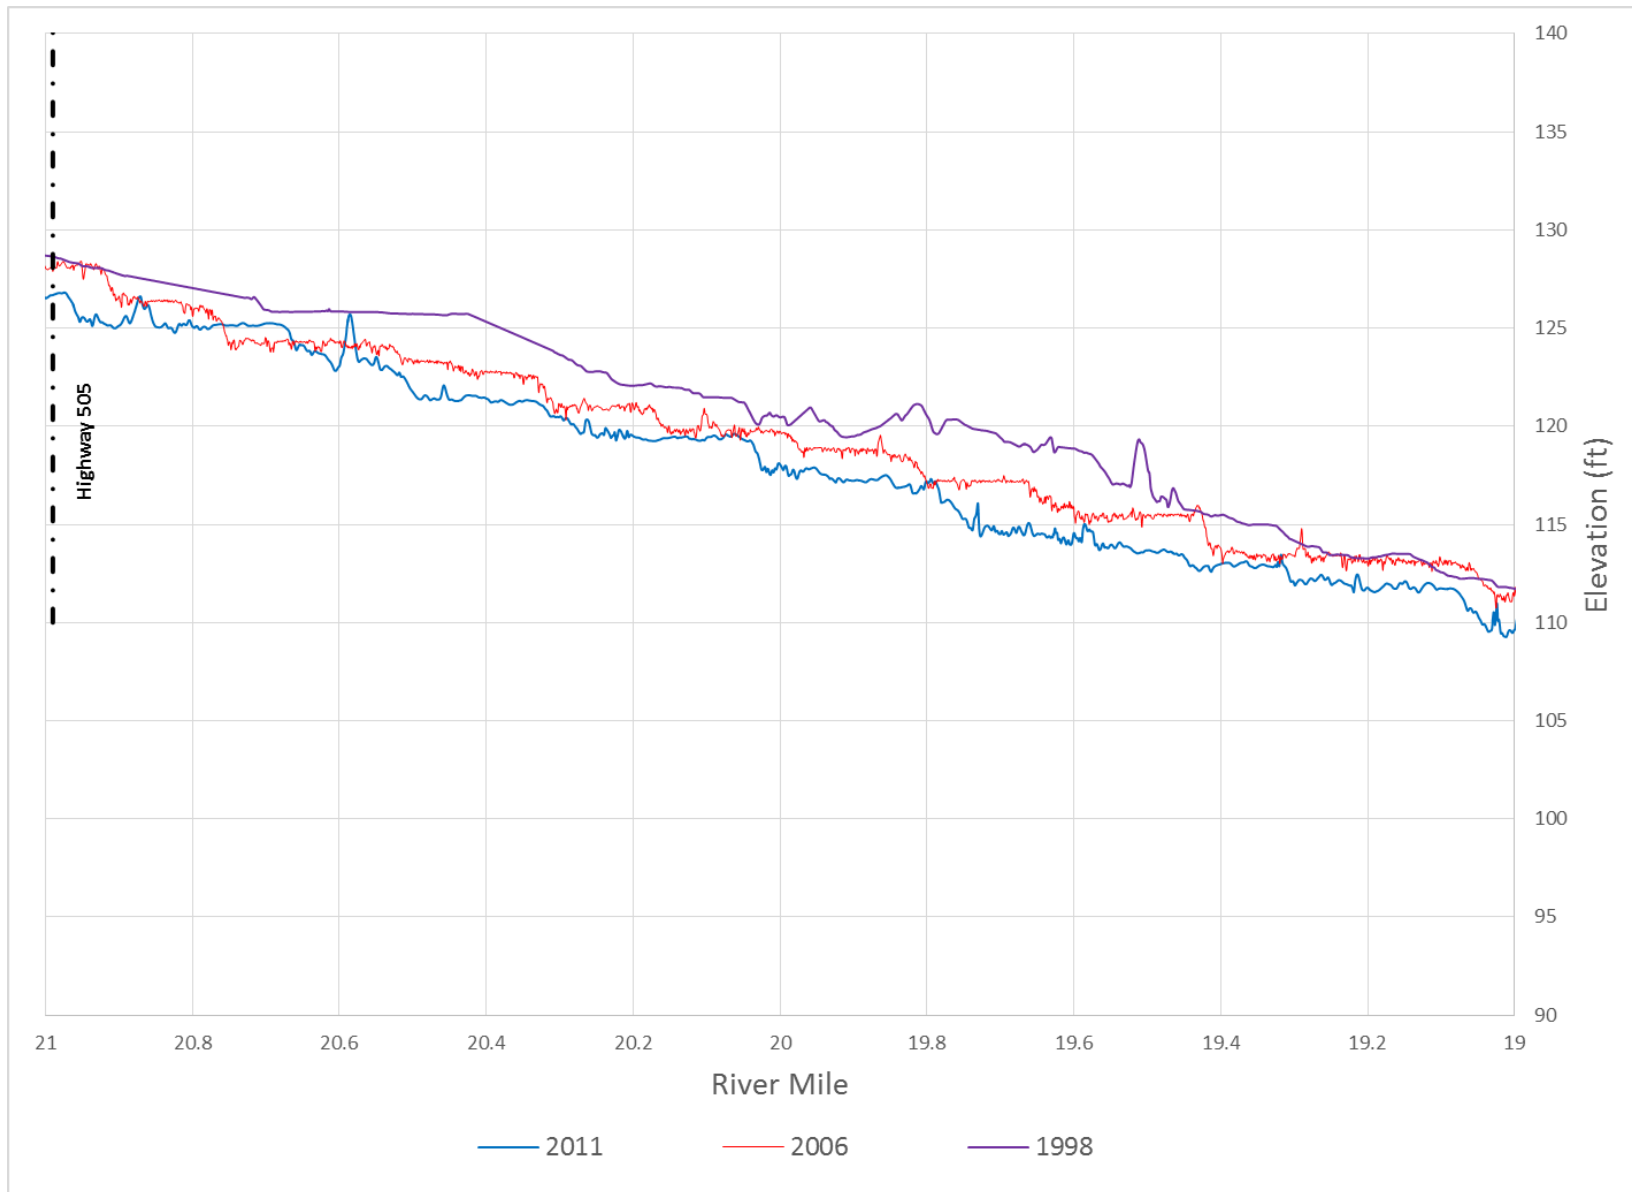
The Guesisosi reach channel is partly dynamic, with moderate lateral migration occurring in the upstream third of the reach during peak flows as low as 15,000 cfs. This reach has experienced approximately 789,000 tons of net deposition between 1996 and 2011, with smaller volumes (tens of thousands of tons) of inter-annual deposition and erosion. Figure 1.14 is a channel migration map showing how the channel becomes much more laterally constrained in this reach, with the only significant migration occurring in the upstream third of the reach. There is very limited room for bar formation in the middle of this reach. However, significant bar formation has occurred at the upstream and downstream ends of the reach. Figure 1.15 is a map of the deposition and erosion that has occurred throughout this reach, and Figure 1.16 is a plot of the channel thalweg profile in 1998, 2006, and 2011 showing consistent lowering throughout the reach. The deposition in this reach is not increasing the base elevation of the active channel and is therefore occurring almost exclusively on the bars at the upstream and downstream ends of the reach. The lateral confinement in this reach, combined with the bar deposition that has occurred since 1996, may be causing the decreasing thalweg elevation trend as high flows become increasingly confined to the active channel and the increased shear stresses from these flows erode channel bed sediments and transport them downstream. The active channel beneath the Highway 505 bridge has lowered several feet since 1997 and should continue to be carefully monitored for signs of additional channel degradation.

FIGURE 1.14: ACTIVE CHANNEL LOCATIONS IN THE GUESISOSI REACH IN 1996, 1998, 2005, 2006, 2011, AND 2015.

FIGURE 1.15: AREAS OF EROSION (REDS) AND DEPOSITION (GREENS) BETWEEN 1996 AND 2011.

FIGURE 1.16: APPROXIMATE CHANNEL THALWEG ELEVATION PROFILES IN THE GUESISOSI REACH IN 1998, 2006, AND 2011.

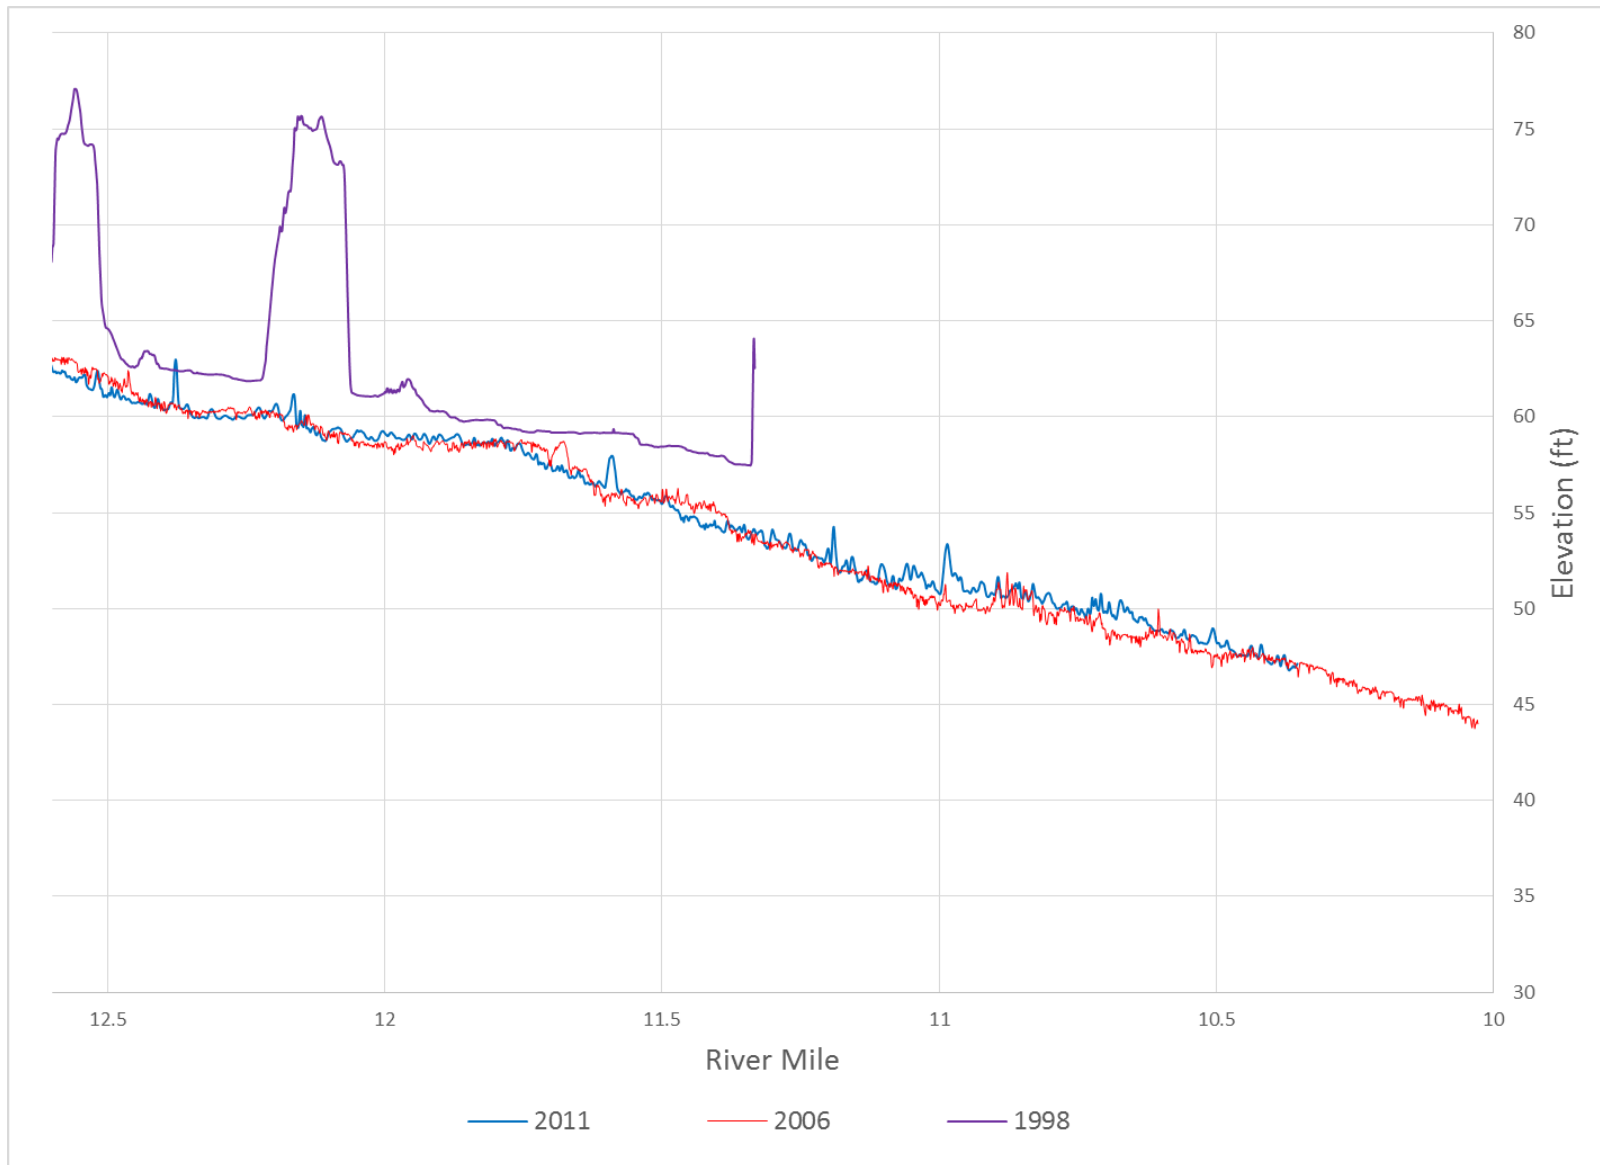
The Rio Jesus Maria reach is quite stable laterally, with minimal migration after peak flows exceeding 30,000 cfs. This reach has experienced approximately 282,000 tons of net deposition between 1996 and 2011, with small volumes (tens of thousands of tons) of interannual erosion. Figure 1.23 is a channel migration map showing how this reach is the most laterally confined of all the geomorphic reaches in the CCRMP area, with almost no lateral channel migration occurring between 1996 and 2015. Figure 1.24 is a plot of the channel thalweg profile showing how the thalweg elevation has remained relatively stable throughout the reach between 2006 and 2011. Topographic data from 1998 was not available for most of this reach. Deposition in this reach between 2006 and 2011 has been relatively limited, and it appears that it could be occurring in the active channel, as the base thalweg elevation has increased in many locations and has not decreased significantly elsewhere in the reach.

FIGURE 1.23: ACTIVE CHANNEL LOCATIONS IN THE RIO JESUS MARIA REACH IN 1996, 1998, 2005, 2006, 2011, AND 2015.

FIGURE 1.24: APPROXIMATE CHANNEL THALWEG ELEVATION PROFILES IN THE RIO JESUS MARIA REACH IN 1998, 2006, AND 2011.

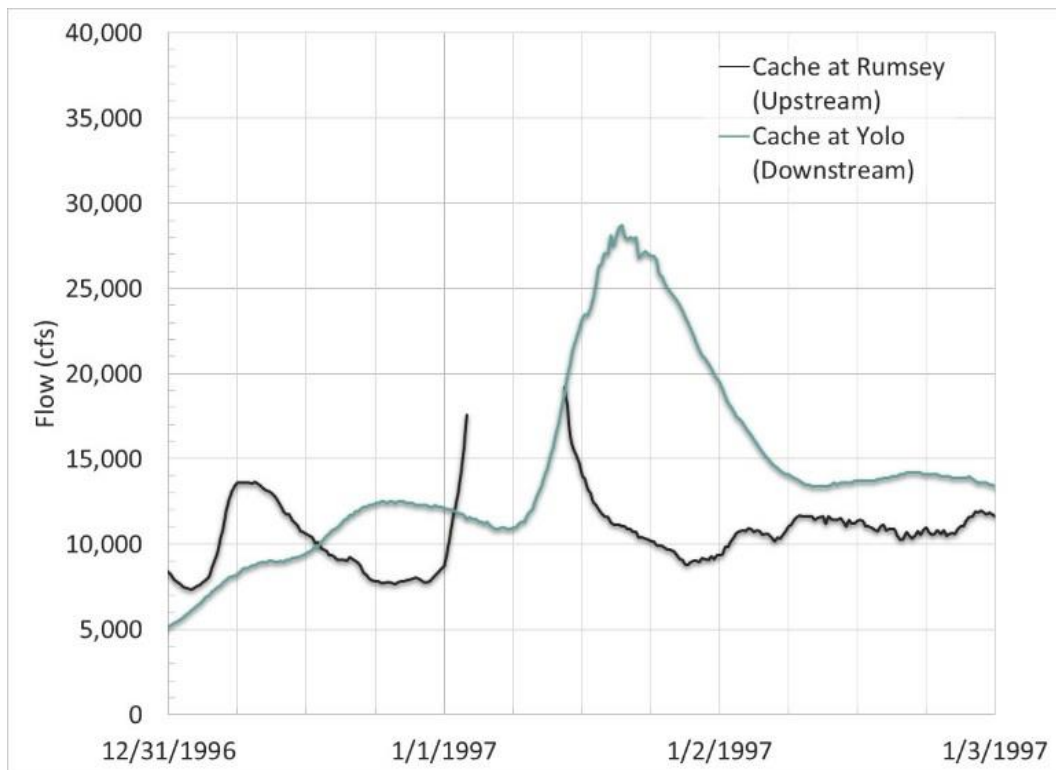
The 1997 event peaked at 28,700 cfs on January 1, 1997 and lasted for approximately one day according to the Yolo gage (Figure 2.2). Although the peak flow at the Rumsey gage was not reported for this day, the rising and falling limbs indicate that the peak was likely greater and the duration shorter as compared to the downstream Yolo gage.

FIGURE 2.2: CACHE CREEK HYDROGRAPH AT RUMSEY AND YOLO, JANUARY 1997.

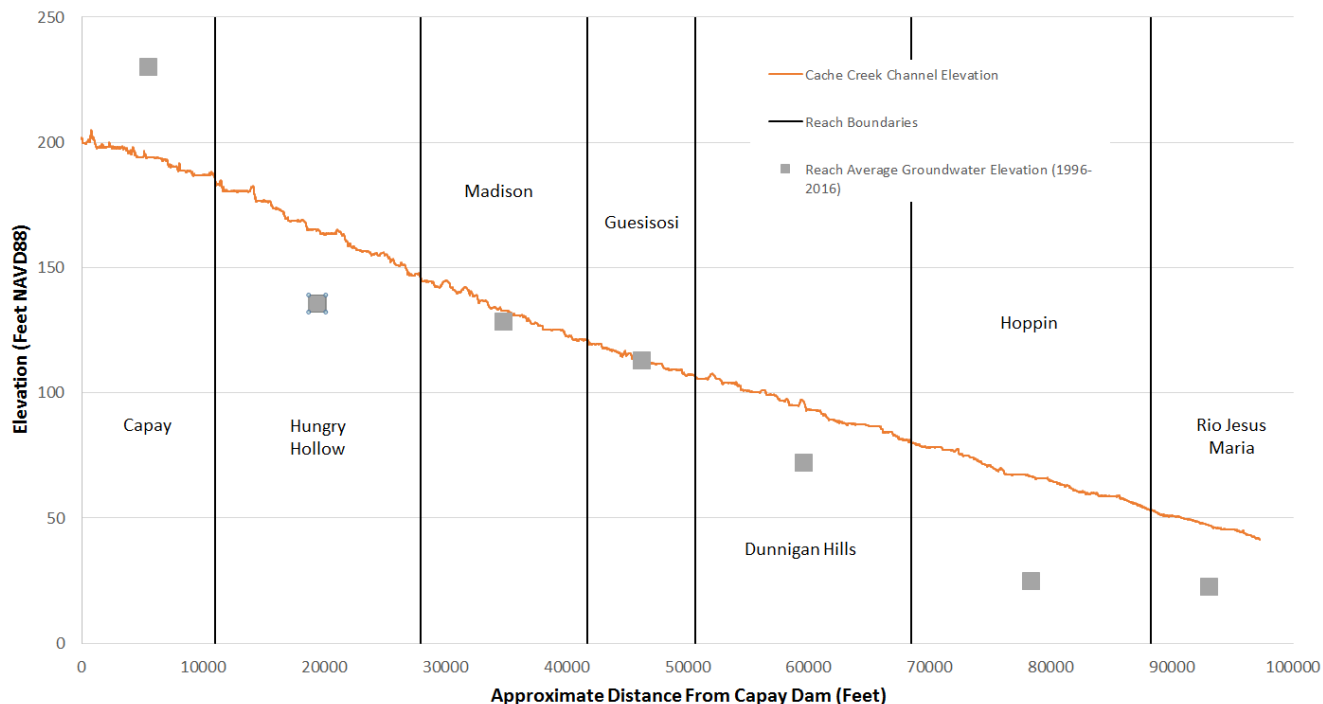
FIGURE 2.7: COMPARISON OF REACH AVERAGE GROUNDWATER ELEVATIONS (1996-2016) VS CACHE CREEK CHANNEL BED ELEVATION.

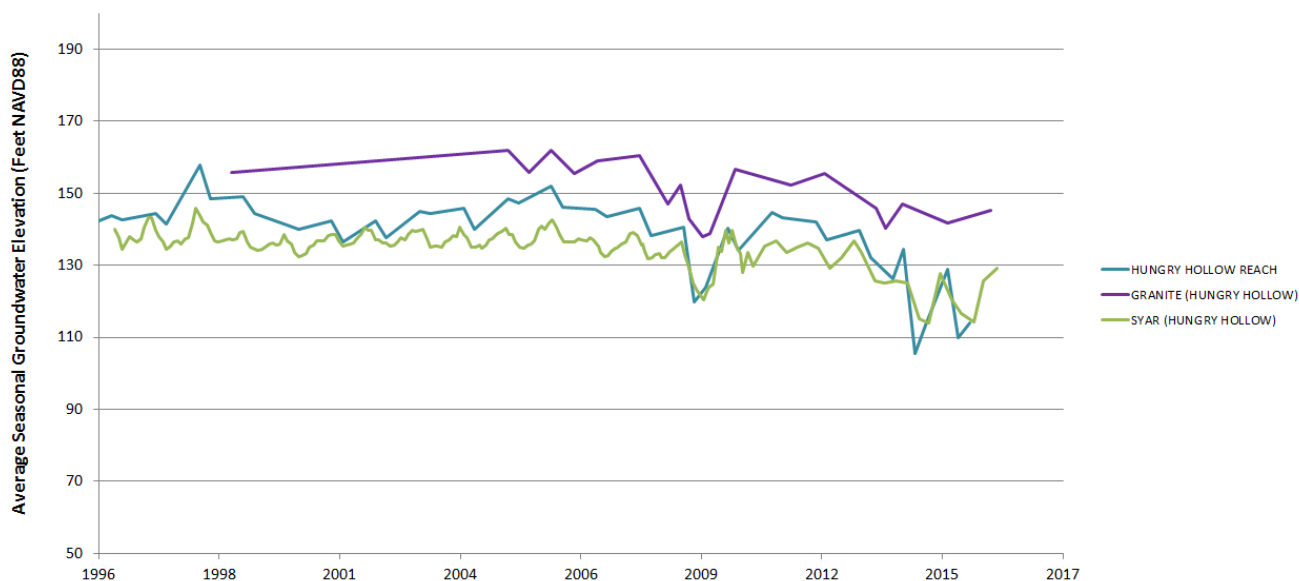
the most downstream end of the reach, and therefore its groundwater levels are slightly lower than the average levels for the reach. Both mining plant’s groundwater data generally follow the annual and seasonal patterns of the CASGEM wells, however.

FIGURE 2.8: COMPARISON OF GRANITE AND SYAR GROUNDWATER MONITORING DATA AGAINST HUNGRY HOLLOW REACH AVERAGES, (1996-2016).

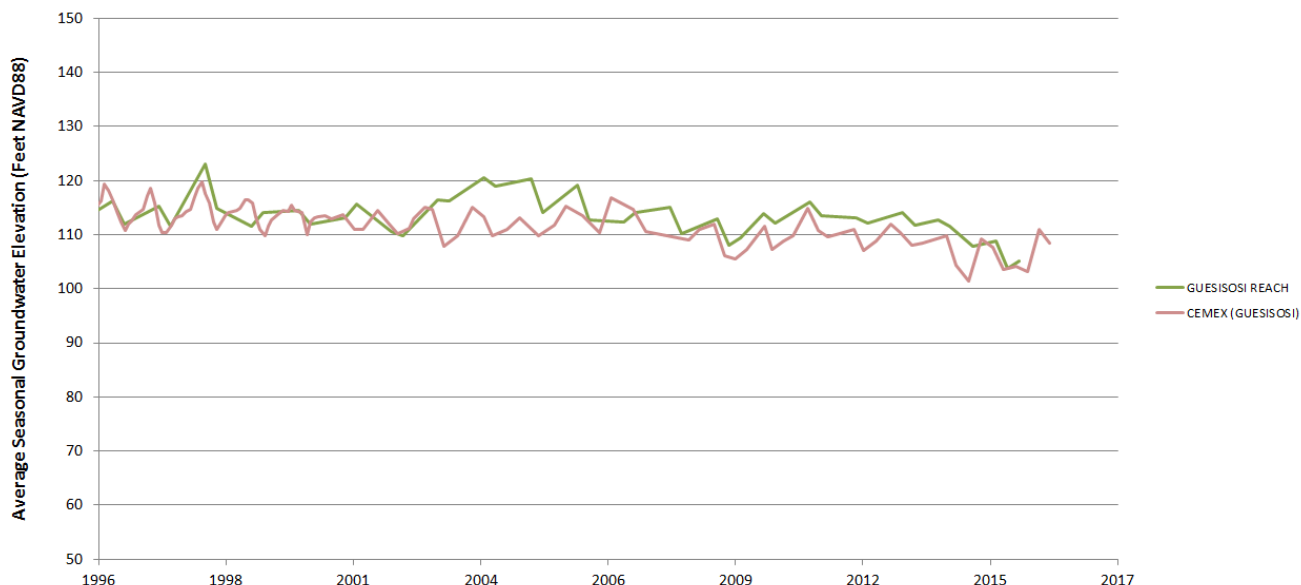
Cemex currently performs off-channel mining in the Guesisosi Reach, and Figure 2.10 shows their groundwater elevation data. The data closely match reach-averaged levels in CASGEM wells.

FIGURE 2.10: COMPARISON OF CEMEX GROUNDWATER MONITORING DATA AGAINST GUESISOSI REACH AVERAGES, (1996-2016).

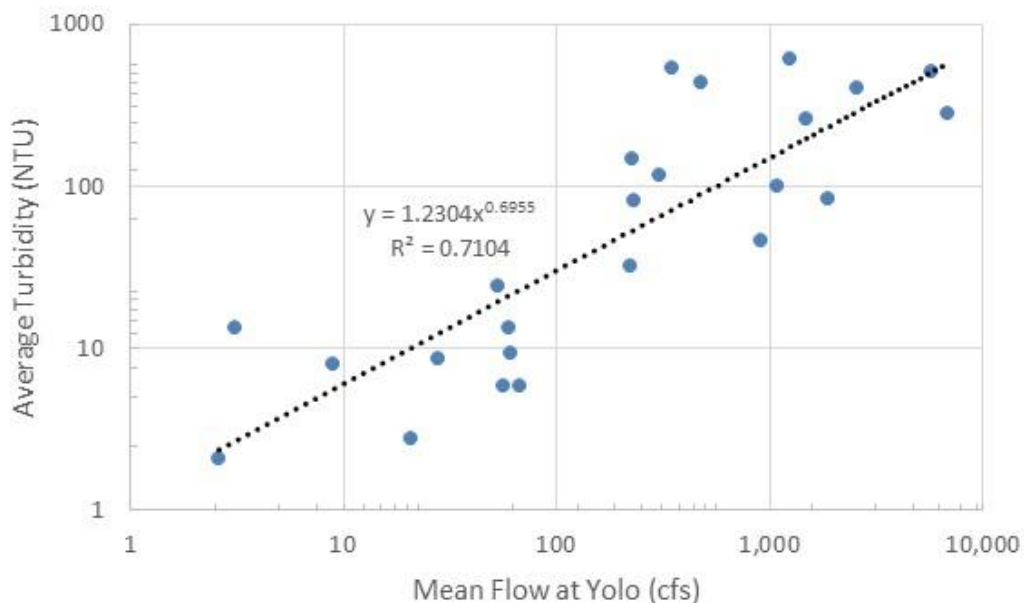
FIGURE 2.13: CORRELATION BETWEEN TURBIDITY AND MEAN DAILY FLOW.

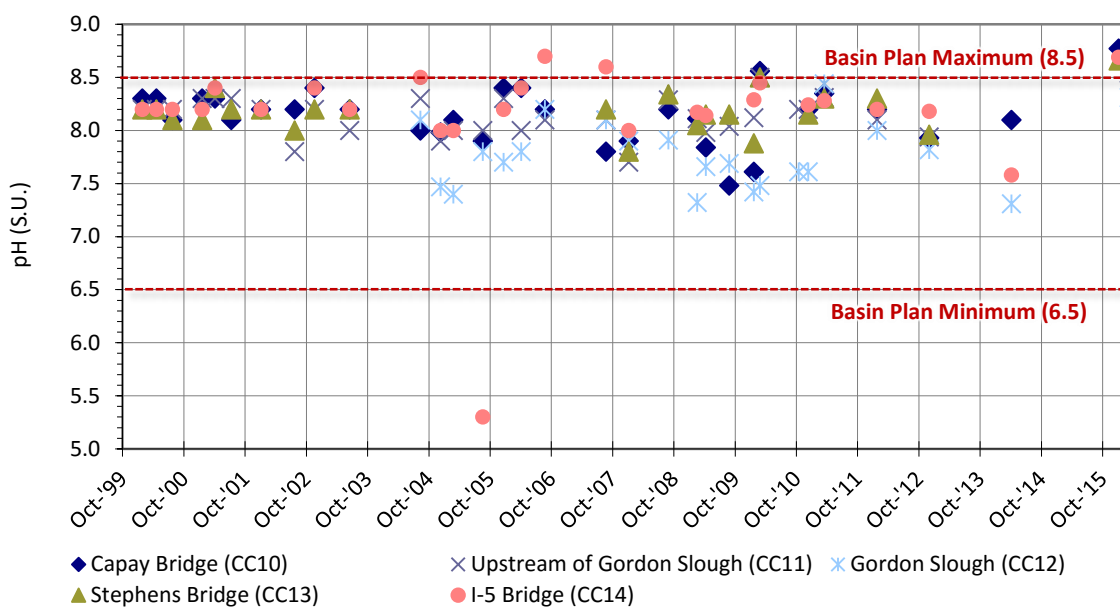
FIGURE 2.17: CACHE CREEK PH (WATER YEARS 2000–2016).

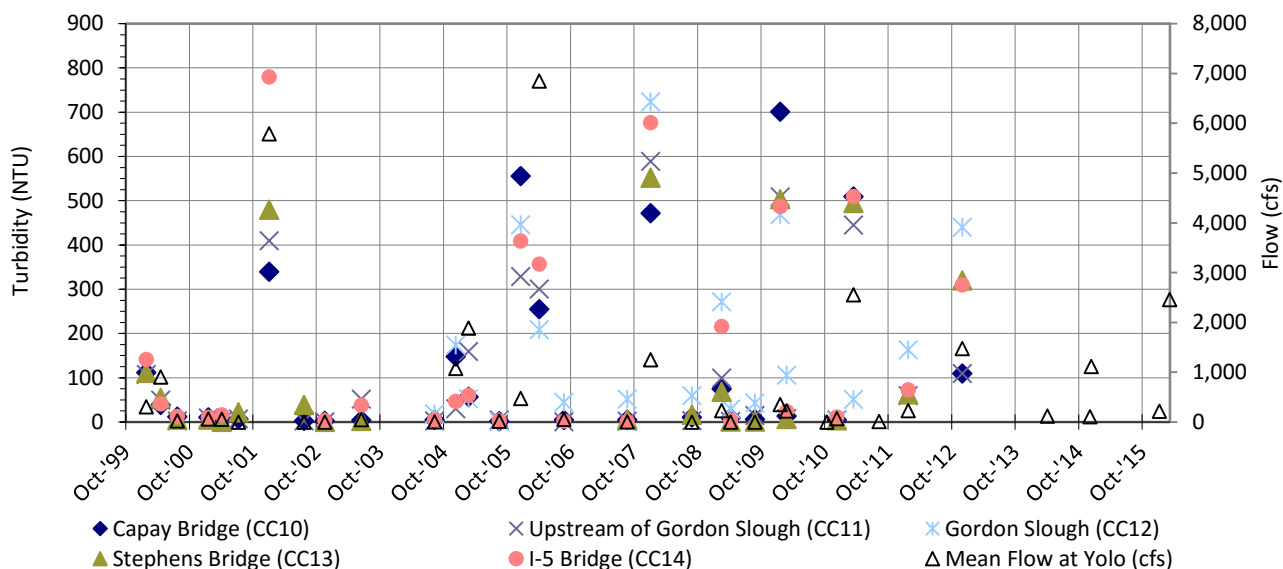
FIGURE 2.21: CACHE CREEK TURBIDITY (WATER YEARS 2000–2016).

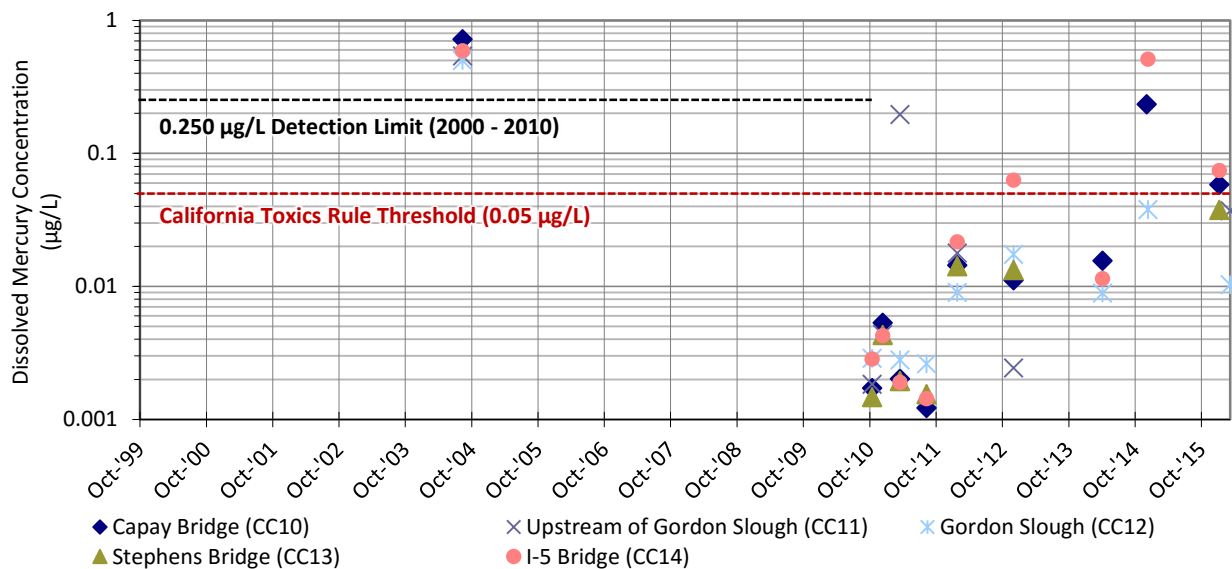
FIGURE 2.26: CACHE CREEK DISSOLVED MERCURY (WATER YEARS 2000–2016).

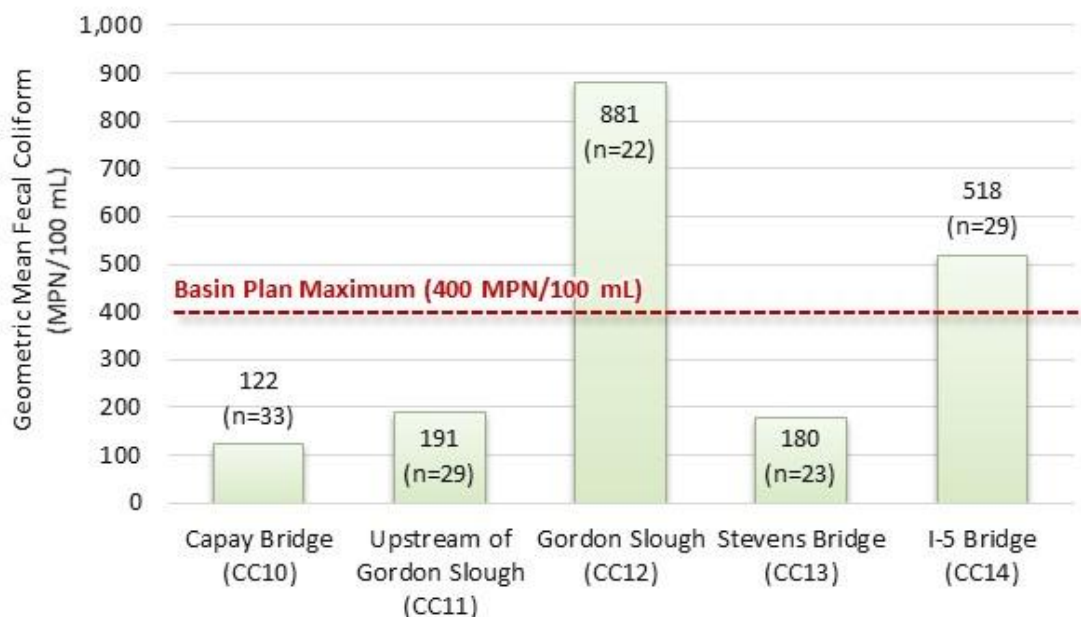
FIGURE 2.30: CACHE CREEK GEOMETRIC MEAN OF FECAL COLIFORM BY SAMPLE LOCATION.

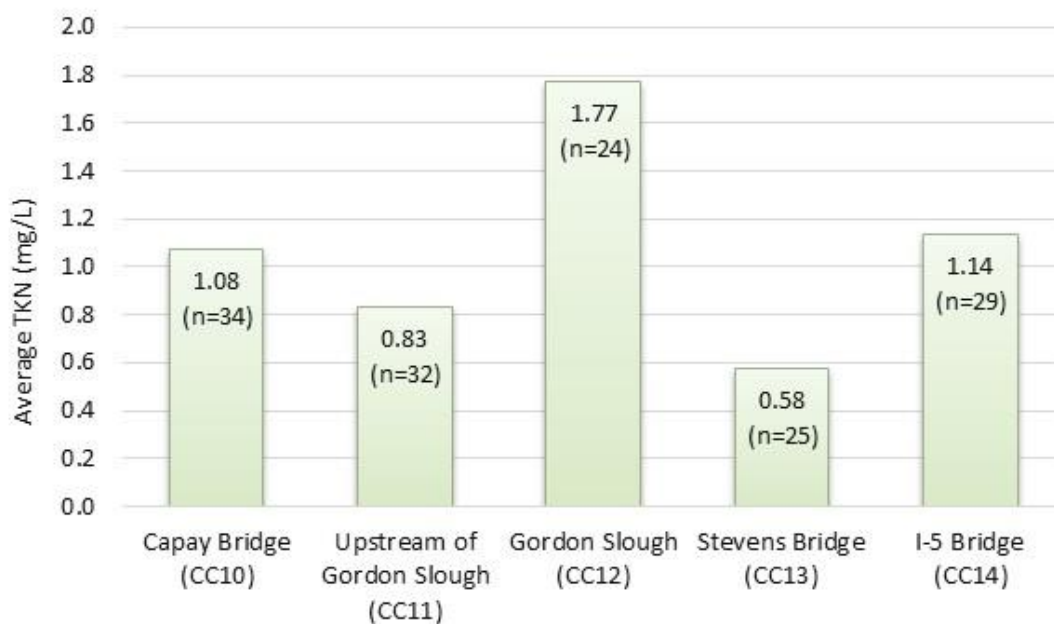
FIGURE 2.34: CACHE CREEK AVERAGE TOTAL KJELDAHL NITROGEN BY SAMPLE LOCATION.

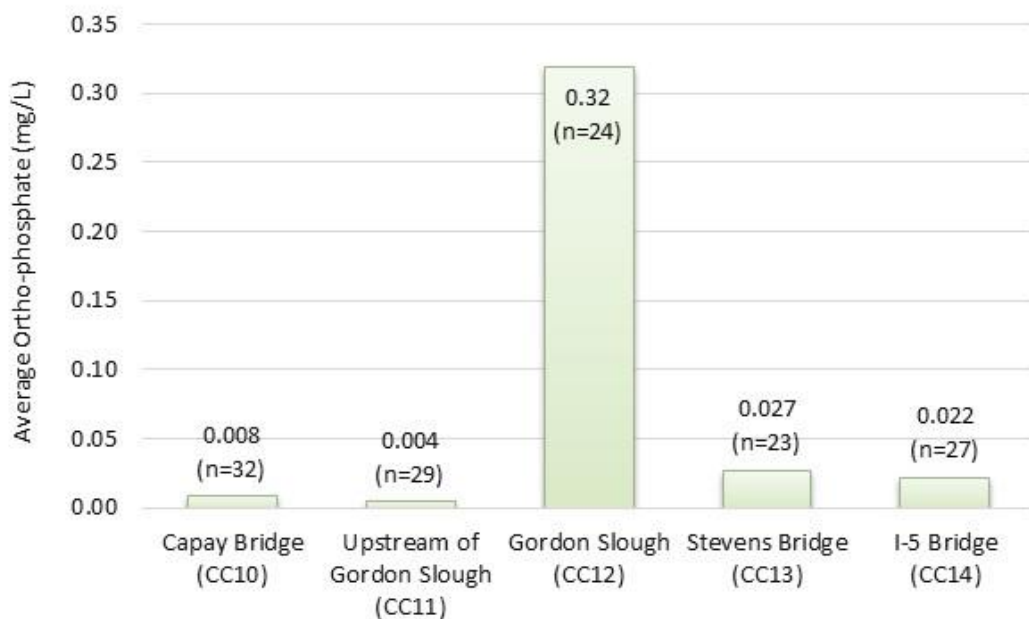
FIGURE 2.39: CACHE CREEK AVERAGE ORTHO-PHOSPHATE BY LOCATION.

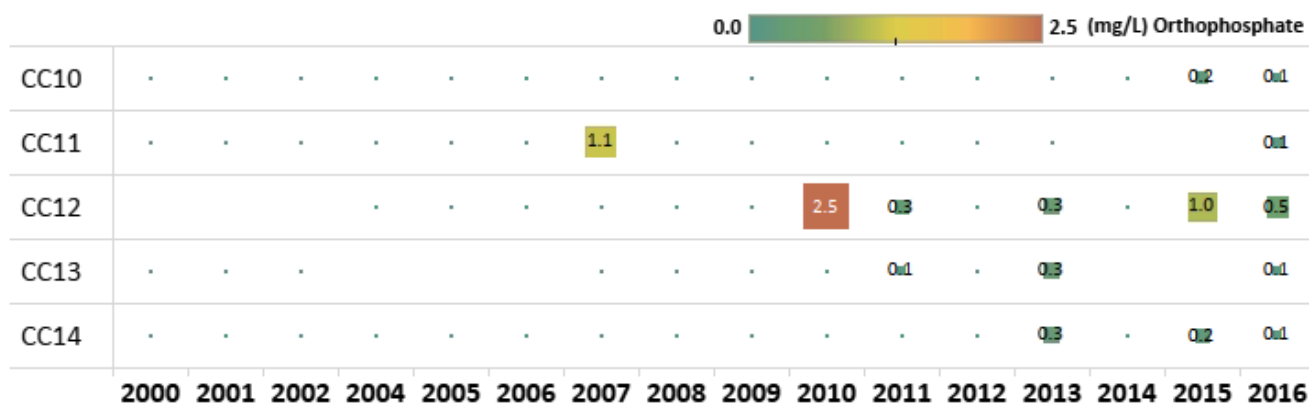
FIGURE 2.40: CACHE CREEK AVERAGE ORTHOPHOSPHATE TRENDS (WATER YEARS 2000–2016).
