NOTICE OF VIOLATION AND REPORT OF RECENT INSPECTION, WILD WINGS WATER RECYCLING FACILITY, YOLO COUNTY

INSPECTION REPORT

28 December 2017

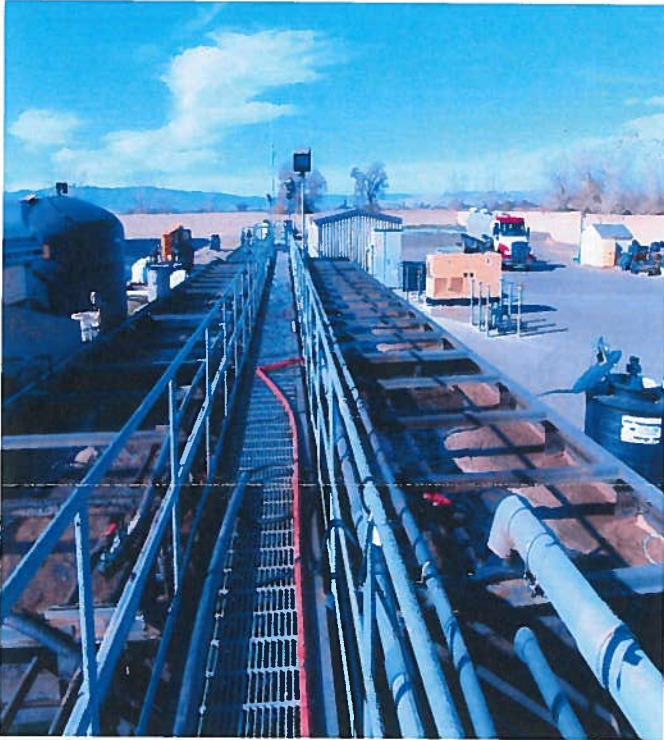
Wastewater was being treated in the aeration basins and secondary clarifiers (Figure 1). The flocculent tank and tertiary filters were bypassed. Sand from the tertiary filters was observed on the ground adjacent to the filters (Figure 2). Secondary treated wastewater was discharging into the recycled water pond. Solids were observed on the liner of the recycled water pond below the effluent discharge pipe. Freeboard in the recycled water pond appeared to be about 15 feet. Engineers assessing the treatment plant explained that a blockage downstream of the clarifiers caused the water levels in the treatment system to rise and allowed excess solids to pass over the clarifier to the tertiary filter system and ultimately into the recycled storage pond.

Figure 1. Package plant.

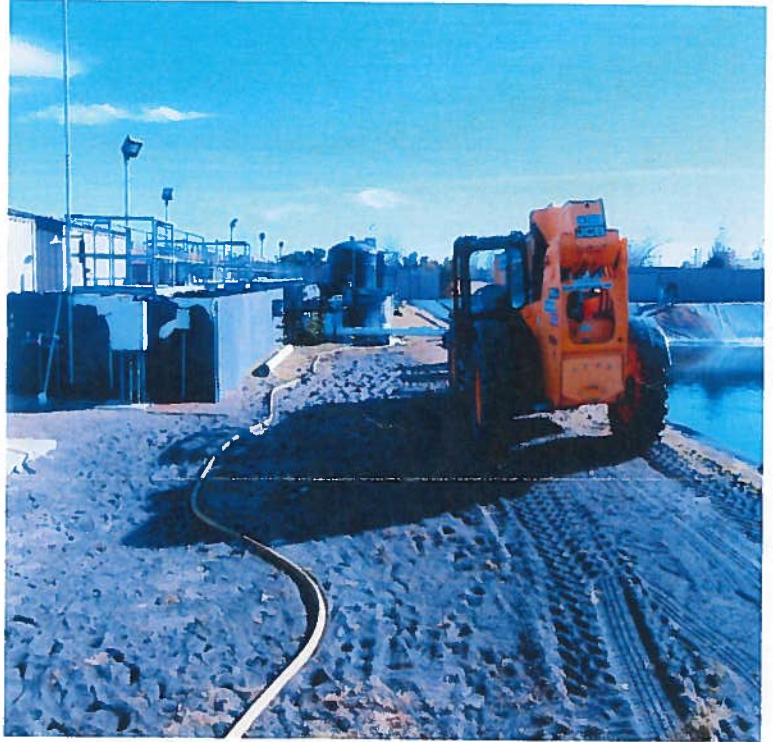
The overflow of wastewater to the storm water basin, the discharge of spent tertiary filter media (sand and anthracite) to the ground surface and the discharge of secondary treated wastewater to the recycled water pond are violations of Discharge Prohibition A.4 of Order R5-2002-0077 which states, "*Bypass or overflow of partially treated waste is prohibited, except as discussed in the Standard Provisions.*"

Figure 2. Tertiary filter sand dispersed to the ground between the filters (left) and the recycled water pond.

Board staff appreciates the County's efforts to promptly assess and correct the operational issues and violations observed at the WWRF. As discussed during the inspection, until the WWRF is operating in compliance with the WDRs and the storage ponds have been cleaned out, leak tested and placed back in service, please continue to submit weekly status reports documenting both completed and outstanding repairs to the WWRF.

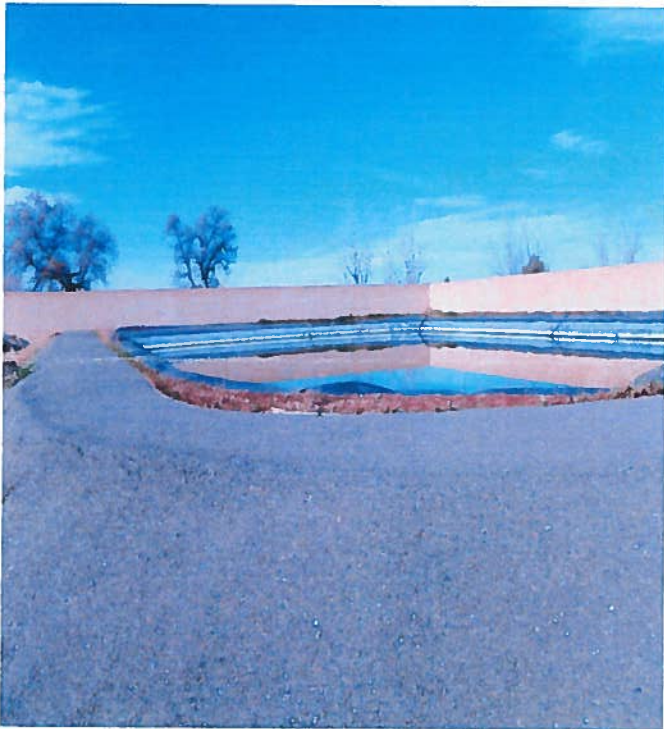
A tanker truck was removing wastewater from the emergency storage pond for off-site disposal. The pond appeared to have approximately 5 feet of freeboard (Figure 3).

Figure 3. Emergency Storage Pond.

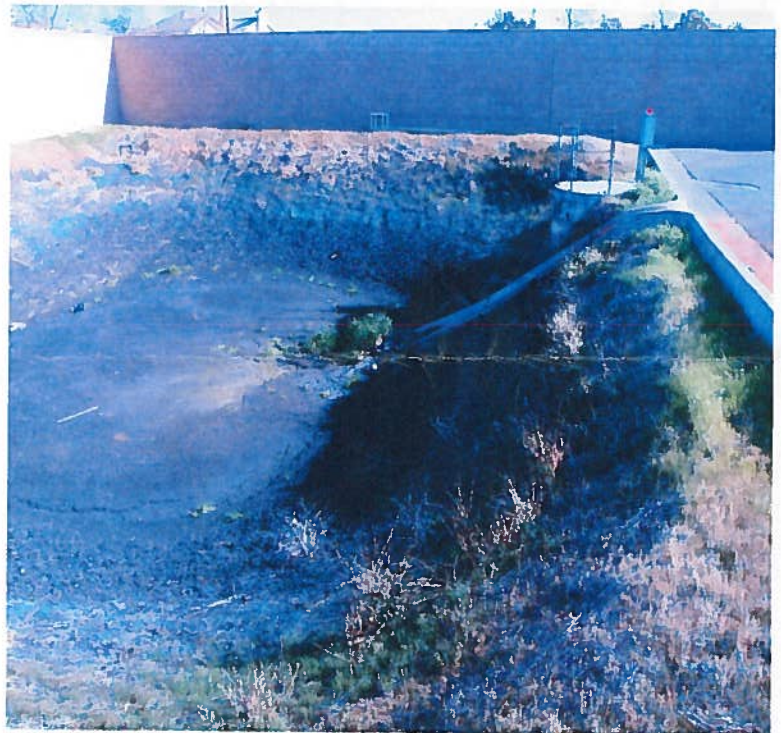
The facility's storm water basin contained solids associated with overflows from the treatment facility (Figure 4).

Figure 4. Storm water basin with solids from the WWTF.

On 10 January 2018, Board staff received a status report detailing the work which had been completed to repair the WWRF. The report also contains a tentative schedule for completing additional repairs to the WWRF and to remove the sludge observed within the storm water basin.
