Discharger: Wild Wings County Service Area
Name of Facility: Wild Wings Water Recycling Facility
WDRs Order Number: R5-2002-0077
CIWQS Place ID: 272537
County: Yolo

Re: Wild Wings Wastewater Recycling Facility Status Update

**Wild Wings Water Recycling Facility – Fourth Quarter 2018
Groundwater Monitoring Report
WDR Order No. R5-2002-0077**

**Re: Groundwater Monitoring Report Fourth Quarter 2018
Wild Wings Water Recycling Facility, Yolo County, CA WDR No. R5-2002-0077**

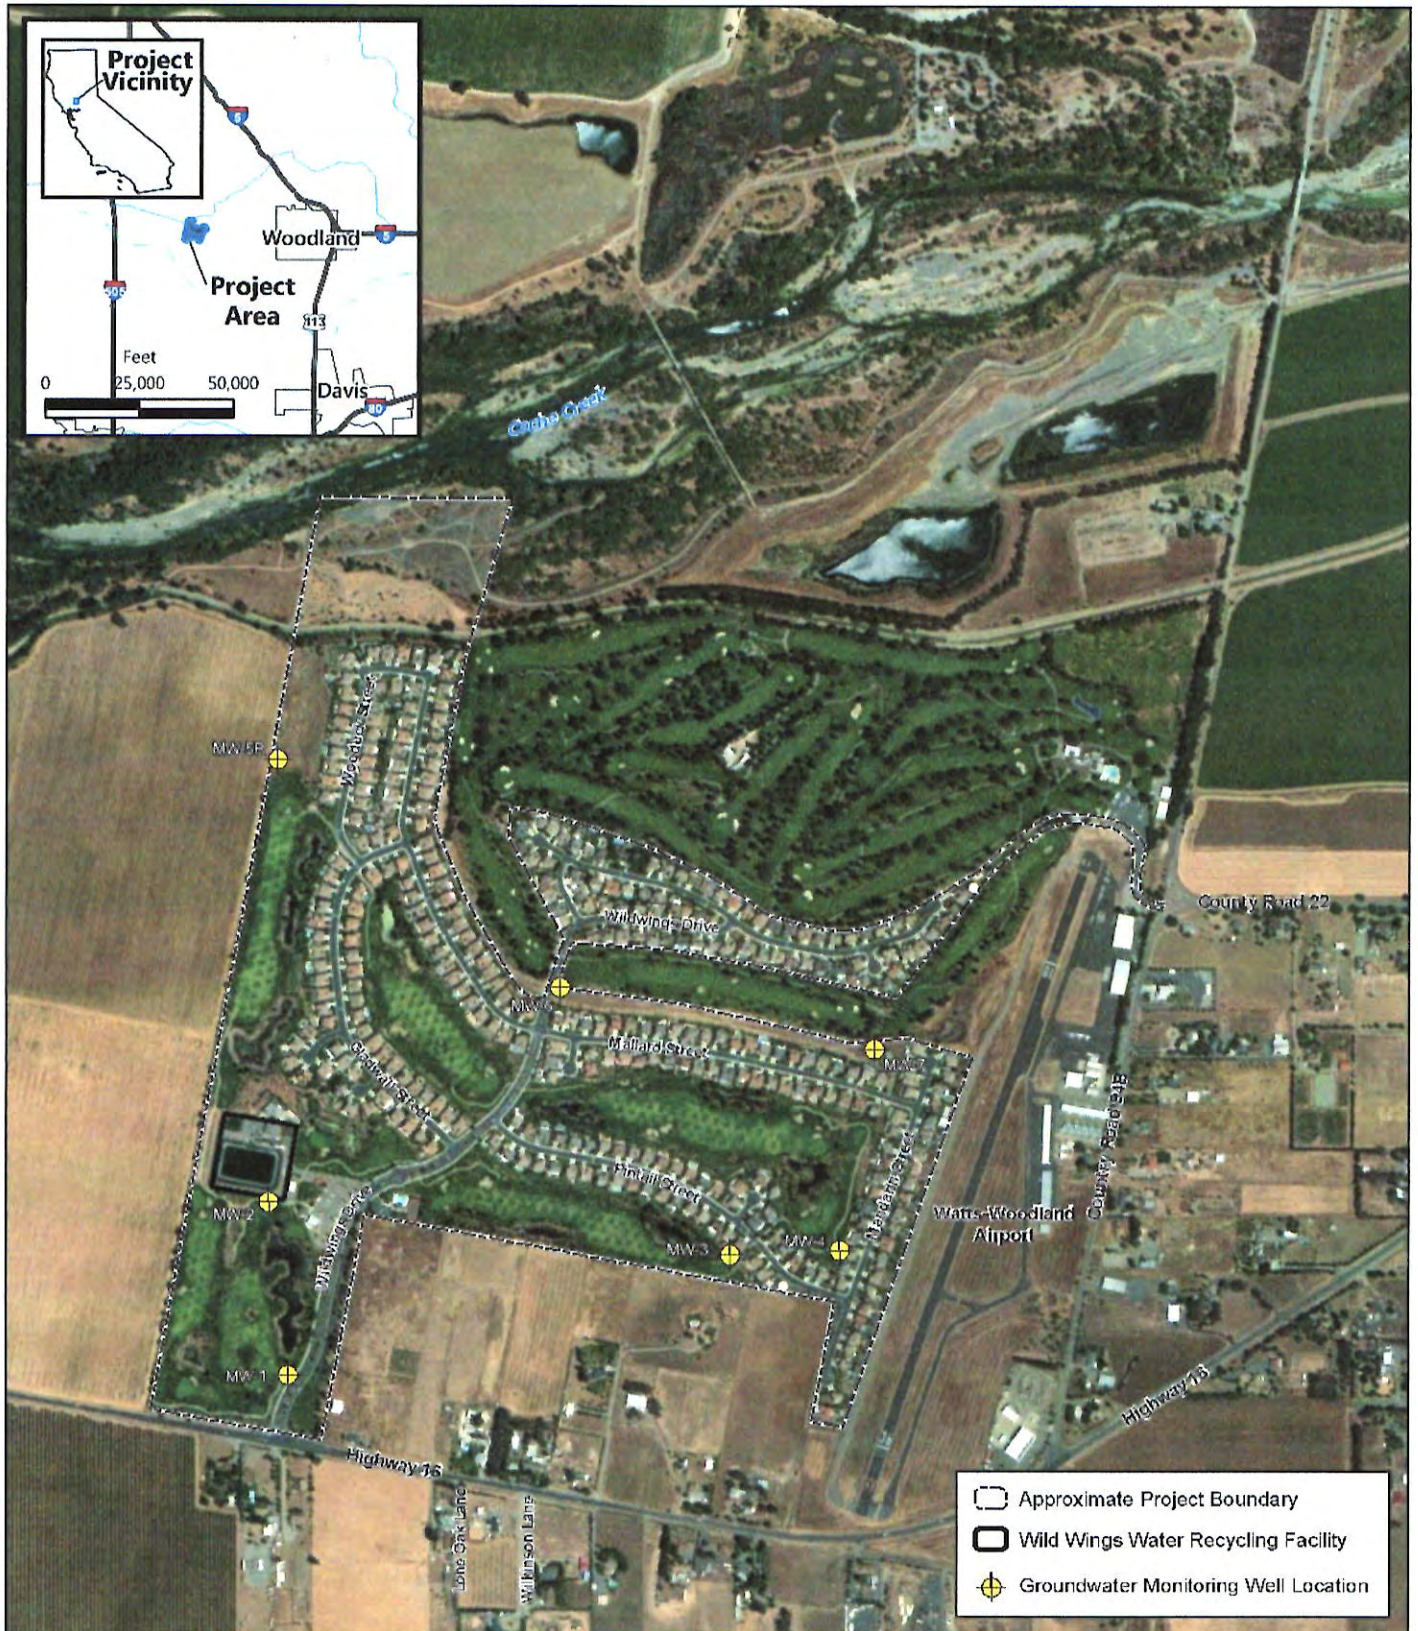
Figure 1
Site and Vicinity

Notes:
 All locations are approximate.
 Aerial Source: USDA, National Agriculture Imagery Program 8 July 2016

The Wild Wings development is located north of Highway 16 and west of County Road 94B at 18530 Wildwings Drive, Woodland, CA 95695, and is surrounded by agricultural land to the west, Cache Creek and the Yolo Fliers Golf Club to the north, the Watts-Woodland Airport to the east, and several rural residences to the south. In early 2015, almond orchards were planted in the agricultural land to the west of the site and water wells were installed to provide water for the orchards. The WWRF encompasses 3.67 acres (400 by 400 feet) along the southwestern side of the Wild Wings development. Figure 1 shows the location of the WWRF along with general site information and locations of seven (7) monitoring wells.

Seven monitoring wells, MW-1 through MW-7, were constructed in May through June 2004. The monitoring wells were installed on the Wild Wings development in the vicinity of the WWRF. The locations of the monitoring wells are shown on Figure 1.
