WELL ASSET MANAGEMENT REPORT
El Macero Well #3
El Macero County Service Area
El Macero, California

Prepared for:
Yolo County, California

March 2019

Prepared by:
California Rural Water Association

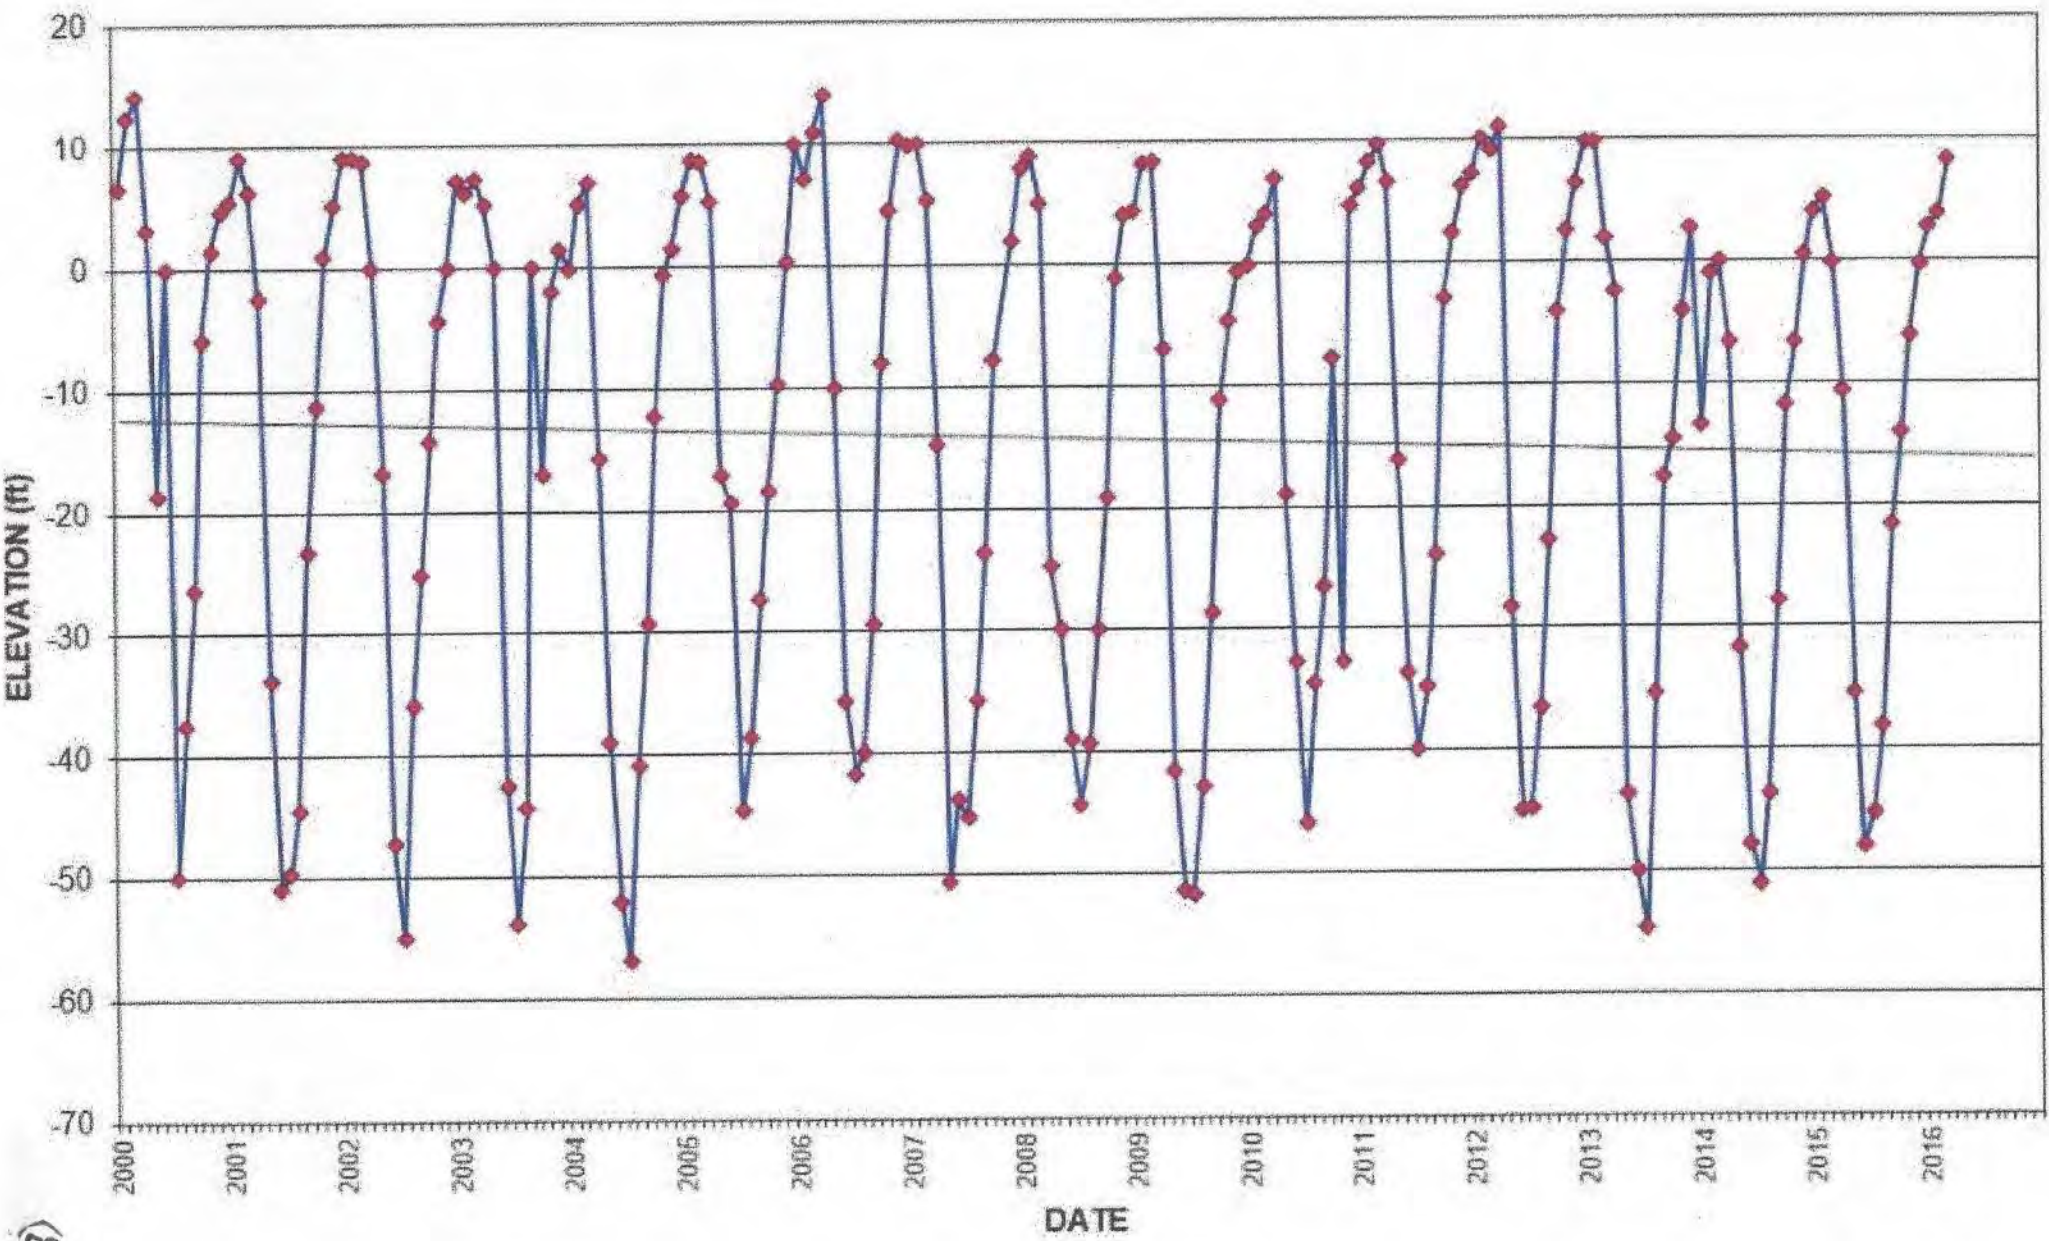
WELL EM3: GROUNDWATER ELEVATIONS 2000 to PRESENT

EM-3

State Well # 08N03E07N001M

Based on water level data between 1991 and 2016 (**Appendix C**), the static water levels in EM-3 show a distinctly seasonal trend, as is common in the Central Valley of California. Dry summer conditions combined with increased agricultural pumping, cause the water table to decline significantly in the summer months, as reflected in the EM-3 records. The difference between summer and winter water levels can be as much as 80 feet in EM-3.

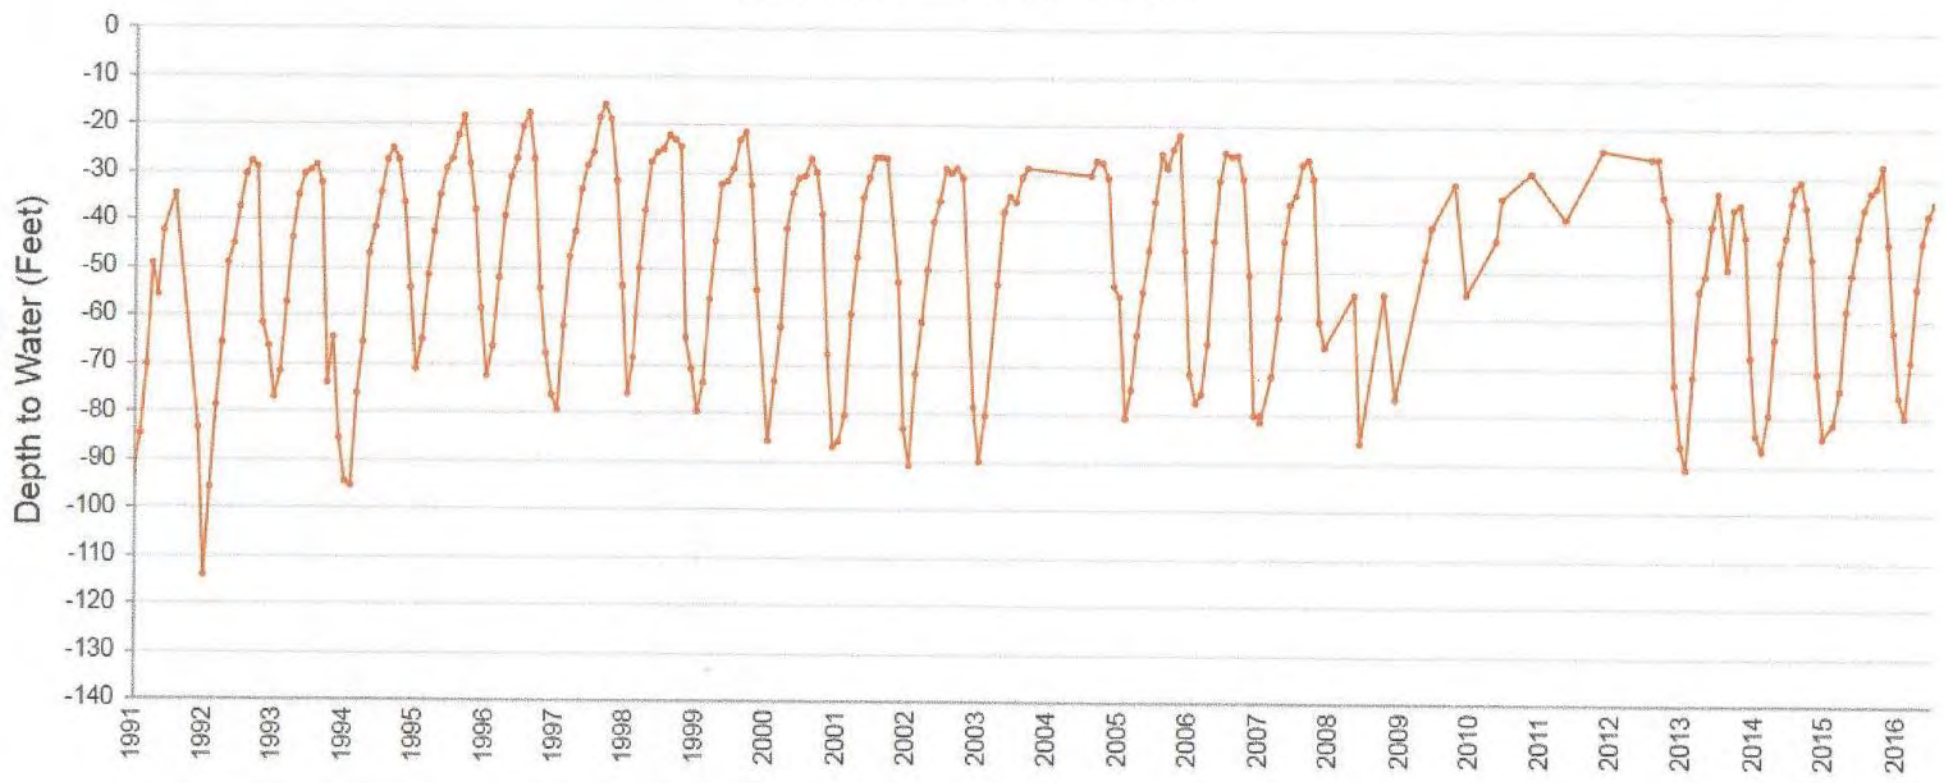
(b)

EM 3 Depth to Water, Feet
