Teichert Shifler Project

Determination of Waters of the U.S.

December 5, 2019

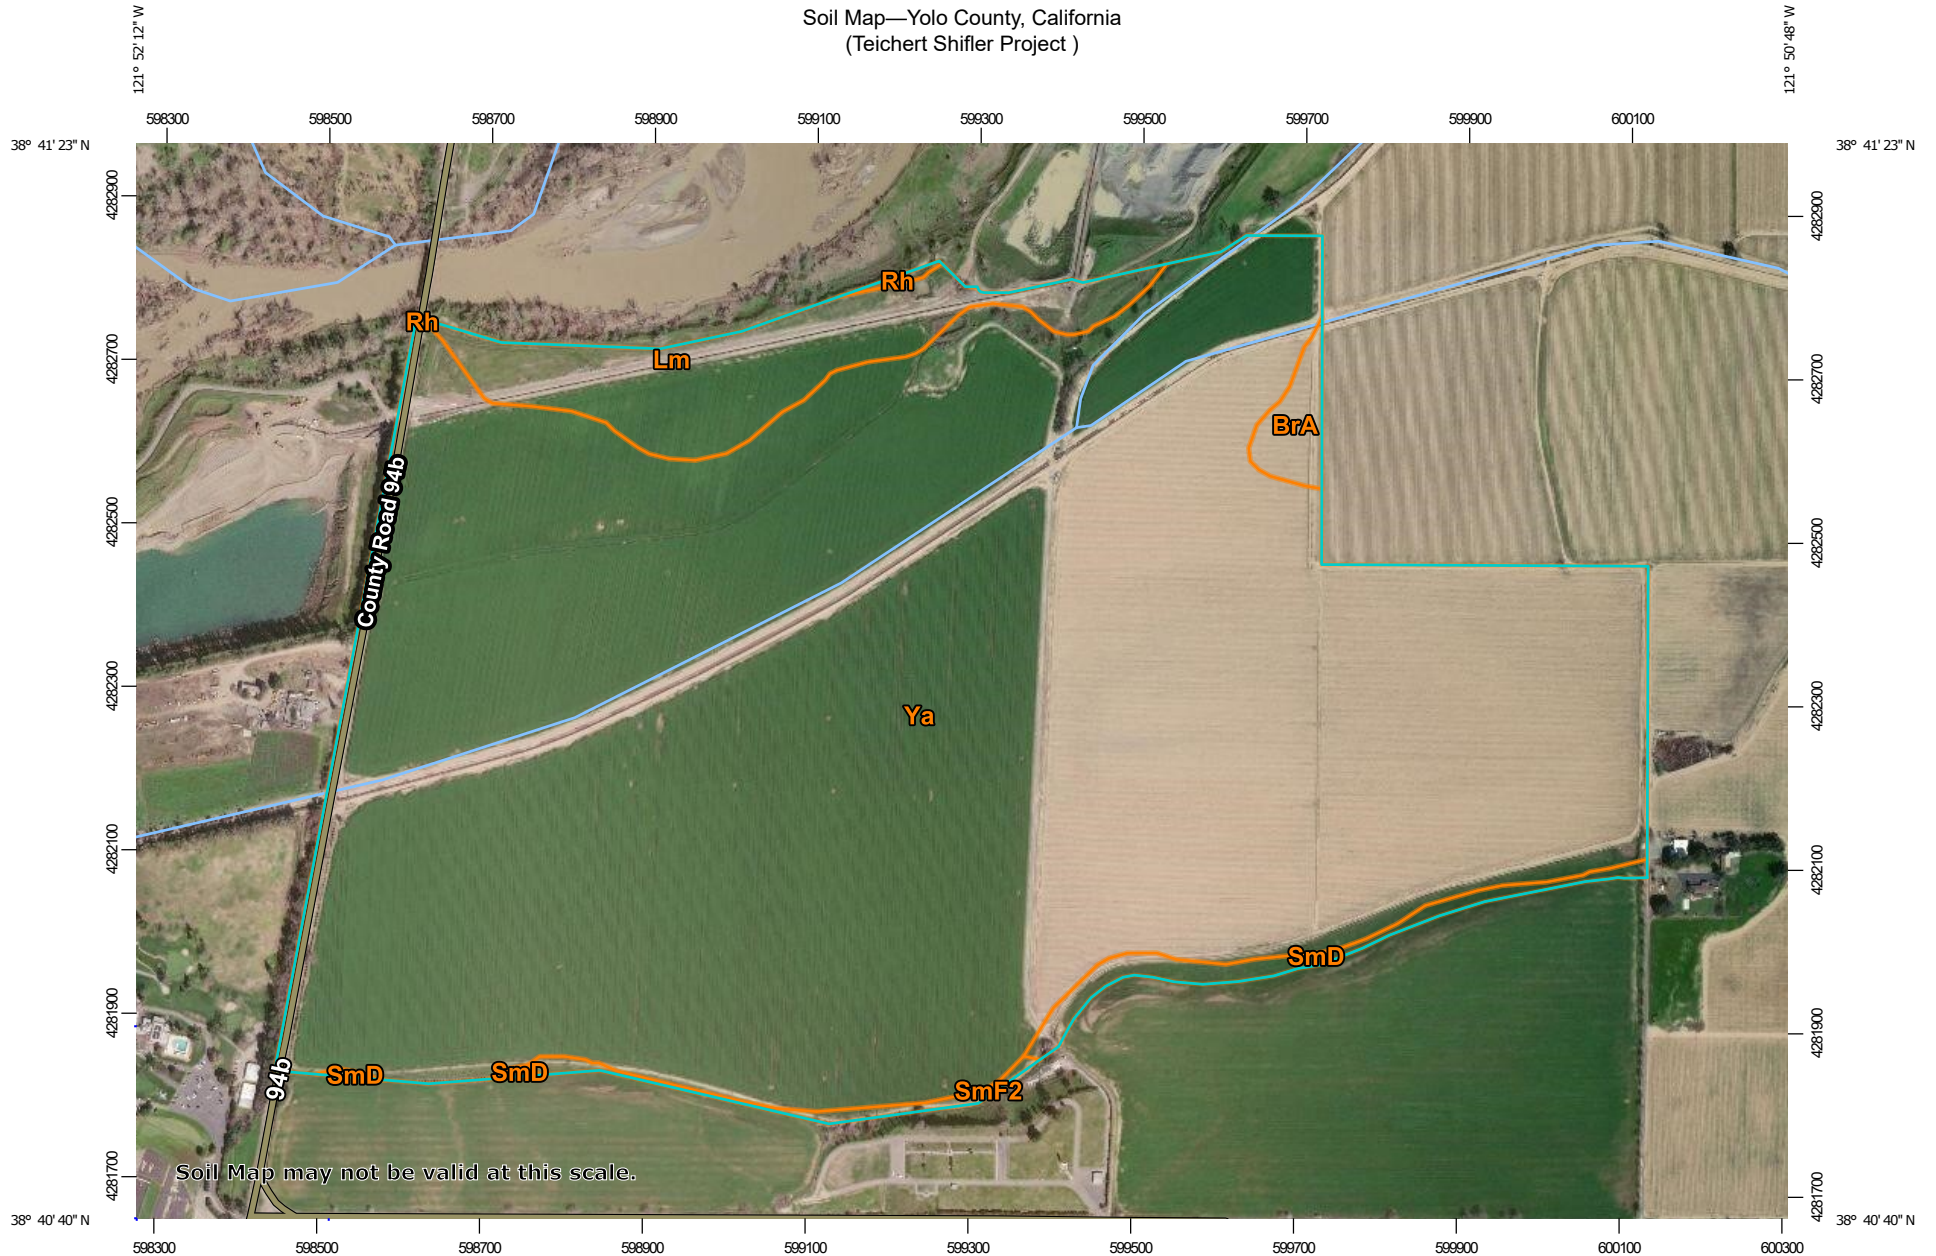
Teichert Shifler Determination of Waters
Figure 3. Soils Map

The following soil types occupy the wetland study area (with map symbol in Figure 3 and acreage):

See text for identification and description of soil map unit codes.

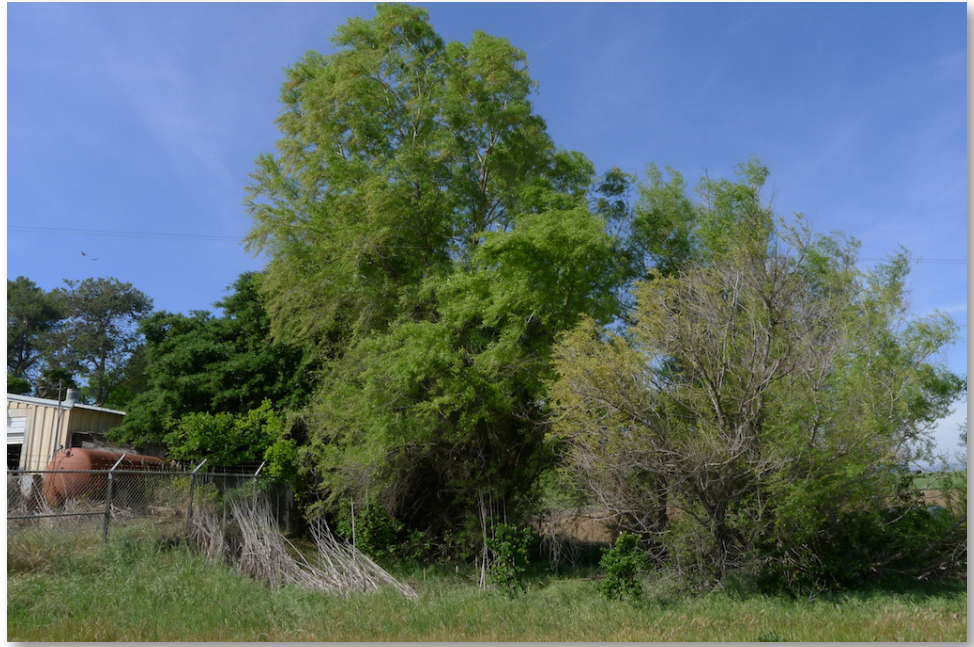
Photo 1. Setting of DP-2 through DP-5 at southern site boundary. Fence is at boundary; shed and tank are off site. Willow area is represented by DP-5; points DP-2 through -4 are behind vegetation at right edge of photo. Tall dead gray stems in center left foreground are *Typha* surrounded by live upland grasses (*Avena* and *Bromus diandrus*), which cannot survive prolonged saturation. Leakage discharge obviously used to go there, but now flows further behind (as seen from this viewpoint).

The setting of this area is shown in Photo 1 (Appendix A). Photo 2, Water leaks abundantly from irrigation works immediately outside the southern site boundary (Photo 2), supporting lush cattails (*Typha angustifolia*) on top of the hillside (Photo 3), then flowing under the fence and into the study site (Photo 4). This is the irrigation supply for the cemetery (marked on the USGS map as Monument Hill), so it is understandable that it would run frequently at all times that the turf would be under water stress. Though frequent, this irrigation leakage is intermittent; it (and the surface water downslope, within the site) is absent for long periods, during which the wetland vegetation it supports dries out and dies, and is replaced by an upland understory (DP-5). When the irrigation system is turned on, however, the flow is substantial (Photo 5) and attains the toe of the slope (Photo 6), where it infiltrates in the moderately permeable Yolo loam soils. In order to keep the farm perimeter road dry, a ditch is usually excavated at the toe of the slope (DP-4), which terminates in both directions, not far from the point where the irrigation leakage arrives at the toe of the slope. Observation of soils within a few feet of the surface water that was present on July 12, 2019 showed that no redoximorphic features or other hydric soils indicators were present on that date (Photo 4). Even under the ponded water, color difference between matrix and redox depletions was only between 2.5YR 3/2 and 2.5YR 3/1 (Photo 7; contrast is defined as "faint", insufficient to constitute a hydric soils indicator). Soils under the willows on the hillslope (DP-5) also lacked hydric field indicators. In both the herbaceous and the woody shrub layer, decidedly upland species (e.g., interior live oak, *Quercus wislizenii*) are mixed in with a FACW willow (*Salix gooddingii*), and no indicators of wetland hydrology are present either.

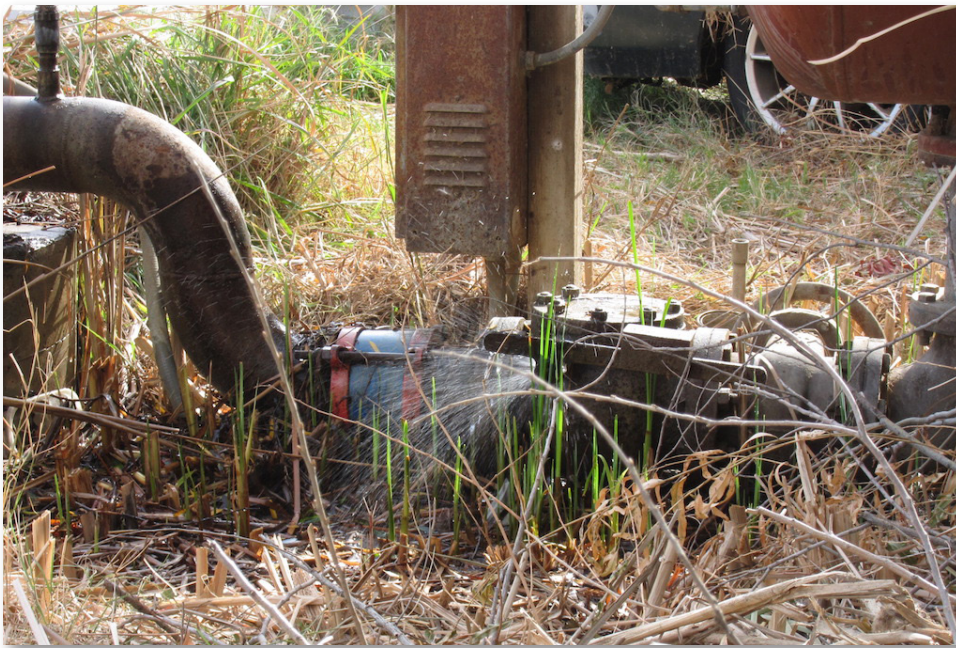
Photo 2. View through boundary fence to leaking irrigation works 10-20 feet away. Water spray is clearly visible. Corner of the tank in upper right corner of photo is the same tank that is seen behind the fence in Photo 1.

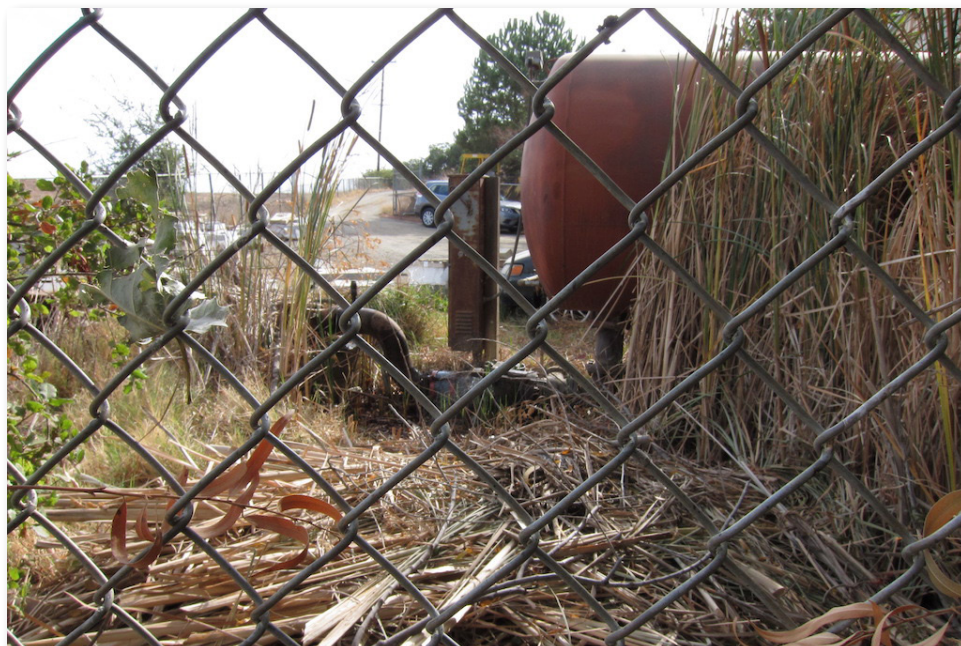
Photo 3. Abundant *Typha* off site, at top of hillside, supported by leakage from irrigation.

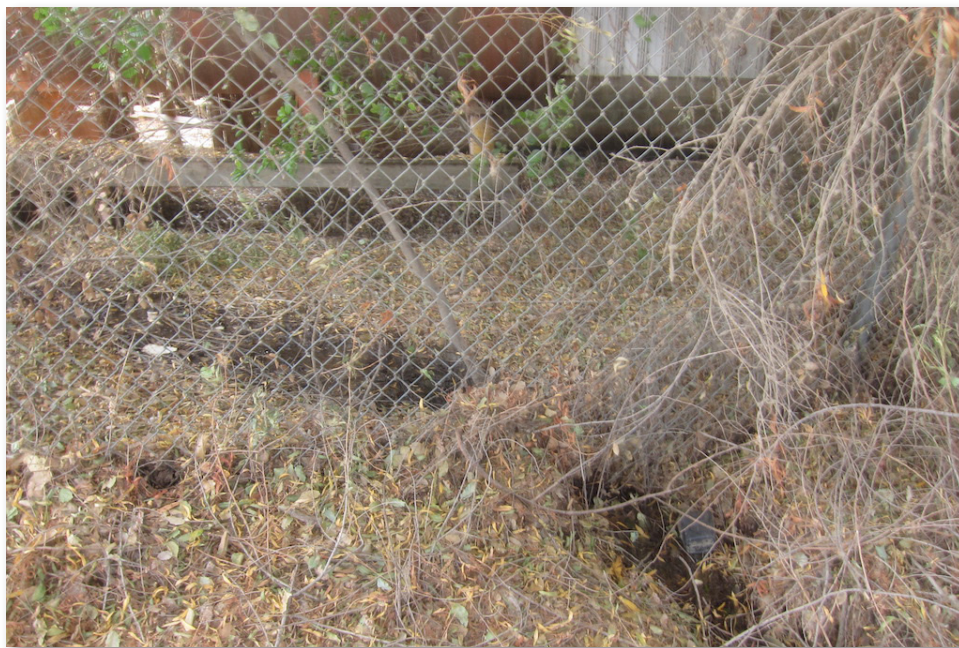
Photo 4. Leakage flow entering site under property boundary fence.

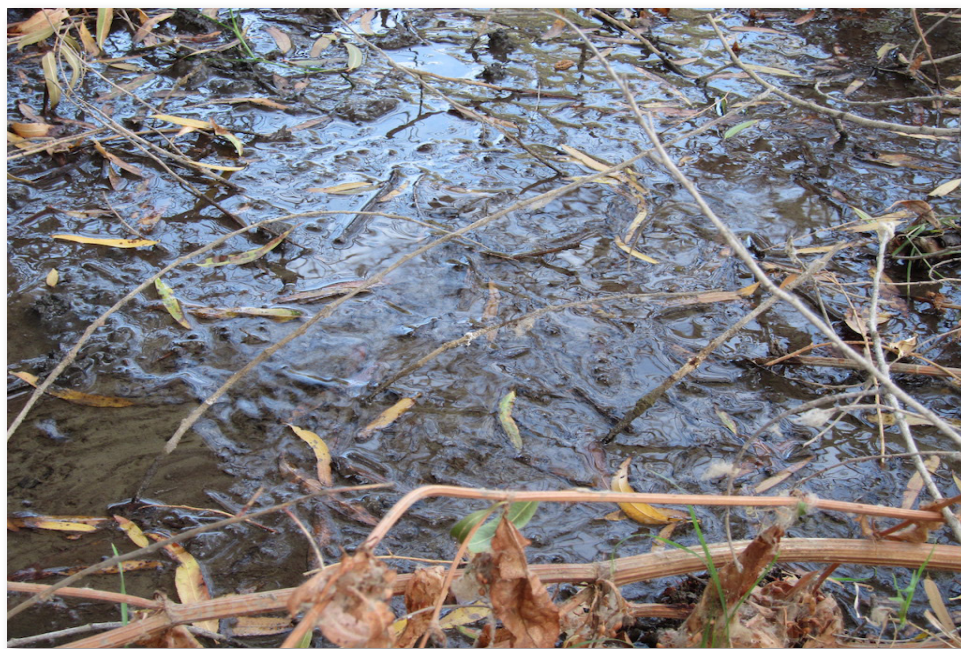
Photo 5. Ripples in flow down hillslope demonstrates that it's not just a small amount of seepage, instead, it's a substantial continuous flow whenever the off-site irrigation system is turned on.

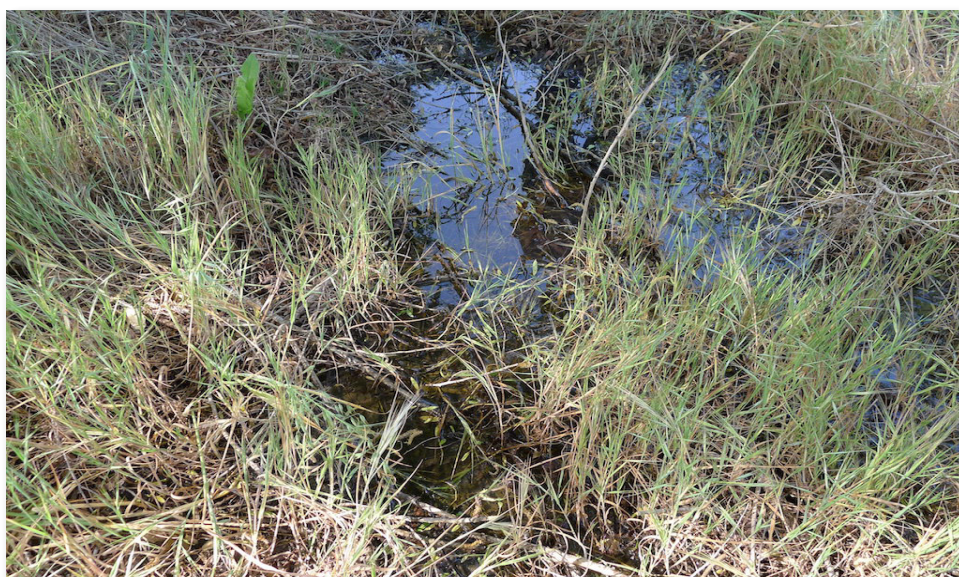
Photo 6. Leakage flow ponded at the toe of slope, on April 24, 2018. Grass is *Cynodon dactylon* (FACU). If surface water such as this had been present throughout the winter, vegetation would be dominated by FAC or wetter species. Instead, this is fresh leakage flow, with the irrigation system just having been activated as the weather warms up. DP-2 is located within a few feet of the standing water visible here.

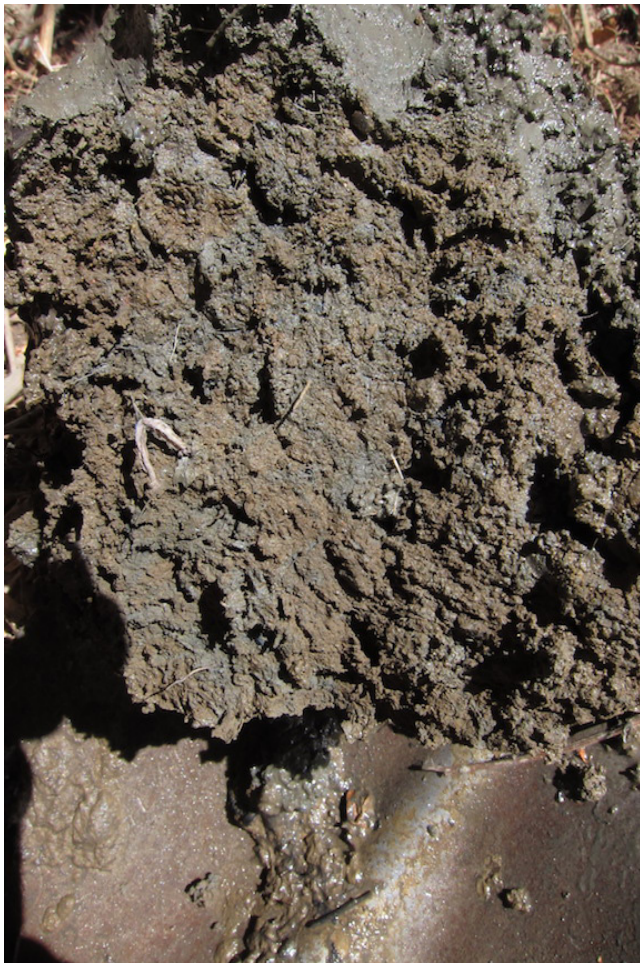
Photo 7. Saturated ped from soils under standing water near DP-2, showing faint redox contrast (2.5YR 3/2 vs. 3/1). Soil was drier below about 10" than it was at the surface. Both of these circumstances are consistent with the saturation having been present only for a short period of time. As indicated by previous photos, this hydrology is not a normal circumstance.

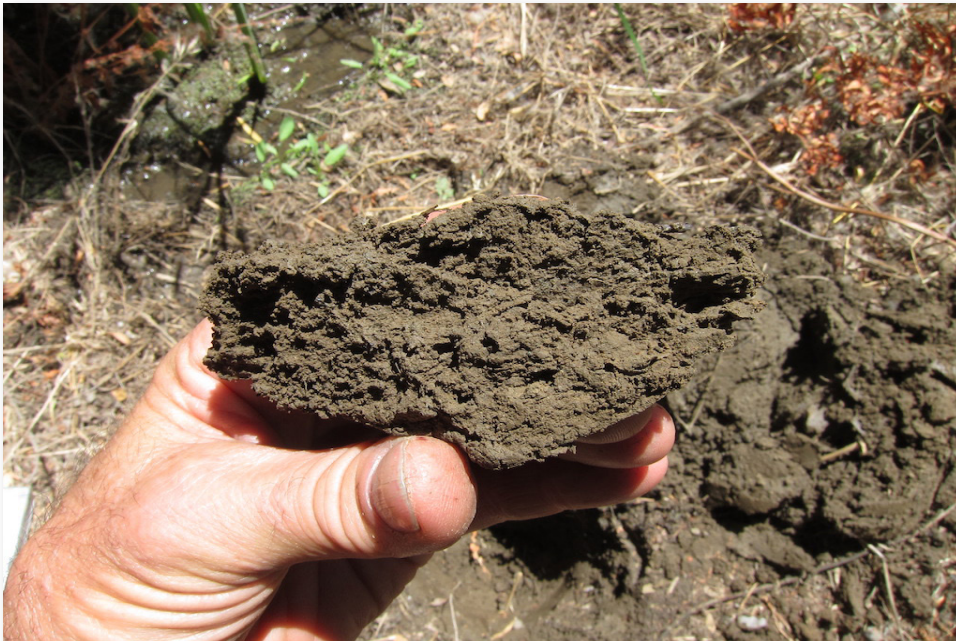
Photo 8. Soil from test pit at DP-2, with no redoximorphic features at all (100 percent 2.5YR 3/2).

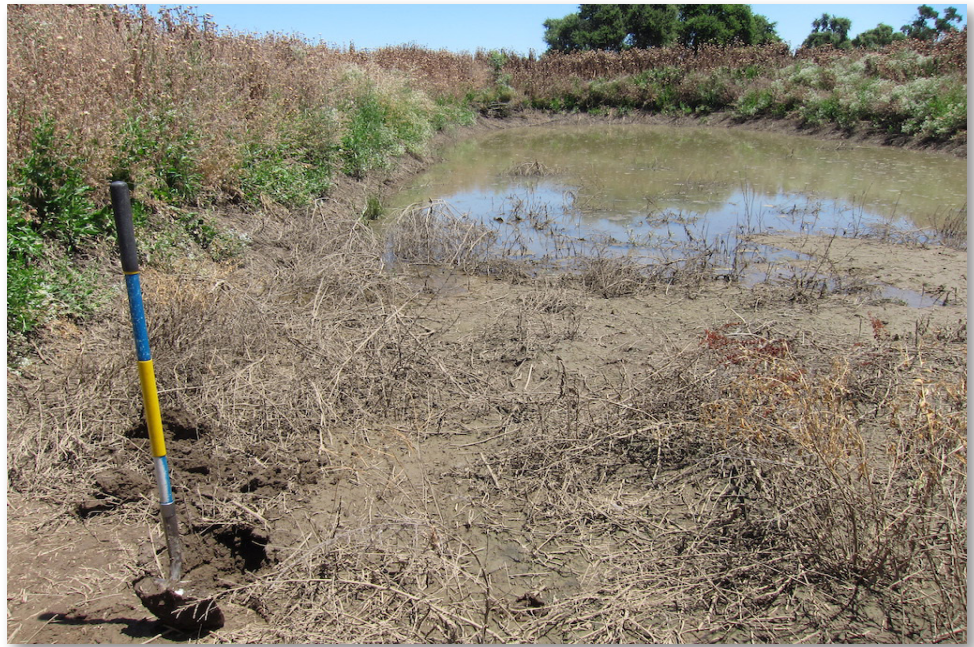
Photo 9. Setting of DP-1, in infiltration basin that had recently partially filled from irrigation tailwater (July). Inflow is behind photographer; there is no outflow other than infiltration into the basin floor. Though the soil surface is only a few inches above the water level, no water table or saturation was encountered in the test pit to its maximum depth of 20 inches. This feature is constructed on dry land and its hydrology (standing water) is artificial (derived from pumped and diverted irrigation flow). I have visited this feature multiple times in winter months and it is never ponded or even moist at those times, because there's no irrigation flow.

Two excavated basins are present in the northern part of the site (Photos 9, 10). These receive irrigation tailwater collected in row-end ditches and perhaps also rain runoff, although the permeability of Yolo loam is 4.5623 micrometers/second (0.647 inches/hour; NRCS, 2019), which means that only intense rainfall is likely to produce any runoff at all, and even under this circumstance, it would infiltrate into the basin floor within a short period of time. Even during the exceptional water year from October 1, 2018, to September 30, 2019, rainfall for an entire 24-hour period only exceeded two inches on five occasions. In many visits, I have never seen water or seemingly saturated soil in either basins except during active irrigation. Presence of sediment on plant debris at DP-8 (not within a basin) certainly indicates that depressions do fill with water at times, but not for long (as indicated by absence of hydric soils indicators). In July, living vegetation extending right to the basin floor at DP-1 was strongly dominated by UPL species (in other words, there was no OHWM above the basin floor indicated by physical markers or change in vegetation).

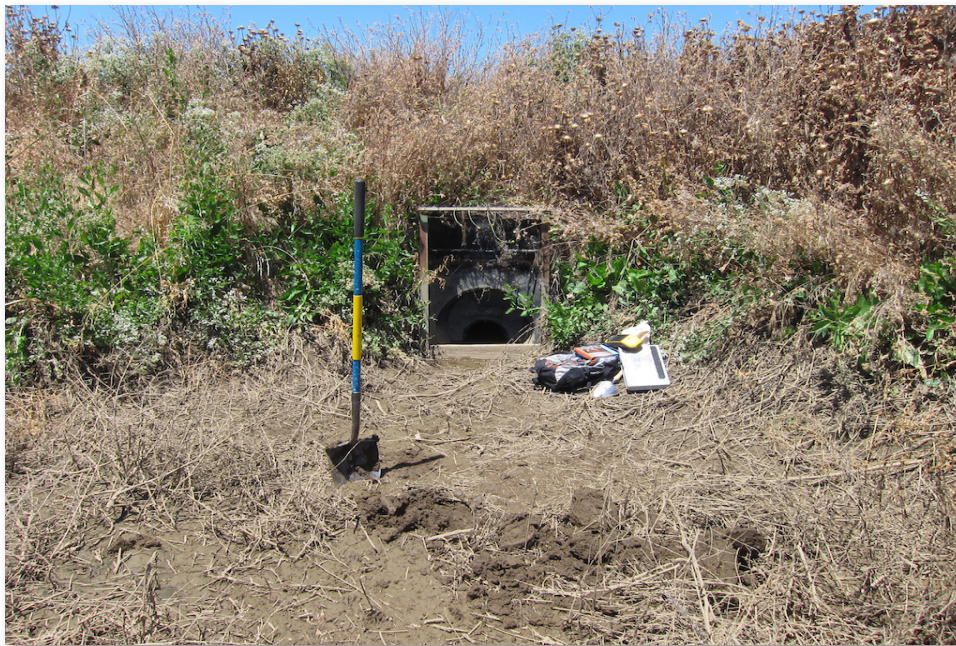
Photo 10. Inflow to infiltration basin. Shovel is in the same location as in Photo 9. Vegetation on berm includes *Lepidium latifolium* (FAC) but is dominated by UPL species.

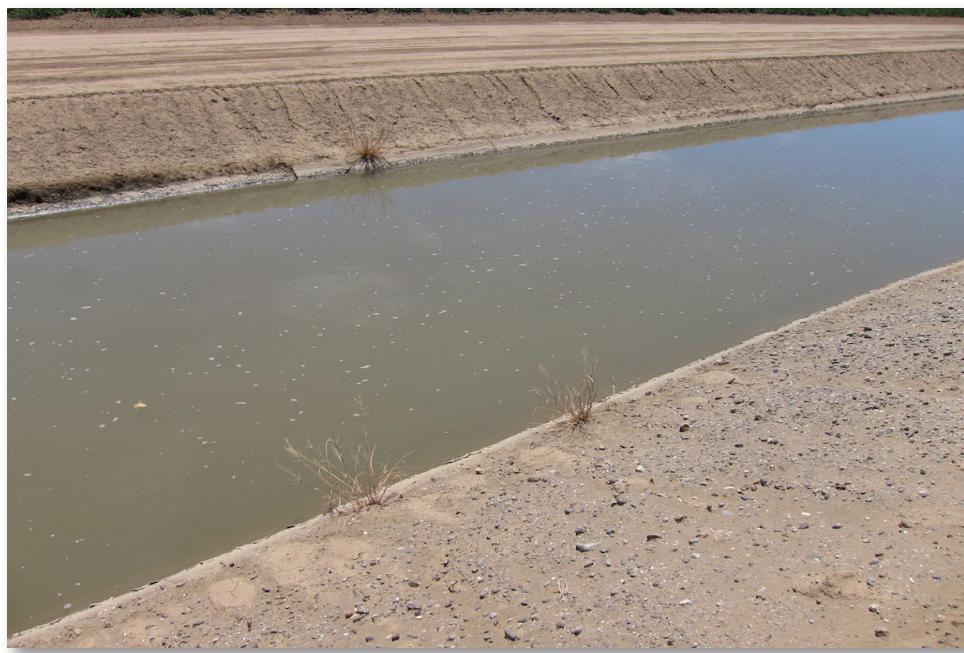
Photo 11. Moore Canal (feature IC-1), near the cross section OHWM-2. Canal is quite uniform throughout its length within the site: sideslopes are 1.5:1 to 2:1, and the canal is concrete lined nearly up to the maximum flow level. A slightly incised OHWM can be discerned in the soil just above the concrete, and, as seen in the photo, occasional plants of *Leptochloa* (*Diplachne*) *fusca* var. *uninervia* (Mexican sprangletop, FACW) grow exactly at that point, but not higher. Canal is flowing almost to maximum capacity, which is consistent with presence of irrigation tailwater in the basin shown in Photos 9-10 (taken on the same date).

Moore Canal (IC-1) conveys water from Cache Creek (source point approximately 1.94 air miles west of the site boundary), flows eastward through the site, and ultimately discharges into Willow Slough, which is tributary to the Sacramento River, a navigable water of the U.S. Magnolia Canal is hydrologically contiguous with Moore Canal, albeit separated by a large irrigation control gate, and though it flows eastward also, it appears to be blind-ending, without a confluence with any other tributary of the Sacramento River. Strictly speaking, since the gradient of the invert is in the opposite direction, any potential for it to be tributary to a water of the U.S. is questionable; it is more accurately regarded as being an isolated water (if any at all). However, in the present report, it is tentatively included in the table of jurisdictional irrigation canals.

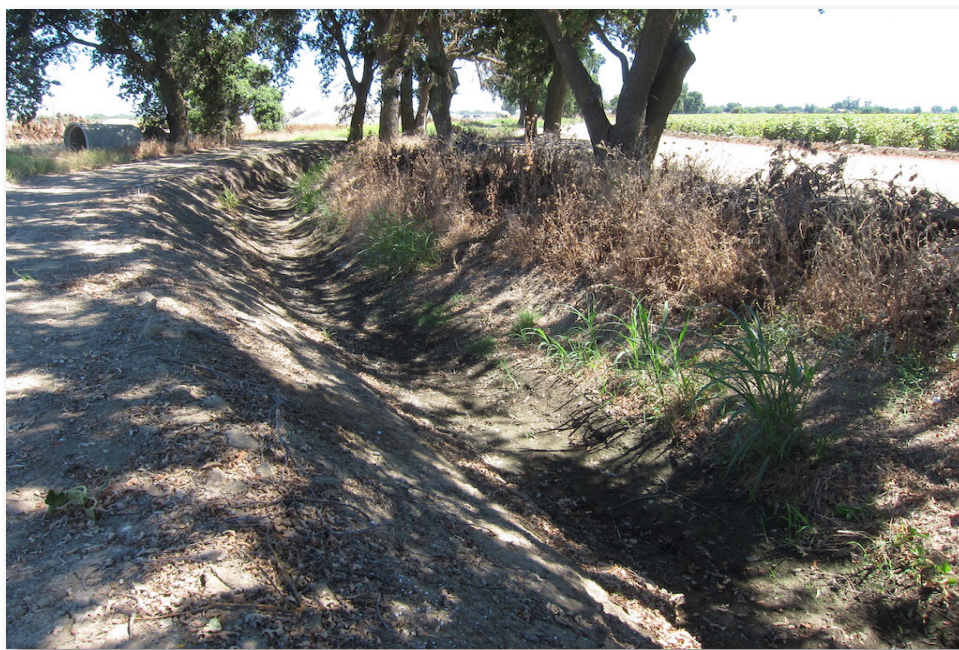
Photo 12. Magnolia Canal. Like Moore Canal, there is no floodplain or even a low terrace; flow is confined to the excavated channel under all possible conditions. This much smaller irrigation canal is unlined and supports FACU and UPL vegetation on its banks (*Quercus lobata*, *Brassica*, *Bromus diandrus*, *Carduus pycnocephala*, *Cynodon*, *Silybum*, *Sorghum*).

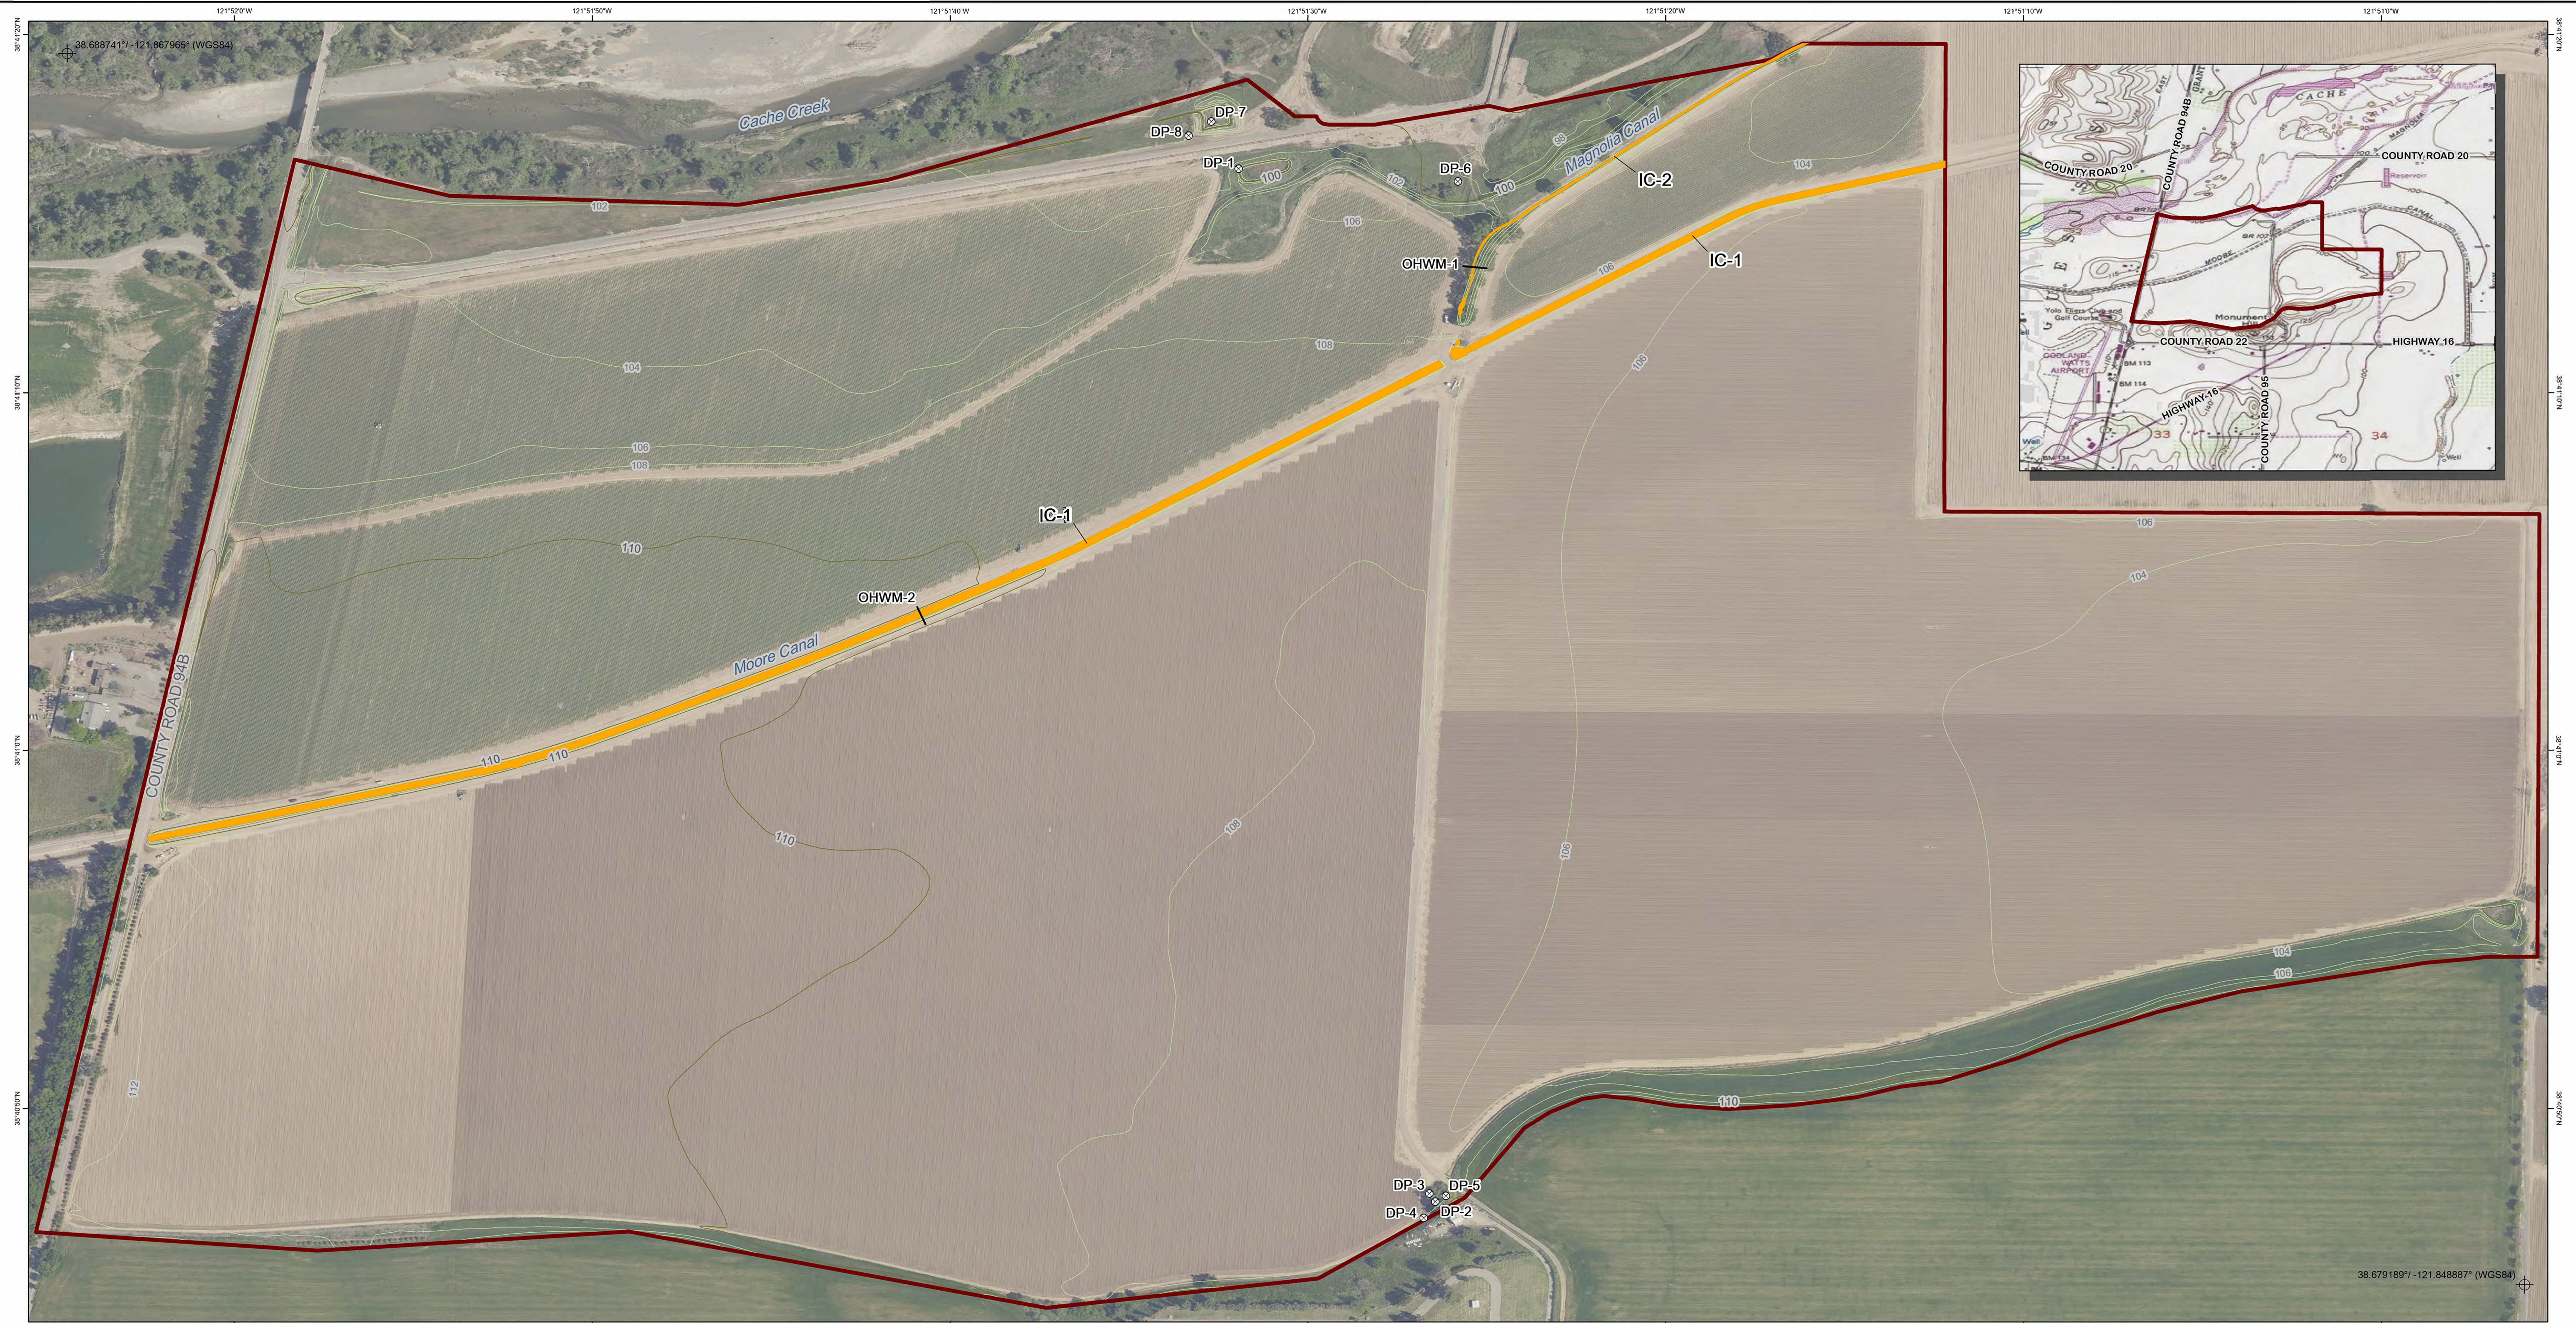
Teichert Materials: Shifler Project
Fig. 4. Aquatic Resources Delineation Map

Three-parameter wetland determination data points were studied at eight locations (see Figure 4, Aquatic Resources Delineation Map). Five of these were in an area affected by run-on from an irrigation system leak just off site, and the remaining points were located in or near two sediment/infiltration basins near the northern site boundary. All of these non-wetland determinations are discussed below.
