TEICHERT AGGREGATES

OFF-CHANNEL MINING AND RECLAMATION APPLICATION

CACHE CREEK HYDRAULICS STUDY for SHIFLER MINING REACH

CACHE CREEK HYDRAULICS STUDY – SHIFLER REACH

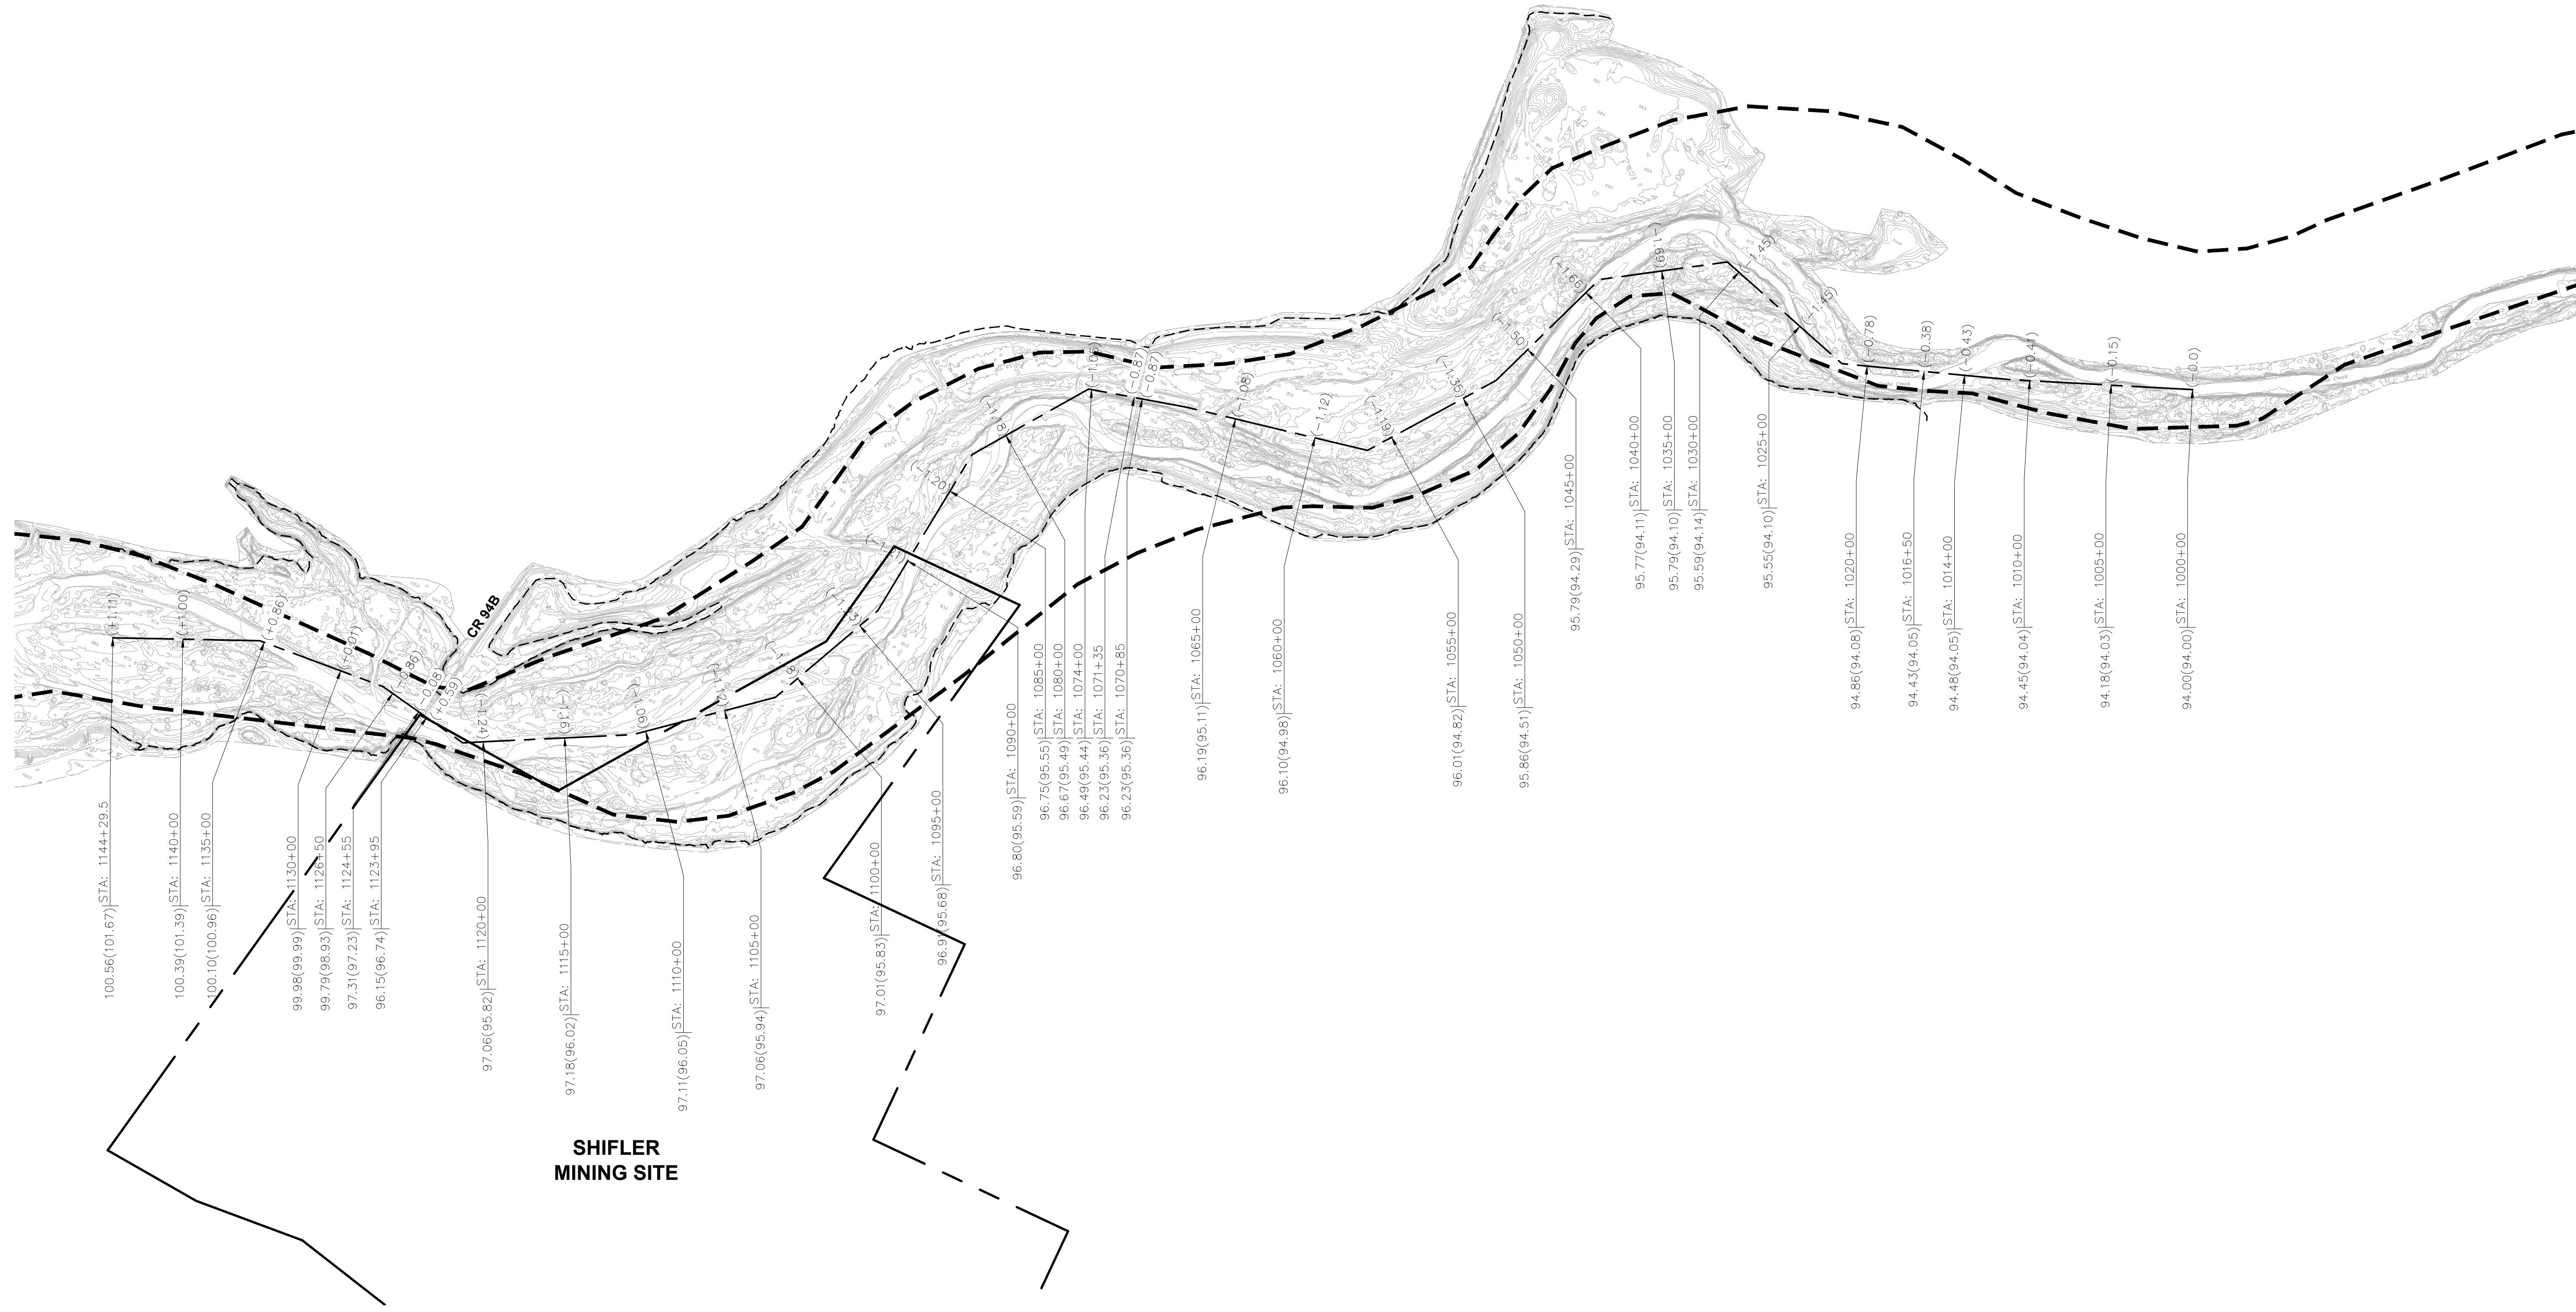
**TEICHERT AGGREGATES
CACHE CREEK HYDRAULICS STUDY
APPROXIMATE 100-YEAR FLOOD ELEVATIONS**

1. 100-YEAR WATER SURFACE ELEVATIONS CALCULATED USING 100-YEAR FLOW (Q_{100})=61,500 CUBIC FEET PER SECOND BASED ON U.S. ARMY CORPS OF ENGINEERS "LOWER CACHE CREEK, YOLO COUNTY, CA-CITY OF WOODLAND AND VICINITY FLOOD REDUCTION STUDY," MARCH 12, 2001.
2. 100-YEAR FLOOD ELEVATIONS ANALYSIS BASED ON APRIL 2010 AERIAL TOPOGRAPHY AND AUGUST 2010 HEC-RAS HYDRAULIC MODEL.

Areas of storage that have no conveyance are represented on the cross-section plots as "ineffective flow areas" and the tops of banks are graphically represented on the cross section plots as "bank stations". The streamwise locations of the cross-sections are shown on the fold-out drawing (Sheet 1 of 1) in Appendix D, attached.

Appendix D – Fold-out drawing: Approximate 100-year Water Surface Elevations

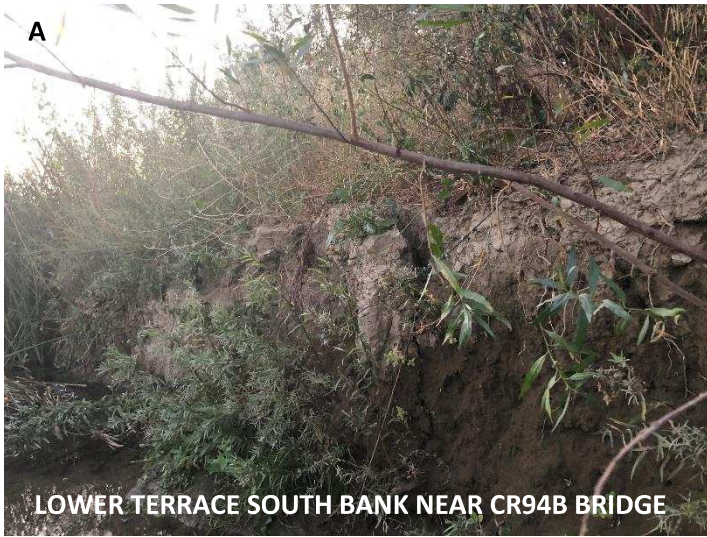
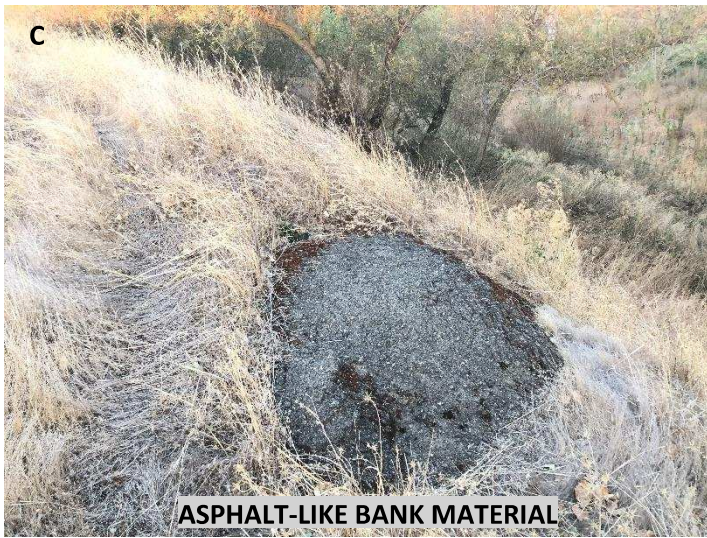
Photographs along Southern Bank

A site visit was completed on November 1, 2019 to assess conditions of the southern bank of Cache Creek. The visual inspection revealed little to no evidence of erosion along the southern bank in the area of the proposed project. The bank is 90-95% vegetated with mature trees, willows, shrubs, and grasses present. These features increase the roughness coefficient of the stream in the flood stage and assists with additional bank reinforcement and stabilization. Throughout the entire reach along the Shifler property the southern bank has a mid-slope terrace. The portion above the terrace is armored with what appears to an asphalt-like material that is likely part of fill material placed sometime in the past. This resistant bank material provides additional protection against erosion. Recent fine sediment deposition noted upon the mid-slope terrace bench is evidence that flow velocities decrease once it reaches the bench. This further reduces the erosion potential on the southern bank. See Attachment B for photographs from the site visit illustrating the highly vegetated, terraced, and partially armored southern bank along the Shifler property.
