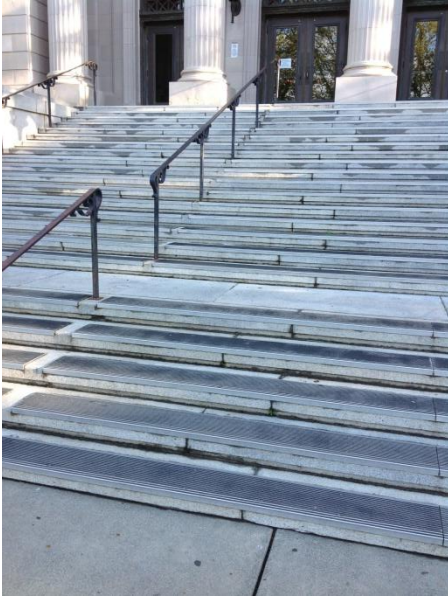
Image 5 – Grand Entry Stairway

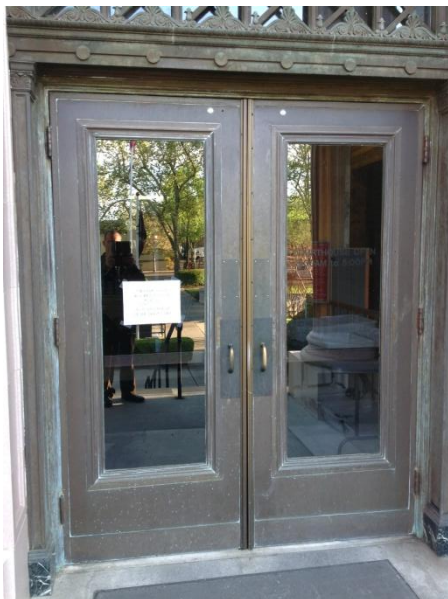
Image 7 – One of Three Main Entry Doors

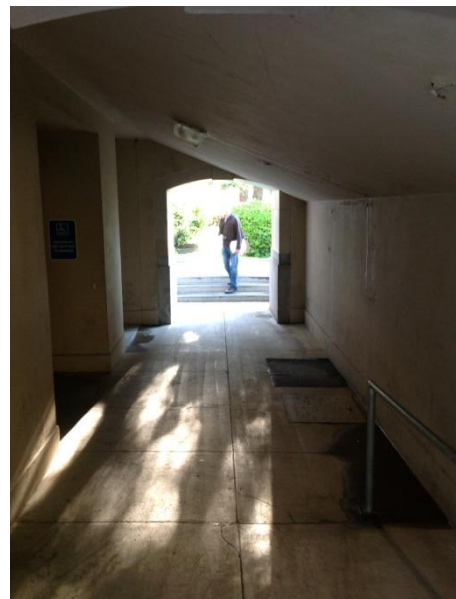
Image 8 – Main Basement Entry Below Grand Entry Stairway

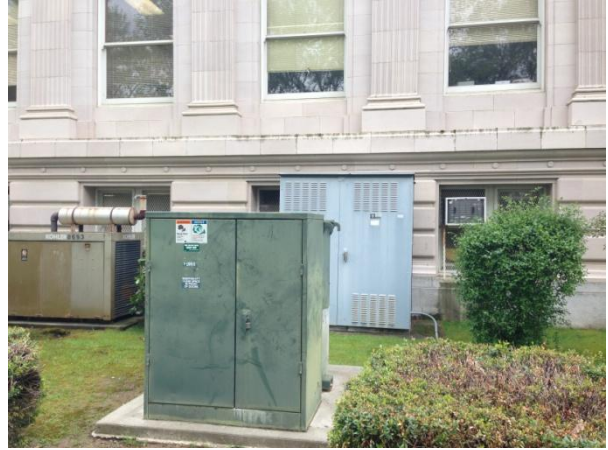
Image 26 – Transformer-Generator-Electrical Switch Gear

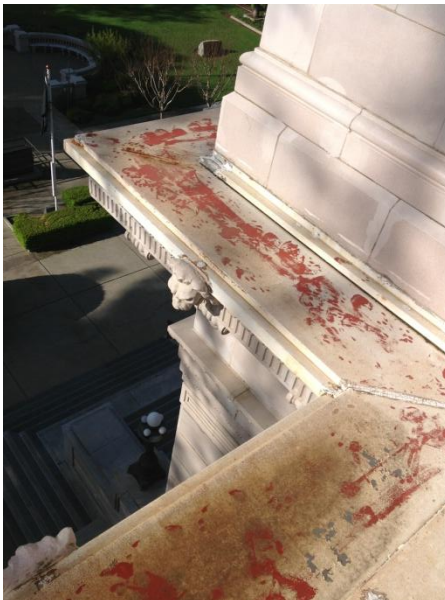
Image 27 – Standing Water at Cornice

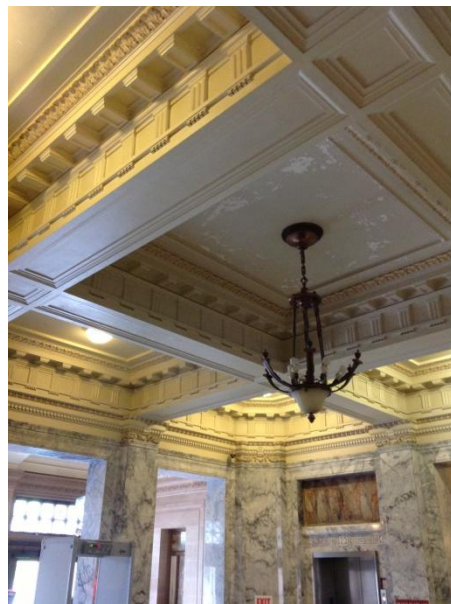
Image 56 – First Floor Rotunda Ceiling

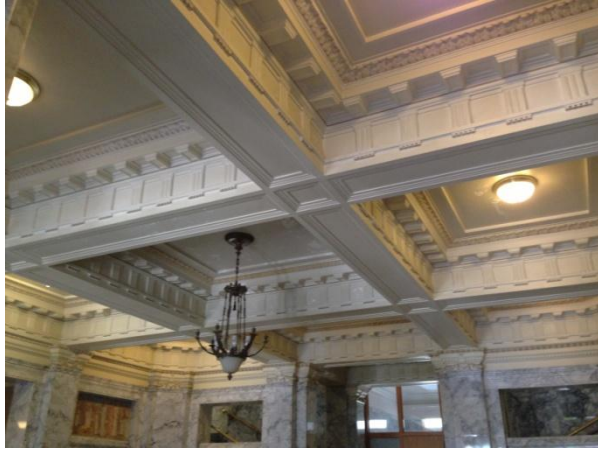
Image 57 – First Floor Rotunda Ceiling

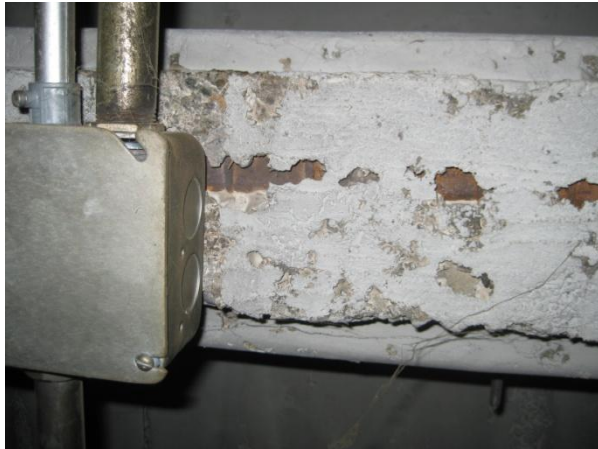
Image 73 – Exposed Rebar – Underside of Concrete Floor Joists

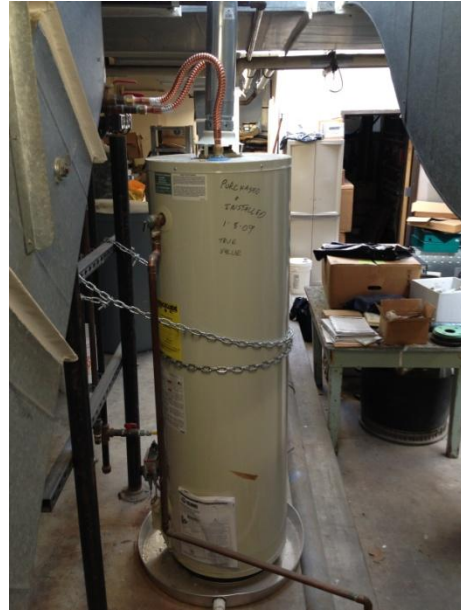
Image 86 – Domestic Hot Water Heater
