LIONAKIS

# TABLE OF CONTENTS

Yolo County Administration Office  
625 Court Street, Room 202  
Woodland, CA 95695

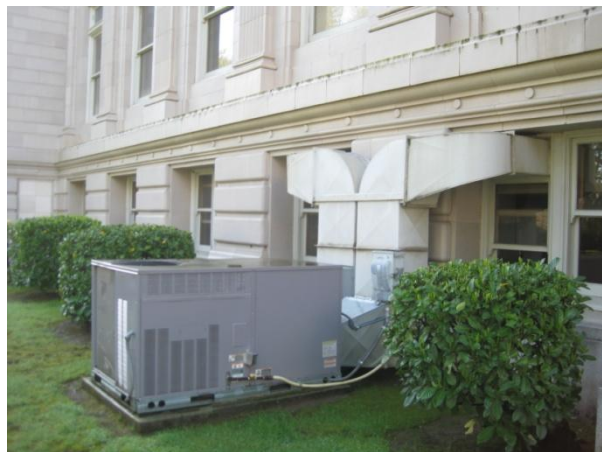
**Mechanical:** In general, the mechanical equipment serving the building is in good condition due to replacement of the equipment under the Energy Retrofit project in 2003. By continuing to follow the current preventative maintenance program, the recently replaced equipment can be expected to last an additional 10-15 years.

Image 23 – Mechanical Unit at Basement

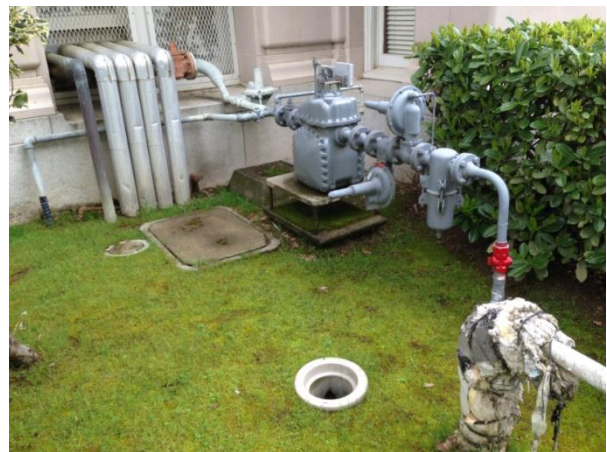
**Plumbing:** In general, the plumbing system is in average condition but is beginning to show signs of aging.

Image 24 – Plumbing Utility Entry – Domestic Water, Gas and Fire Sprinkler

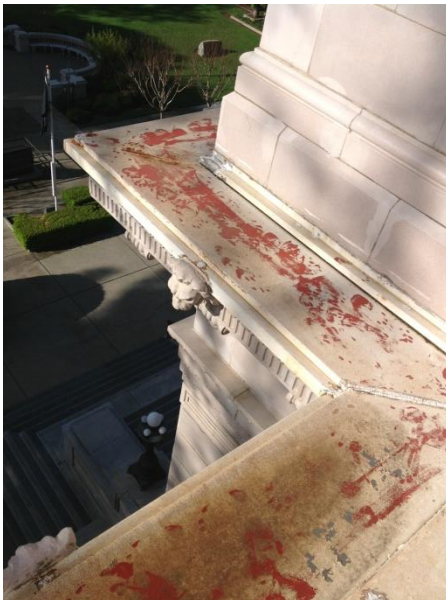
Image 27 – Standing Water at Cornice

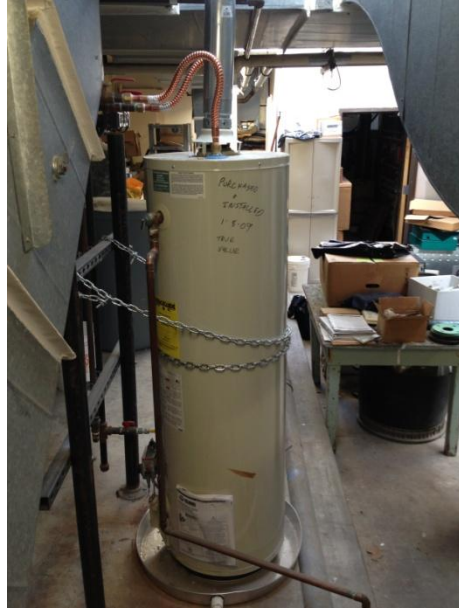
Image 86 – Domestic Hot Water Heater

Since the building qualifies as a historic structure, any non-historic components of the building such as new or replacement plumbing equipment and new appliances need to comply with the Building Energy Efficiency Standards and Appliance Efficiency Regulations.
