2017 CACHE CREEK ANNUAL STATUS REPORT

**** Public Review Draft – Not Yet Approved by Board of Supervisors ****

October 1, 2016 to September 30, 2017

CACHE CREEK TECHNICAL ADVISORY COMMITTEE

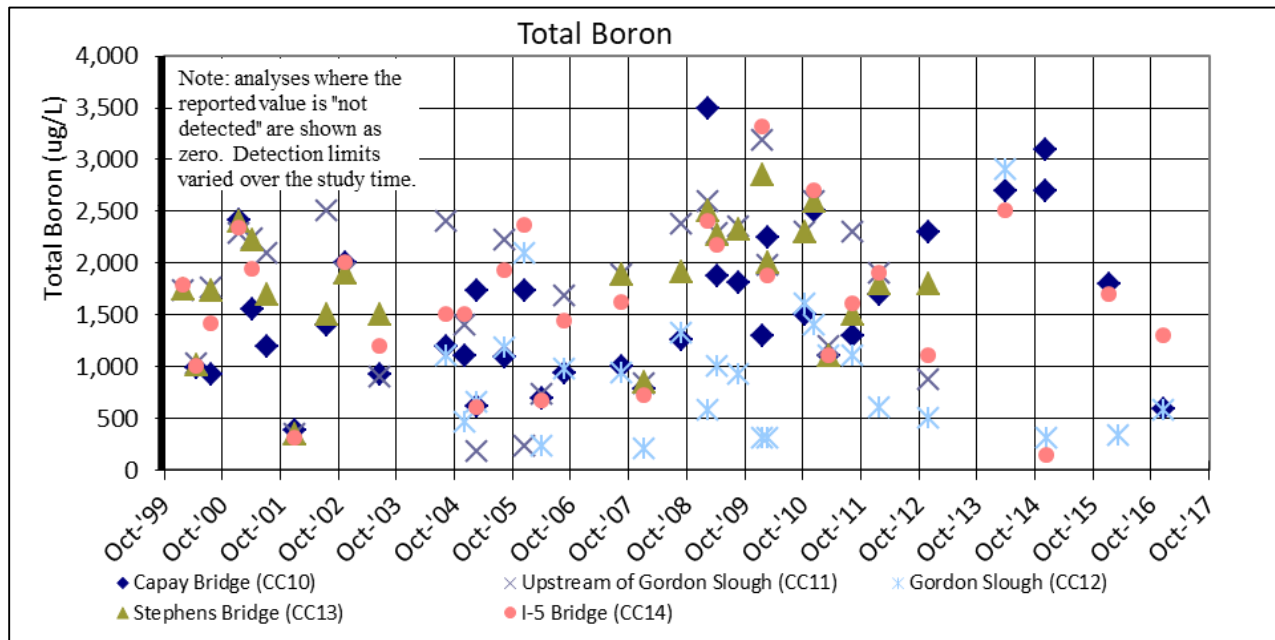
Boron was present in Water Year 2017 at similar concentrations to previous years, and generally lower than observed in 2016 and 2015. At the I-5 Bridge location, boron was detected slightly above the California drinking water standard (1). The TAC Hydraulic Engineer recommends no specific action other than continued attention to boron concentrations.

Figure 1: Boron concentrations in the CCRMP area from Water Year 1999 through Water Year 2017.

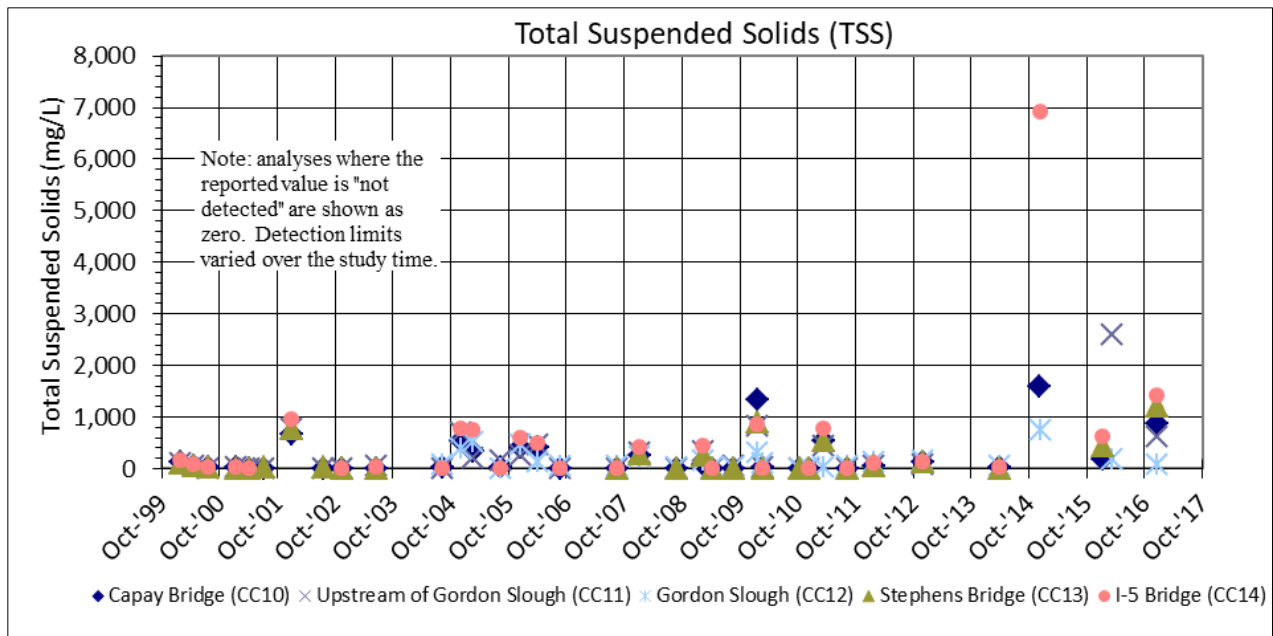
Total Suspended Solids (TSS) concentrations were more consistent throughout the study area than the previous two years, but at most sites were higher than historical averages (Figure 2). However, the samples were taken at a relatively high flow (3,000 cfs at Yolo) which may have been more likely to be carrying higher suspended sediments than typical storm events.

Figure 2: Total Suspended Solids concentrations in the CCRMP area from Water Year 1999 through Water Year 2017.

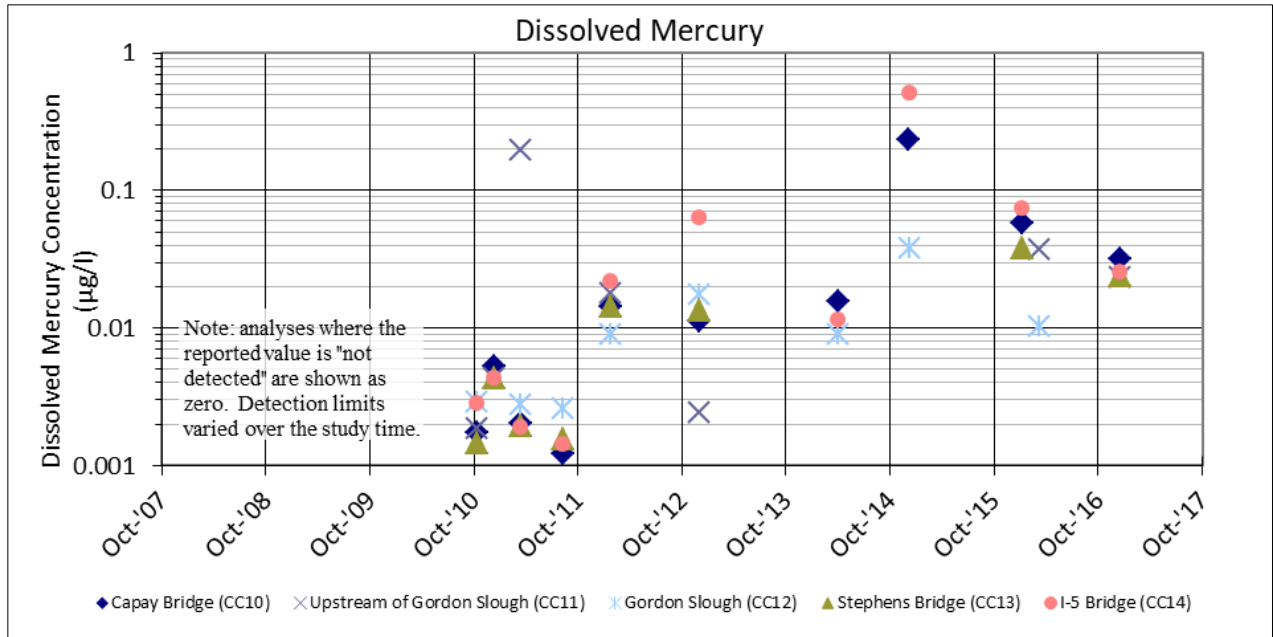
Mercury concentrations – both total and dissolved – showed more consistent concentrations throughout the CCRMP area than in previous years (Figure 3 and Figure 4). After spikes in mercury at the Capay Bridge and I-5 Bridge in water year 2015, the samples analyzed in water year 2017 were lower but still a bit higher than levels typically seen in 2010-2014.

Total mercury concentrations exceeded the California Toxics Rule (CTR) threshold of 0.05 micrograms per liter at all sites. Dissolved mercury concentrations were lower than both 2015 and 2016. It is not clear why mercury levels continue to be elevated relative to 2010-2014. In a notable difference from recent years, most of the mercury was present as particulate-attached mercury, rather than as dissolved mercury. Because total suspended solids were higher than typical in this year’s samples, and the flow during sampling was near the storm peak, higher levels of fine sediment particles in the samples may explain why more mercury was associated with particles rather than dissolved.

Figure 3: Dissolved mercury concentrations in the CCRMP area from Water Year 2008 through Water Year 2017.

In addition, as previously recommended, the TAC Hydraulic Engineer continues to recommend continuation of coordination with other entities assessing broader mercury issues in the Cache Creek watershed, including the California Department of Water Resources (DWR), the Central Valley Regional Water Quality Control Board (RWQCB), the US Geological Survey (USGS) and the Bureau of Land Management (BLM) to ensure that relevant mercury information is shared with the broader on-going mercury studies.

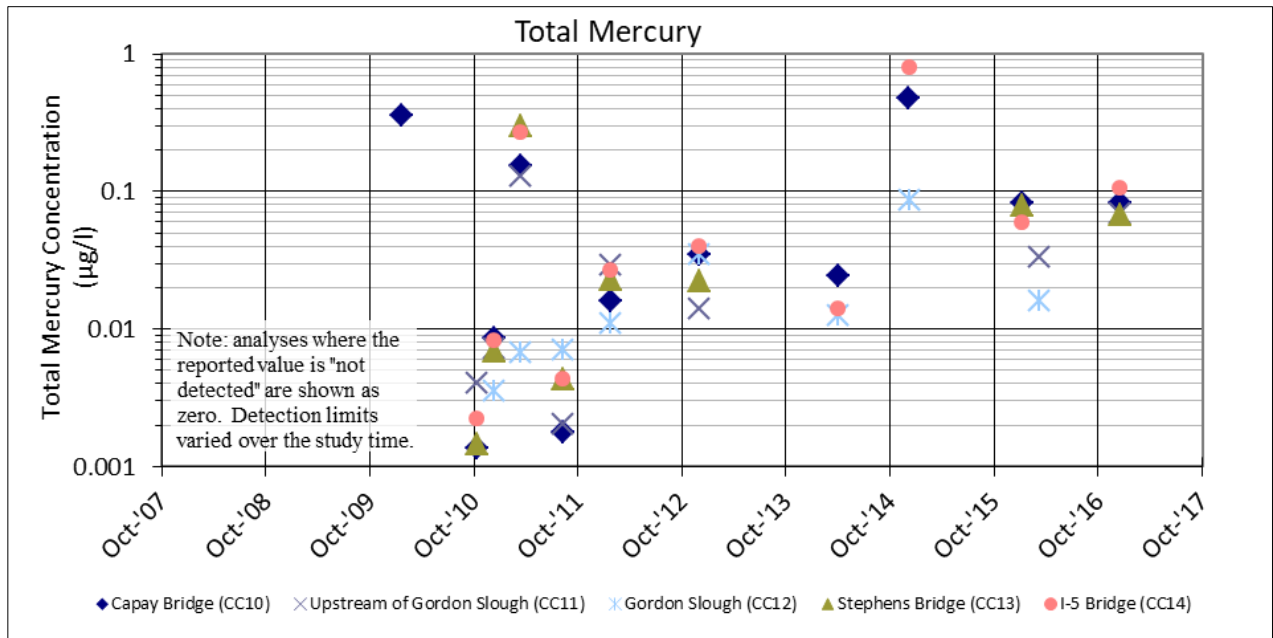
Figure 4: Total mercury concentrations in the CCRMP area from Water Year 2008 through Water Year 2017.

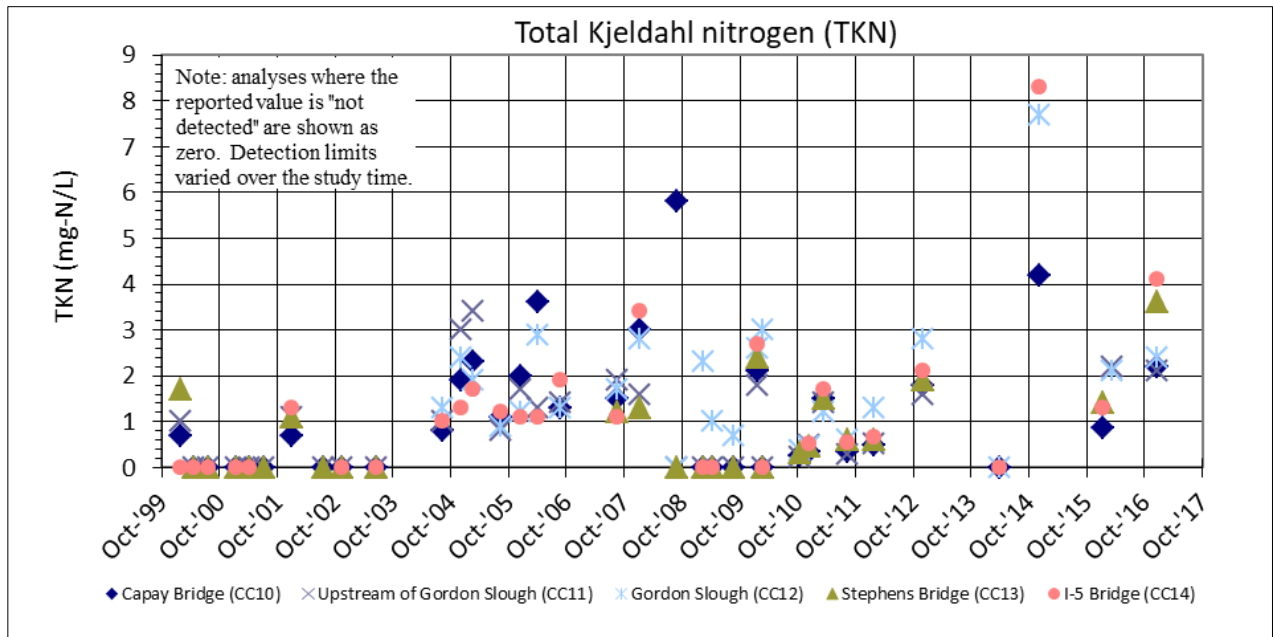
Total Kjeldahl Nitrogen (TKN) concentrations were higher in Water Year 2017 than 2016 but were in line with historical levels (5). The TAC Hydraulic Engineer recommends no specific action other than continued attention to all nitrogen species concentrations in the future to determine if the spike in TKN 2015 was anomalous.

Figure 5: Total Kjeldahl Nitrogen concentrations in the CCRMP area from Water Year 1999 through Water Year 2017.

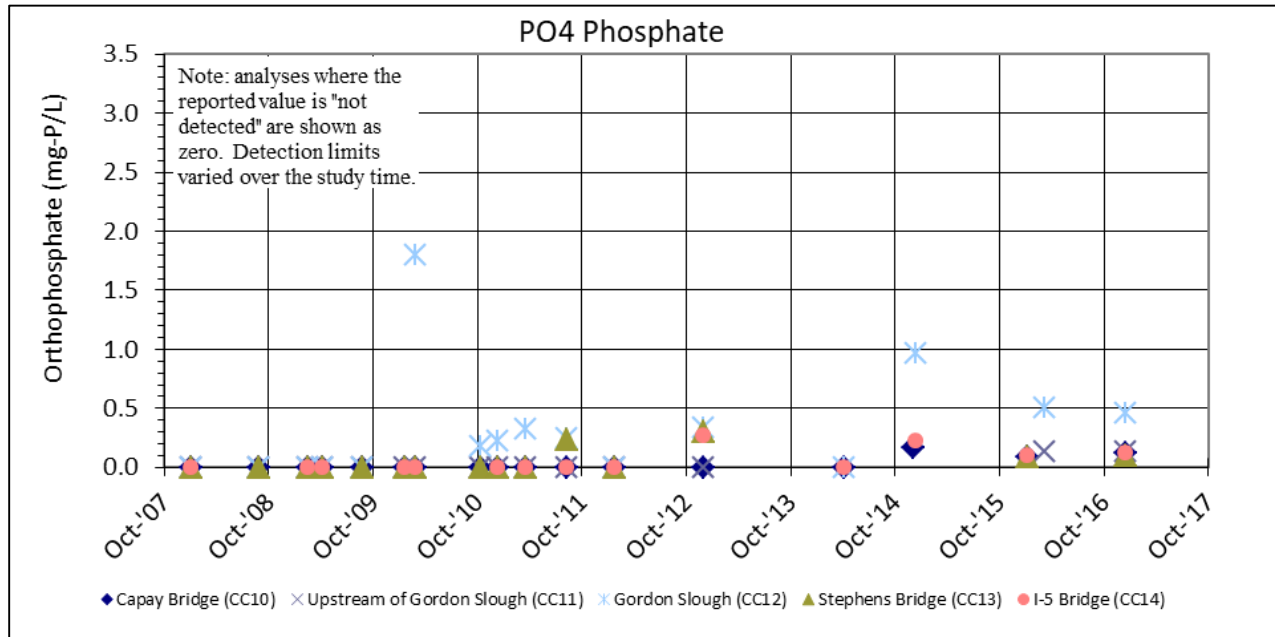
Orthophosphate concentrations in Water Year 2017 samples were typical of previous years and similar to 2016. The Gordon Slough site continued to exhibit the highest concentrations of all sites sampled as has typically been the case (Figure 6).

Figure 6: Total Orthophosphate concentrations in the CCRMP area from Water Year 2008 through Water Year 2017.

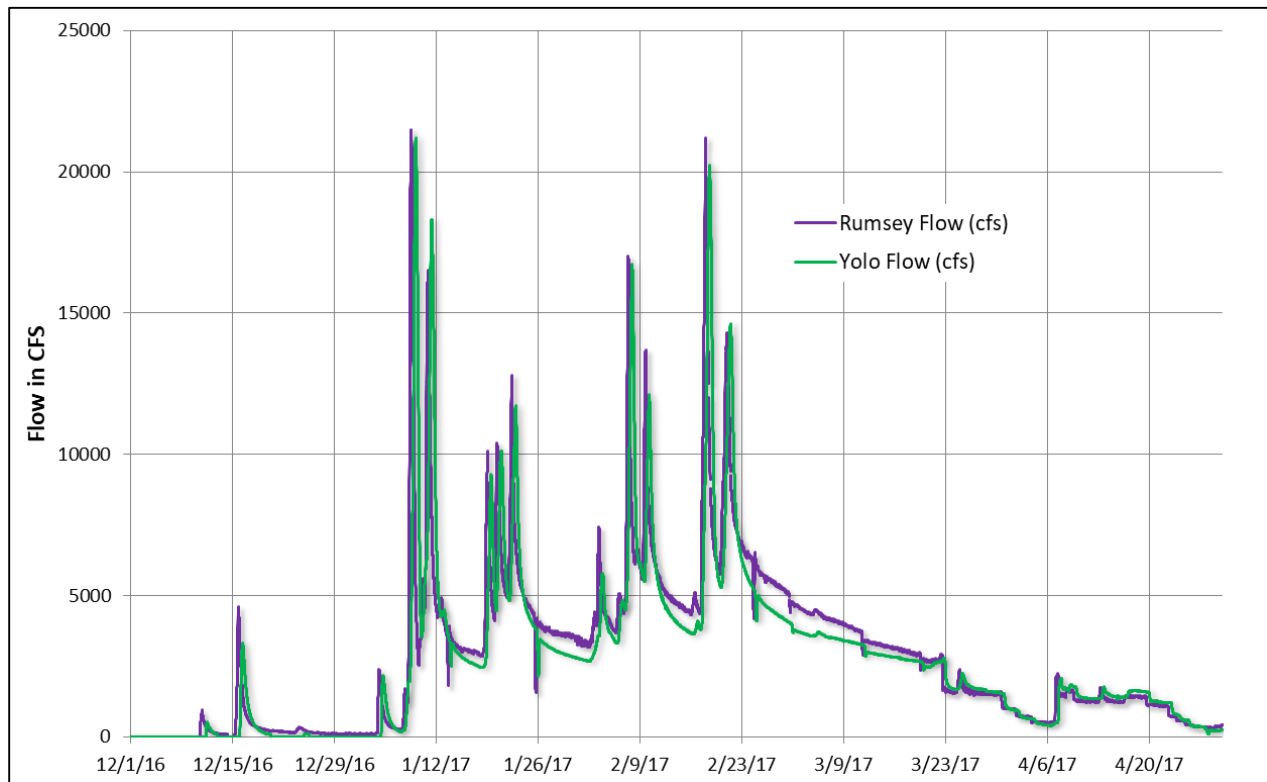
The largest storm peaked at Rumsey on January 8, 2017 at 21,500 cfs and at Yolo on January 9, 2017 at 21,200 cfs (Figure 7). Another storm event on February 18, 2017 also exceeded 20,000 cfs. These events represent approximately 5-year return interval flow events for Cache Creek. Figure 8 below compares instantaneous flows at the Rumsey (upstream) and Yolo (downstream) gages during the period of recorded flows in Cache Creek (approximately 12/01/2016 through 4/30/2017). The 2-year return interval flow for Cache Creek is approximately 11,000 cfs, meaning that in addition to the two ~5-year events, five more events of a magnitude between the 2- and 5-year return interval occurred while two events in January reached 10,000 cfs.

Figure 7: Instantaneous (i.e. hourly) flows between 12/01/2016 and 04/30/2017 at the Rumsey and Yolo gages.

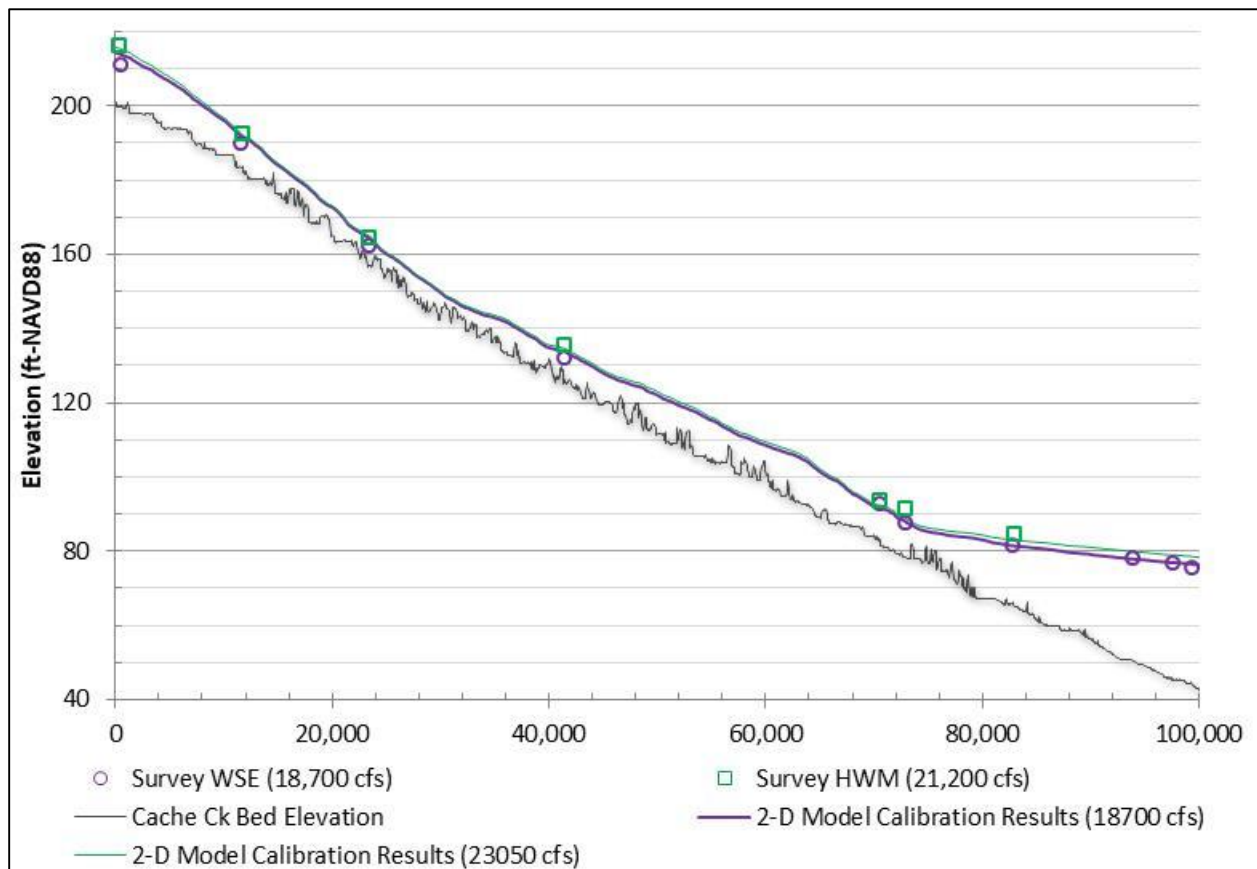
As shown in Figure 8, the hydraulic model predictions matched the surveyed water surface elevations very well.

Figure 8: Longitudinal profile of water surface elevations measured on 01/09/2017 and predicted by calibrated 2D hydraulic model.

Similar water surface elevation profiles are recommended to be surveyed in the future during larger events to further calibrate the hydraulic model, and any discrepancies between water surface elevation surveys and Yolo gage data should be noted.

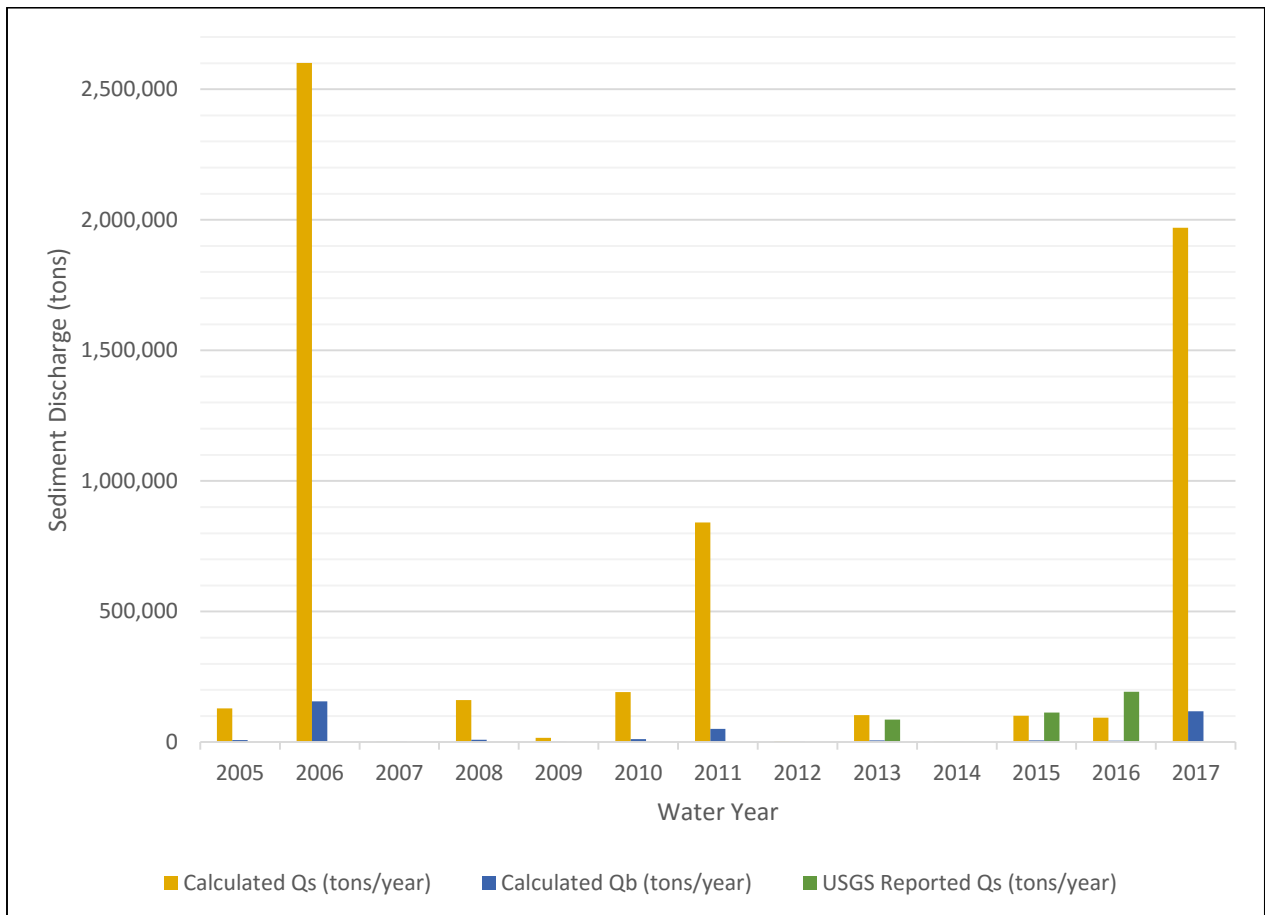
Figure 17: Cache Creek total sediment transport in tons/year. Includes Q_s calculations made using provisional data. *USGS suspended sediment transport data only available for Water Years 2013, 2014, 2015, and 2016.

Table 3 is a ranked summary of suspended load and bed load transported to, and through, the CCRMP reach over the last thirteen Water Years. Total sediment transport in Water Year 2017 increased dramatically from the preceding drought periods, accounting for 31.7% of the total sediment load over the past thirteen years. Water Years 2006 and 2017 transported nearly three quarters of all the sediment over this time period. The extremely wet conditions in the Winter and Spring of 2017 (see Chapter 3), with extended periods of flows exceeding the mobilization threshold for sediment in Cache Creek, resulted in the high sediment transport in 2017.
