**Property Condition and Code Compliance Assessment
for the Davis Communications Site**

County of Yolo | Parks and Recreation Department

January 29, 2008

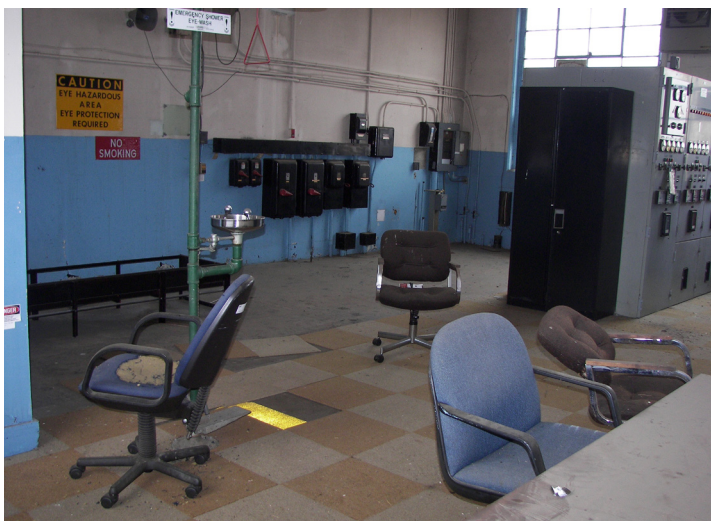
(c) Instrumentation

- Structural and building envelope integrity is sound.
- Steel beams are exposed to the interior spaces.
- HVAC and other mechanical and electrical systems are antiquated and should be removed/ replaced. The two diesel-fired backup generators are potentially salvageable.

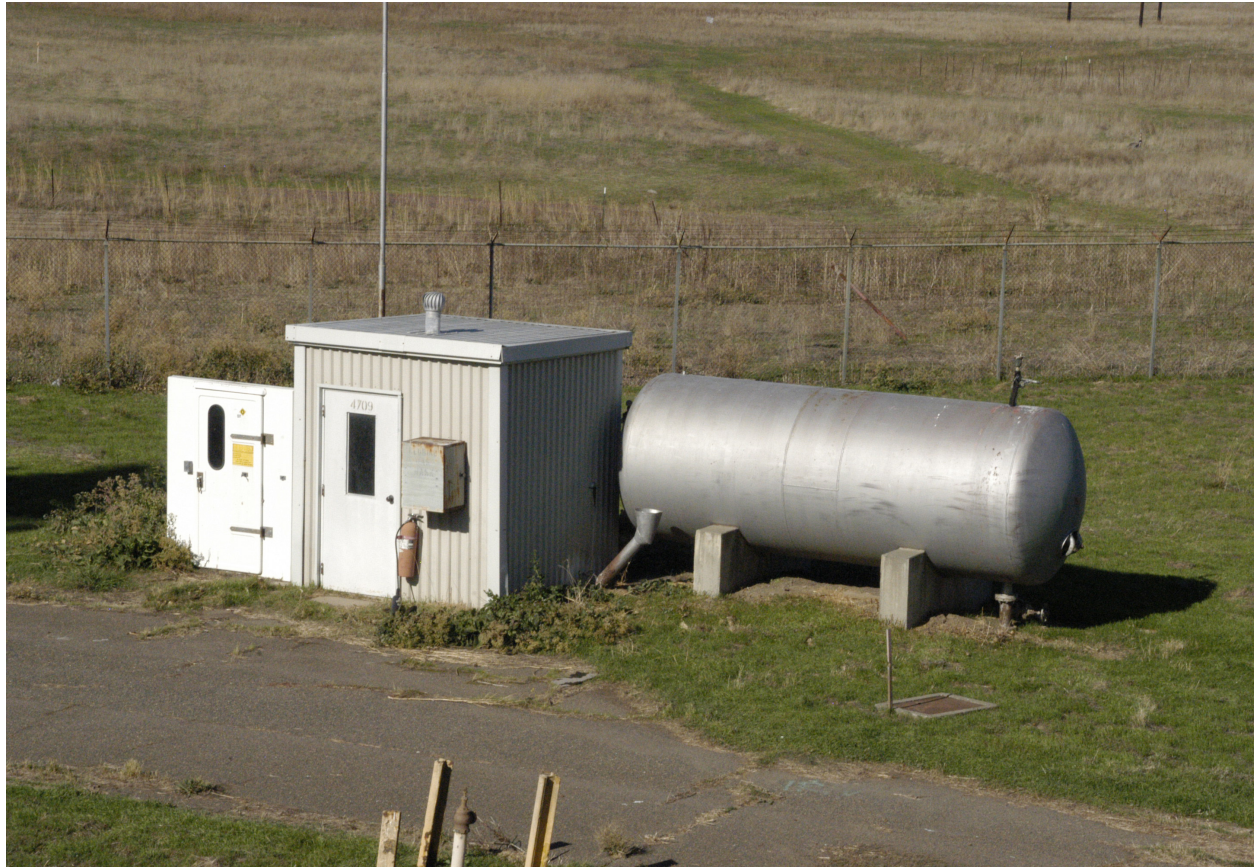
Filtration Shed, Pumphouse and Storage Shed

There are no sources of potable water at the Davis Site. A production well at the Davis site provides non-potable water for fire suppression. The well water is chlorinated, and is obtained from the C and D Zone aquifer units. Contaminants have been detected previously in this production well. The Air Force reserves the right to prohibit use of the production well if it appears, as a result of data evaluation, that the ongoing groundwater remedy is being adversely affected. Further, it restricts anyone from installing a "replacement water supply well" without their approval. The adjacent (and slightly uphill) 320 acre Yolo County Grasslands Regional Park has high concentrations of nitrates in its well water, making it non-potable.
