2008 Creek Walk Summary

YOLO COUNTY

Parks and Resources Department

2008 CREEK WALK SUMMARY

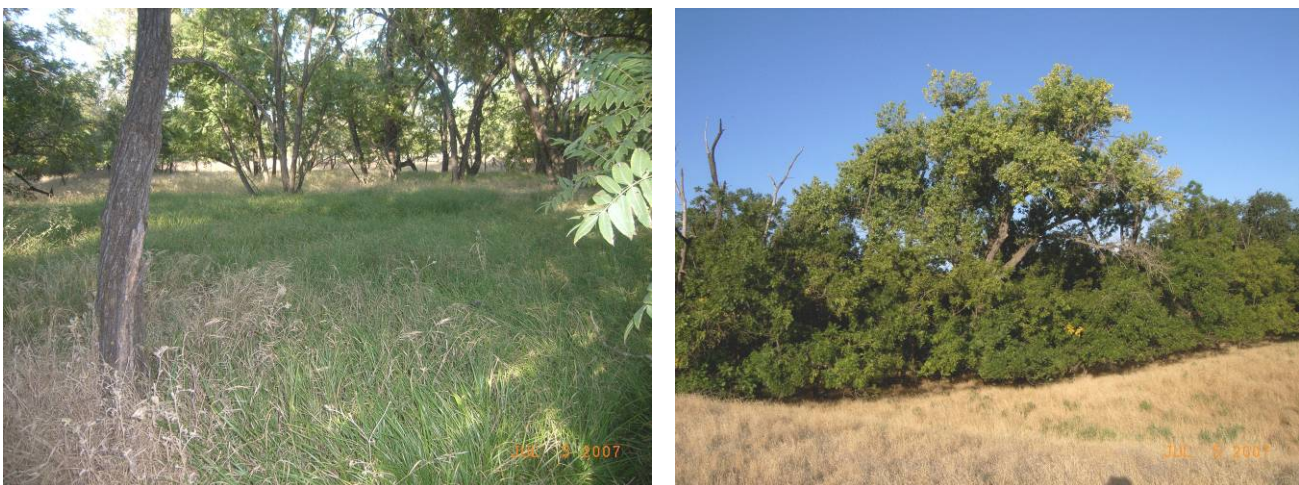
Figure 3. Stands of native vegetation on north bank in Capay Reach.

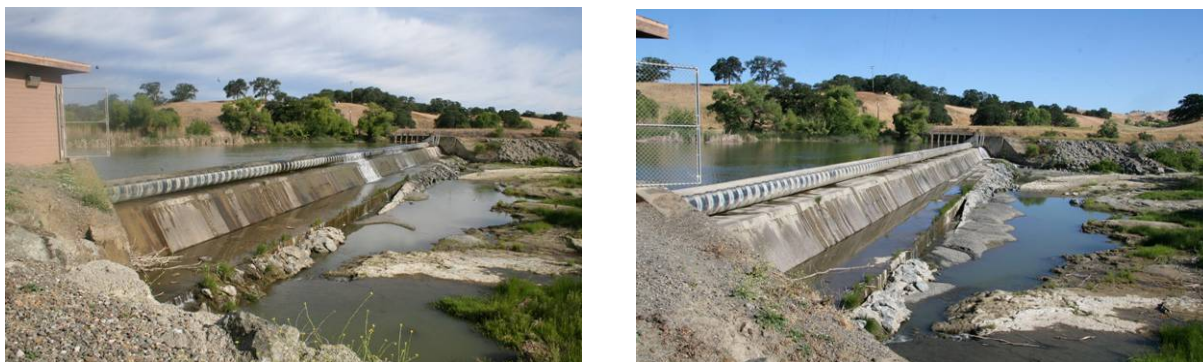
Winter flows easily overtop the dam, and Max said that sediment also passes freely over the dam during high flows. The pond upstream from the dam is shallow (probably 2 m max.), and a rubber bladder fine-tunes discharge during low flow summer conditions. The channel below the dam shows extensive erosion, especially near the north bank. Almost all loose gravel has been scoured from the channel on the downstream side, leaving patches of eroded, cohesive Tehama Formation. High flows have scoured up to 3 m into underlying sediments of the Tehama Formation. In the past year, a concrete and boulder patch on the apron has eroded slightly, although side-by-side comparison of photos taken one year earlier shows little large-scale change to the apron:

Figure 6. 2007 photo of Capay diversion dam.

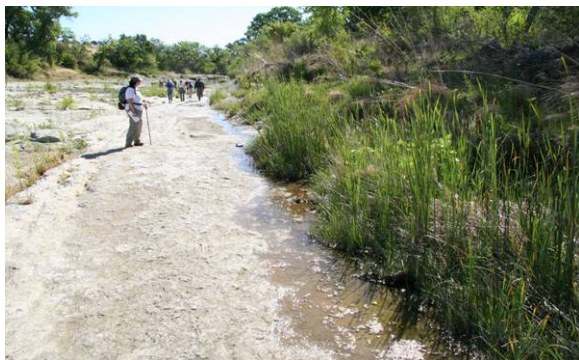
Figure 8. Seeps along the south bank at RM 28.2.

through the soil profile. Seeps on the north bank may be leakage from the unlined irrigation canal.

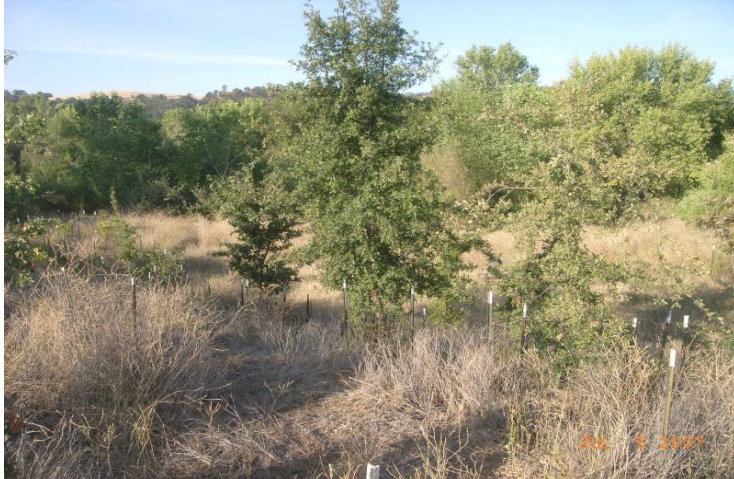
Figure 12. Restoration work done at the PG&E Palisades site.

Significant changes have occurred since the 2007 Creek Walk. Sediment has collected in new areas, erosion patterns have changed, and beavers have raised the water level upstream from the pillow blanket. A beaver dam is attached to the pillow blanket along the south bank. The beavers utilized the solid abutment of the pillow blanket and eroded clay bedrock as anchor points. Comparing photos between years there is no significant difference in the water levels before and after the beaver dam was created. The scour found at the Palisades is probably unrelated to the beaver dam. Any sediment deposition

that occurs due to the beaver dam occurs at low flow. At high flows, the beaver dam is insignificant as far as affecting the flow and sediment dynamics (deposition or erosion) are concerned. The scour that occurred upstream of the concrete blanket occurred at much higher flows as Cache Creek overtopped the pillow blanket. There is also no apparent negative impact due to the beaver dam on the stream morphology. Large, heavy chunks of pillow blanket have been tossed onto the top of the protective pad, and erosion has undercut the top edge of the pillow blanket. A 1-1.5 m deep scour hole is present on the upstream edge of the pillow blanket, and the concrete has been undercut by at least 60 cm in places. Loose pillows have also been moved in behind the sediment traps along the north bank (see figure 6 above). Erosion of this intensity would probably occur during peak winter flows. This area is a continuing concern, and the pillow blanket seems like a temporary solution that requires annual maintenance. A significant portion of the concrete was visible, and this may be due to localized erosion and migration of a nickpoint that has moved through this area. The concrete blanket reduces or eliminates in-channel geomorphic processes locally. Erosion ideally should be addressed before high flows return next winter to avoid losing larger chunks of the protective blanket or to prevent complete failure of the blanket and breach of the pipe. As it is required by the DFG to do work in-channel prior to October 31, it is unlikely that work will be completed this year, but should be planned for the 2009-2010 season. The beavers are part of this system, and design or construction people should consult with biologists or ecologists to consider the effects of a new concrete patch on the beavers. The beavers might also be considered a nuisance and removed, although this is likely to be controversial and not entirely necessary.

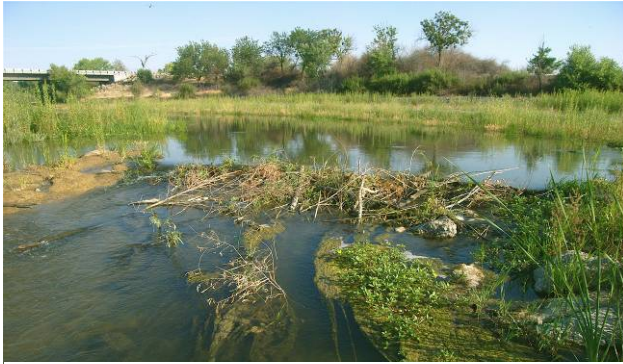
Figure 17: Beaver dam downstream from CR-85 Capay Bridge.

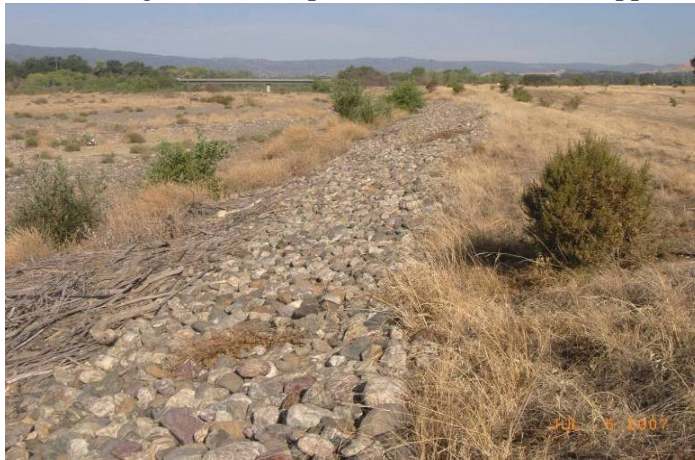
Figure 20. Bank protection extending downstream of Capay Bridge

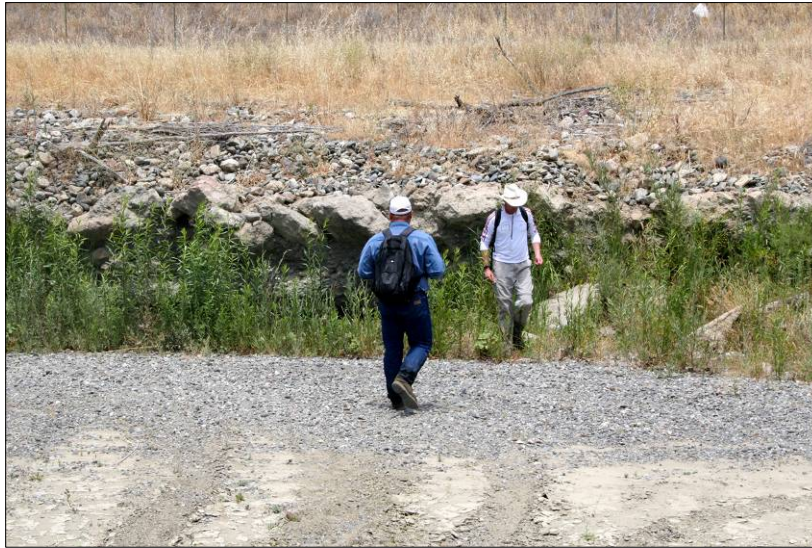
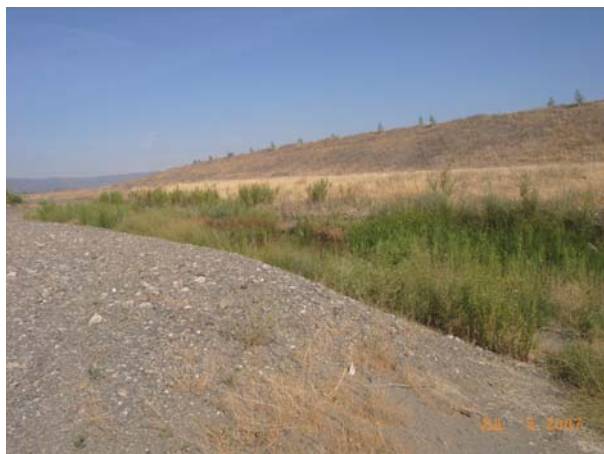
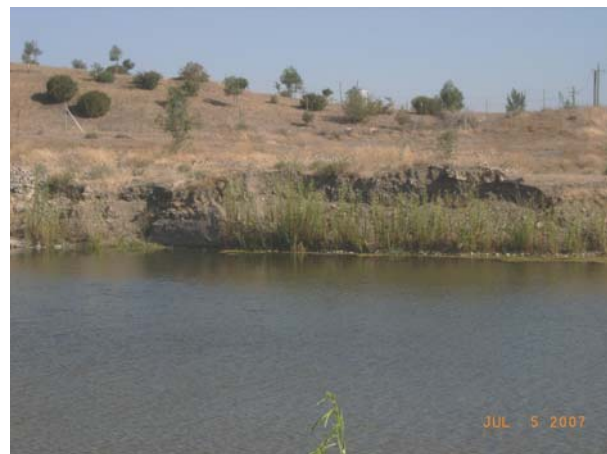
bank eroded again during the 2005-2006 winter flows. Granite also planted native vegetation on the bank and installed drip irrigation to promote successful plant establishment. The County reviewed the project and issued the Flood Hazard Development Permit for this project. Bank stabilization at this site allows commercial mining within 66 m of the active channel, under the guidelines of the CCRMP. More than 600 m of the north bank have been stabilized, and the company submitted a plan to stabilize another 300 m of bank in August 2007. The project was

Figure 24 (above), 25 (below left), and 26 (below right). Granite Co. bank stabilization eroding at the toe.

approved by the TAC, but the project has been held up since during its review by ACE. The existing bank stabilization has been fairly effective on a broad scale, although localized scour has undercut portions of the bank, exposing some of the boulders that anchor the toe of the bank (see photo). These erosional scars are tens to hundred meters long, and are at the level of the stream channel. It appears that the lower rock embankment was not planted. The higher embankment was planted with a variety of species, such as Fremont Cottonwood, Interior Live Oak (*Quercus wislizeni*), pine, *Ceanothus* sp., and other species. The site would benefit greatly from a riparian (vegetative) buffer on the lower slope and at the base of the slope. The active channel is closer to the north bank along this reach, and the site should be monitored closely for signs of additional erosion. Continued erosion would threaten a nearby haul road and gravel pit. The higher embankment area was

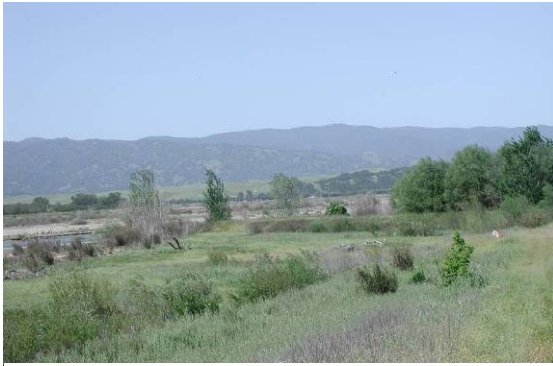
mature vegetation is absent, the spur dikes and intervening lowlands have collected a layer of silty sand that sustains a grassy cover. The toes of all spur dikes have been eroded, and this should be monitored carefully. Previous Creek Walk reports noted similar erosion at the toe of these dikes. One possible solution to prevent erosion and prevent exposure of concrete rubble would be to use concrete rubble in the body of the spur dike, and natural boulders on the toe of the dike. As noted above, we still need to investigate the environmental hazards associated with using concrete in the

Figure 32. Syar South spur dikes and revegetation (RM 24).

Creek. With this proposed solution, the concrete and boulders would be covered with soil and vegetated. If the toe eroded, natural boulders would be revealed and not concrete rubble. In addition, improving the vegetation on the spur dikes would not only help prevent erosion, but would increase wildlife habitat on Cache Creek.

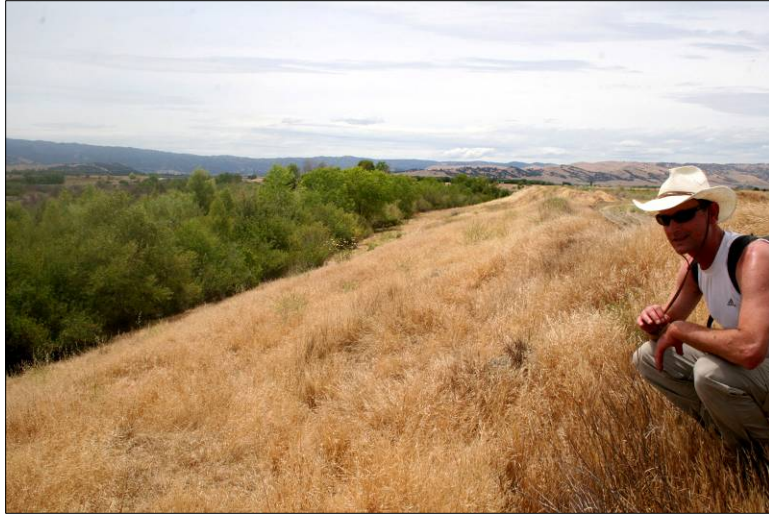
effectively slow and deflect flows, and, in turn, protected the vegetation from being washed out. The low berm and willow prism protect the north bank from erosion during moderately high flows. The berm was constructed with concrete rubble as part of the base structure. The concrete rubble was considered by some as unsightly. In 2008, we noted again the unsightly concrete rubble, where it has become exposed in this berm. The method of a berm near the channel with a “trench” behind it, which is filled with vegetation, all of which protects the bank, seems to be an effective solution. It

Figure 34. Esparto-Reiff bank protection/habitat enhancement.

was suggested by Eric Larsen that, perhaps, the berm could be more temporary. Without the concrete rubble, the berm might more easily disintegrate leaving the riparian zone as the “bank protection”. However, the high berm borders a settling pond, and it is essential to maintain a buffer zone between the stream and the mining operation at this location. The levee protects wash water ponds at this site, and any significant breach in the levee would release fine sediment to the stream, resulting in a severe water quality issue.

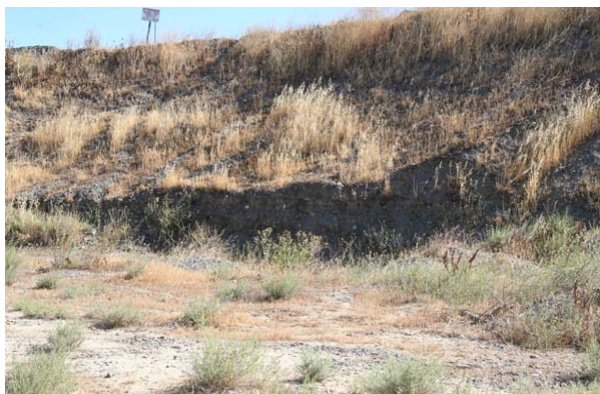
Figure 35: Erosion at the levee toe, RM 23.2.

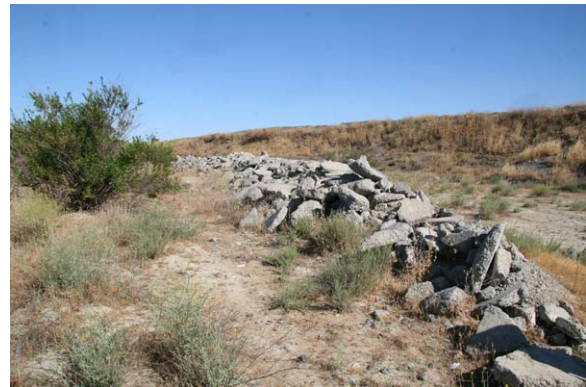
Figure 36: Bare concrete rubble protects the base of the levee at RM 23.2.

1. Success criteria need to be evaluated of the Questa Engineering designed levee repair.
2. The County needs to work with Teichert to develop an alternative to using exposed concrete in Cache Creek for bank protection. Bioengineering designs should be encouraged.
3. Soil and plantings should be evaluated and only native species to Cache Creek should be used to revegetate the area.
4. The County should meet with Teichert to inspect and explore options for this area.

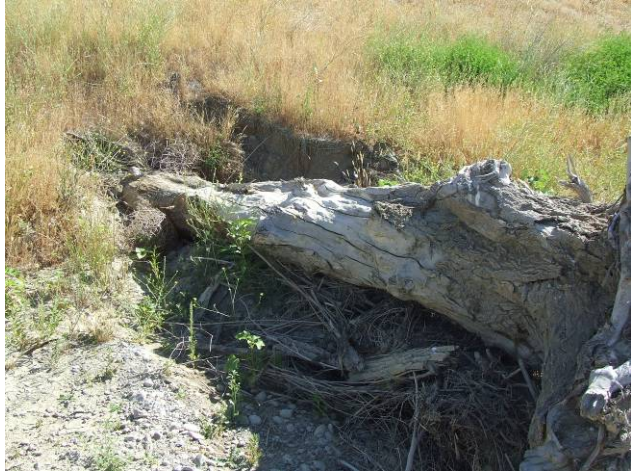
Figure 37. Esparto-Reiff bank protection/habitat enhancement.

Bank erosion occurred at this Teichert site after the floods of 2006. Several protection measures were implemented, including root wads, restoration, and coir fabric placed on the slope. Questa Engineering designed a series of cabled-together root wads to redirect the flows. One hundred fifty meters of cabled oak root wads were added on the downstream end of the project in 2006. Root wads were tied together with cables and placed in the channel at RM 22.8, but they are too far from the base of the levee to provide protection during high flows. Several of these root wads have scour holes on the downstream sides, and cattails are growing in low, marshy ponds that surround the root wads. The root wads have failed to protect the

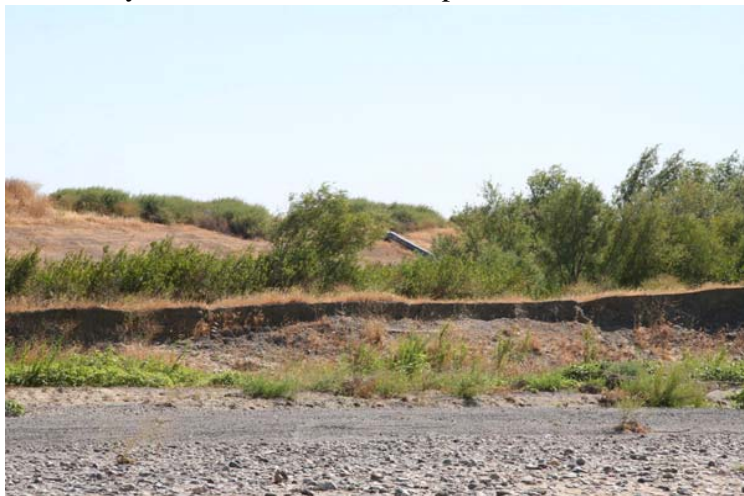
A large drainage pipe at RM 22.5 should be investigated because of water quality concerns. This pipe is about 40 cm in diameter, and looks relatively new. It is probably an agricultural drain from the nearby orchard, but this is a potential source of contaminants to the stream. The preferred

approach is to avoid artificial drainage into the stream wherever possible. A secondary terrace or bluff in the main channel may restrict drainage from the pipe to a backwater or oxbow area directly under the pipe. This containment would have a filtering effect, and may partially mitigate the effects of agricultural drainage. Fine sediment has accumulated on the terrace surface, and willows are more established at this site. Bank Swallow nests were observed at RM 22.4, and are restricted to the loamy cap that overlies coarser, gravel-rich channel sediments.

Figure 40. Drainage pipe has outflow onto a low terrace surface contained within the main channel.

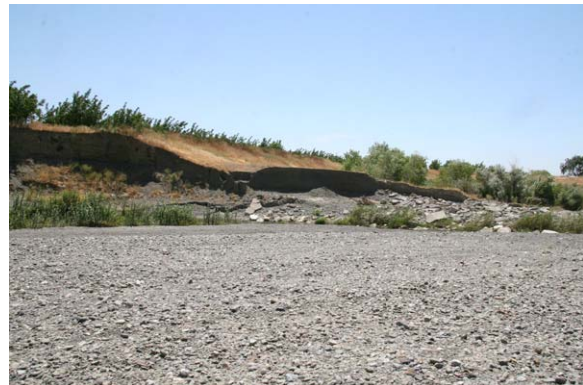
Figure 43: Active erosion of upstream spur dike, RM 21.55 north bank.

The broken concrete core of the spur dike constructed here was disturbed although large pieces remained in place. The spur dikes downstream of the damaged spur dike showed little sign of erosion. Vegetation between the spur dikes is thriving and several inches of sediment have accumulated over the past year. The spur dikes are buried, covered with vegetation that dates back to 2002, and are barely visible. Loamy soil up to 0.60 m thick blankets the areas between the spur dikes along the north bank.

3. Design an erosion control project that deflects the energy of the channel meander located upstream of the Dunbar site and reform the existing upstream spur dike at the Dunbar site to stabilize the north bank. Significant accumulation of fine particle soil has occurred behind the existing spur dikes and both planted and naturally occurring vegetation has flourished showing that in-channel vegetation within this subreach can survive as long as it is protected from high energy flows. Repair of the eroded spur dike should be investigated as a component of the design of any further bank protection designs for the area.

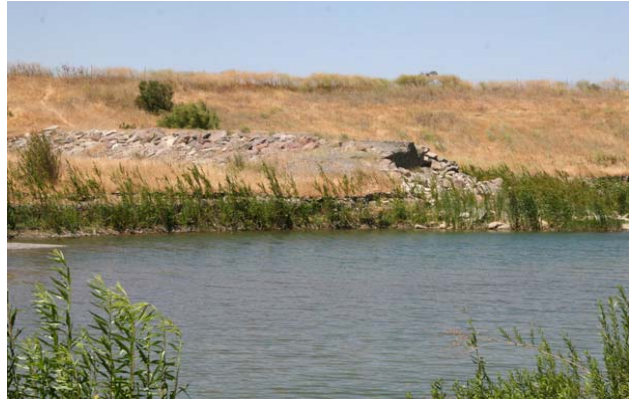
Figure 43: Erosion at upstream (south bank) spur dike, RM 21.3 in 2007 (left) and 2008 (right).

The tip of the upstream spur dike (south bank side) is highly eroded, and this erosion was noted in previous Creek Walks. This upstream spur dike impinges on a meander bend and forces flow toward the channel center, so it is subject to the highest erosive force. The second spur dike (in a downstream direction) also has erosion at the tip, although this erosion is less severe. This would be a good site for a quick comparative study between old and new air photos. It is difficult to tell how much of the upstream dike has been removed without this comparison. Erosion should be monitored carefully at these spur dikes. Beavers have built a low dam across a portion of the Creek at RM 21.5, although this does not have any significant effect on the carrying capacity of the stream.

1. It was noted in 2006, that the tip of the most upstream dike was eroded and a relatively deep scour hole had formed in the channel adjacent to the dike. Erosion of the south bank (three to four foot high vertical bank) was noted just upstream from this dike. Aerial photographs need to be viewed to see whether there was further erosion between 2006 and 2008.
2. The County should work with the landowner and Syar to cap the spur dikes, amend the soil, and establishing a greater diversity of vegetation along and in between the spur dikes and on the upper portions of the rip-rapped slopes.

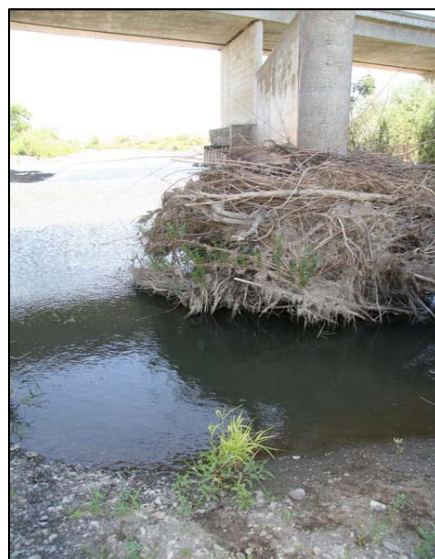
The channel is constricted by a factor of 0.5 to 0.7 times the normal width as it passes under the I-505 Bridge, resulting in increased stream velocity. This bridge has a longitudinal pier construction on the abutments that interferes with any flow that is not perpendicular to the bridge. As a result, extensive scour pools up to 1.5 m deep have formed around each abutment. This structure should be monitored during and after high flow events to assess damage to the bridge support structures. The visual inspection did not reveal any significant changes around the bridge supports since the 2007 Creek walk.

Figure 47: Scour hole on upstream end of I-505 Bridge support.

1. Monitor the I-505 abutments and use HEC-RAS to examine longer term solutions for the I-505 Bridge that would reduce scour and risk to the abutments.
2. See the recommendations above for CEMEX's property in the CCRMP area.

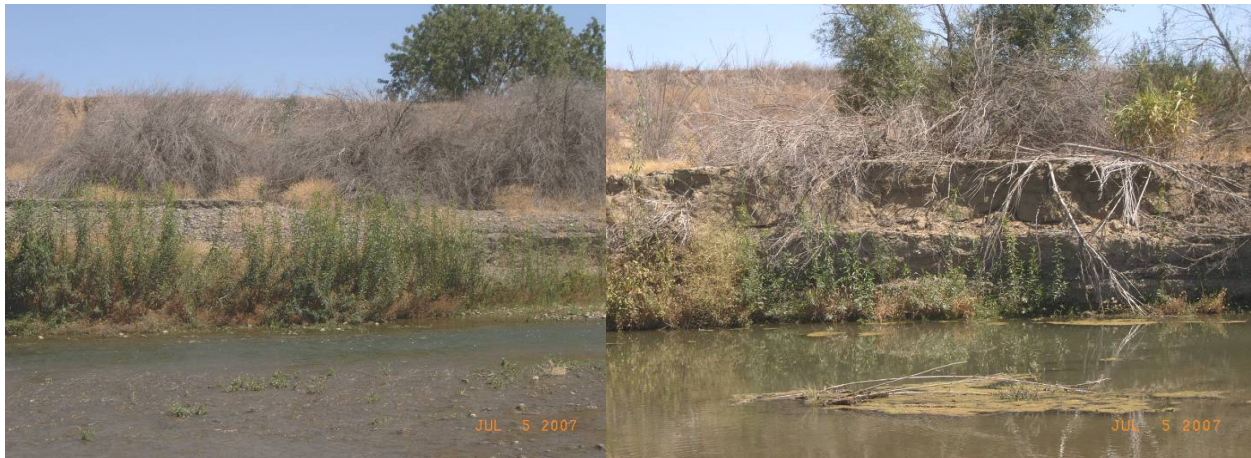
Figure 48. Tamarix killed by spraying.

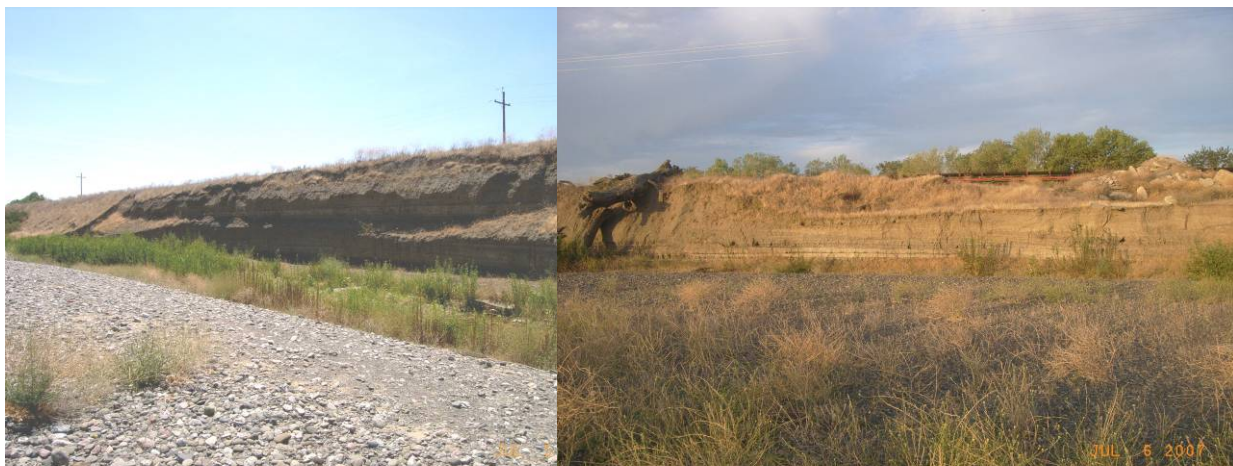
Adjacent to the bank, in the channel, there is a large deposit of gravel, with a downstream slump-face of about 1.5 m in elevation. For some locations, the removal or skimming of the in-channel bars would provide benefit for the long-term stability of Cache Creek. If Cache Creek is continuing to deposit gravel and other sediment sizes, it will aggrade unless skimmed. Such aggradation can tend to intensify the flow strength on the adjacent bank, as it seems to be doing in this area. Bar skimming in areas like this could tend to alleviate erosion on the bank. The County’s In-Channel Maintenance Mining Ordinance approved this year by the Board of Supervisors will be useful for working in areas like this on the Creek. Skimming the mid-channel bar in this location would alleviate pressure on the bank. The magnitude of the near-bank velocity reduction using a HEC-RAS model should be modeled.

Figure 55. Location for proposed bank stabilization by CEMEX approved by the TAC in 2007.

3. As there are a number of other areas also indicated in danger of levee failure or undergoing bank erosion, CEMEX must complete bank stabilization plans for the entire extent of their property and work in conjunction with Yolo County, Caltrans, the DFG, and the ACE.

6. CEMEX will need to submit a Flood Hazard Development Permit (FHDP) application which must be reviewed by the TAC and approved by Yolo County, Caltrans, DFG, and ACE.

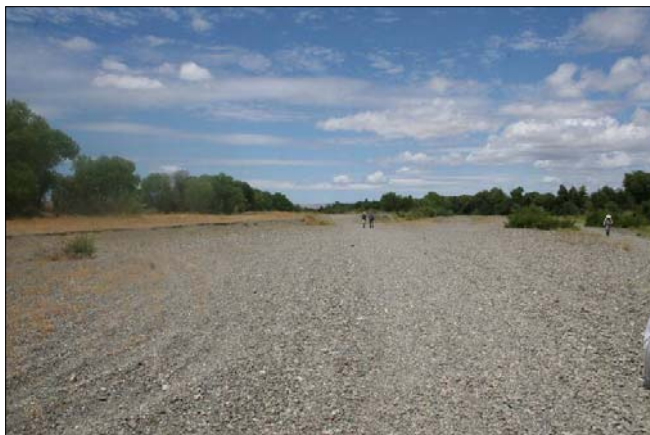
Figure 56. Large gravel bars in the Guesisosi Sub-reach

As natural as this area seems, heavy usage by OHVs has scoured the in-channel gravel bar. While the soil may be gravelly and, thus, inherently difficult for vegetation to establish, OHV use would have caused further erosion and prevented more vegetation establishment in this reach.

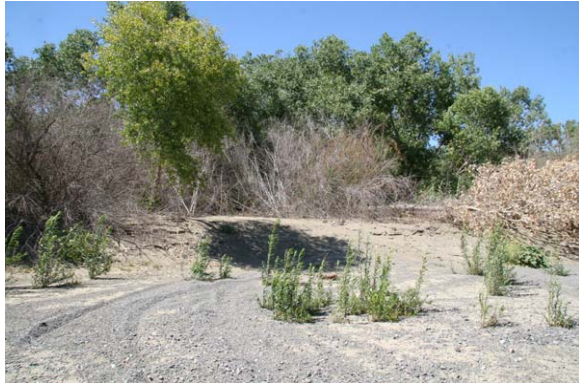
Figure 64. Complex sandy bars with established vegetation and dead tamarisk at RM 17.1.

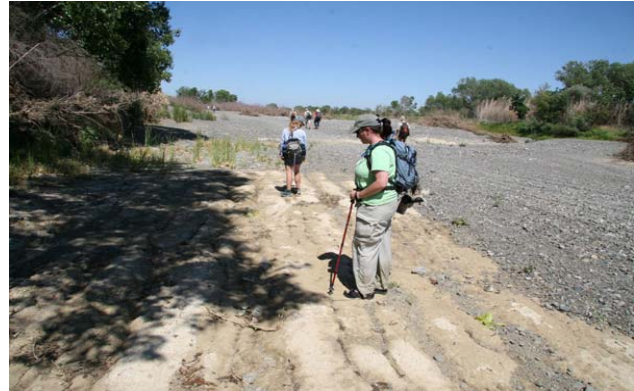
Figure 65. Bedrock exposure near RM 17.1.

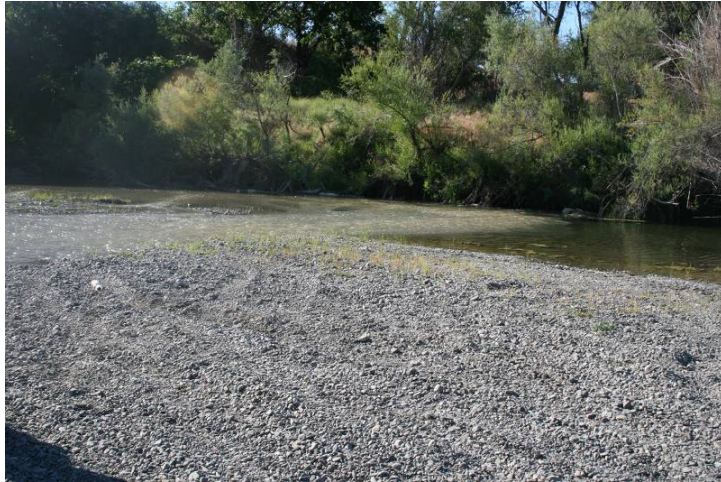
Figure 67. Vegetation on south bank at outfall of Gordon Slough and just west of CR-94B.

Yolo County has designated this as a monitoring point for water quality, and there is an obvious problem with high turbidity here. High turbidity persists for a mile or more downstream from this confluence. Other chemical constituents also have elevated levels. This site is also monitored by the RWQCB, and YCFCWCD. Tim Horner suggested that the Salisbury/Gordon Slough might be a target for more comprehensive restoration, including grading and wetlands construction in the low-lying areas. A more sinuous channel would allow fine sediment deposition, and a settling basin or wetlands area would help the downstream turbidity issue as

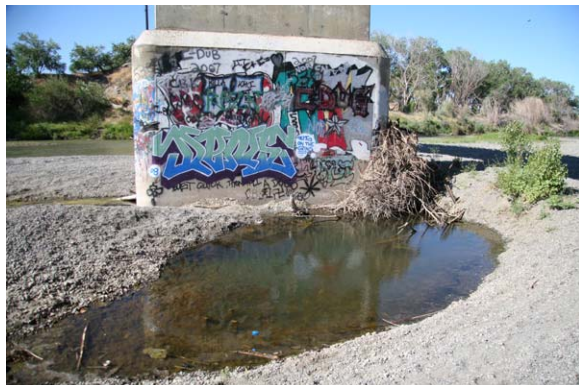
The CR-94B Bridge has scour pools up to 1 m deep around the abutments. Flow is constricted by a factor of 3 under the bridge, and erosion will continue to be a problem at this site. The channel widens dramatically downstream from the bridge, and banks have a gentle slope. Low banks are covered by older, established vegetation at the edges, and midstream bars have silty caps with young willow growth.

Figure 71: Scour pool under CR-94B Bridge.

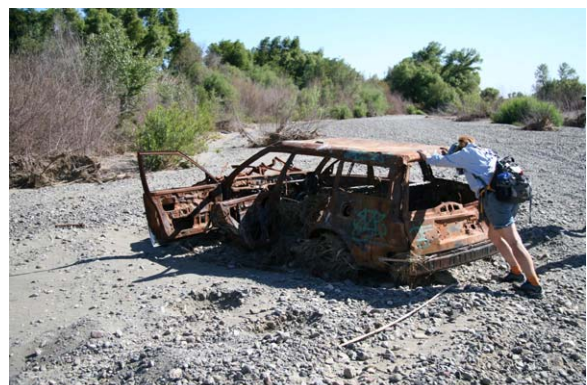
Figure 72: Abandoned car at RM 15.4.

River mile 15.5 and downstream: In 2007 and 2008 we noticed an abandoned and burned car that poses a water quality, aesthetic and safety problem. The car should be removed before (additional) automotive fluids are released into the channel. This is a relatively natural reach, with low (3-4 m high) graded banks, abundant established riparian vegetation, and mid-channel gravel bars that have formed by natural stream processes. Younger vegetation (mostly willows) is starting to take root on the mid-channel gravel bars, and will tend to stabilize the bars in the absence of high flows.

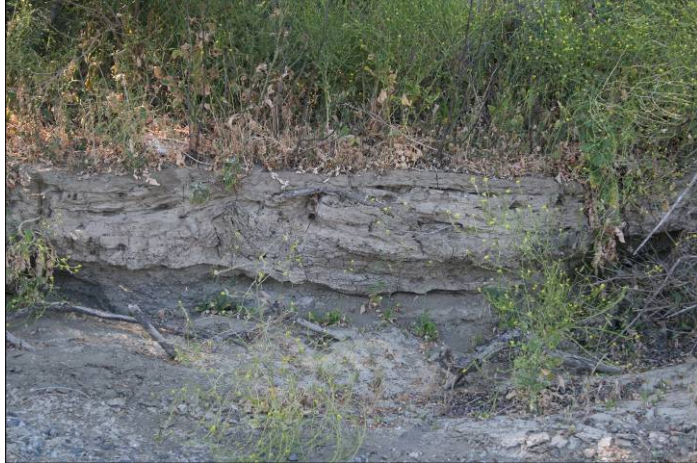
Figure 74. Loamy soil cap.

River mile 15 (Conveyor belt): Stepped or graded banks and naturally occurring mid-channel gravel bars give this subreach a natural, unaltered look. High turbidity from Gordon Slough still persists in the water. Larger vegetation (mostly willows) is well-established on riparian margins, and small willow shoots are starting to grow on mid-channel bars. Yellow Star Thistle (*Centaurea solstitialis*) and Perennial Pepperweed are common invasive non-native plants along this subreach. Some mid-channel bars have up to 0.60 m of loamy soil cap (Figure 74). The channel becomes more constricted below RM 14.9, due in part to levee

construction and bank protection near gravel pits. Bank Swallows were seen nesting along the left bank at RM 14.3. This loamy soil cap and high bank should be preserved to protect the swallow habitat.

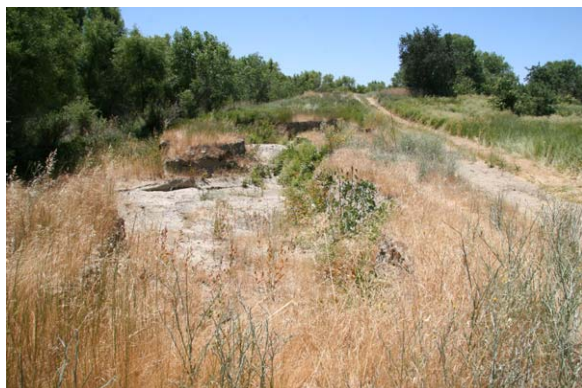
Figure 78: Eroded berm separates Correll pit from Cache Creek at RM 13.7.

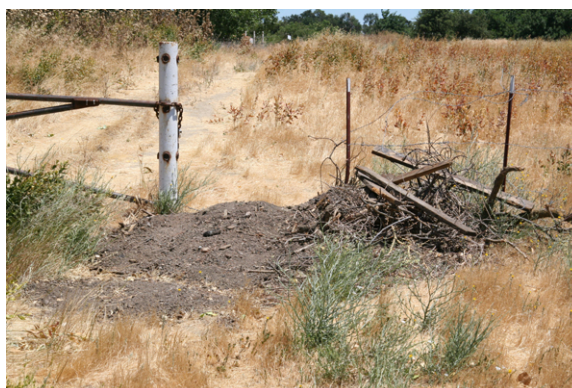
Figure 79: Brush used to block OHV traffic at RM 13.6.

Correll-Rodgers pits, and several strategies have been used to limit OHV use. Brush piles, fencing, gates and signs have all been tried, but OHV use continues to be a problem in this part of Cache Creek. Integrating all of the above strategies and using natural barriers seems like it will be a more sustainable and effective solution.

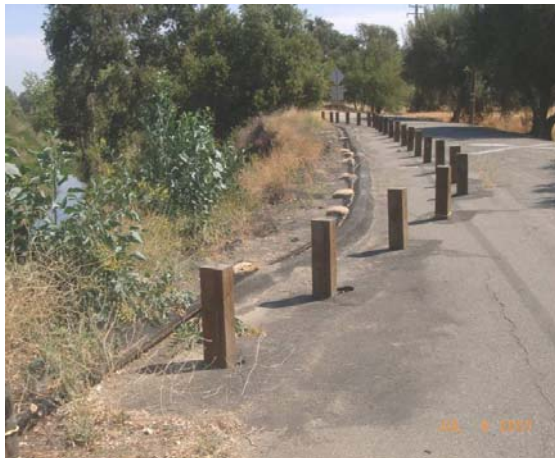
Huff's Corner is on a highly erodible outer meander bend in the river, and is inherently unstable. The river channel in this location has a sharp river bend. The radius of curvature ("tightness") of the bend and the discontinuity from straight to curved channel are one of the most extreme examples on Cache Creek that we visited. The typical (natural) meander wavelength of this portion of Cache Creek is much longer than the existing bend at Huff's corner. Such very tight bends cause high velocities and can produce high forces that tend to erode banks. The curved channel has a very tight apex and sharply-angled bend. This causes extreme hydraulic pressure on the banks. Sharp angles tend to cause flow accelerations that can transmit high flows downstream and perhaps accelerate erosion on the opposite bank downstream from the current project. The river will continue to migrate

Figure 85. Huff's Corner CR-18 prior to bank stabilization work in 2007.

eastward toward existing structures, and it may be a problem to maintain the channel in the present configuration. The current desire is to retain the existing bank line out of fear of impacting nearby private land and I-5, but a "relieved" or "relaxed" bank line in the vicinity of the corner could redirect the flows in a way that would not cause as much upstream or downstream disturbance. This could be done in such a way that would not negatively alter the flow as it passes under I-5.

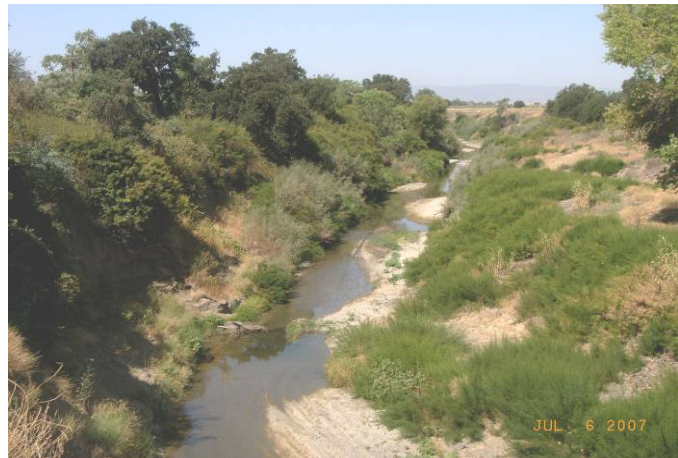
Figure 87. Huff's Corner looking upstream prior to bank stabilization work in 2007.
