Discharger: Wild Wings County Service Area  
Name of Facility: Wild Wings Water Recycling Facility  
WDRs Order Number: R5-2002-0077  
CIWQS Place 1D: 272537  
County: Yolo

**Wild Wings Water Recycling Facility – Second Quarter 2019  
Groundwater Monitoring Report  
WDR Order No. R5-2002-0077**

**Re: Groundwater Monitoring Report Second Quarter 2019  
Wild Wings Water Recycling Facility, Yolo County, CA WDR No. R5-2002-0077**

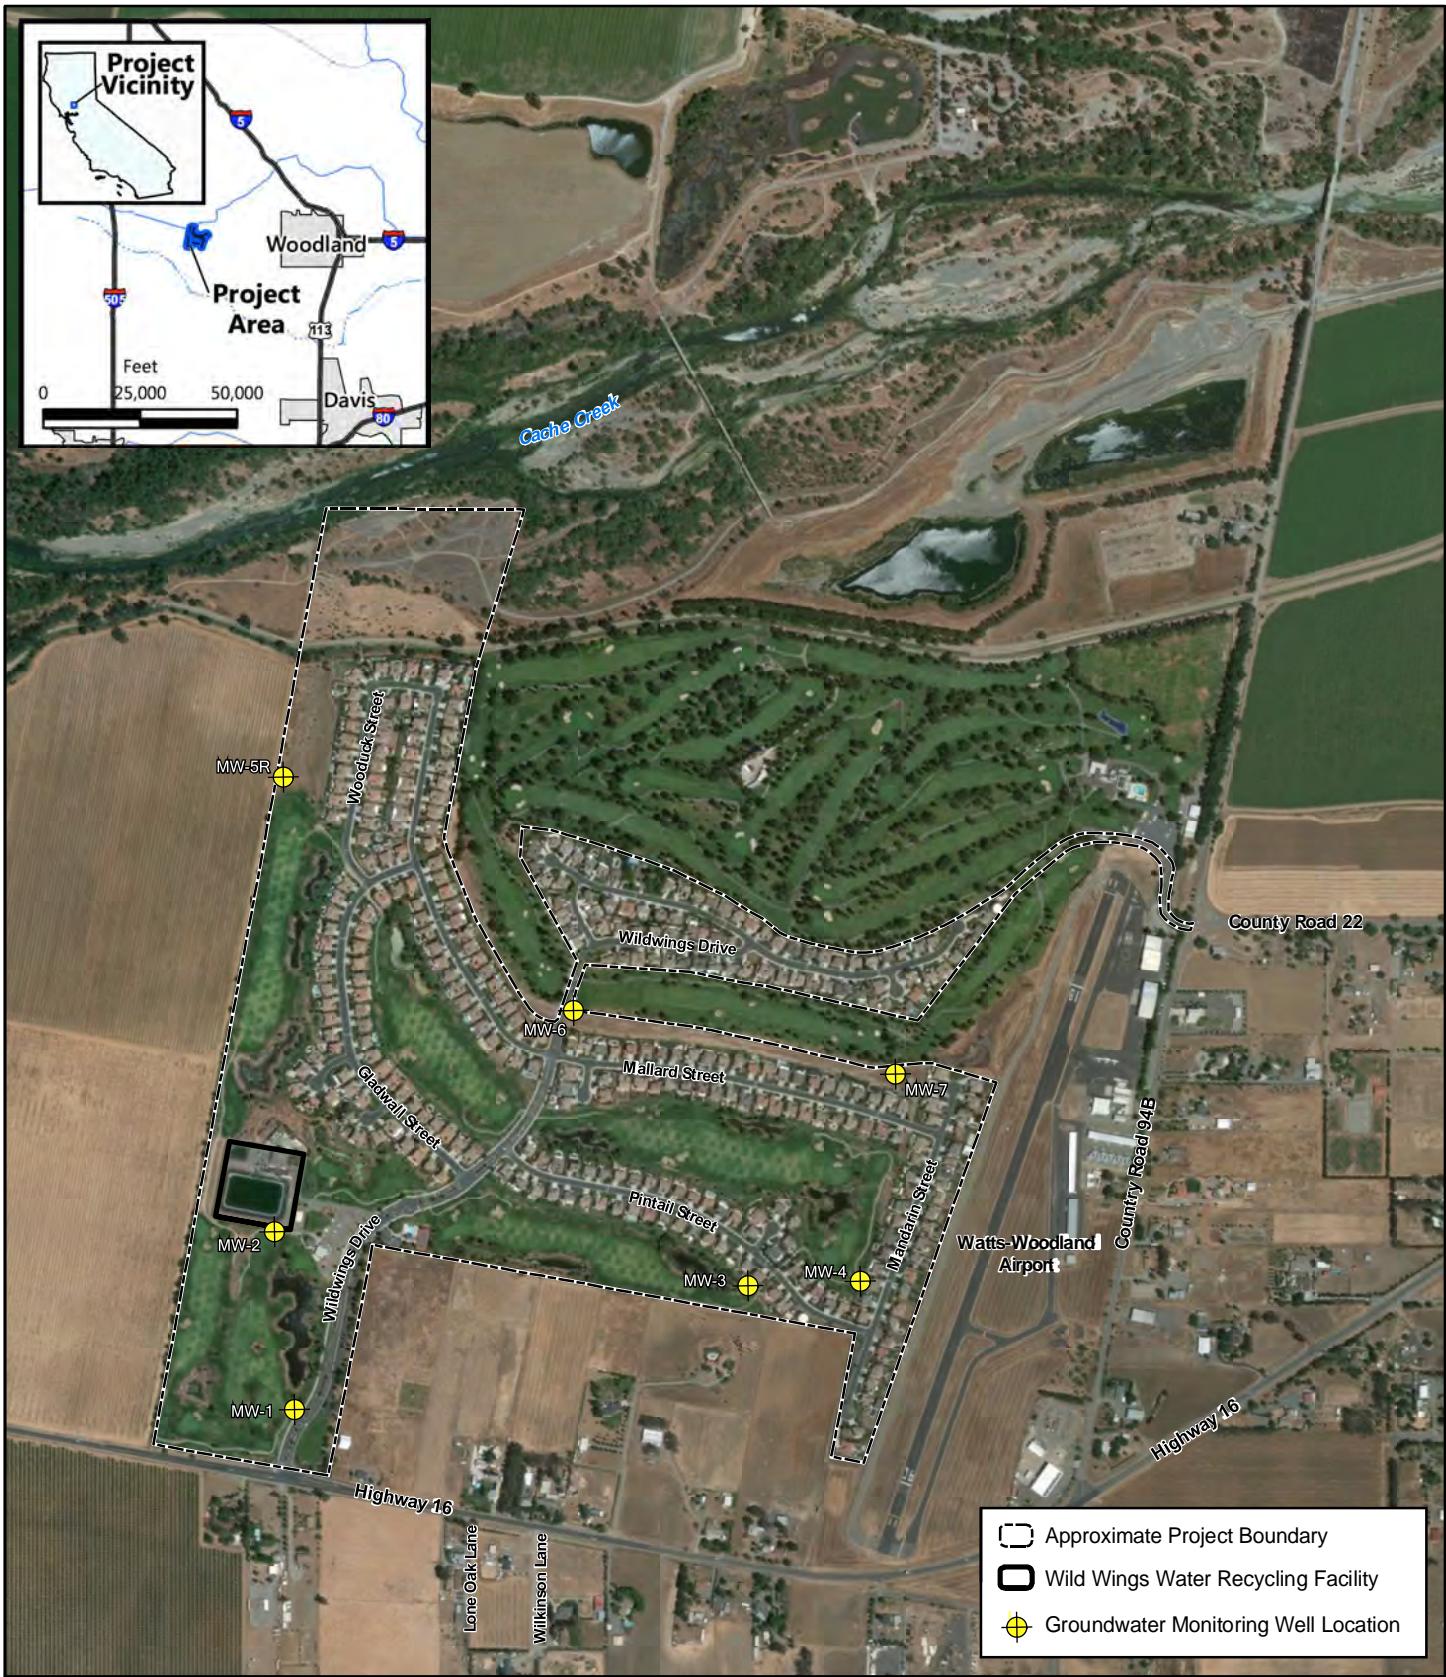
**Figure 1**  
**Site and Vicinity**

The Wild Wings development is located north of Highway 16 and west of County Road 94B at 18530 Wildwings Drive, Woodland, CA 95695, and is surrounded by agricultural land to the west, Cache Creek and the Yolo Fliers Golf Club to the north, the Watts-Woodland Airport to the east, and several rural residences to the south. In early 2015, almond orchards were planted in the agricultural land to the west of the site and water wells were installed to provide water for the orchards. The WWRF encompasses 3.67 acres (400 by 400 feet) along the southwestern side of the Wild Wings development. Figure 1 shows the location of the WWRF along with general site information and locations of seven (7) monitoring wells.

Seven monitoring wells, MW-1 through MW-7, were constructed in May through June 2004. The monitoring wells were installed on the Wild Wings development in the vicinity of the WWRF. The locations of the monitoring wells are shown on Figure 1.

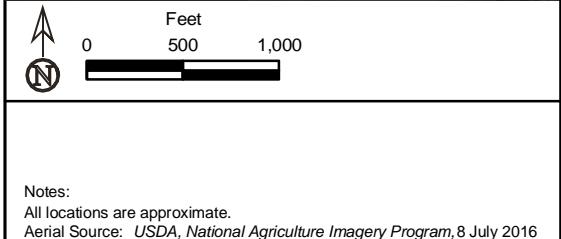
- Approximate Project Boundary
- Wild Wings Water Recycling Facility
- Groundwater Monitoring Well Location
- Groundwater Elevation Contour (ft msl)  
5 Foot Interval
- Groundwater Flow Direction

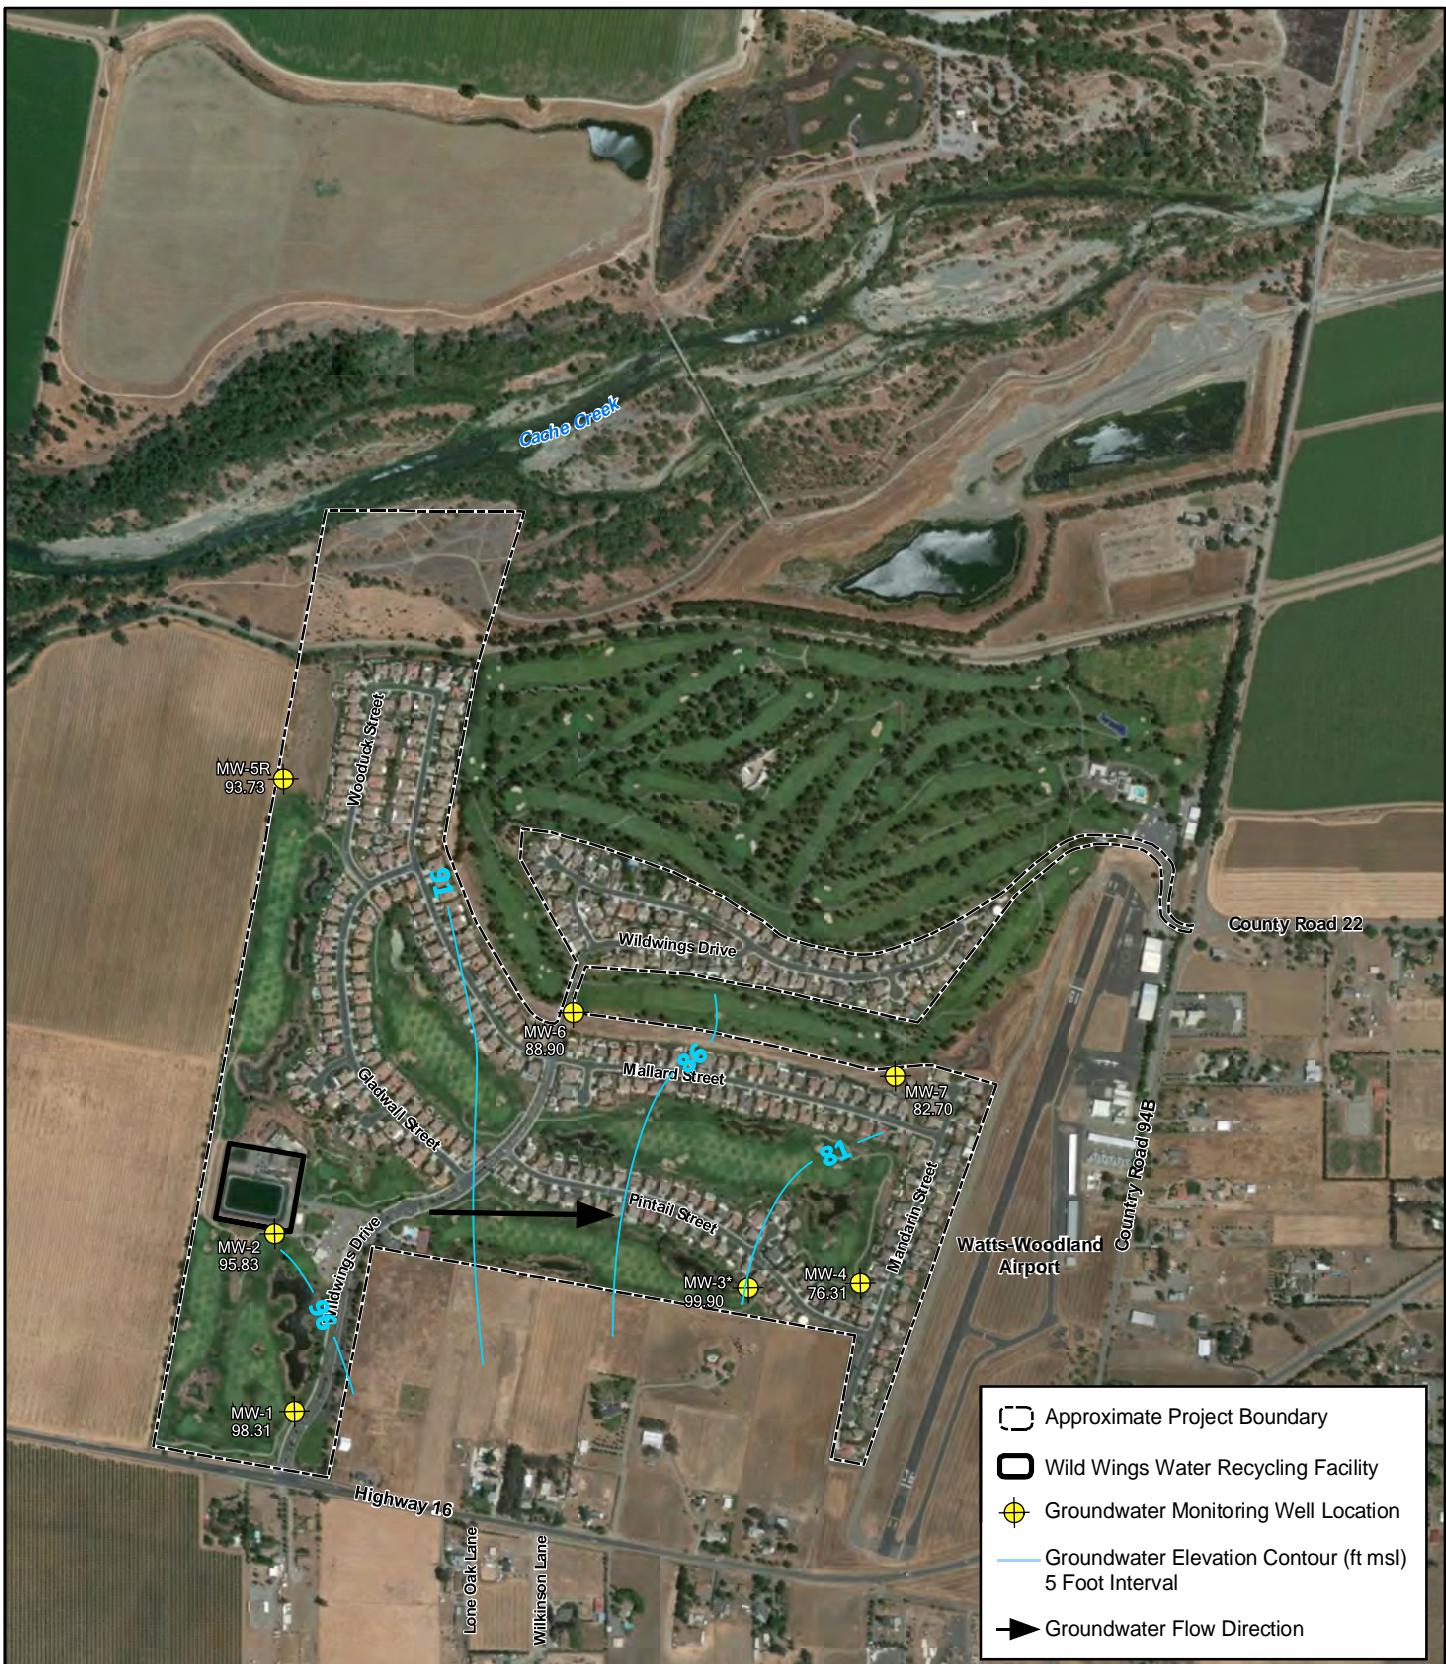
**Figure 2**  
**Groundwater Elevation Contours**

Groundwater elevations in June 2019 (Second Quarter 2019) ranged from 76.31 feet msl in MW-4 to 99.90 feet msl in MW-3, and were within historic ranges. Monitoring wells MW-4 and MW-5R showed the greatest changes in groundwater levels this quarter, with water levels in MW-3 actually declining. This transition from the winter into spring trend continues and is fairly consistent within the monitoring well network. Table 2 lists the water level measurements. Chart 1 shows the current and historic groundwater levels.

Due to MW-3 being screened within a perched water zone it was left out of groundwater contouring, flow direction, and gradient calculations.

The groundwater flow direction and gradient for June 2019 were calculated using wells MW-1, MW-4, and MW-5R, which is consistent with past practice and historically reported data. Using these wells, the groundwater flow direction was to the east (90.3 degrees) with a gradient of 0.006 feet/feet. The groundwater gradient is generally consistent with historic results, but flow direction is more to the east than normal. Figure 2 displays the groundwater surface elevations at each well, the groundwater contours, and flow direction. In the northern portion of the site the groundwater flow direction appears to be influenced by Cache Creek. Table 3 lists the historic and current groundwater flow directions and gradients.

In general, the annual rainfall amounts, irrigation practices at farm lands and golf courses, and variations in groundwater pumping to meet local domestic water needs can impact the local groundwater contours, flow direction and gradients. However, for the First Quarter 2019 monitoring event, these parameters remained within historical ranges for groundwater levels. The most recent GW contours reflect an overall increase from the First Quarter 2019 data corresponding to a wetter winter season. Generally, groundwater levels changes track each other across the various monitoring wells. GW flow gradients remain in the range of historical observations at 0.006 ft/ft for the quarter and the direction of flow is almost due east.

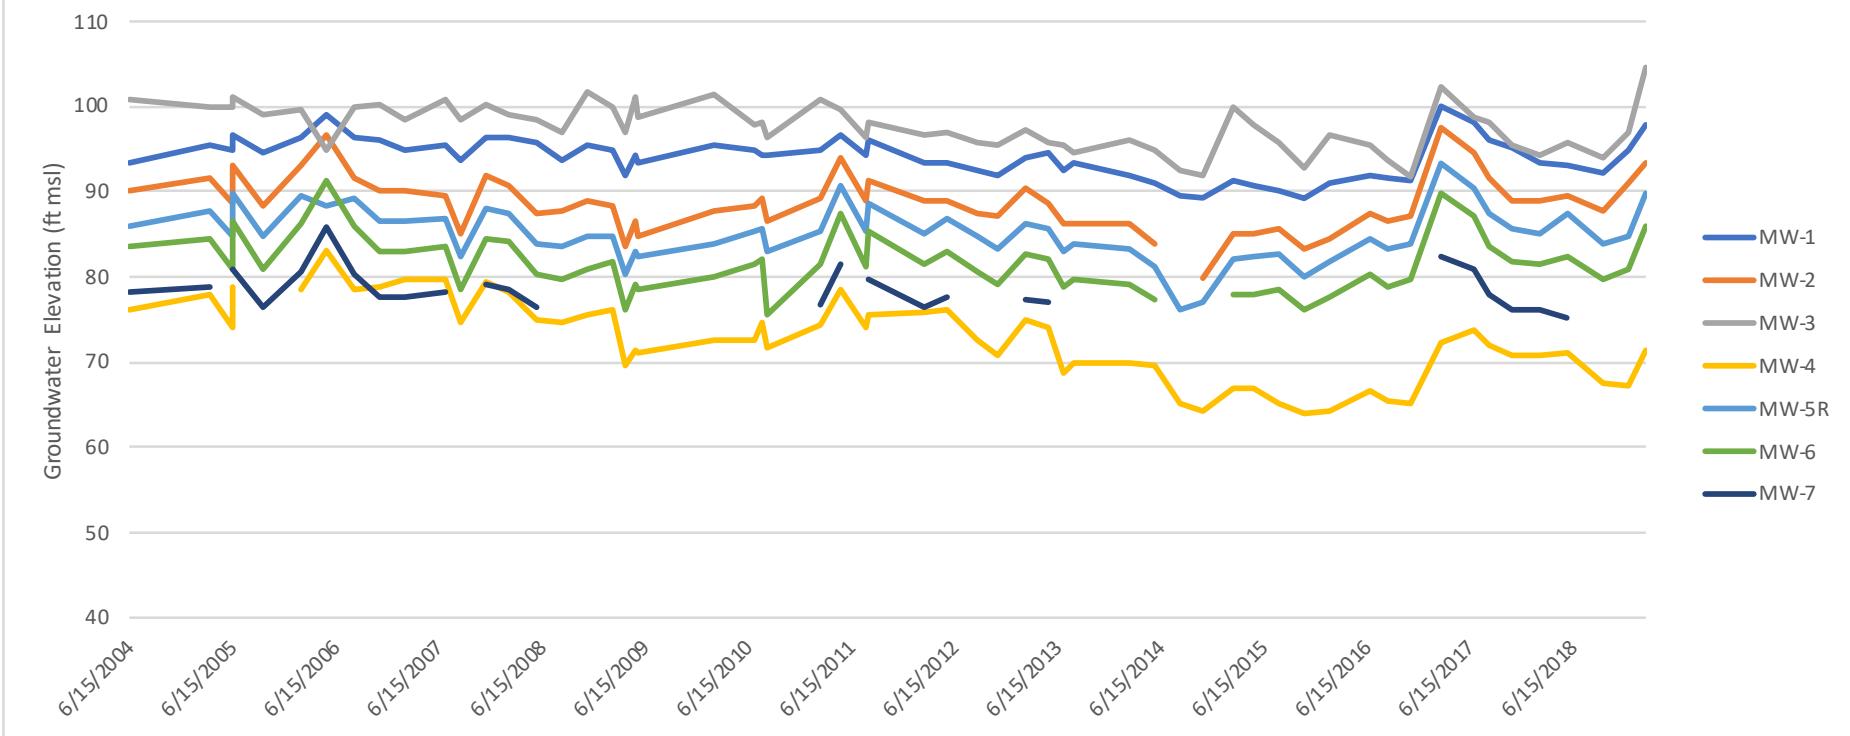
Chart 1  
Water Levels 2004-19

Between the First Quarter of 2019 and Second Quarter of 2019, groundwater levels rose an average of 1.64 feet. This matches what is commonly understood to be seasonal variations with moving from a relatively dry fall into a somewhat wetter winter season. Looking at the generalized pattern of rainfall and groundwater levels in the area since fall 2016 the trends in

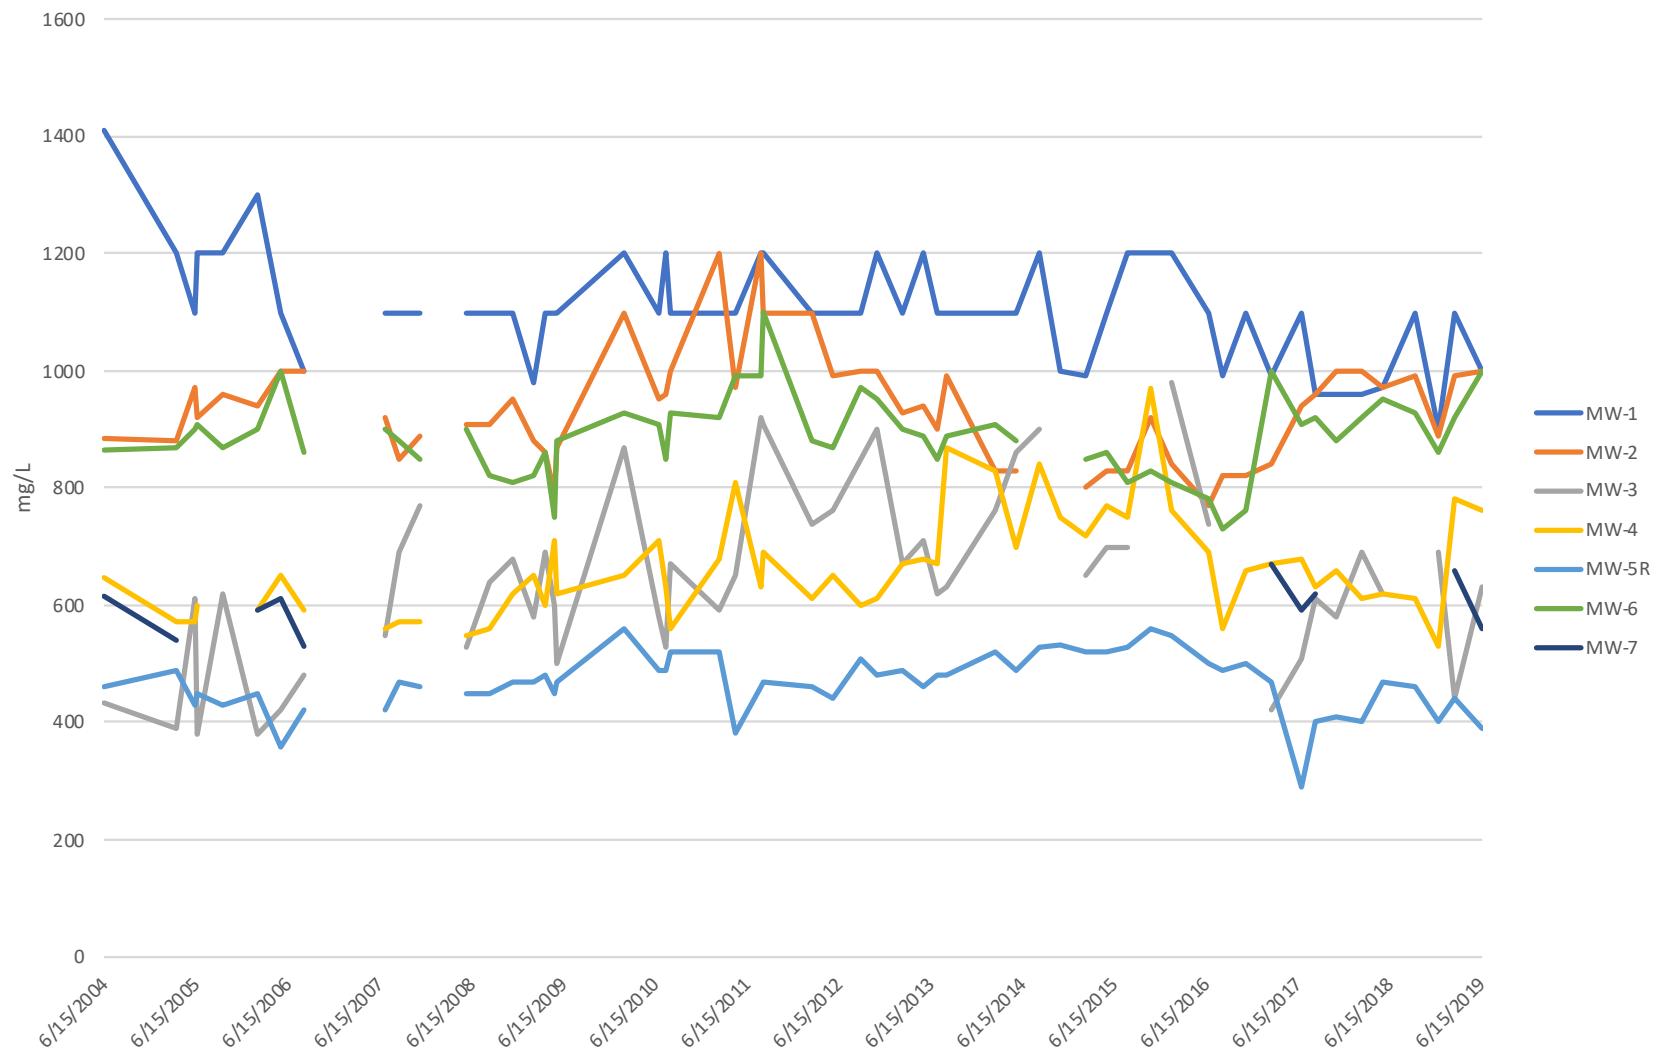
Chart 3  
TDS Trends 2004-19

TDS concentrations were up in three wells and down in four wells this quarter, but the changes were all within historical ranges.

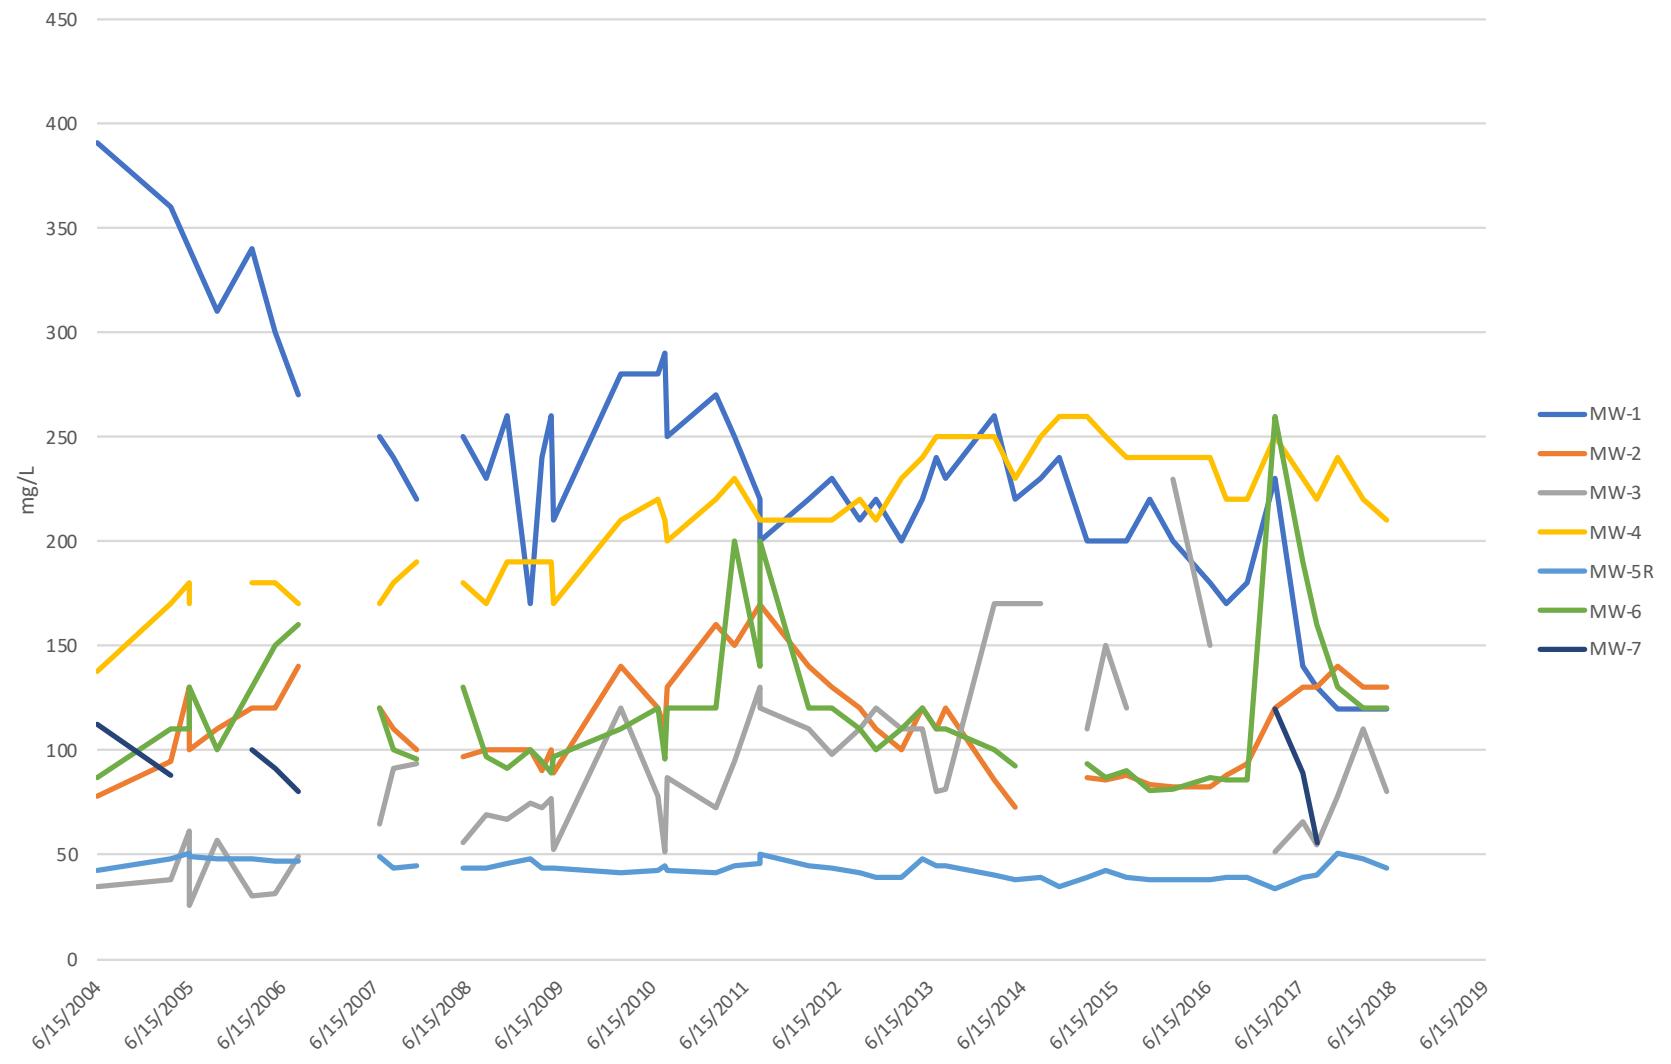
Chart 5  
Cl Trends 2004-19

Overall chloride trends are consistent with prior result ranges with only MW-6 showing a notable increase.

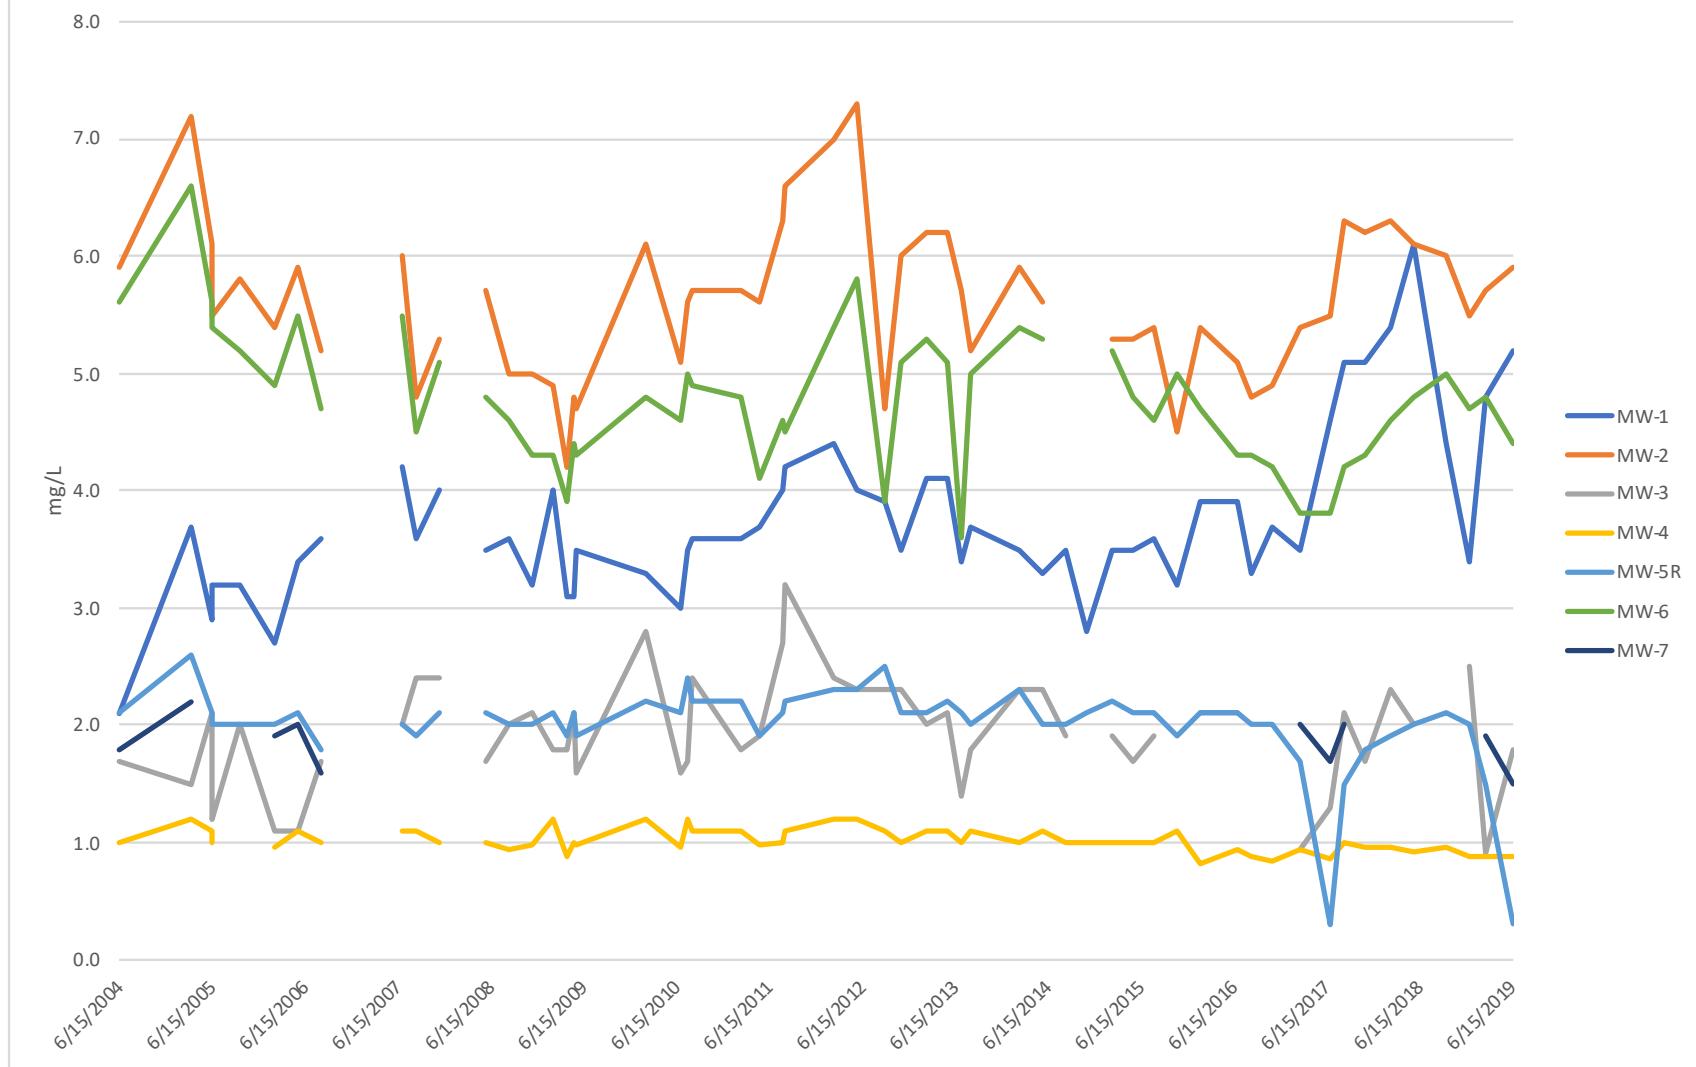
Chart 6  
B Trends 2004-19

The highest nitrate (as N) (14 mg/L) and the highest total N (14 mg/L) were detected in the sample from MW-4. The sample from MW-2 again had the highest boron (5.9 mg/L) concentration detected, also consistent with historic results and mirroring the recent trend of all boron levels being elevated.

The water quality results from the Second Quarter 2019 monitoring event show that every monitoring well sampled exceeded the interim groundwater limitation for boron except for one, consistent with historic results.
