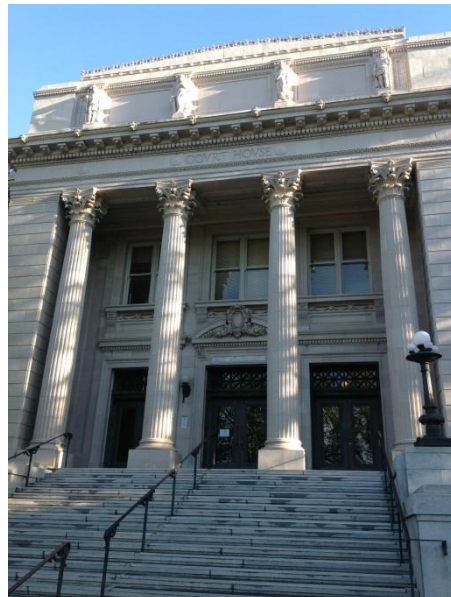
Image 4 – Courthouse Main Entry

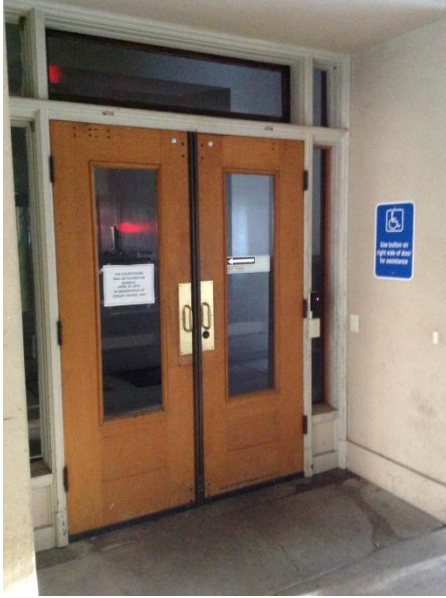
Image 9 – Main Basement Entry

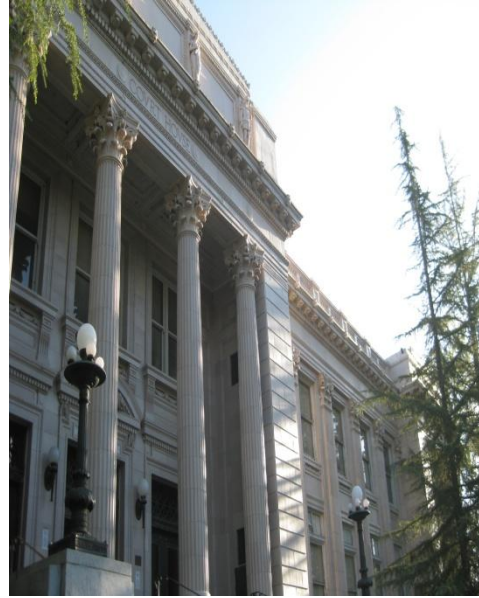
Image 10 – South Façade

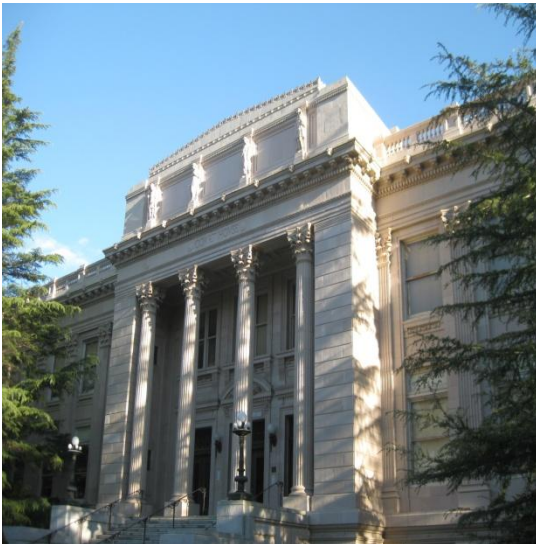
Image 11 – South Façade

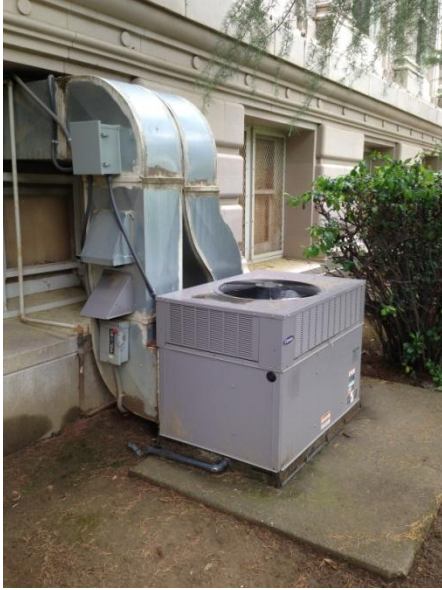
Image 25 – RAC at Grade – First Floor HVAC

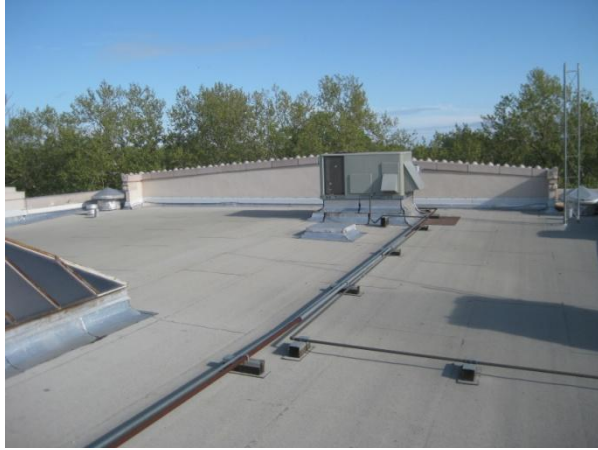
Image 33 – Existing Roof

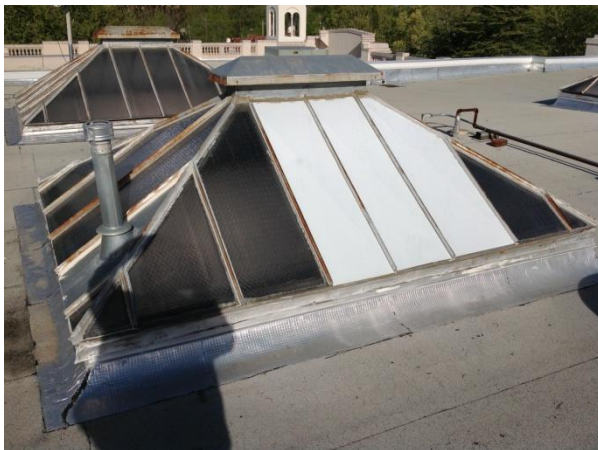
Image 39 – Skylight Over Rotunda

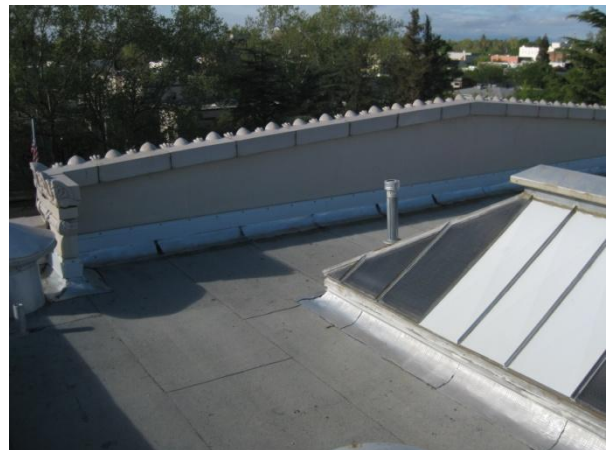
Image 40 – Skylight Over Rotunda

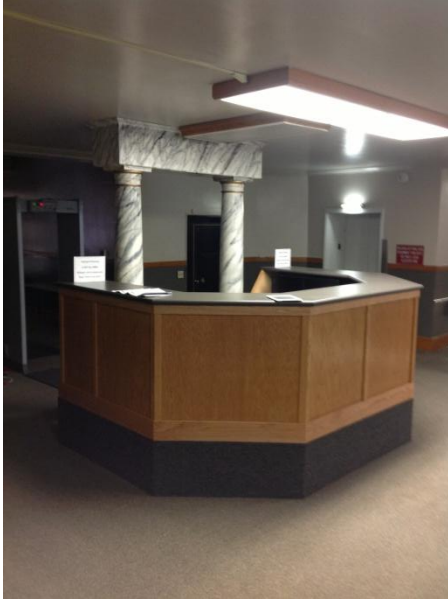
Image 45 – Courthouse Main Entry

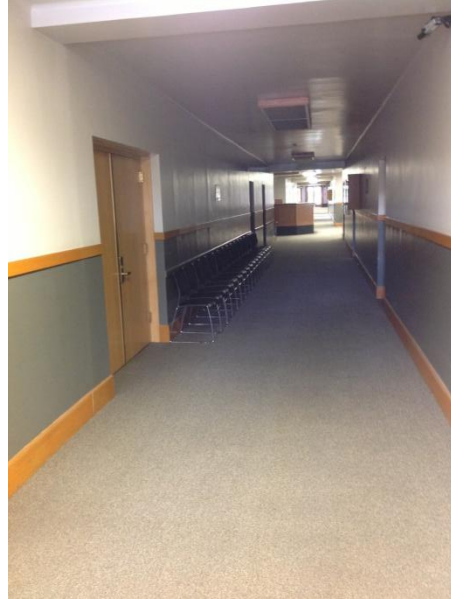
Image 46 – Basement Main Corridor

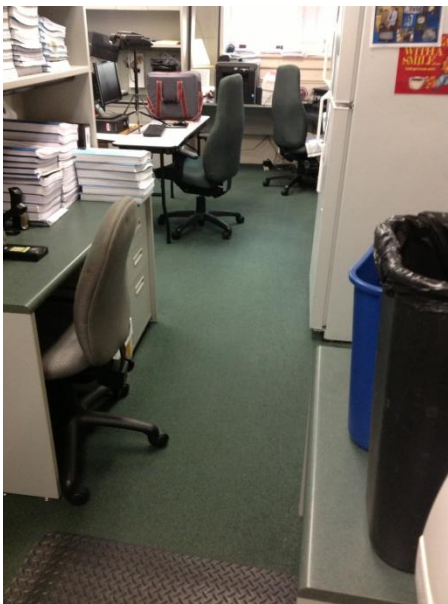
Image 47 – Exiting Office Space

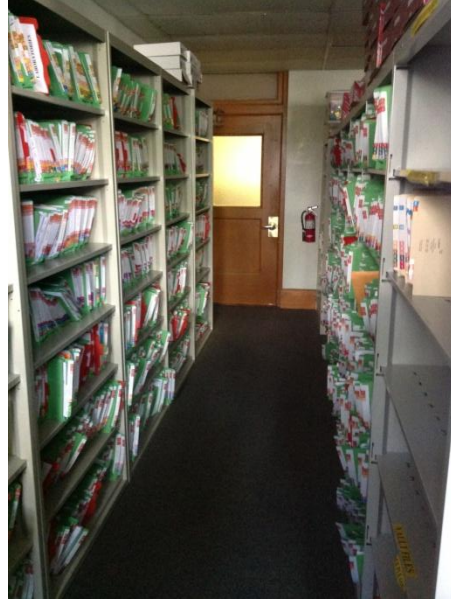
Image 50 – Filing Aisle

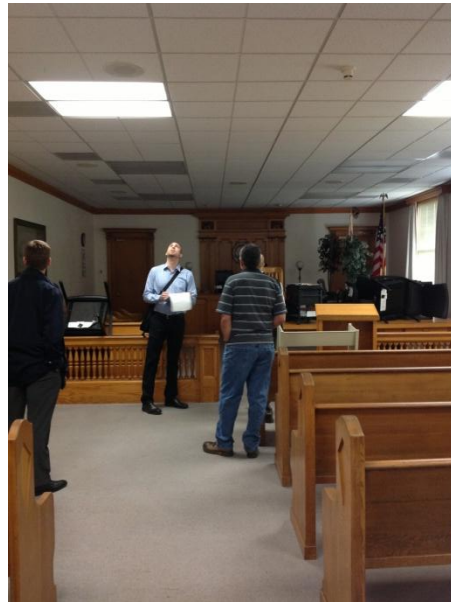
Image 52 – Existing Courtroom

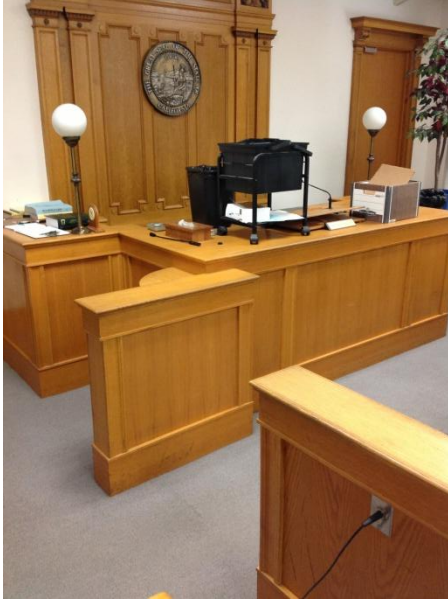
Image 53 – Existing Courtroom

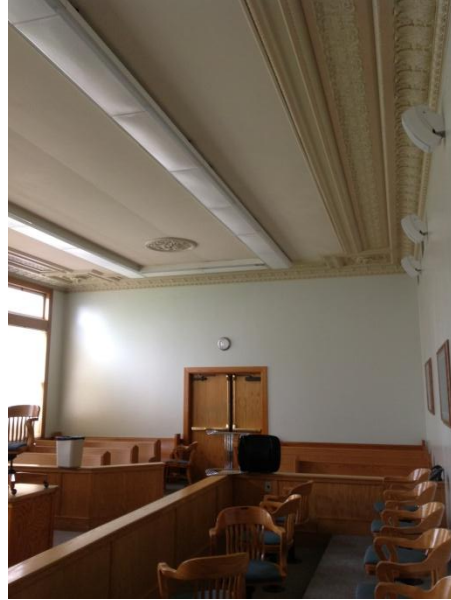
Image 54 – Existing Courtroom

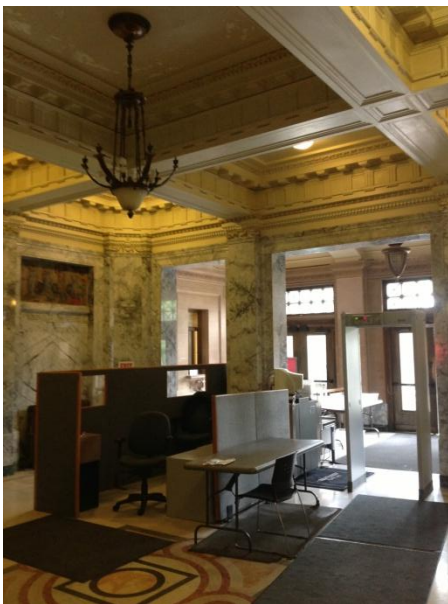
Image 55 – First Floor Rotunda

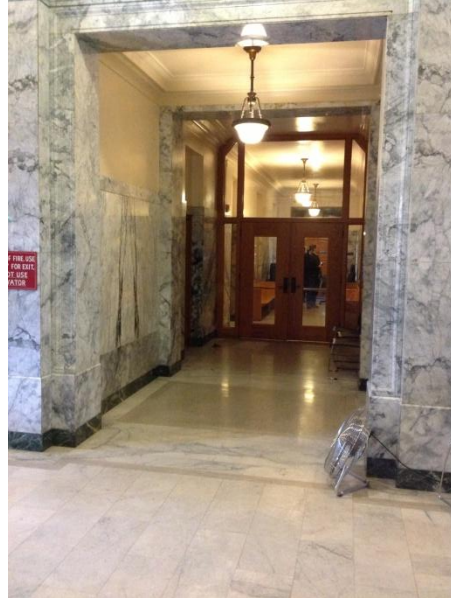
Image 58 – Main Hallway

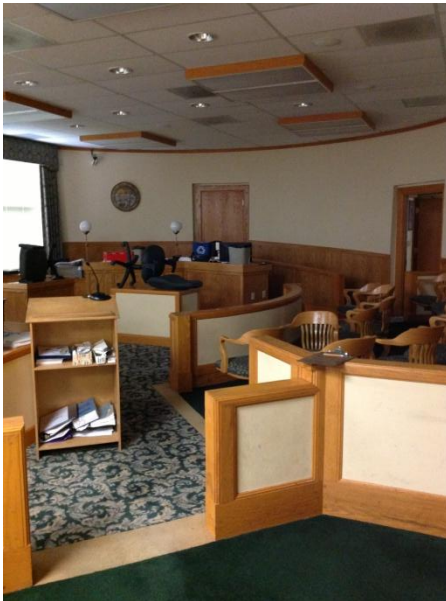
Image 59 – Existing Courtroom

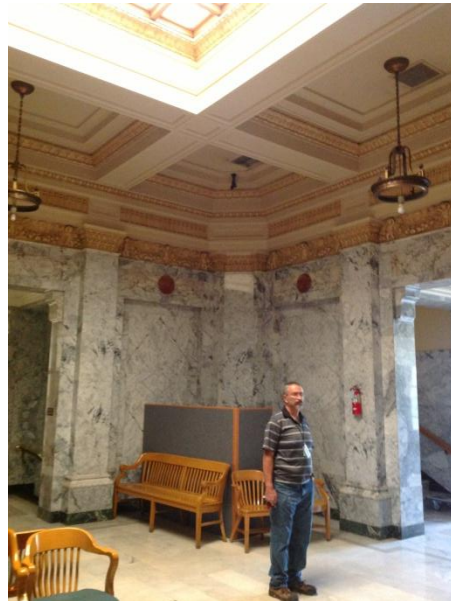
Image 60 – Second Floor Rotunda

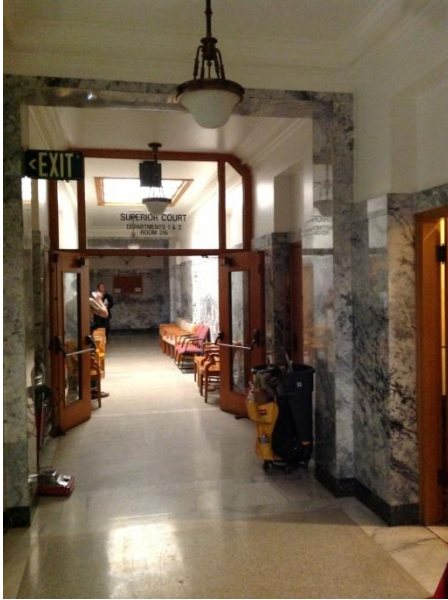
Image 61 – Main Hallway

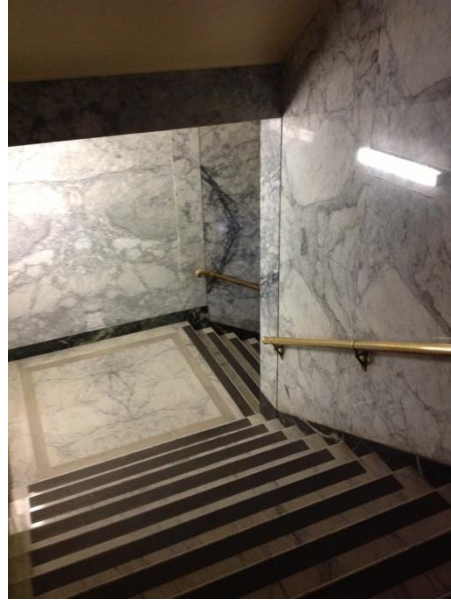
Image 62 – Formal Staircase

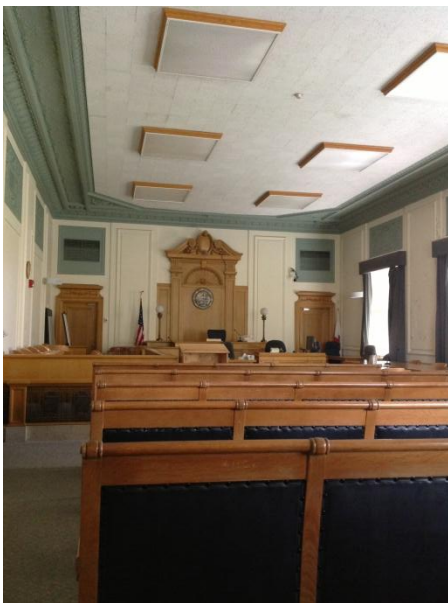
Image 63 – Existing Courtroom

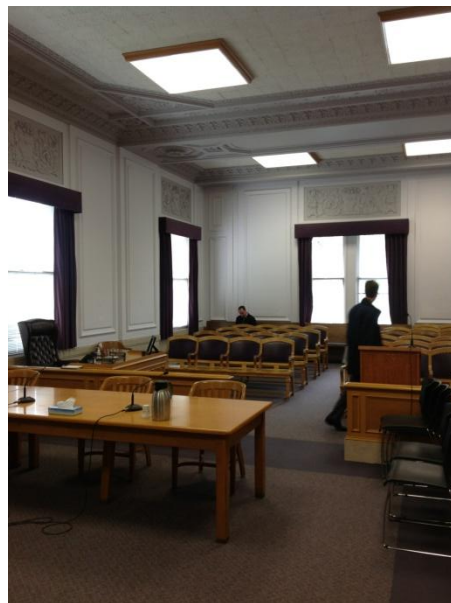
Image 64 – Existing Courtroom

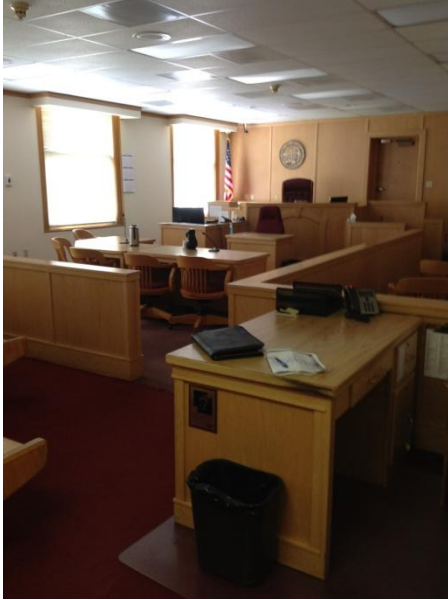
Image 65 – Existing Courtroom

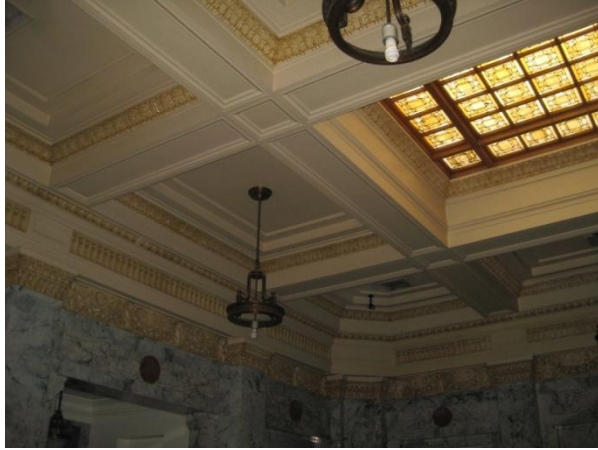
Image 69 – Lobby Ceiling

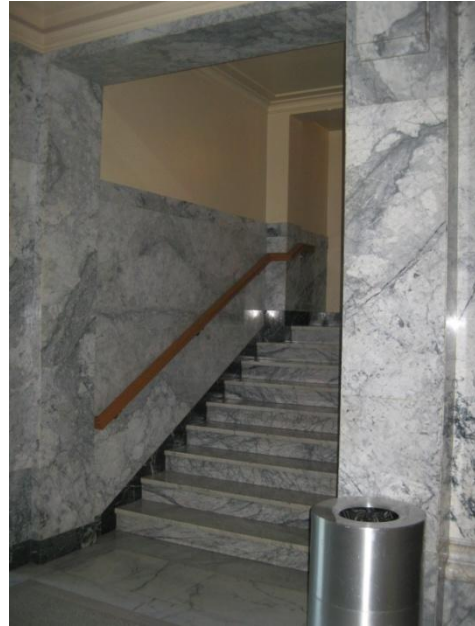
Image 70 – Formal Staircase

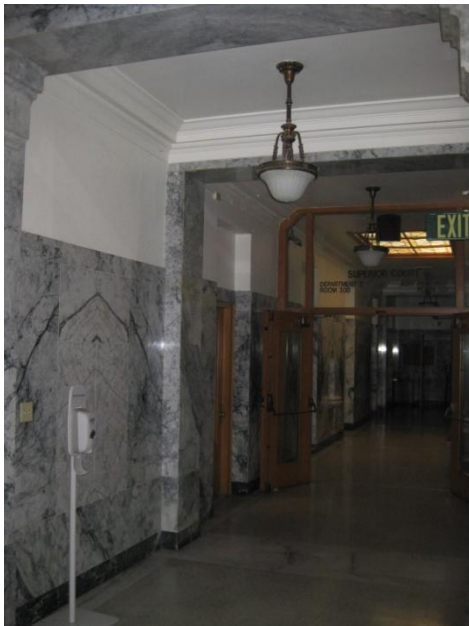
Image 71 – Main Hallway

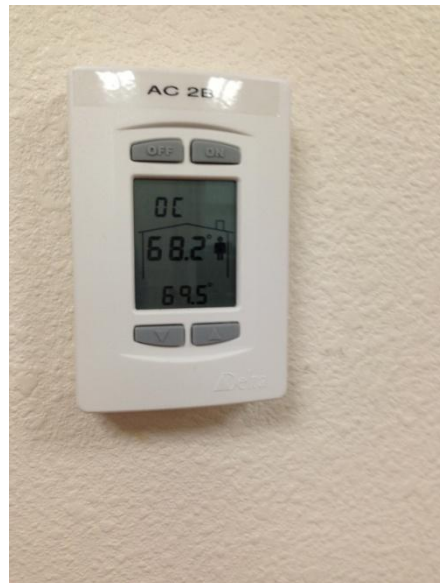
Image 76 – Delta Control Thermostat

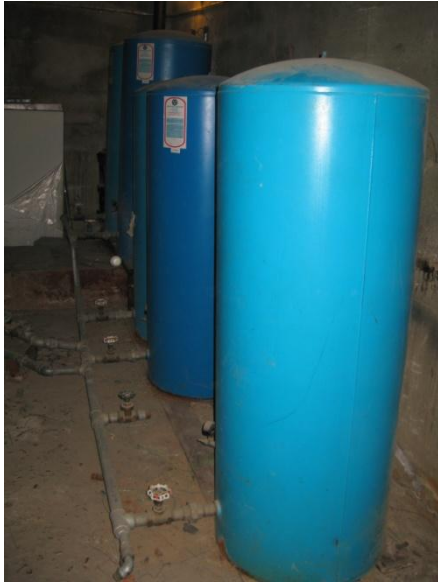
Image 77 – Un-braced Tanks

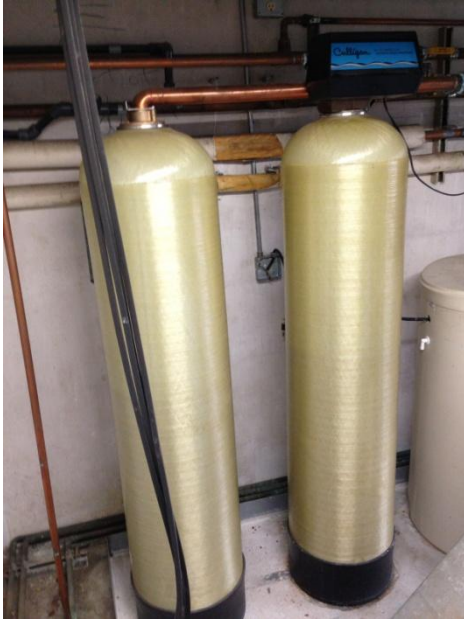
Image 85 – Water Softener

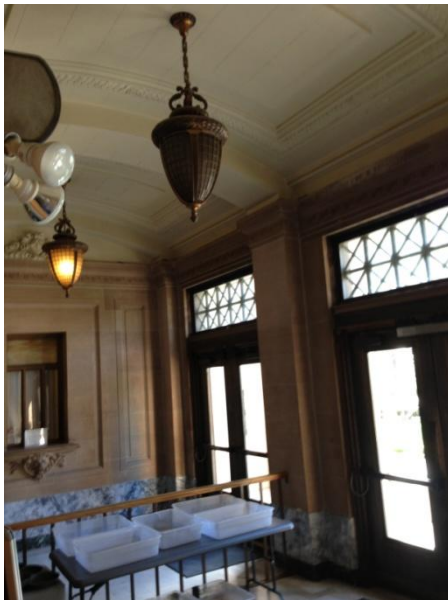
Image 87 – Acorn Pendant Light
