LIONAKIS

# TABLE OF CONTENTS

Yolo County Administration Office  
625 Court Street, Room 202  
Woodland, CA 95695

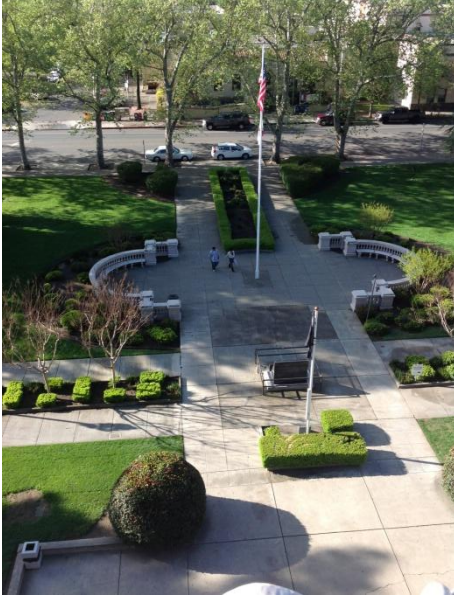
Image 1 – Formal Plaza at South Side of Courthouse

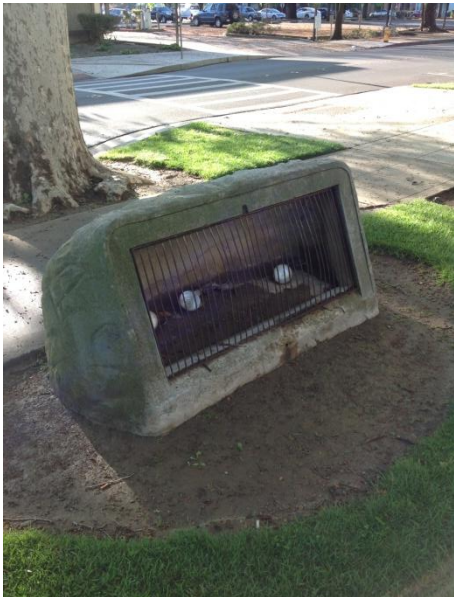
A protective paint surface was observed to be deteriorating from the site elements located at the front plaza.

Image 3 – Faux Rock Lighting Enclosure

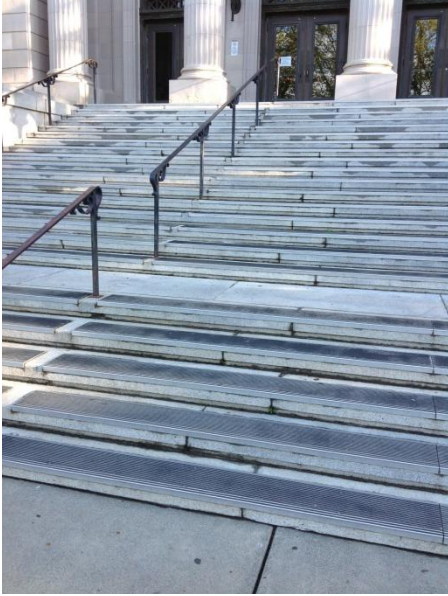
The grand entry stairway is in good condition but has been covered with aluminum treads, likely in response to safety concerns, which deter from the historic nature of the courthouse.

Image 5 – Grand Entry Stairway

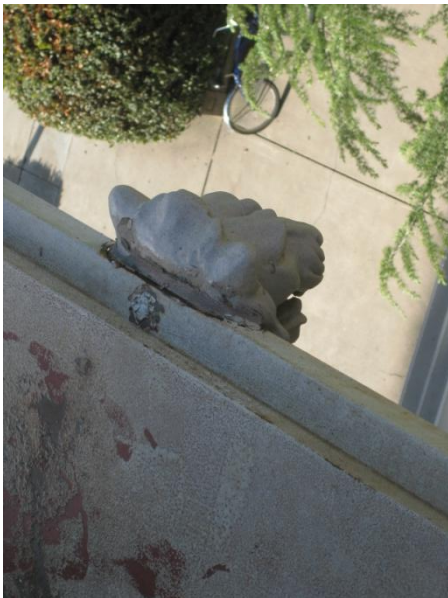
Image 31 – Cornice Element

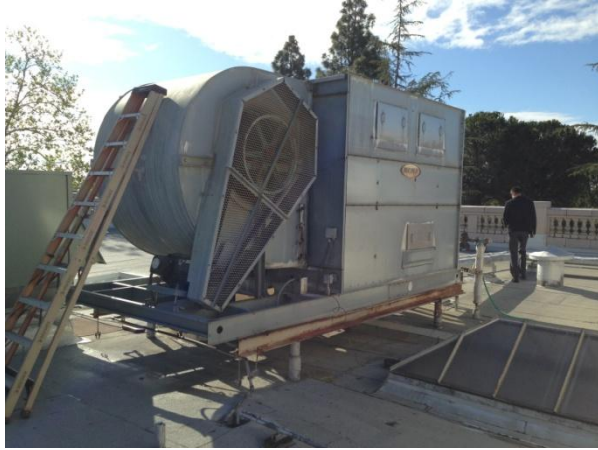
Image 41 – Fluid Cooler

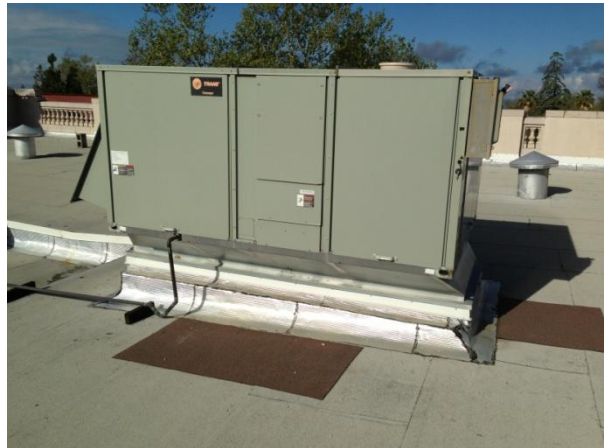
Image 44 – Rooftop RAC

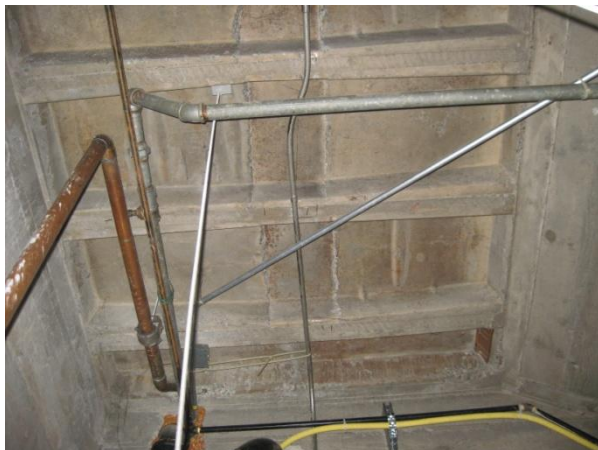
Image 75 – Un-braced Utilities

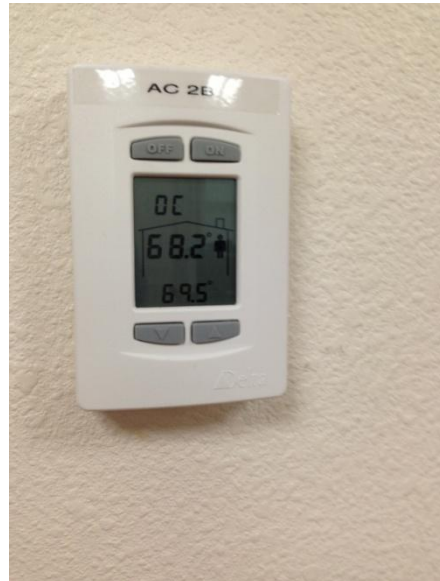
Image 76 – Delta Control Thermostat

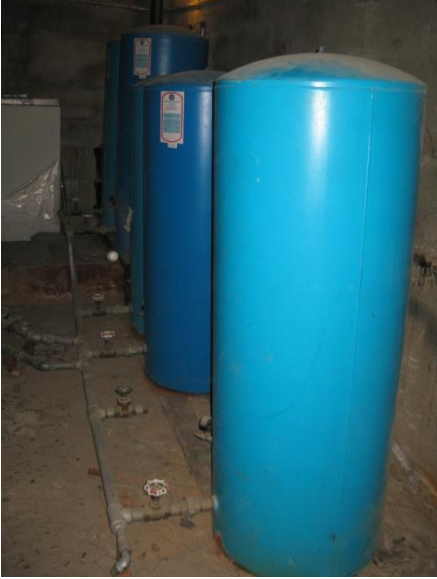
<p>Image 77 – Un-braced Tanks</p>	<p>Image 78 – Tank without Base Anchorage</p>

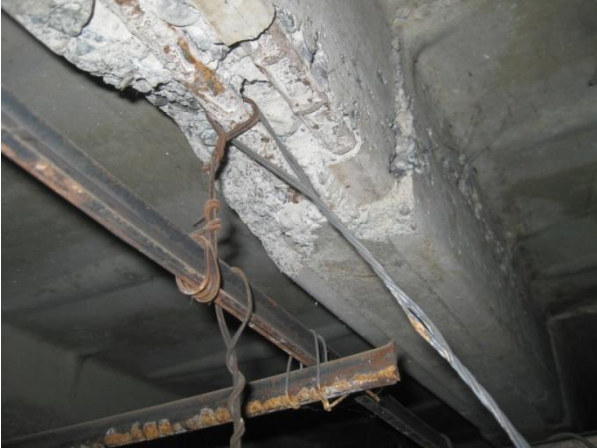
A photograph showing a ceiling area with significant water damage. The concrete is cracked and peeling. Exposed rebar is visible, along with blue flexible hoses and a metal pipe.
<p>Image 81 – Exposed Rebar Supporting Ceiling</p>	<p>Image 82 – Exposed Rebar at Water Damage</p>
  A photograph showing a wall section with hollow clay tiles. The tiles are partially covered by a white plaster or paint that is peeling and cracked. A metal pipe runs horizontally across the top of the frame.

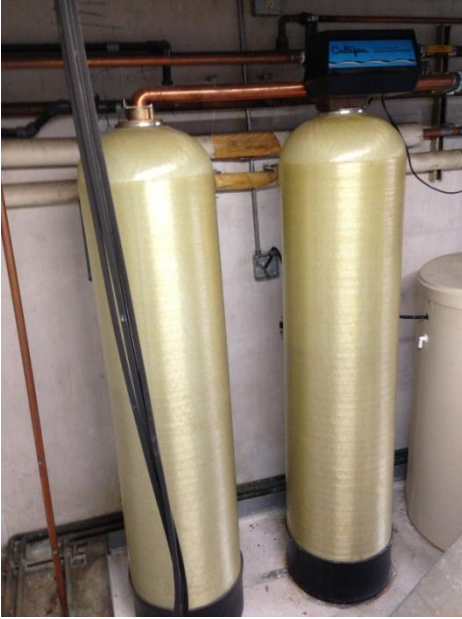
Image 85 – Water Softener

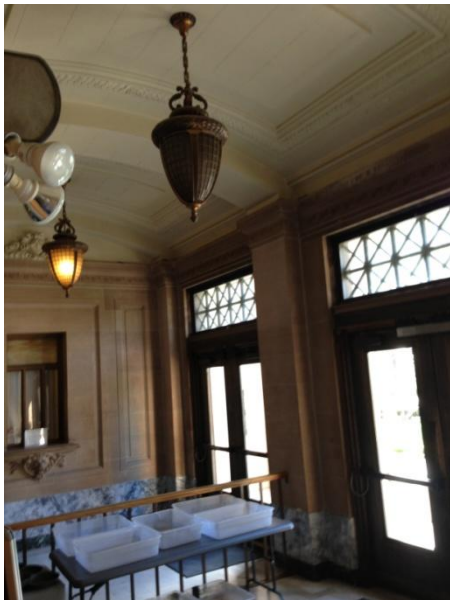
Image 87 – Acorn Pendant Light
